File: 18623/Vaughan/West Don Valley Bridge-BL8-BR003
Date: June 20, 2018

RE: WEST DON VALLEY NORTH BRIDGE BL8-BR003, ANNUAL FIELD REVIEW

WEST DON VALLEY SOUTH BRIDGE M529, ANNUAL FIELD REVIEW - PICTURES

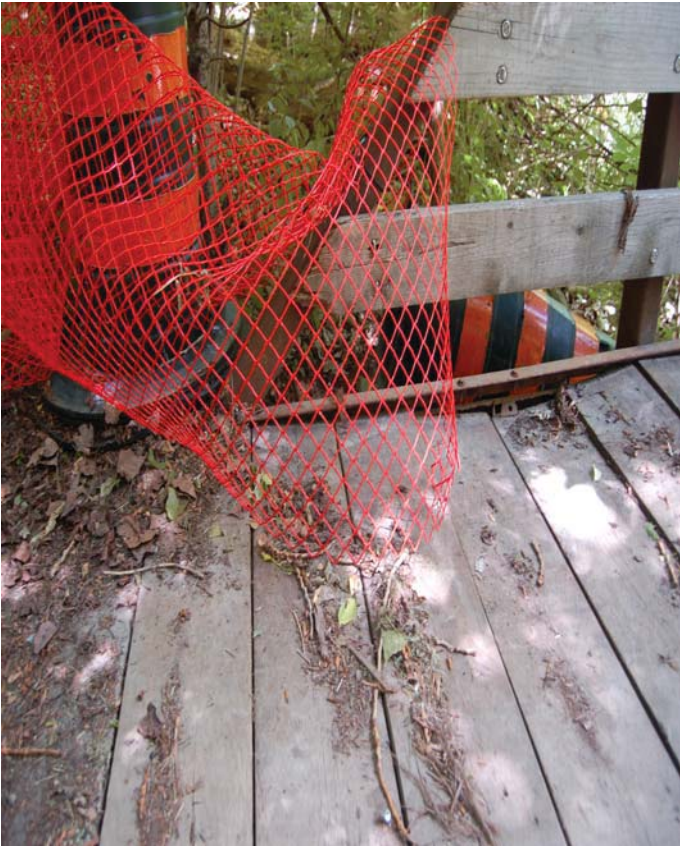
1. Serious deterioration of the wooden deck was observed at west abutment location of the bridge in first three bays. The steel angles supporting wooden deck longitudinally along the main trusses (on both sides) for the entire bridge length rusted away in first four bays, causing support loss for the decking.
2. The two main trusses are in good condition. Two pilot holes previously drilled through the bottom of the lower chord were reviewed and no serious deterioration was observed.
3. The diagonal horizontal bracing had visible surface rusting. Four pilot holes previously drilled through the bottom and side in two selected HSS members

Deteriorated deck support – west abutment – north side

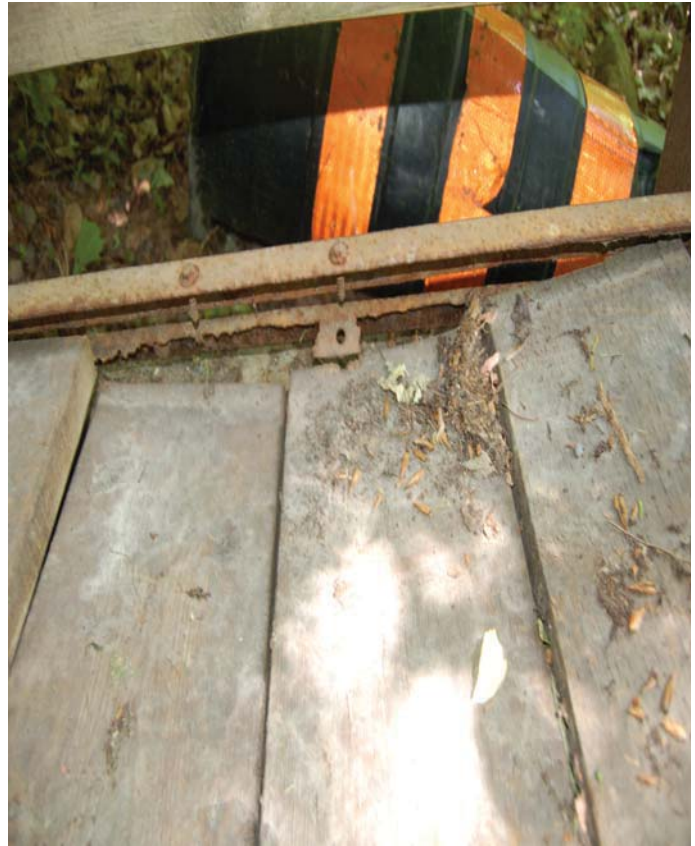
Deteriorated deck support – close up

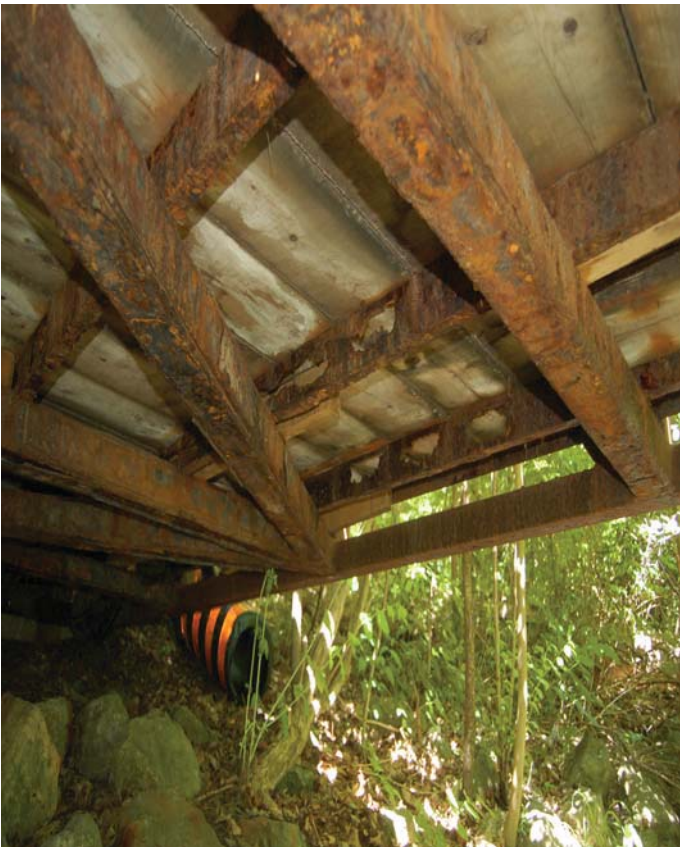
- were re-examined. The loss of material thickness was estimated at 20% to 40%.
4. There are 4 longitudinal channels (76mmx34mm) supporting mid-portion of the wooden deck, spanning approximately 1.1m maximum. Channels in first four bays on the west side of the bridge completely rusted, causing support loss for the decking. See attached pictures. Surface rusting appeared to be relatively shallow and no significant loss of the section was observed for the rest of the bridge.

Rusted away and collapsed channels – bay 3

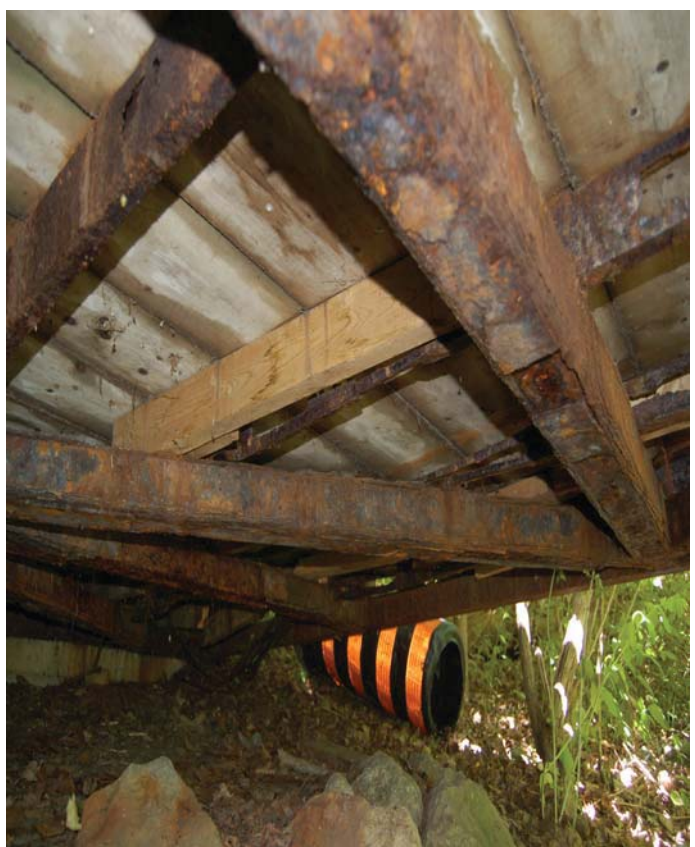
Rusted away and collapsed channels – bay 2

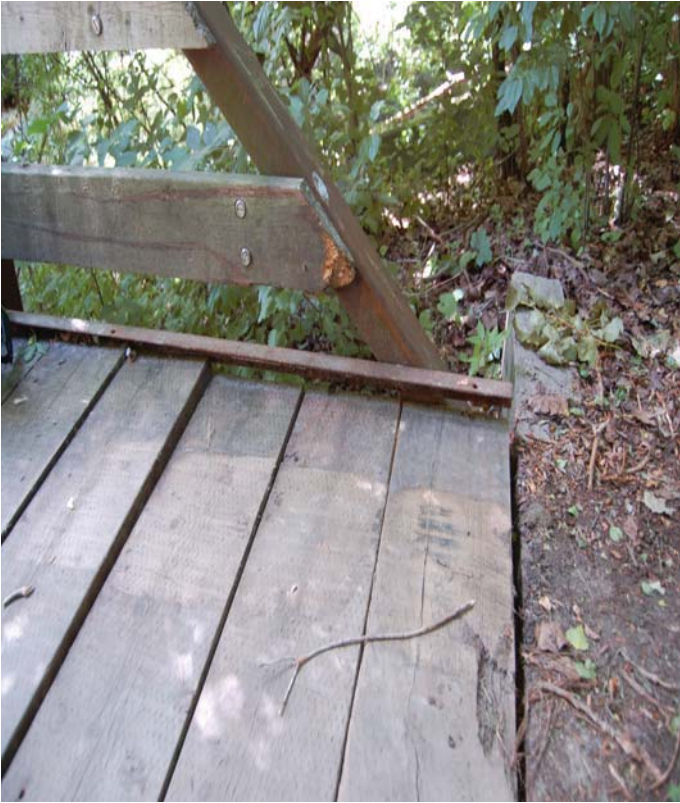
Deteriorated deck support – west abutment – south side
