**2025 ANNUAL PERFORMANCE REPORT**

# **STORMWATER MANAGEMENT SYSTEM**

**Reporting period: Jan. 1, 2025 to Dec. 31, 2025**

A description of the City of Vaughan's Municipal Stormwater Management System to fulfill the requirements of CLI-ECA #011-S701

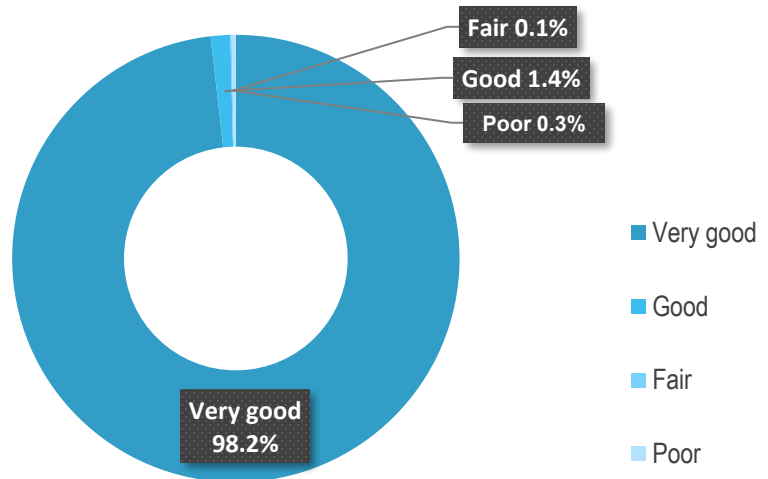
**Figure 1: Asset Condition Summary (SWM System)**

- **providing input to the risk assessment of assets.**
- **providing input to the annual capital and operating budgets.**
- **determining the Authorized System’s condition.** According to the City’s [2025 Asset Management State of Infrastructure Update](#), nearly 98.2 per cent of the City’s service assets in the SWM system are in “Very Good” condition. The remaining assets are in “Good” and “Fair” condition, indicating they meet current needs but may require attention in the future as they age, as shown in Figure 1.
