CITY OF VAUGHAN

EXTRACT FROM COUNCIL MEETING MINUTES OF SEPTEMBER 26, 2017

**RESTORATION OF A DETACHED
RESIDENTIAL BUILDING AND NEW DEVELOPMENT
9869 KEELE STREET AND 9891 KEELE STREET
(WILLIAM BAILEY HOUSE) - MAPLE HERITAGE CONSERVATION DISTRICT
DESIGNATED UNDER PART V, ONTARIO HERITAGE ACT
WARD 1 - EAST SIDE OF KEELE STREET AND SOUTH OF MAJOR MACKENZIE DRIVE**

(GBCA Project No: 17021)

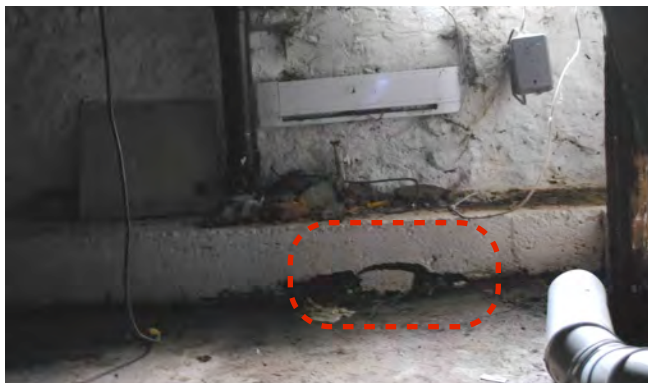
The rubble stone foundation appears to have been recently painted. Underneath this is a poured concrete floor which has encountered some deterioration, especially at the foot of the staircase, and is also evident on the floor and sill plate. This is likely due to standing water at a recent point in time. The presence of moisture retention in the concrete is evident from dampness to the touch, and from visible wicking on cinderblocks that support the furnace.

Above: Deterioration of concrete foundation on the east elevation.

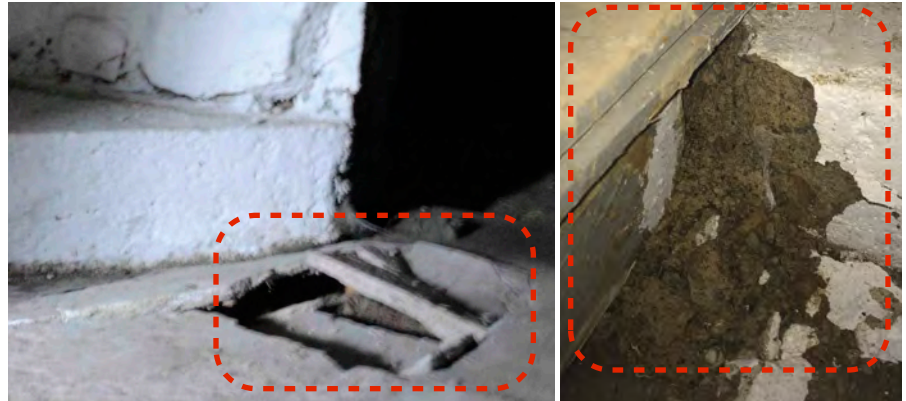
Above: Location of significant deterioration/buckling of the concrete floor before entry to boiler room, to the left. At the right, concrete foundation deterioration at foot of stair.

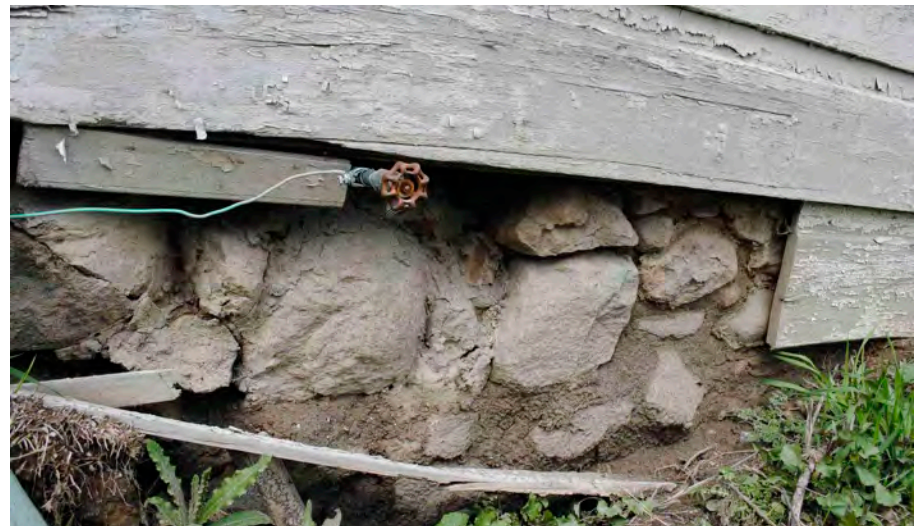
The exterior walls are constructed of rough-cut stone masonry ("rubble masonry" is a common term used). The varied coursing pattern, uneven in some areas, indicates a rapid construction. The mortar joints are heavily deteriorated. Most of the foundation walls will likely require repointing all the mortar joints and grout consolidation of the wall.

Below: Significant deterioration of mortar joints of rubble foundation on the north facade.

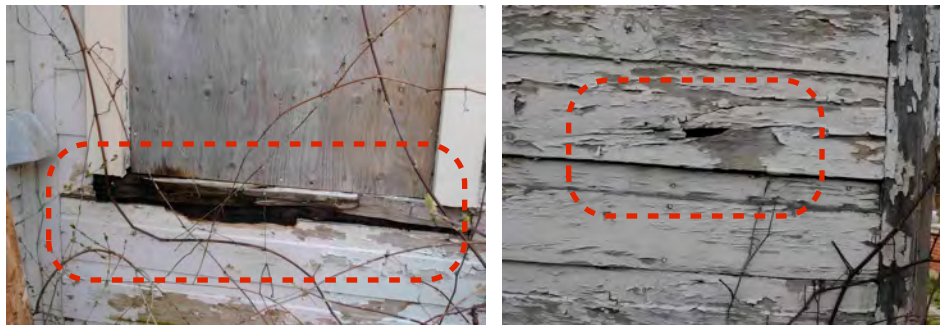
In several places, window sill's have deteriorated, which suggests that excessive moisture has been trapped inside and drying of the wood has been insignificant and deterioration has occurred at different levels.

Above: Detail of wood cladding deterioration, peeling paint, and sill rot noted on the east elevation.

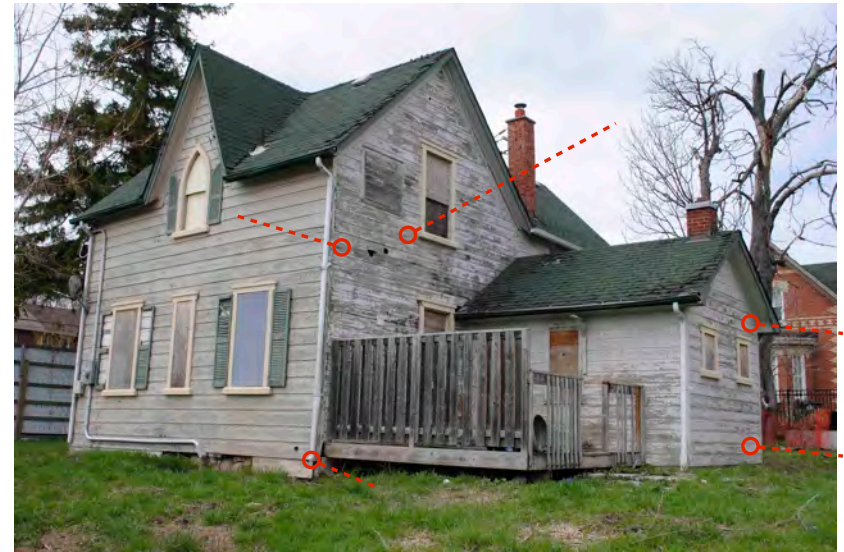
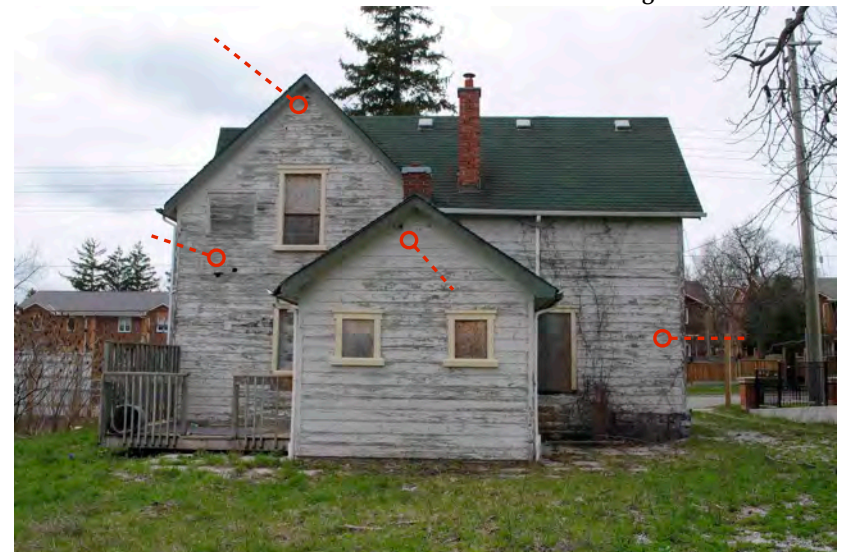
The wood siding on the east elevation is different than that on the west, north, and south elevations. While the structure does not appear to have settled, it is probable that the siding was replaced due to deterioration.

Above and Below: South and east facade exhibits wood cladding condition with areas of deterioration and openings. It is evident that different degrees of deterioration have occurred in wood elements of the building.

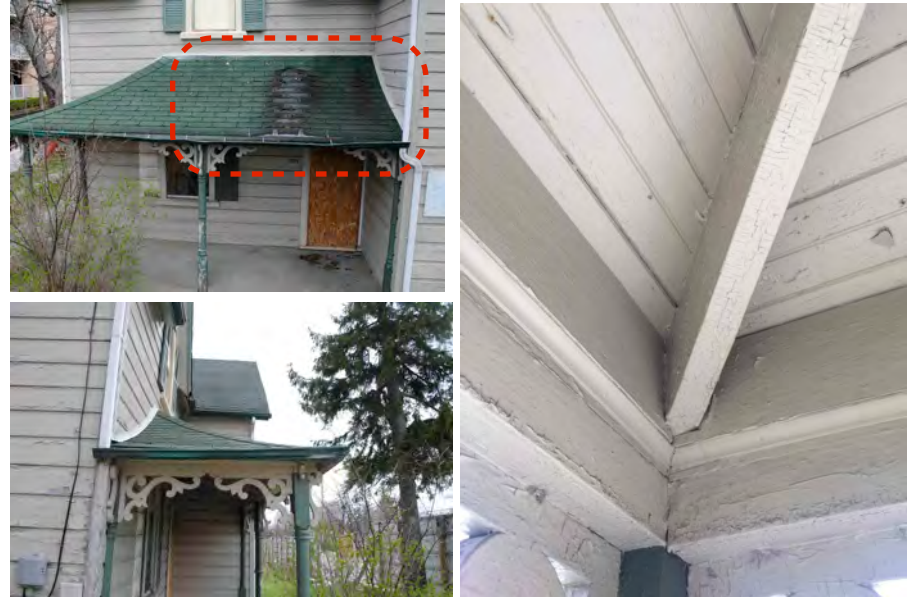
Above: Porch exhibits substantial damage to asphalt shingles which may also be responsible for wood deterioration below this surface. An invasive exploration will be required to determine the extend. Below: Roof shows further damage of shingle covering.

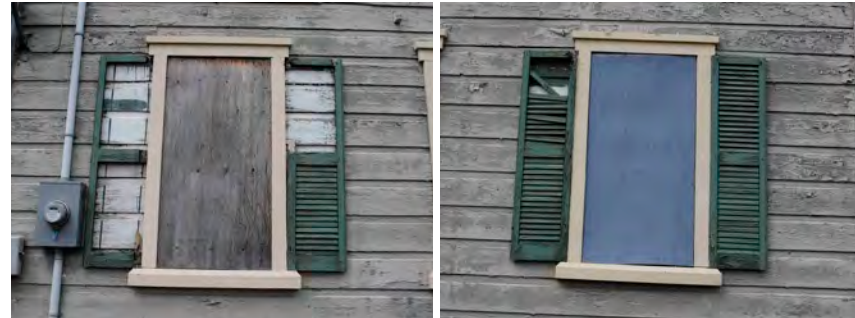
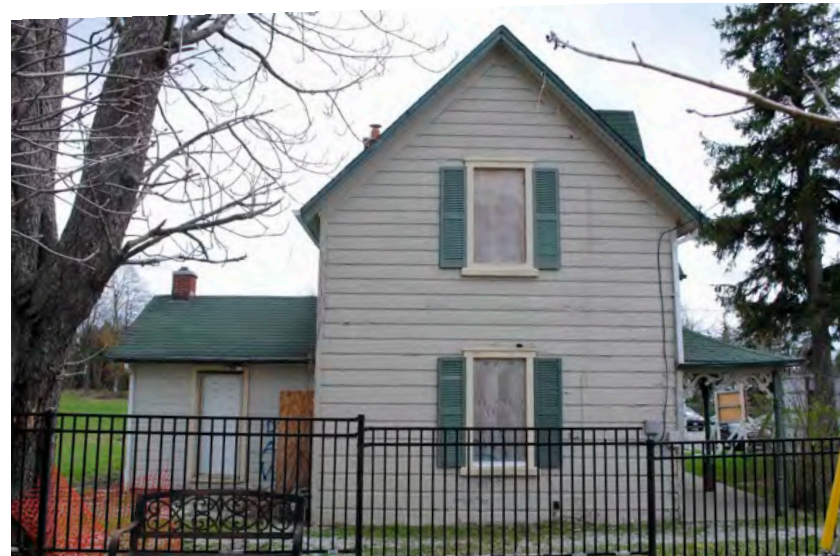
Shutters (not original) that hang on the exterior are in very poor condition and have seen noticeable damage as a consequence of exposure and lack of maintenance.

Above and Below: Rapidly deteriorating condition of shutters on east facade, compared with relatively good condition of shutters on the west facade below.

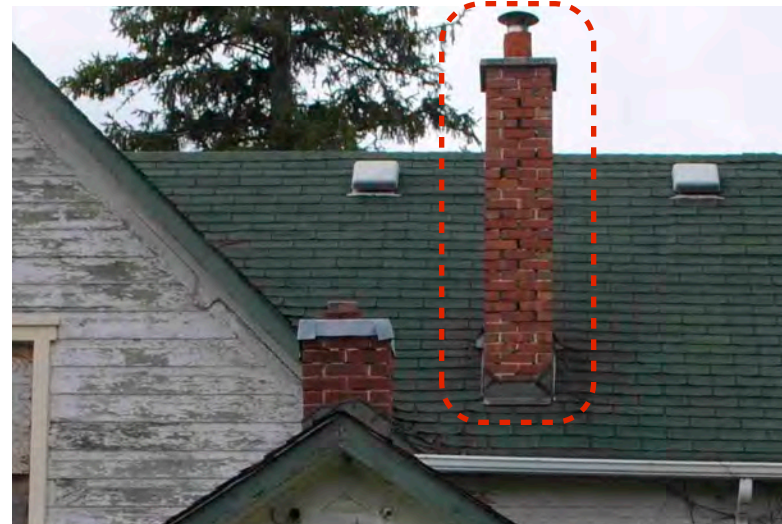
The building has two brick chimneys: one on the east slope of the gable roof and the other on the rear tail. It is likely that the original heating of the home was likely a fireplace in the main house, and a cast iron woodstove in the rear tail. Although only reviewed from the ground, the brick chimneys appear to have many defective mortar joints, as well as broken and damaged bricks. The flashing is not correctly installed.

Above: Defective mortar joints evident on chimney's above, will require repointing.

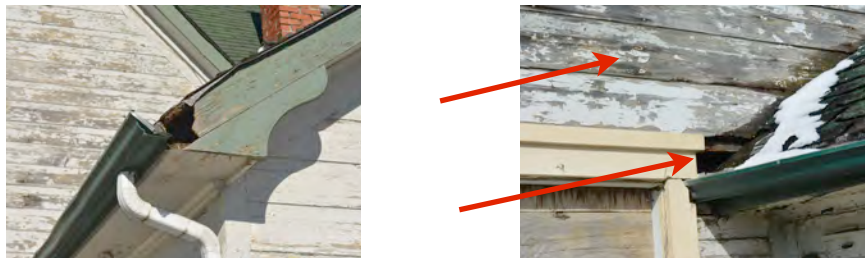
The exterior cladding is generally in fair to poor condition, signs of age and lack of maintenance are clearly evident. The paint work is currently failing, as evidenced by peeling and cracking of the finishes and gaps in the joints between cladding elements and trim. In several locations there are holes in the wood cladding and the fascia board.

Above: Deterioration of the wood cladding and fascia board on the south elevation

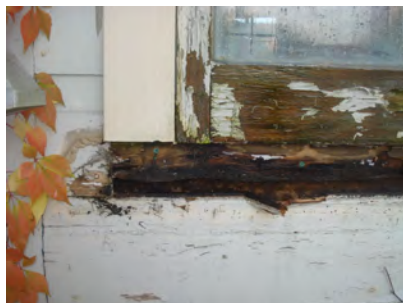
In several places, window sill's have deteriorated, which suggests that excessive moisture has been trapped inside and drying of the wood has been insignificant and deterioration has occurred.

Left: Sill rot notes on the east elevation.

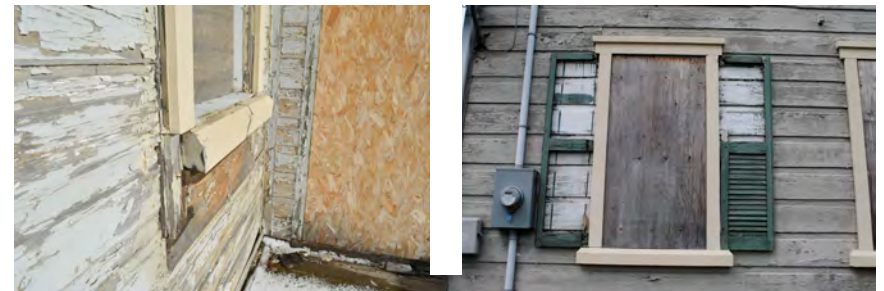
Shutters (not original) that hang on the exterior are in very poor condition and have seen noticeable damage as a consequence of exposure and lack of maintenance.

Above left: Deterioration of the styrofoam surrounds and peeling paint on the south elevation

Above right: Deterioration of one of the wood shutters, south elevation.

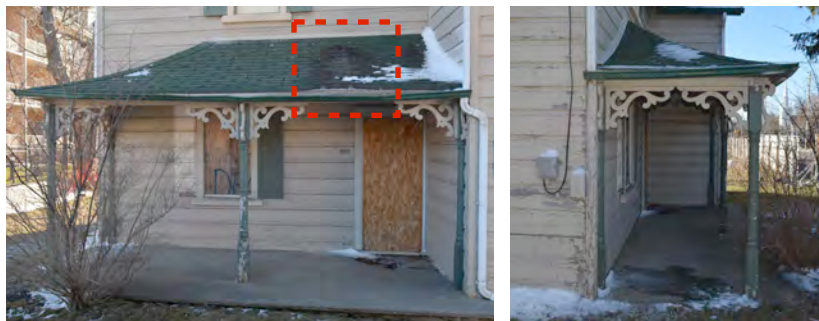
Above left: Some water staining is visible on the porch roof.

Above right: Side view of the porch, pilasters show some deterioration, at the base there is some areas of rot.

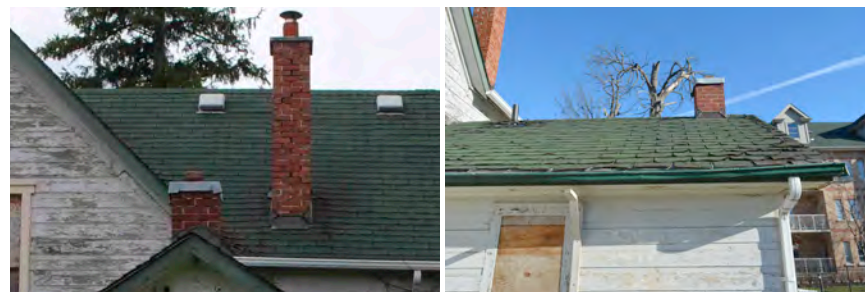
The building has two brick chimneys: one on the east slope of the gable roof and the other on the rear tail. The brick chimneys appear to have many defective mortar joints, as well as broken and damaged bricks. The flashing is not correctly installed.

Above left: Some water staining is visible on the roof. The mortar joint on the chimney are severely deteriorated.

Above right: Deteriorated asphalt shingles.
