**RESTORATION AND ALTERATIONS TO KLEINBURG UNITED CHURCH
DESIGNATED UNDER PART V, ONTARIO HERITAGE ACT
10418 ISLINGTON AVENUE, KLEINBURG-NASHVILLE HERITAGE CONSERVATION
DISTRICT
WARD 1 - VICINITY OF ISLINGTON AVENUE AND STEGMAN'S MILL ROAD**

Building Condition Assessment
Kleinburg United Church | KLEINBURG

Prepared by:
Lynch + Comisso: Architecture + Light
23 January 2017
1628

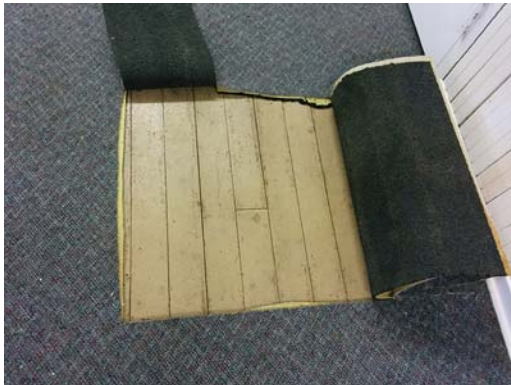
Slab on grade at Basement appears to be slightly sloping to the west. Carpet was pulled out in one location and a wood floor was observed. At door between existing kitchen and stairwell at northwest corner, Basement floor construction could be partially observed and appears to be 2x2 wood strapping at 16" o/c with a wood decking on top. Thickness of concrete layer underneath is not known and was not visible. Concrete floor has rough rubble surface. In the kitchen and washroom areas the wood floor was covered with asbestos vinyl tile concealed with sheet linoleum. The wood floor appears to be damaged. Refer to the designated substances Survey completed by EXP Services for the City of Vaughan on September 28, 2016.

Test hole in existing carpet at Basement level wood floor below

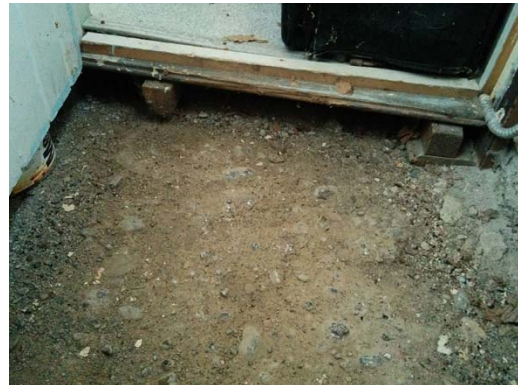
Space below existing NW stair at door to kitchen shows existing 2x2 sleepers at 16" o.c. with wood floor above.

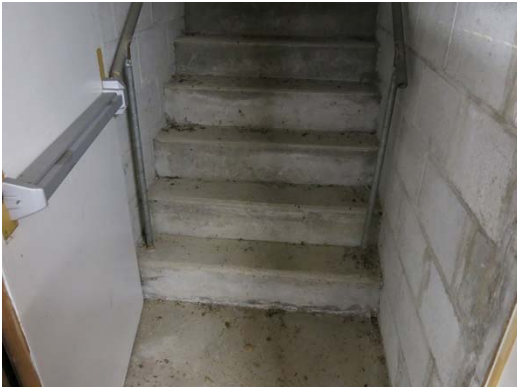
The existing concrete stair from the Basement to grade at the south elevation is in good condition. The masonry walls appear to have been built at a later date as the brick used is not the same as the Church building and is veneer on wood framing. The riser of the stairs are vertical and do not have the 1" nosing required by code. There is no landing at the top of the stair before the exit door.

South stair from Basement – lower landing

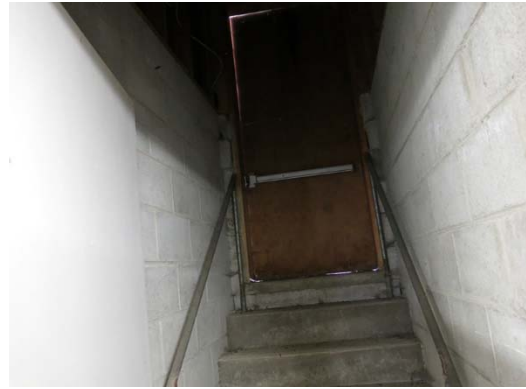
South stair from Basement – no upper landing

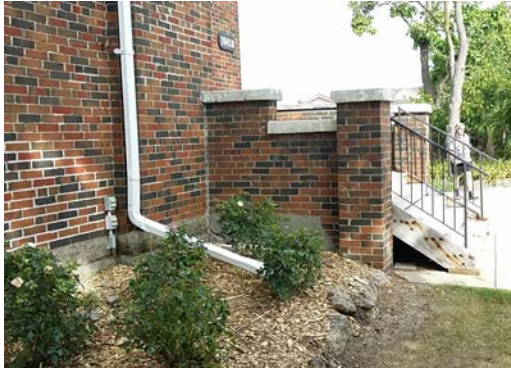
The main exterior stairs have been removed and replaced with temporary plywood stairs which are showing signs of rot. The stair side walls are masonry and are cracking at the joint with the existing church building. The front stair tread appears to be bearing on the concrete sidewalk. Refer to the masonry section for further comments.

Northeast stair – temporary wood stair bearing on sidewalk

The main exterior stairs (East) are in poor condition showing signs of rot. Plywood has been added to temporarily address this issue. Wood stairs require replacement with wood or concrete stairs to provide a stable and durable means of egress from the building.

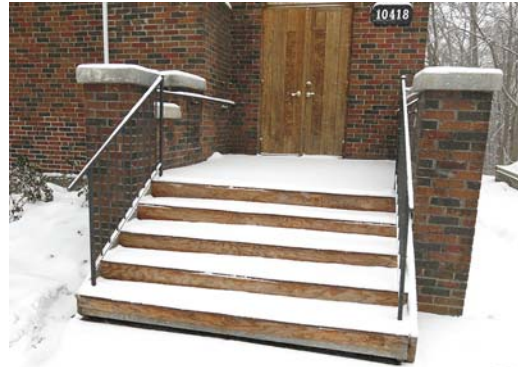
Temporary wood stair between existing masonry side walls.

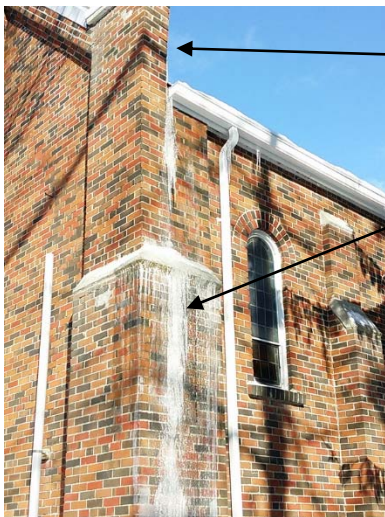
Southwest Corner

Exterior masonry and concrete block stone walls of the building are generally in good condition considering exposure and age of building (approximately 90 years old). Some minor cracking and damage due to water penetration was noted on all sides. Masonry or mortar damage was more noticeable below window sills and exterior corners of walls and buttresses. Typically the mortar joints have washed out allowing the water to enter in the wall causing the spalling of the mortar and the bricks during freezing and thawing cycles.

Water and ice saturating face of brick

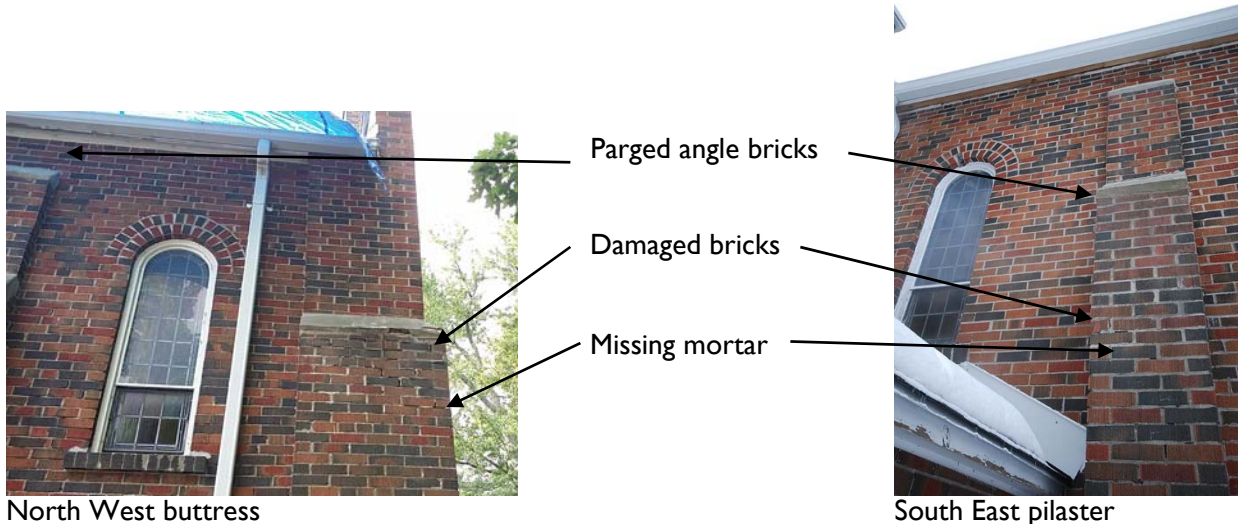
are visible. The brick courses below the caps have significant amounts of missing mortar and the bricks have spalled in many locations. In some areas the spalled and damaged bricks have been left in place and patched with mortar. The parapet wall at the Southwest corner and North East corner are also not straight and true but leaning towards the building. Damaged brick and missing mortar is visible in these locations.

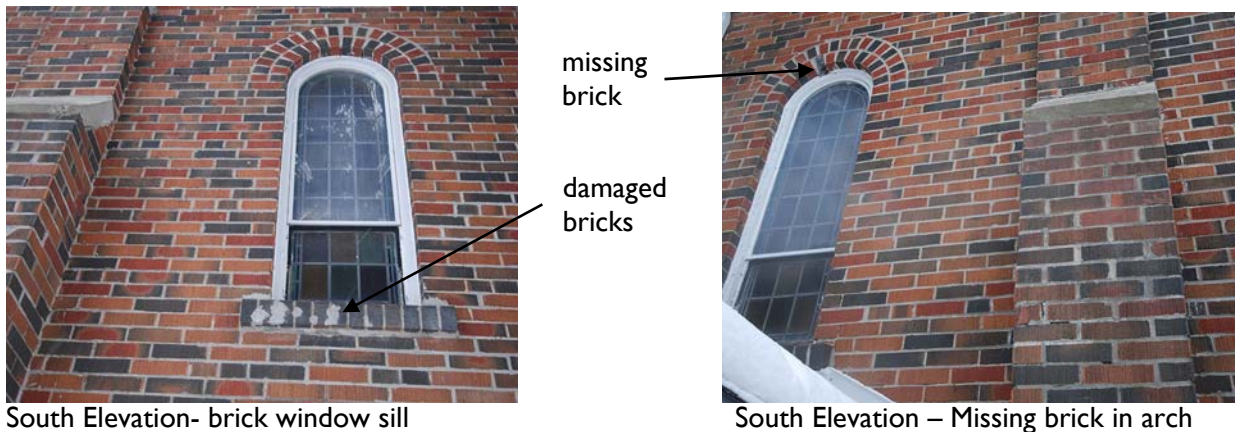
The existing windows sills are made of angled row lock black bricks. The sills on the south side and east side of the building show signs of deterioration. The bricks have been previously patched with mortar. There is also a brick missing from the window arch on the south side.

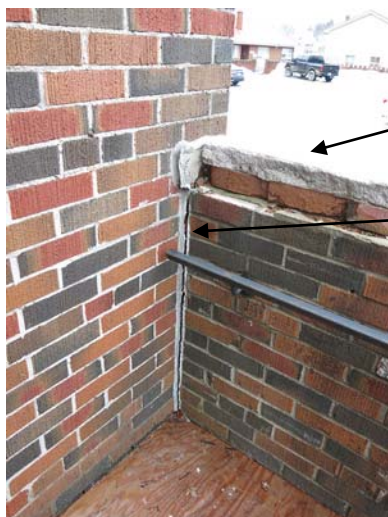
Roman stone coping over the stair walls has developed cracking and is crumbling in some areas. It appears that stone coping is not adequately tied to the stair wall as cracking can be observed at the locations where stone coping is bearing on the masonry wall.

Exterior East Stair- broken coping & Gap

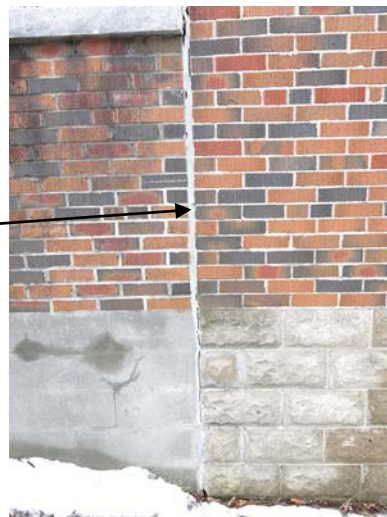
Exterior East Stair- Gap at Church wall

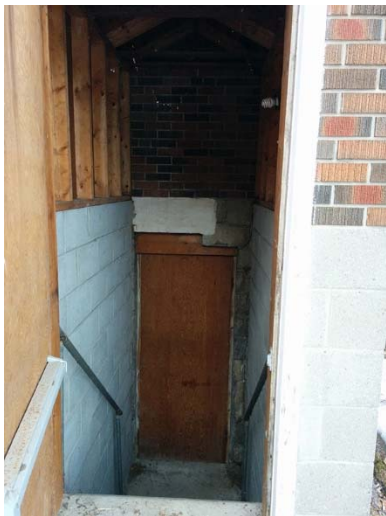
A south exit stair complete with a new enclosure of masonry veneer on wood framing on concrete block foundation has been built at a later date from the church. A window was removed and a door added to access the new stair. It appears that the top two courses of the block wall are cantilevering and are picking up the stone header at the east end.

South concrete stair

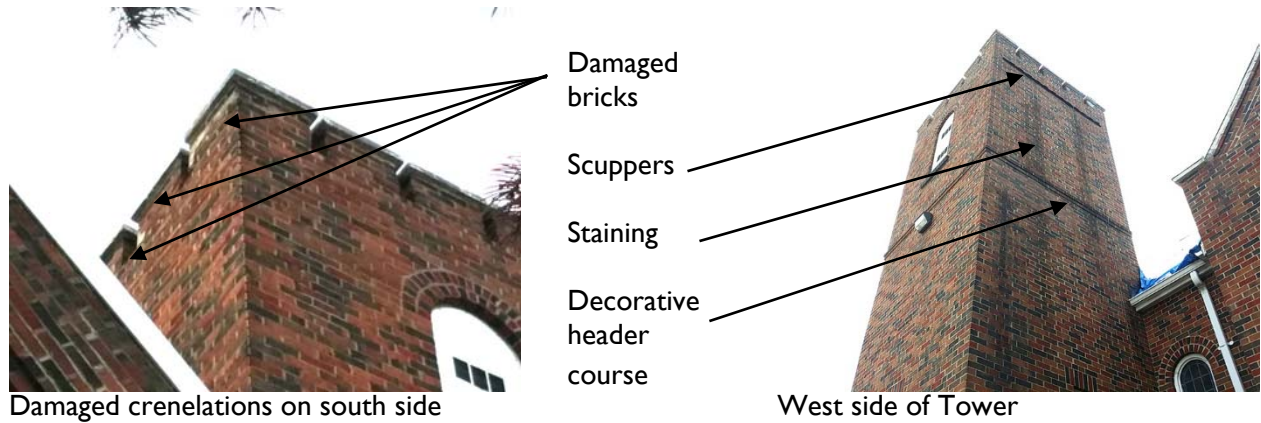
The masonry of the Bell Tower also appears to be in good condition with the exception of the three sections of the crenelations / parapet wall at the South side of the tower which are deteriorating. The tower bricks are stained from the water runoff below the scuppers on the west side.

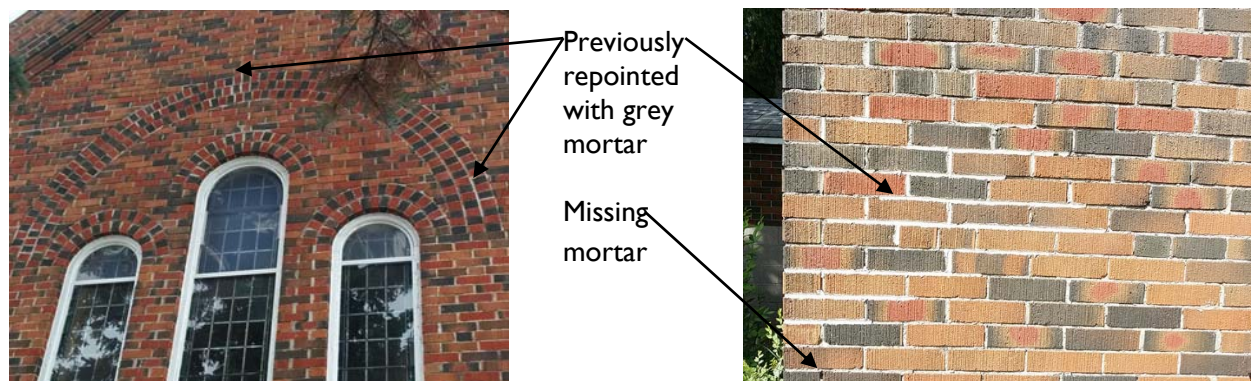
Some of the existing joints have been repointed in the past and the joints were not properly tooled, nor does the mortar colour or aggregate match the existing. Mortar is flush and overlapping the brick face. Exterior masonry is stained due to atmospheric pollution and residue from flashing.

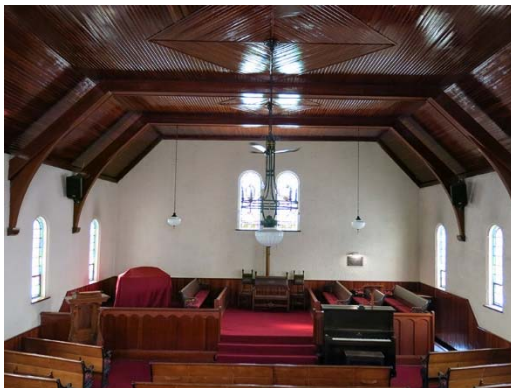
Throughout the Ground Floor level of the Church there is wood wainscoting on all perimeter walls. The wainscoting is in good condition and shows the expected signs of wear and tear due to its age.

Ground Floor wainscoting around perimeter

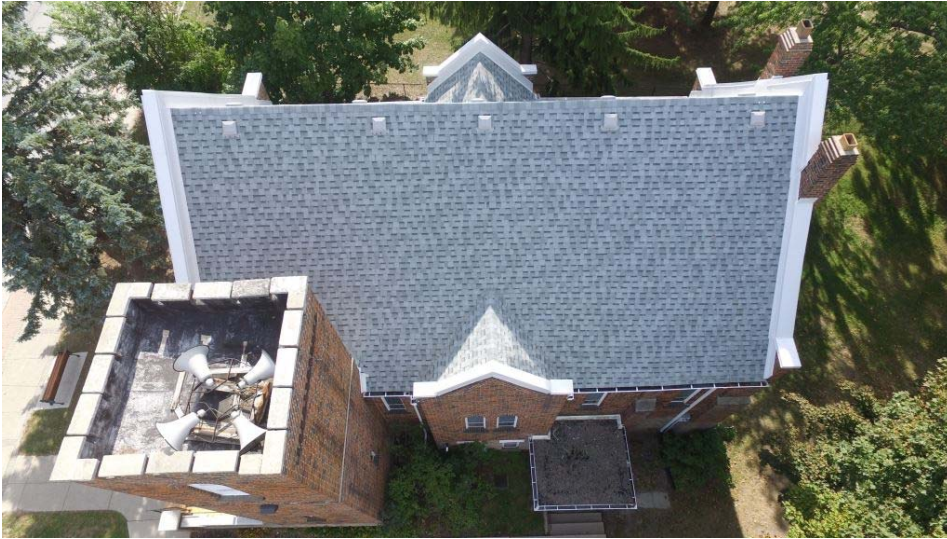
Asphalt shingles were installed in 2016 along with new vents, flashing, gutters and downspouts. As such, the asphalt shingled roof system of the Church was observed to be in good condition. It is not clear if the vents installed properly ventilate the attic space. Typically soffit vents or roof edge vents would be installed to promote airflow within the attic.

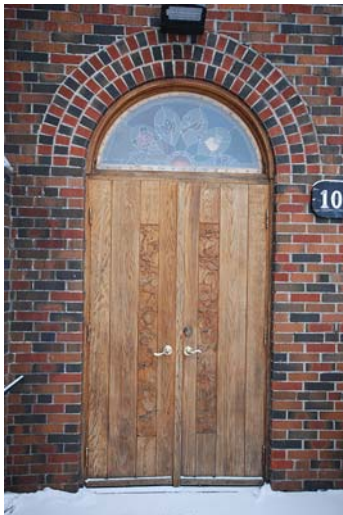
East Entry Door

The front doors are not the original ones installed on the building. The original pair of doors appear to be a raised panel design with a one over one arrangement judging from the limited photo inventory provided. The current front door has two leaves comprised of vertical solid oak staves. It has decorative carvings on the front in two staves that are about 1/2" (13mm) deep. The door was commissioned for the church in the recent past and occupies an important place in the hearts of many who attended services at the KUC. With respect to building code and technical requirements, the door does not meet code and is not barrier free. In addition, the doors do not provide an adequate seal against the elements. The door hardware is not of commercial quality and the hinges are deteriorating.

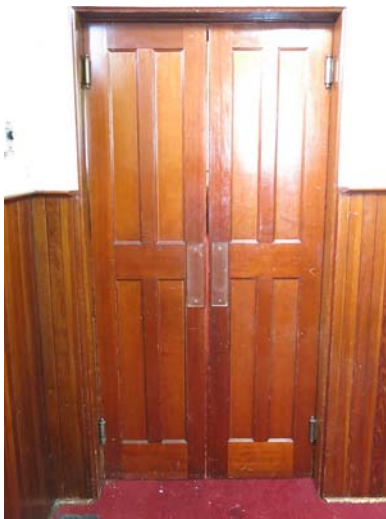
There is a set of double wood doors to the Sanctuary from the East Entry which is in fair condition. The door width does not meet barrier free standards. All other wood doors in the Basement show signs of deterioration and are in poor condition.

Interior East Entry to Sanctuary Doors

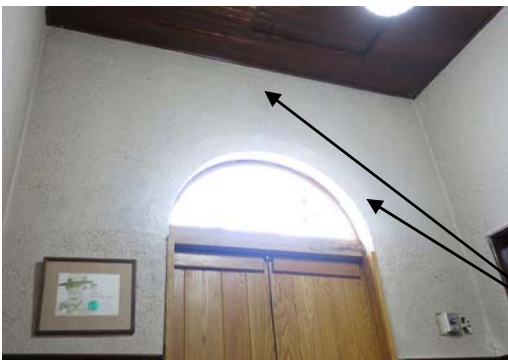
- Minor cracks are visible at some windows on the Ground Floor
- Minor cracks at the plaster transept arches where the plaster arch meets the wood ceiling in the Ground Floor Nave.

Cracks in plaster above East Entry Arch

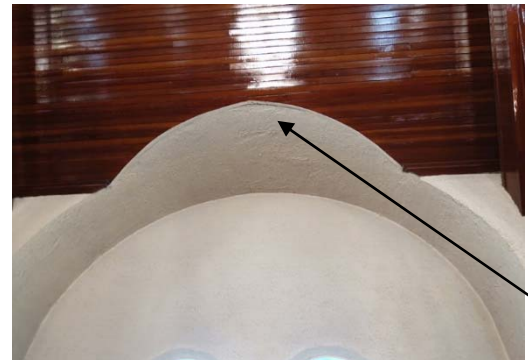
Cracks at transept arches and wood ceiling

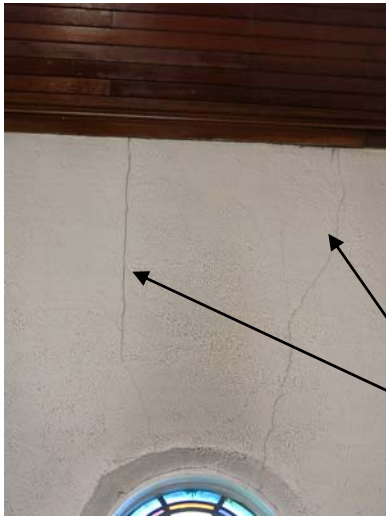
Cracks above stain glass windows

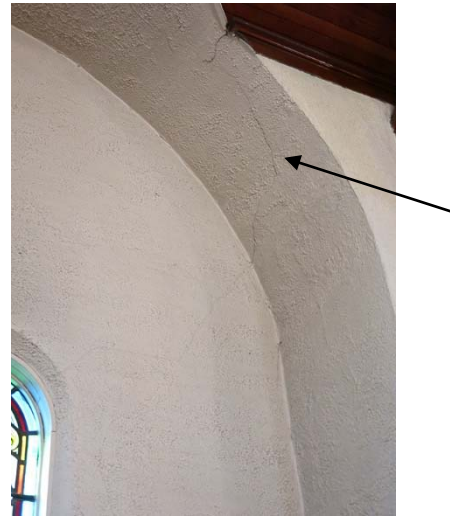
Cracks at transept arches

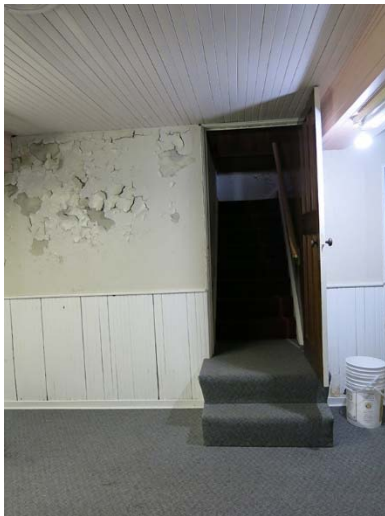
Basement North Wall

The paint in the Church is in fair condition on the Ground Floor. The paint in the Basement is in poor condition and is peeling in numerous locations. The paint was found to contain lead in the Designated Substance Survey provided by the City of Vaughan.

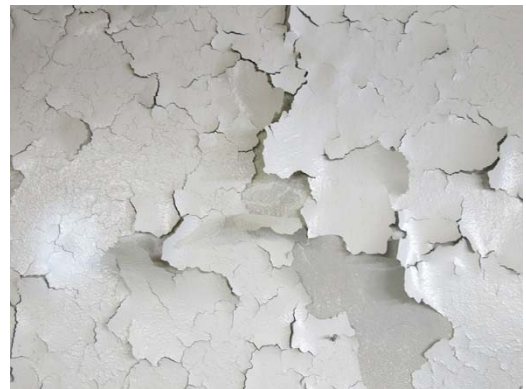
Peeling paint in Basement

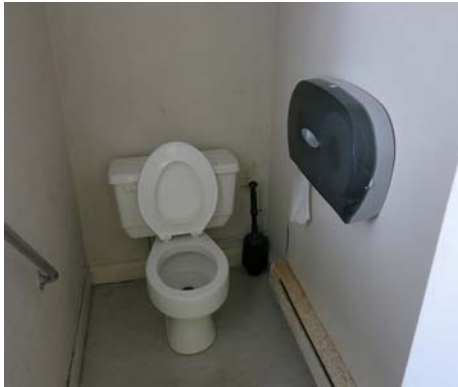
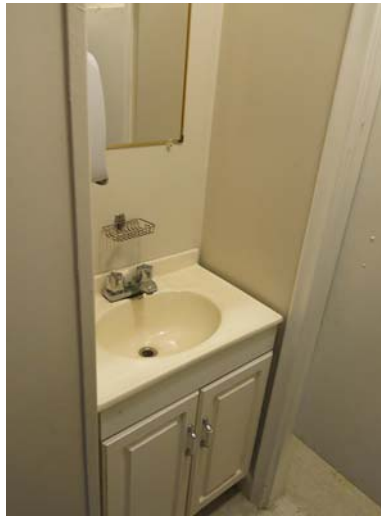
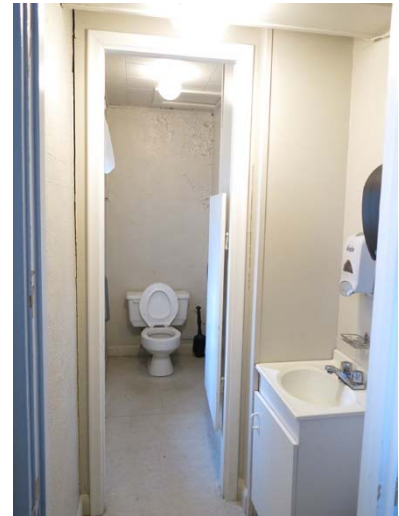
Basement Washroom

The public washrooms located in the Basement vestibule are in very poor condition and need to be improved and made accessible. They contain inefficient fixtures, bad lighting, ventilation and inadequately finished doors. The washrooms are raised above the floor level and have a step up at the door. The washrooms are too small to contain wheelchair access. The number of washrooms are not adequate for the proposed program.

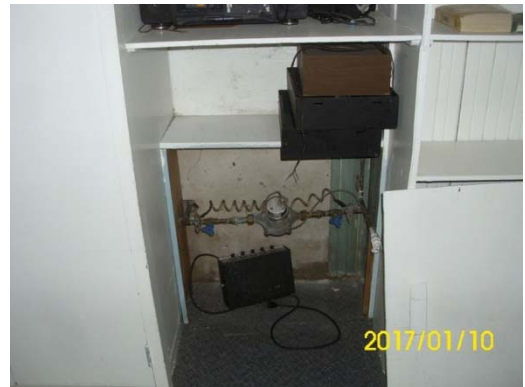
The domestic hot and cold water piping distribution system appears to be of copper piping and fittings and in good condition. A ½" (12.7mm) copper water line complete with water meter enters the Basement in the south-west corner for domestic cold water which is undersized. The utilities plan for the street indicates there is a ¾" (19mm) line to this site. An existing 40 gallon (150L) electric hot water tank is located via the Basement, below the stair in the north-west corner of the Basement. There are two washrooms and a kitchen located at the west end of the Basement which domestic hot and cold water are serving. Plumbing is routed through the ceiling space of the Basement from the water meter to serve this area. The plumbing fixtures in the existing men's and women's washrooms are in poor condition. The existing domestic water main is not equipped with a back flow prevention assembly.

Entering water main and meter at south-
east corner of Basement

The domestic hot and cold water piping distribution system requires revision to accommodate the renovated and relocated washrooms to meet current standards. We recommend a back flow prevention assembly be added and all plumbing fixtures be replaced with new low flow types and low flow aerators should replace existing faucet aerators.

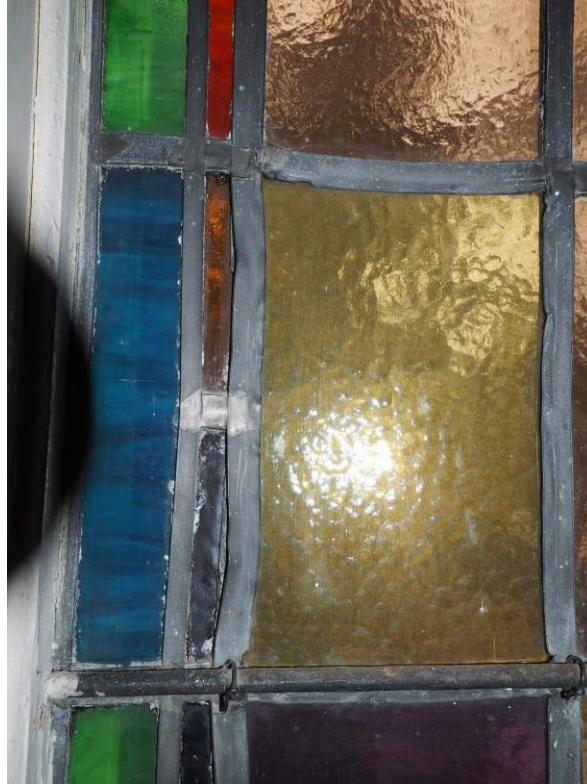
Lead

The lead matrix supporting the glass is in excellent condition, with no identifiable material fatigue and deformation only occurring at repair interventions and unsupported bottoms at ventilators.

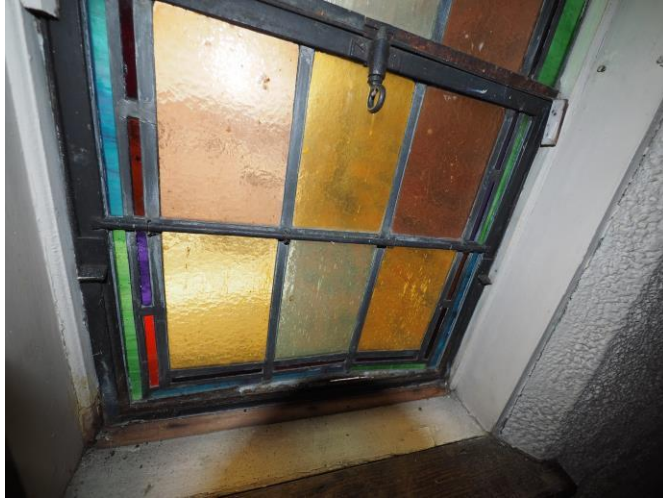
Metal Ventilators

The metal ventilators are showing surface corrosion without any significant depth of rust. Putty and later applied sealants are failing

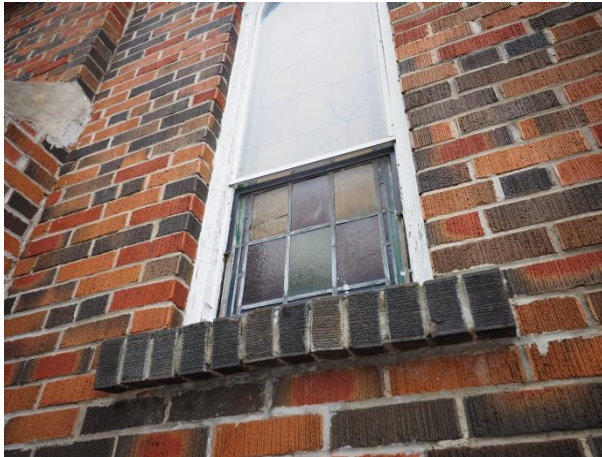
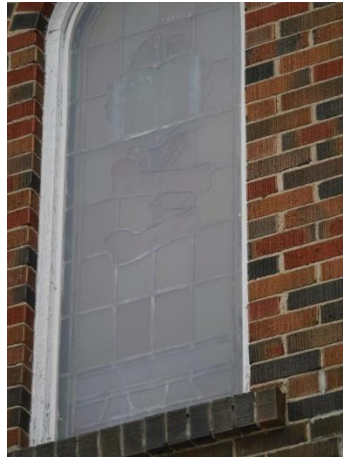
Frames

The wooden frames are in excellent condition. There is no major rot and only some degradation due to lack of maintenance. Putty and later applied sealants are failing. Unvented plastic exterior sashes are causing condensate oxidization
