**2. PROPOSED RENOVATIONS AND ADDITION OF 8006 KIPLING AVENUE IN WOODBRIDGE
HERITAGE CONSERVATION DISTRICT
WARD 2 - VICINITY OF WOODBRIDGE AVENUE AND KIPLING AVENUE**

Heritage Impact Statement
8006 Kipling Avenue, Woodbridge, ON
In the City of Vaughan
17 March 2015

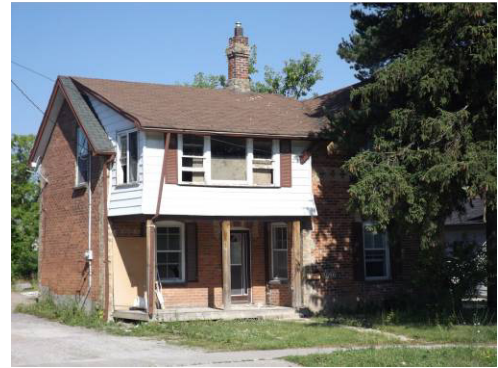
Figure 4. Front (east) view of the house. The later sunporch is evident.

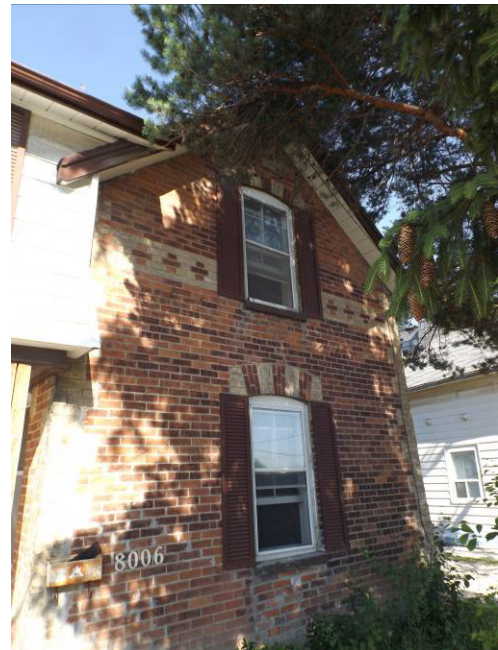
Figure 5. The projecting gabled bay on the front, which is hidden by the tree in the photo above.

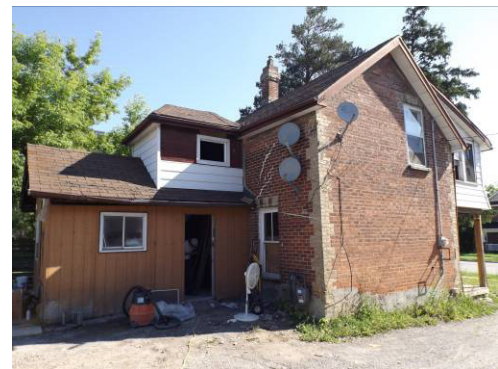
Figure 6. View from southwest showing later rear additions.

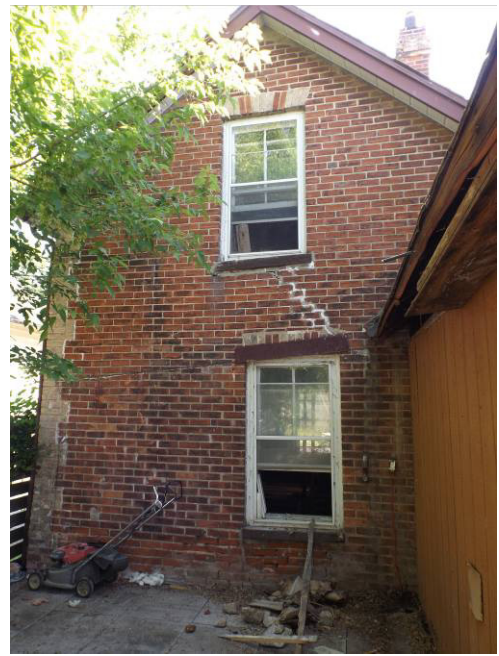
Figure 7. Rear (west) view of the house. The later addition is on the right..

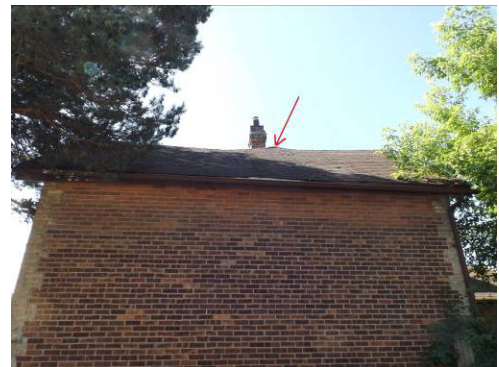
Figure 8. The north wall of the original house is windowless. The bump in the roof ridge due to the raising of the cross ridge is visible just to the right of the chimney.

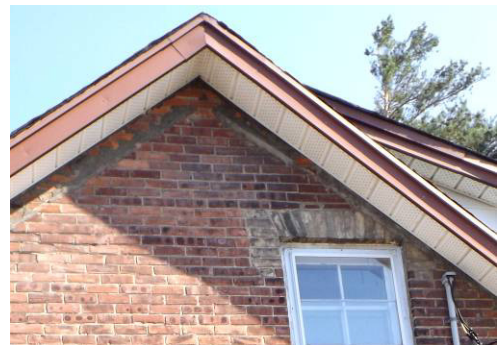
Figure 9. The east gable end cuts across the decorative arch of the second floor window.

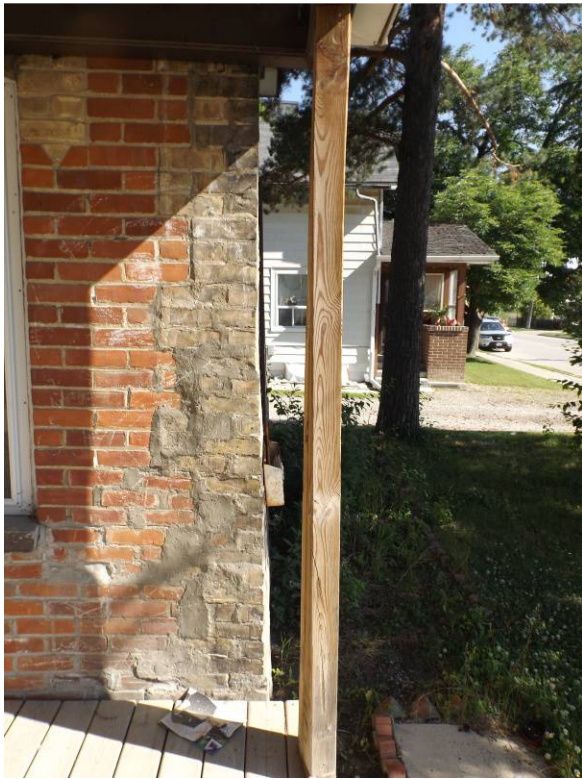
The house has suffered significant uneven settlement of the foundations, and the exterior walls are out of plumb in many places. The brick work shows many settlement cracks, many of which have been poorly repaired. Investigation has revealed that the footings under the projecting gabled bay are only 2 feet below grade. 140 years of frost heave explains the cause of the damage to that part of the building.

Figure 10. Desperate repairs to masonry at the northeast corner.

The exterior masonry of the existing house will require extensive repair. (See Figures 10-13, and Supplemental Photograph in the Addenda.) In addition, the later and unsympathetic sunroom addition will be removed. All of the brick behind was removed when it was constructed. This brickwork will have to be replaced (about 1000 bricks), and a front wall dormer will be constructed. We propose to use brick removed from the existing rear wall where the addition abuts it to provide the material for repair and replacement of missing wall. The elevations of the proposed project are shown in Figures 25 through 28.

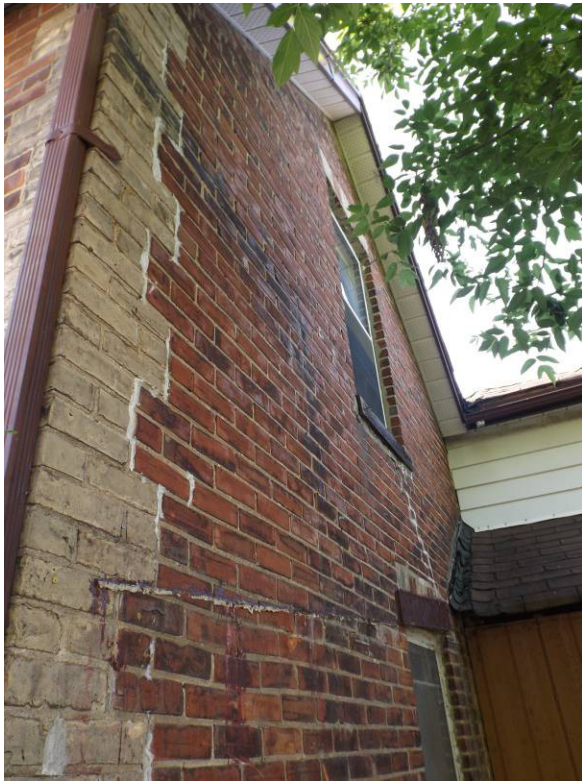
Figure 11. Northwest corner. Note also stepped crack between the windows.

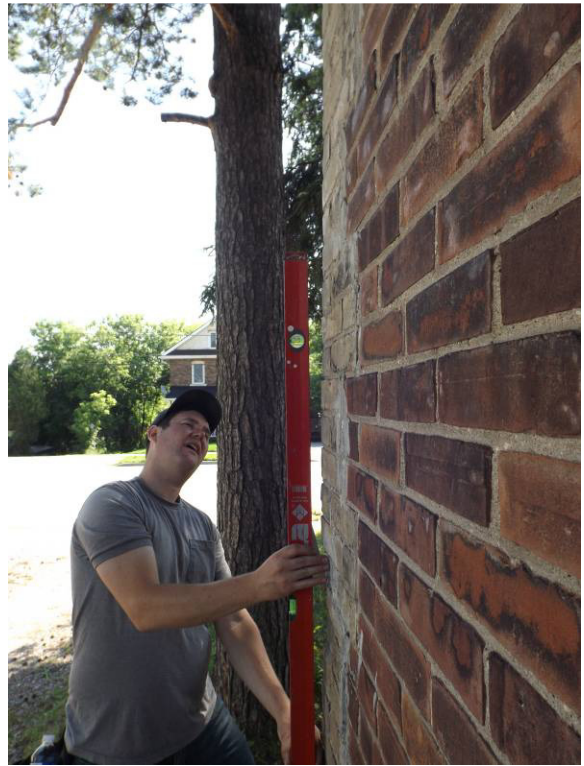
Figure 12. Northeast corner out of plumb in north-south direction.

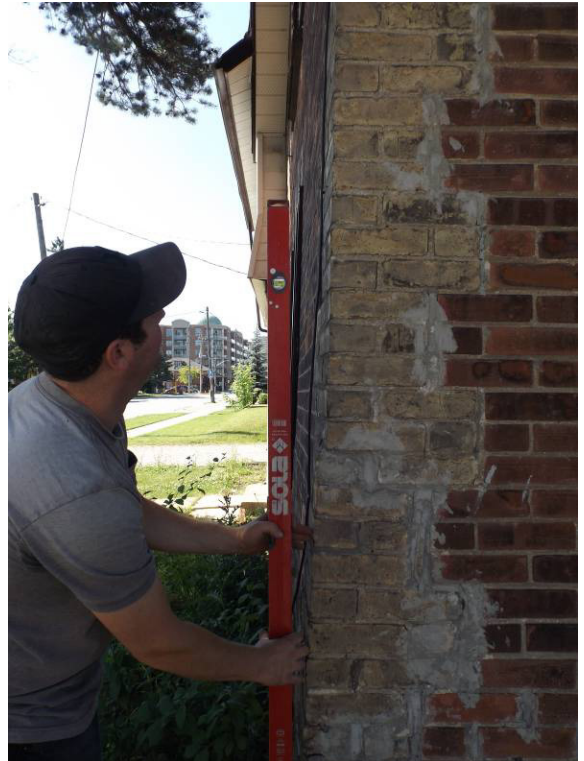
Figure 13. Same corner out of plumb in the other direction too.

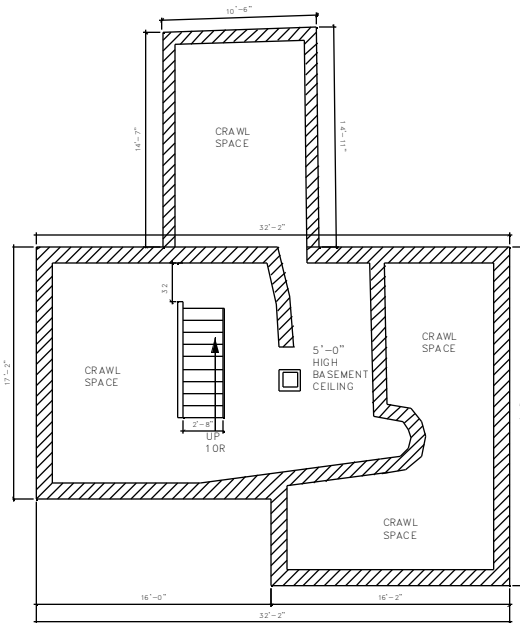
BASEMENT FLOOR PLAN

Figure 14. Footings around crawl space on the right (north) part of the building are only 2 feet below grade—the cause of the structural deficits. The basement area is only 5 feet high.

The first order of business is to stabilize the structure by underpinning the existing deficient foundation to a depth of 4 feet in order to get the bearing level below the frost line. The basement portion of the house, which has a ceiling height of only 5 feet will also be underpinned, to provide a useable height basement. These steps will provide a solid foundation under the heritage resource, to forestall future movement. At the same time, existing deficiencies in the ground floor framing will be corrected. The basement of the rear addition will be full-height.

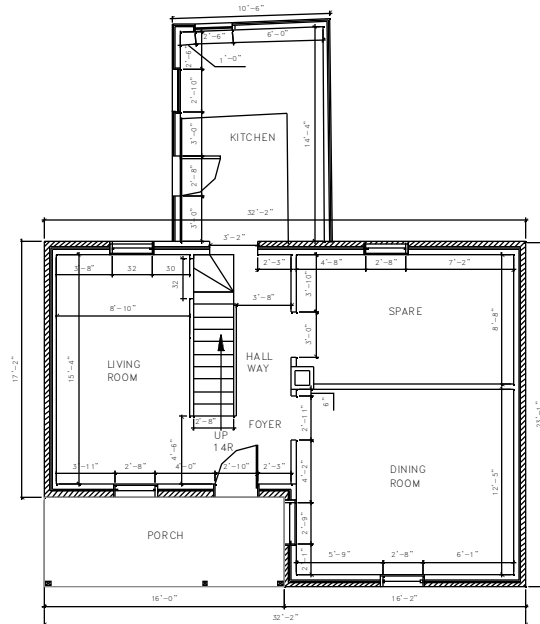
MAINFLOOR PLAN

Figure 15. Original room layout consists of small rooms, the largest being only 12' 5" x 14' 6". The room designated "spare" was probably the original kitchen, with the chimney for the stove in the corner. In keeping with its modest character, the ceilings are only 8' high. The current kitchen is of indeterminate age. There may have been a "tail" here originally.

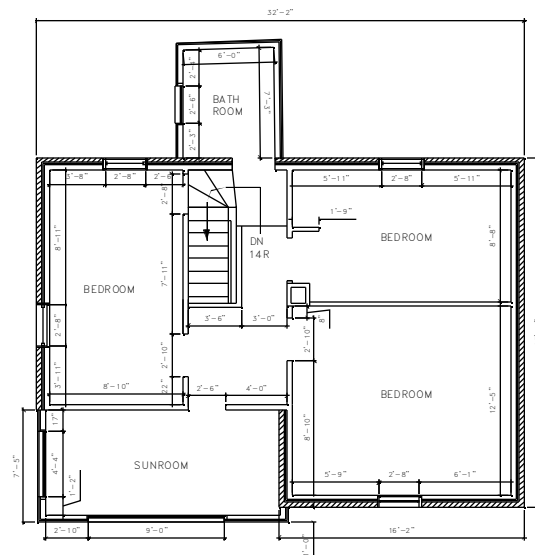
2ND FLOOR PLAN

Figure 16. The bathroom at the rear and the sunroom at the front are definitely later additions. In adding the sunporch, all of the brick on the original 2nd floor of the house, and all of the east-facing roof slope was removed.

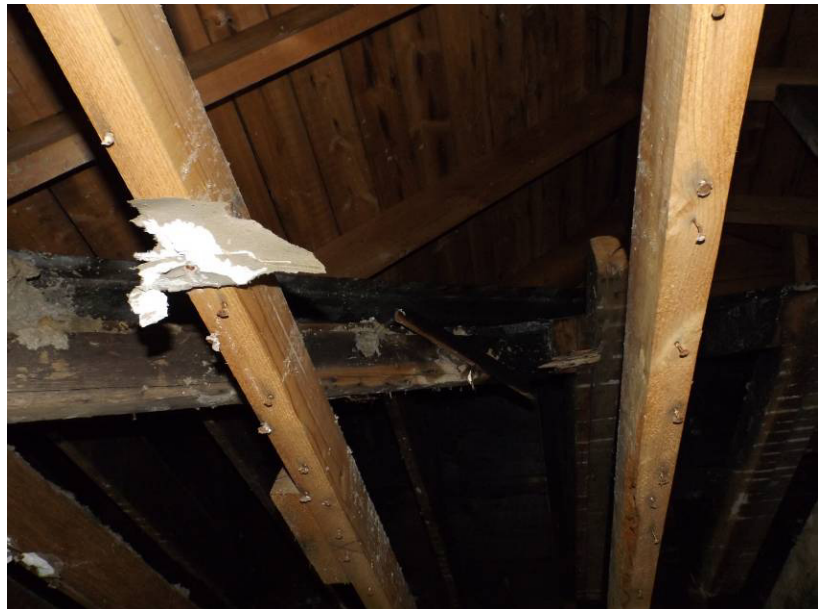
Closer examination shows a number of other alterations that would not have been obvious to Murdoch. The south gable is asymmetrical: the west eave is higher than the east, which is unlikely to be an original condition. There is evidence of fire in the roof, which may have led to a reworking. It is impossible to determine which height would have been original, but the east slope cuts across the decorative arch of the window, suggesting that the east eave was lowered. Except for the southernmost three rafters, the entire roof was reframed at a much shallower slope, incorporating the sunporch addition. In addition, the foundation does not appear related to the construction above. The Murdoch research indicates a smaller original footprint, and it's possible that some of the foundation of the previous configuration remains. It's very possible that the original heating was by the kitchen stove, and that the basement was constructed to accommodate a later furnace.

Figure 17. Evidence of a fire: Extensive charring over the back bedroom in the second floor.

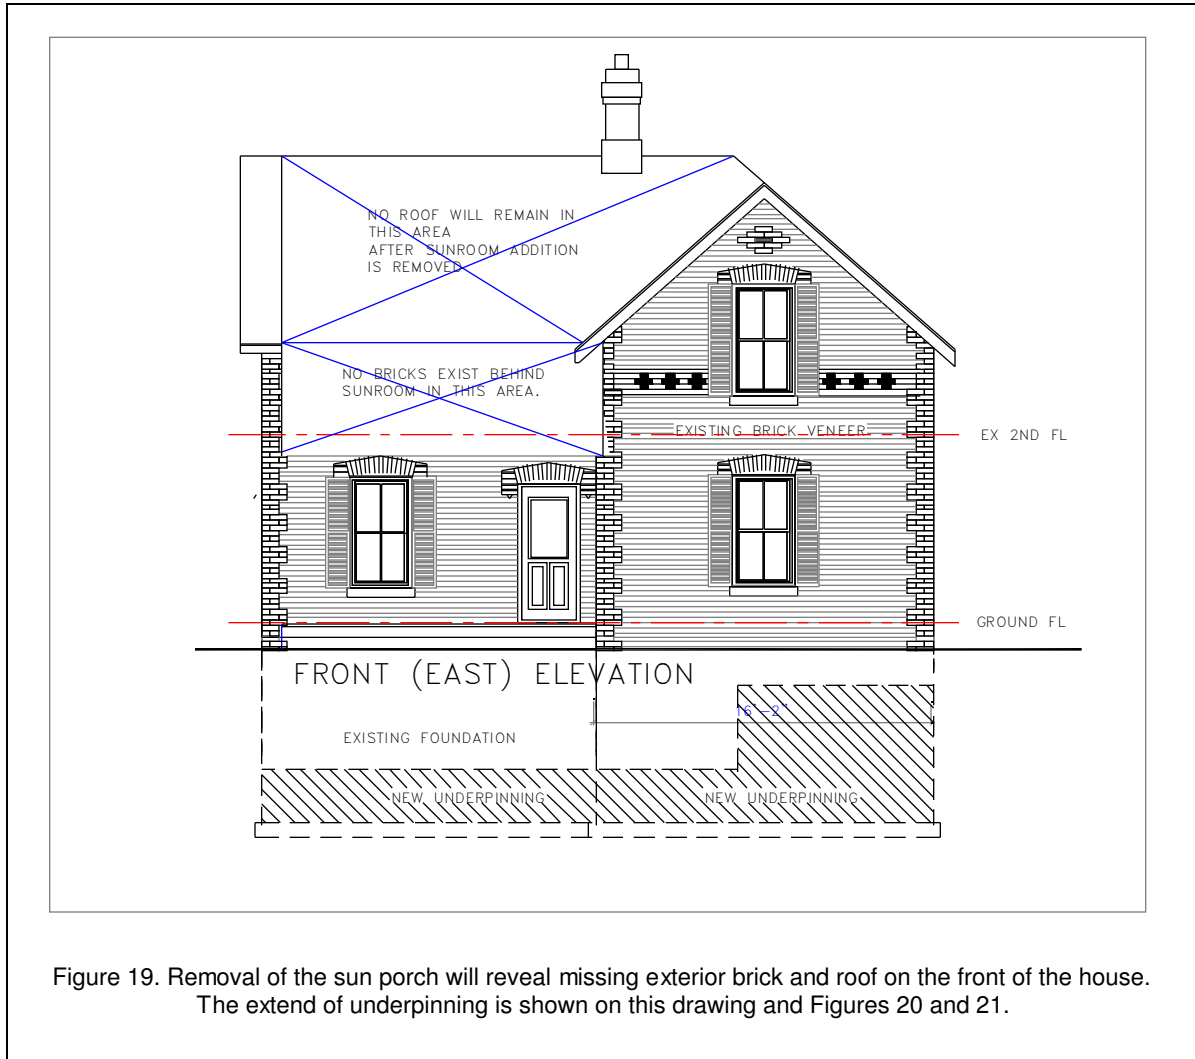
Figure 19. Removal of the sun porch will reveal missing exterior brick and roof on the front of the house. The extend of underpinning is shown on this drawing and Figures 20 and 21.

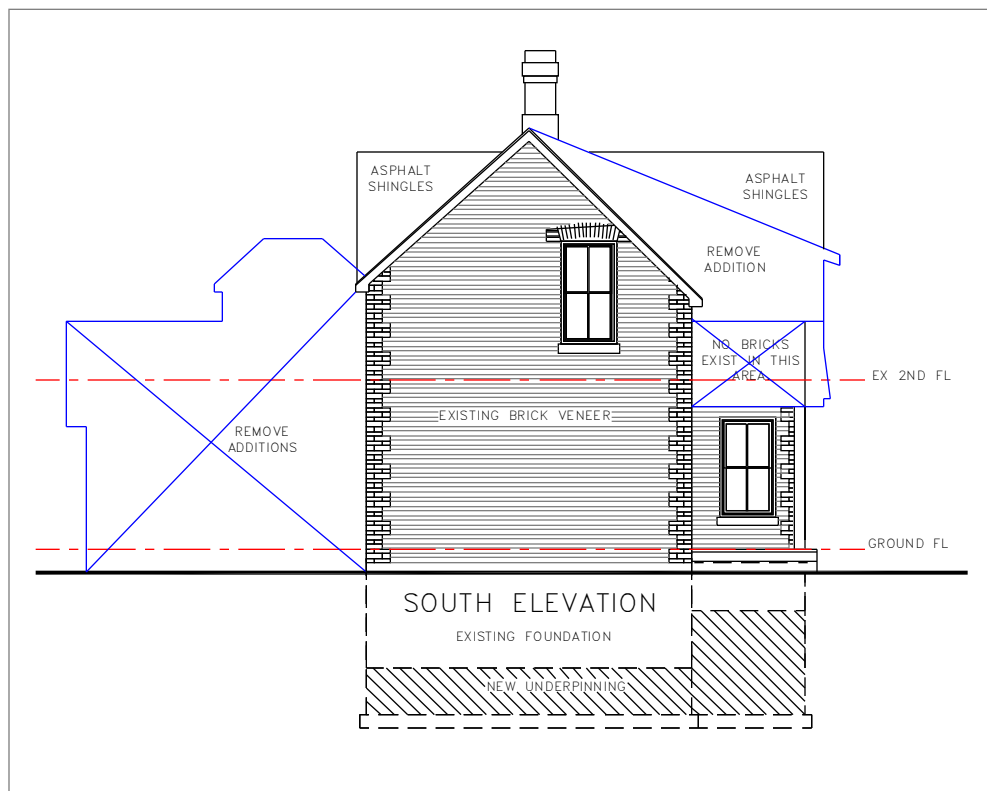
Figure 20. Additional brick is missing on the south of the projecting front-gable bay.
