HERITAGE VAUGHAN REPORT

TITLE: RESTORATION & REPAIR

9995 KEELE STREET

MAPLE HERITAGE CONSERVATION DISTRICT

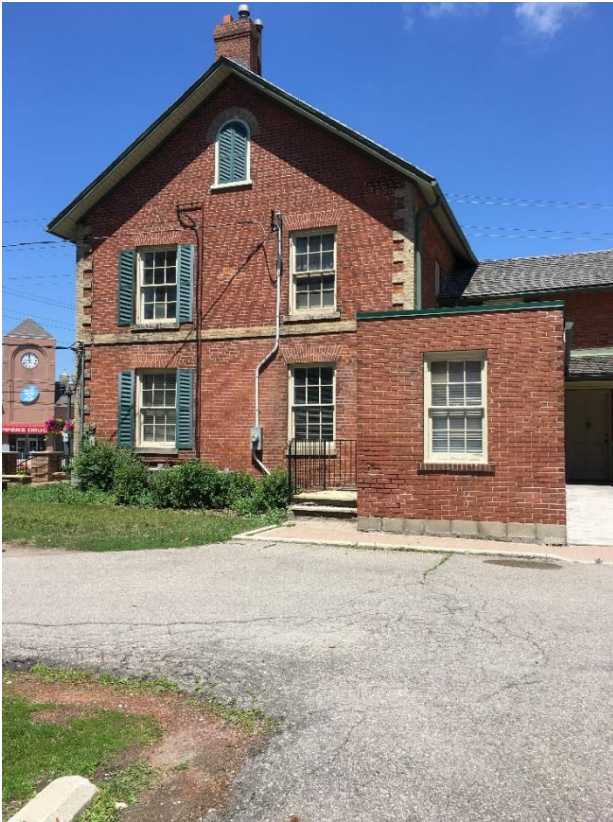
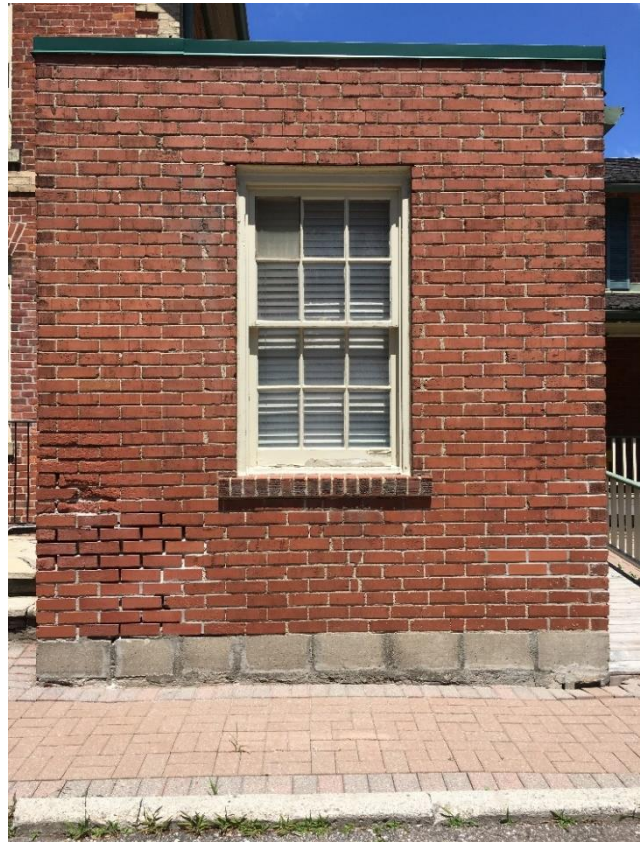
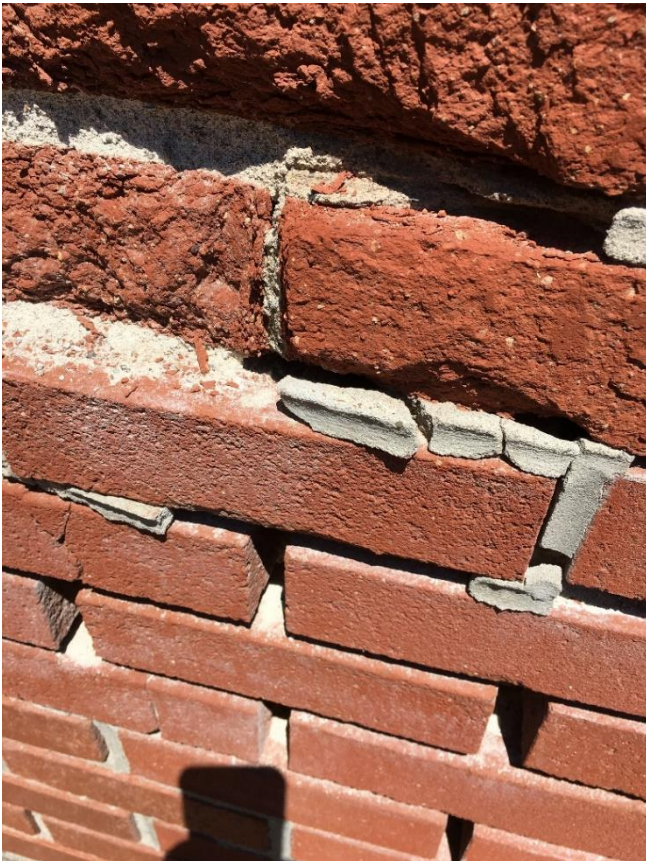
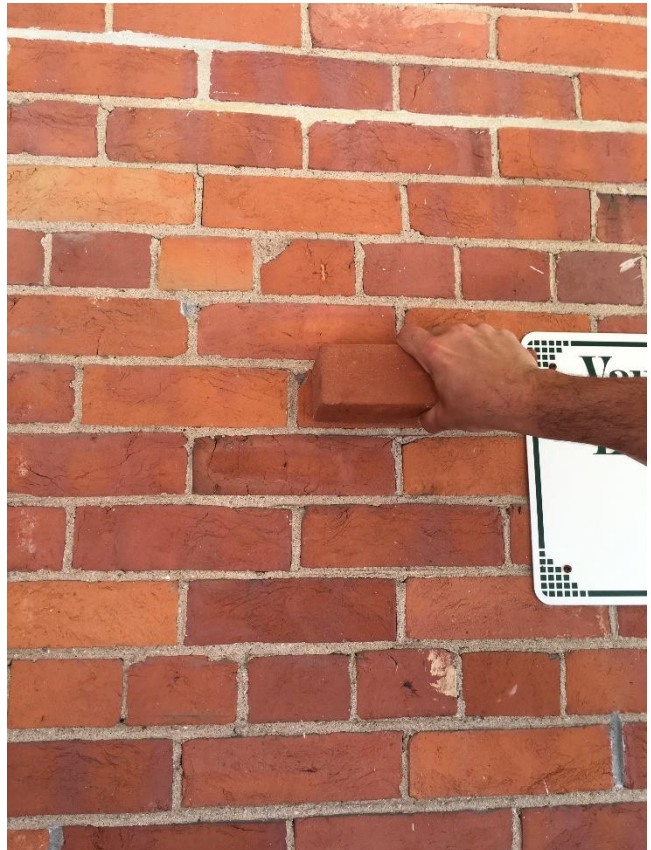
9995 Keele Street – South Facade

The proposed alteration and restoration work is to repair the masonry brick on the south façade of the structure. Both the original house and the later addition require this work as the bricks have degraded due to road salt exposure.

- Removal of deteriorated brick cladding and mortar.
- For bricks that require replacement, the contractor in consultation with City Staff, has selected matching bricks of similar colour, size and finish as shown in Attachment #4. The selected replacement brick for the 20th century addition to the house is a Riverdale Smooth with a 1:1:3 lime federal white and brick sand mix mortar. This mortar reflects the typical mix and addition of Portland cement that would have been used at the time of construction of the addition between 1920 and 1954.
- The brick for the original “tail” structure is a Glen-gary brick with a 1:1:6 ratio mortar mix with a buff blend for certain areas. This buff blend reflects the varying historic mortar in colour.

In both sections, the replacement of bricks and refinishing of the mortar work will be finished to match existing, original work.
