HERITAGE VAUGHAN COMMITTEE AUGUST 16, 2017

**RESTORATION OF A DETACHED RESIDENTIAL BUILDING AND NEW DEVELOPMENT
9869 KEELE STREET AND 9891 KEELE STREET (WILLIAM BAILEY HOUSE) - MAPLE
HERITAGE CONSERVATION DISTRICT
DESIGNATED UNDER PART V, ONTARIO HERITAGE ACT
WARD 1 - EAST SIDE OF KEELE STREET AND SOUTH OF MAJOR MACKENZIE DRIVE**

(GBCA Project No: 17021)

Date of issue: May 15, 2017

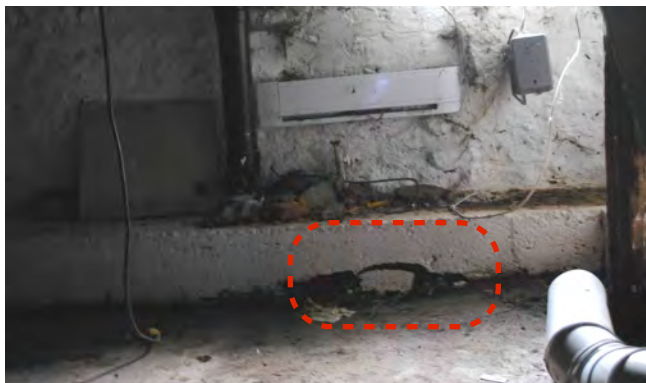
The rubble stone foundation appears to have been recently painted. Underneath this is a poured concrete floor which has encountered some deterioration, especially at the foot of the staircase, and is also evident on the floor and sill plate. This is likely due to standing water at a recent point in time. The presence of moisture retention in the concrete is evident from dampness to the touch, and from visible wicking on cinderblocks that support the furnace.

Above: Deterioration of concrete foundation on the east elevation.

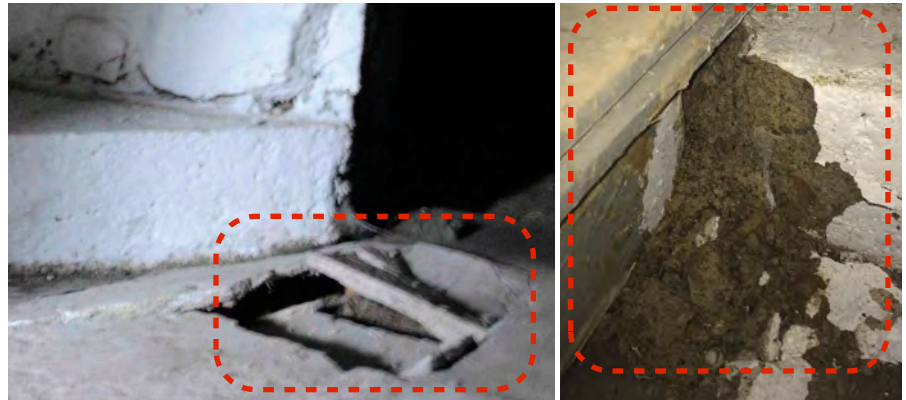
Above: Location of significant deterioration/buckling of the concrete floor before entry to boiler room, to the left. At the right, concrete foundation deterioration at foot of stair.

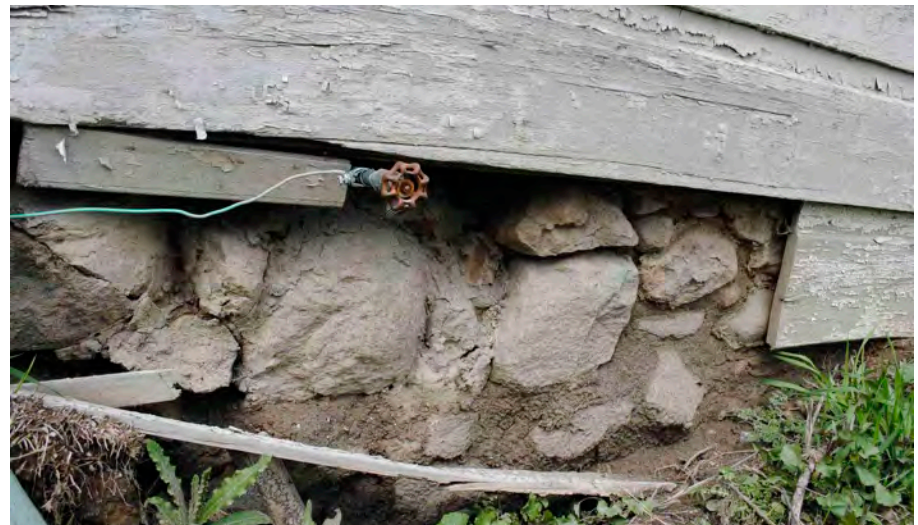
The exterior walls are constructed of rough-cut stone masonry ("rubble masonry" is a common term used). The varied coursing pattern, uneven in some areas, indicates a rapid construction. The mortar joints are heavily deteriorated. Most of the foundation walls will likely require repointing all the mortar joints and grout consolidation of the wall.

Below: Significant deterioration of mortar joints of rubble foundation on the north facade.

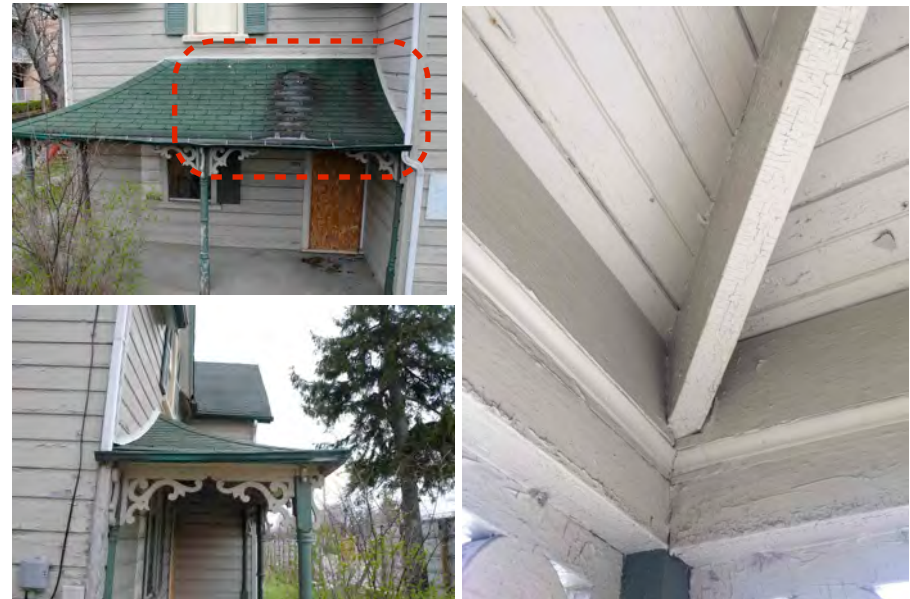
There is evidence of rotting wood at the base of the columns. The roof, supported on these columns, has unique timber rafters that curve from butt to peak, and are covered with tongue and groove boards. They appear to be in fair condition with some water staining evident. A further and more invasive investigation would yield whether or not the lack of air flow in conjunction with moisture retention flow has led to unexposed rot. Because of exposure to the elements, there is very noticeable damage to the asphalt shingles that have deteriorated to the underlay.

Above: Porch exhibits substantial damage to asphalt shingles which may also be responsible for wood deterioration below this surface. An invasive exploration will be required to determine the extend. Below: Roof shows further damage of shingle covering.

The verge board is in good condition, and these elements, in addition to the rafters and pilasters will be restored.

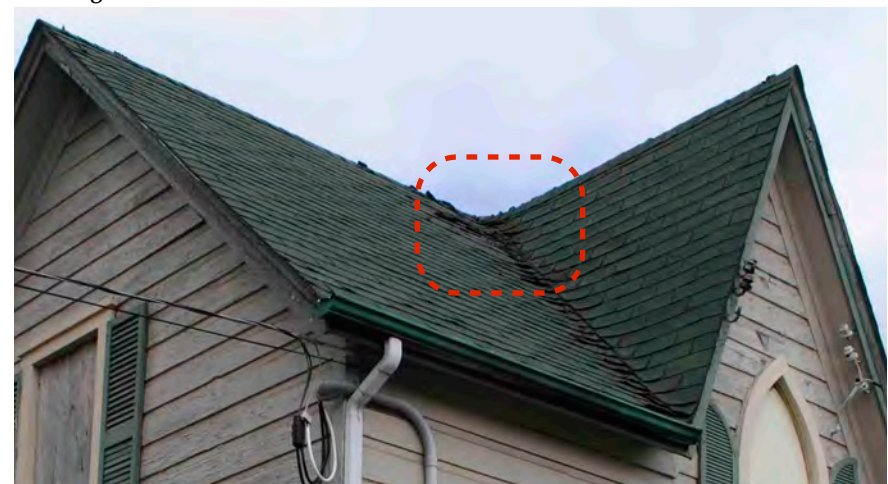
The asphalt shingled roof was not accessible for close inspection. The roof shingles are not original and are in poor condition. Water stains were found in several locations on the second floor, which would suggest leaks in the roof. At these locations it is possible that the surrounding roof joists have deteriorated due to moisture.

The rainwater disposal system consists of aluminum gutters and rainwater leaders that are not original to the building. The existing drainage system is in poor condition.

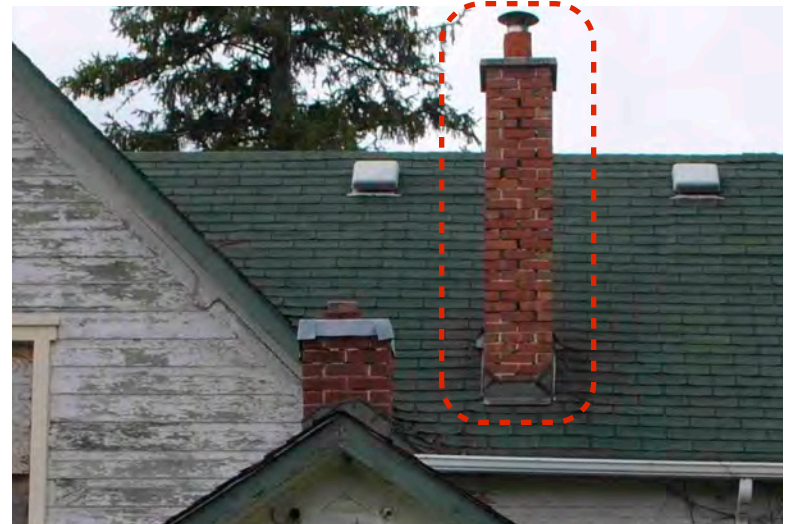
The building has two brick chimneys: one on the east slope of the gable roof and the other on the rear tail. It is likely that the original heating of the home was likely a fireplace in the main house, and a cast iron woodstove in the rear tail. Although only reviewed from the ground, the brick chimneys appear to have many defective mortar joints, as well as broken and damaged bricks. The flashing is not correctly installed.

Above: Defective mortar joints evident on chimney's above, will require repointing.

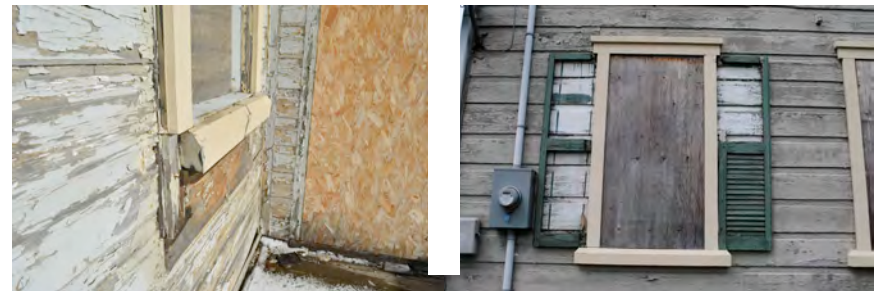
Shutters (not original) that hang on the exterior are in very poor condition and have seen noticeable damage as a consequence of exposure and lack of maintenance.

Above left: Deterioration of the styrofoam surrounds and peeling paint on the south elevation

Above right: Deterioration of one of the wood shutters, south elevation.

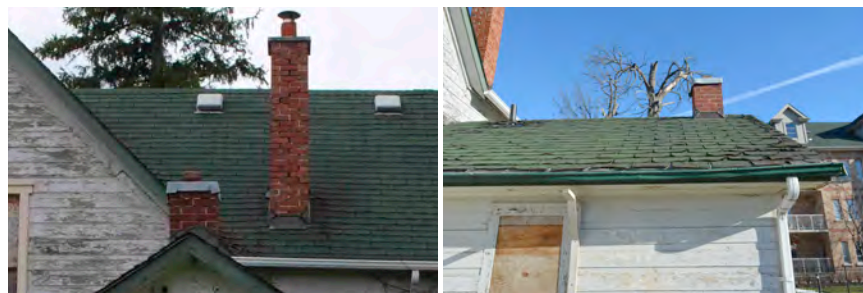
The building has two brick chimneys: one on the east slope of the gable roof and the other on the rear tail. The brick chimneys appear to have many defective mortar joints, as well as broken and damaged bricks. The flashing is not correctly installed.

Above left: Some water staining is visible on the roof. The mortar joint on the chimney are severely deteriorated.

Above right: Deteriorated asphalt shingles.
