**ALTERATIONS TO EXISTING HOME AND DEMOLITION OF EXISTING OUTBUILDING
148 WALLACE STREET
WOODBIDGE HERITAGE CONSERVATION DISTRICT
WARD 2 - VICINITY OF WALLACE STREET AND HIGHWAY 7**

Re: Barn Review, 148 Wallace Street, Toronto, Ontario
Our Project No. ADM-02017020-00

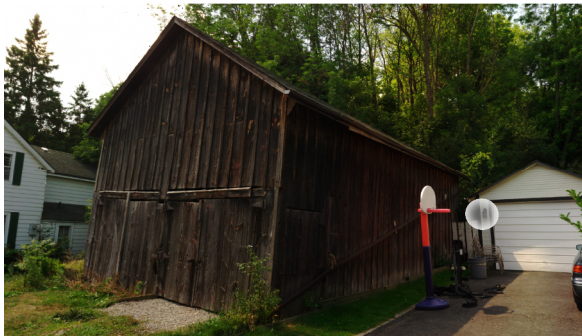
East Elevation

The building is leaning noticeably towards the neighbouring property to the north, and also leaning more severely to the west. This leaning has occurred due to the general lack of a properly designed lateral load resisting system, and the deterioration of the secondary elements that provided the building with its primary means of lateral stability, (in particular the barn board walls nailed to the primary perimeter structure).

As requested, we visited the above-mentioned site to review the existing barn structure to determine its structural condition. Based on our visual review, it is our opinion that this barn in its present condition poses significant and unpredictable risk to humans and should be demolished as soon as possible.

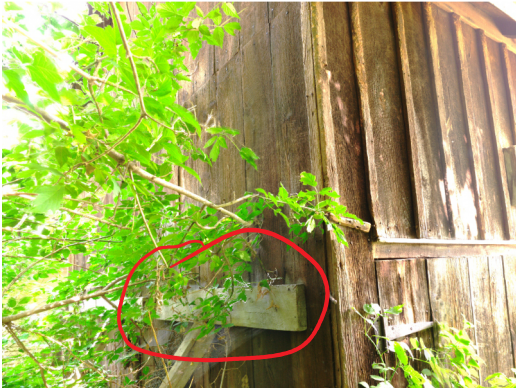
At the rear of the building on the west side, a series of diagonal braces has been installed, attached to the siding of the west wall, sloping west back to the ground, presumably in an attempt to prevent further movement towards the west. It does not appear that these braces or the connections to the exterior wall were engineered and they did not appear to be supported on properly designed foundations where they meet the ground.

South West Corner – Wood braces installed on west wall. The building is also experiencing a significant amount of vertical settlement particularly on the west end, indicating that its foundations are inadequate and failing.

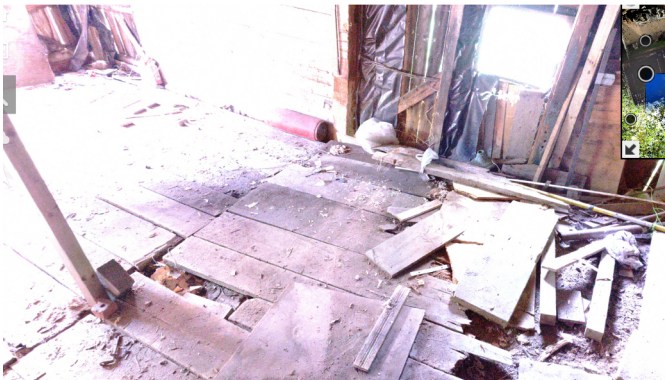
The ground floor of this barn is comprised of wood planks that are showing signs of rot, that deflect significantly under the weight of the average person, and these planks are neither flush nor level. This poses a significant tripping hazard for anyone entering this building.

Typical ground floor condition

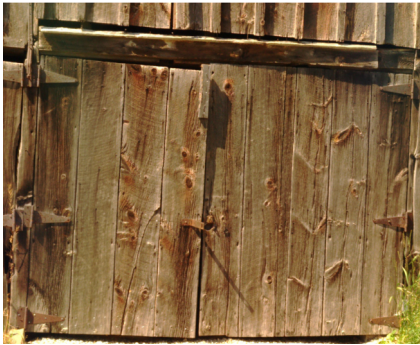
At numerous locations around the outside of the building, the siding has come loose and screws holding door hinges have been stripped due to rot and use. Rotting and movement of the structure has caused the nails hold the siding boards to loosen in many locations making it relatively easy for unwanted access to this building. Anyone entering this building, particularly someone not familiar with the condition of the floor could be seriously injured.

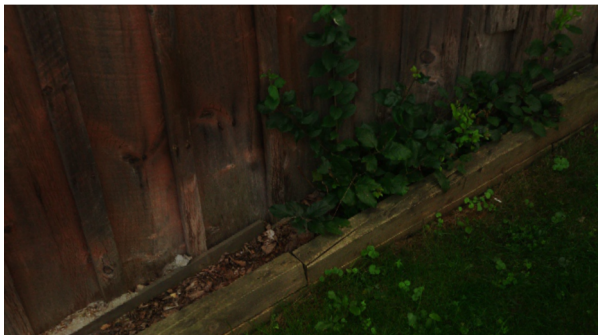
The wood siding that provides that primary lateral support for the building is in direct contact with the ground. Wood in direct contact with the ground is extremely susceptible to rot, which is also a likely contributing factor to the leaning that is happening.

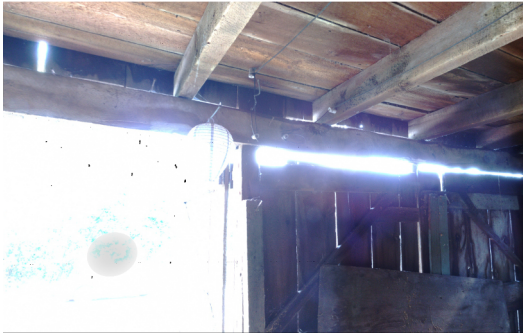
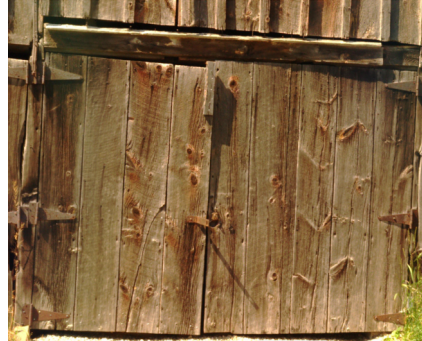
The lintel beams over the main entry doors on the east wall are sagging. These lintels are also the primary support for the east end of the 2nd floor mentioned above. The sagging of these lintels is a clear indication that they were not designed properly.

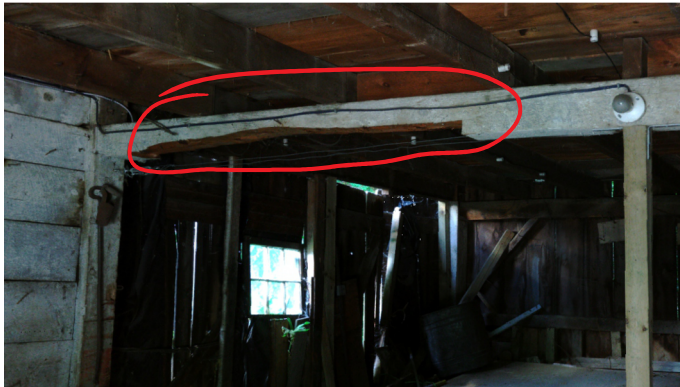
The structural integrity of the interior wood girder supporting the 2nd floor has been severely compromised as it has been split horizontally, losing approximately 50% of its depth. If this beam were to fail completely, total collapse of structure is possible as the collapse of the 2nd floor structure would likely pull down the entire structure. In our opinion, if this building is to remain for any length of time, this girder should be adequately shored immediately.
