DATE July 13, 2016

PROJECT No. 1522372 (8000)

FLUVIAL GEOMORPHIC ASSESSMENT IN SUPPORT OF THE PORTAGE PARKWAY MUNICIPAL CLASS ENVIRONMENTAL ASSESSMENT STUDY, CITY OF VAUGHAN

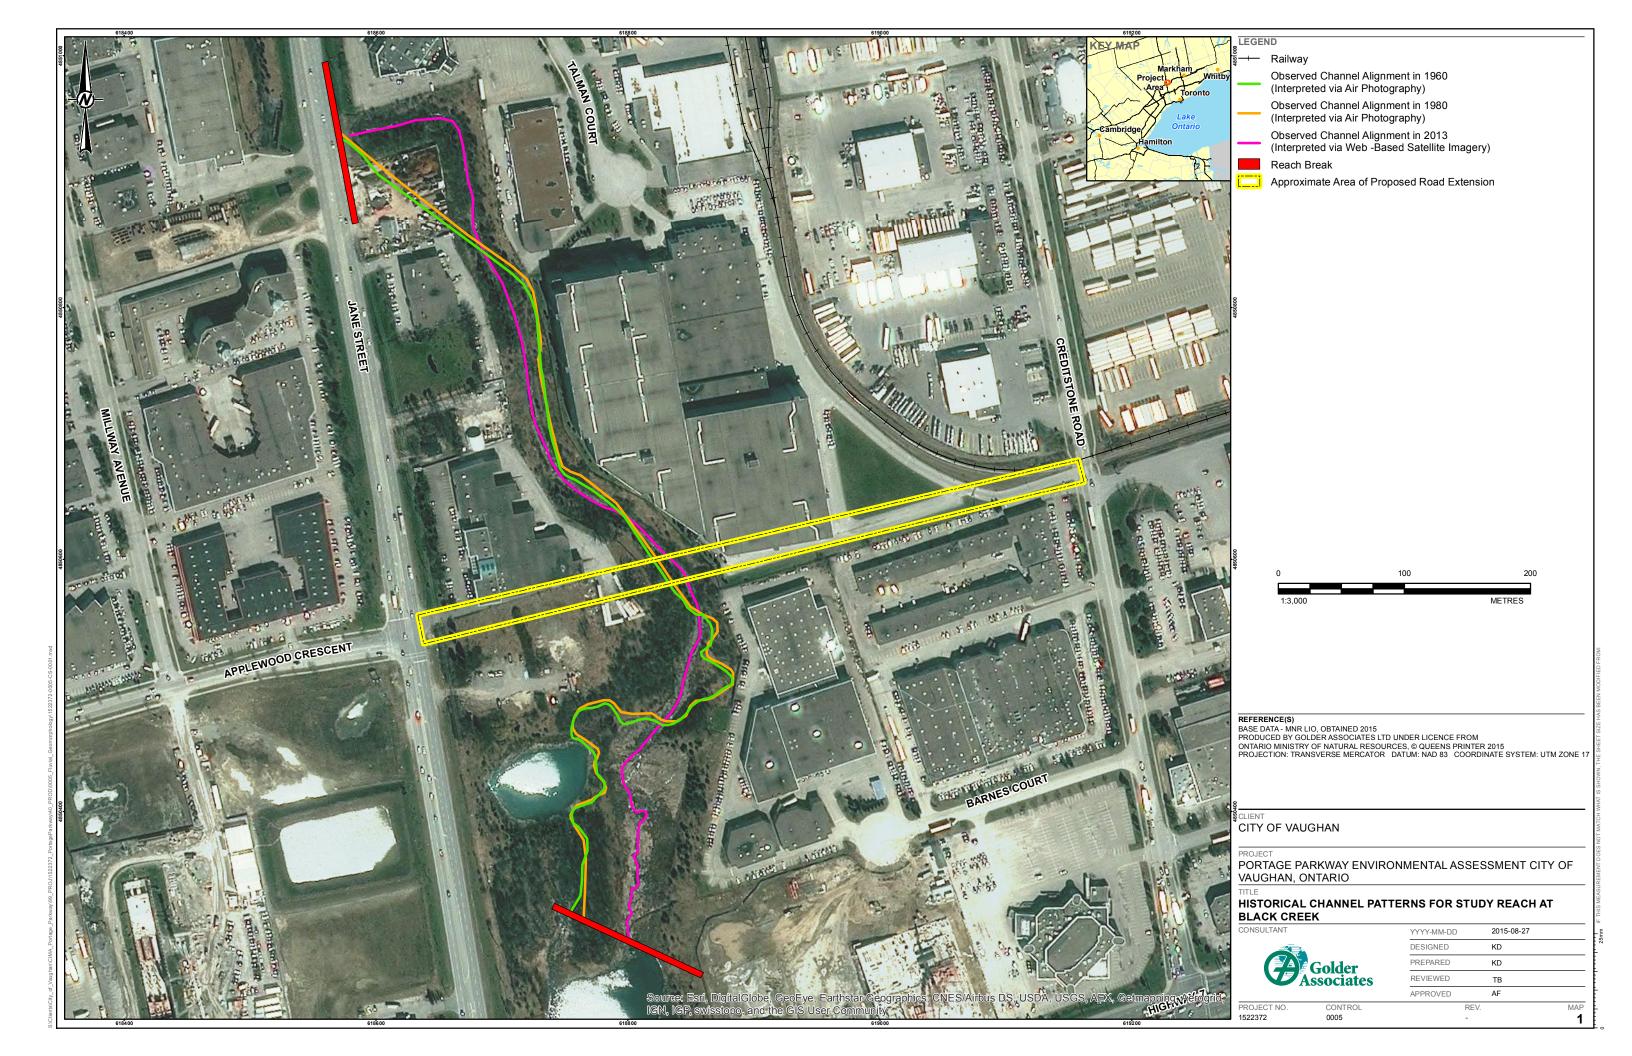
Figure 1 – Historical Channel Patterns for Study Reach at Black Creek

Riparian vegetation within the area of investigation has been historically moderate in density, consisting of tree, shrub and grass cover. In some instances, this vegetation cover limited direct observation of features on the ground. Nevertheless, the watercourse at the study reach was visible on a fairly consistent basis in the air photograph pairs from 1960 and 1980, as well as in the 2013 web based satellite image. These photos/images were used to evaluate the general channel planform at Black Creek and related variations in channel patterns over time. The observed changes in the channel planform at the study reach are illustrated on Figure 1.

The channel at Black Creek appears to have been significantly altered (i.e., diverted and/or realigned) prior to 1960 and at one or more times after 1980, recognizing that, with few exceptions, the watercourse has historically exhibited low sinuosity. For this reason, the observed changes in channel patterns at the study reach are summarized below for the periods before and after 1980:

- From 1960 to 1980, the air photograph analysis showed that the channel followed a very similar pattern. The watercourse for the upper two-thirds of the reach included a relatively straight alignment and was oriented generally northwest to southeast or north to south. In comparison, the section of Black Creek in the lower third of the study reach was historically marked by a strong meandering pattern, noting two particularly prominent meander bends that were located in the area immediately downstream of the proposed stream crossing and that trended in a generally northeast to southwest direction. The results suggest that the upstream section of the reach was straightened before 1960 to accommodate agricultural practices, while the downstream section of the reach was left to adjust naturally. The meander belt axis at the study reach demonstrated no discernible shift prior to 1980.

- Under current conditions, the watercourse follows a mostly straight alignment for the full extent of the reach, albeit with a marked right angle bend at the upstream end of the reach and a broad sweeping bend in the central to downstream portion of the reach. The channel planform in 2013 has been noticeably altered relative to the channel patterns in 1960 and 1980, particularly at the upstream and downstream ends of the study reach (i.e., the channel at the upstream end is now oriented west to east before draining north to south, while the channel at the downstream end has been shifted to the east and no longer includes a meandering channel pattern refer to Figure 1). In addition, the channel is now markedly confined to the surrounding stream valley relative to past conditions. Finally, two stormwater management ponds are now present at the downstream end of the reach (one of which is in line with the main channel, and the other drains to the main channel via a small tributary). The results suggest that the channel has been further straightened and realigned to accommodate urban development and associated stormwater management facilities.

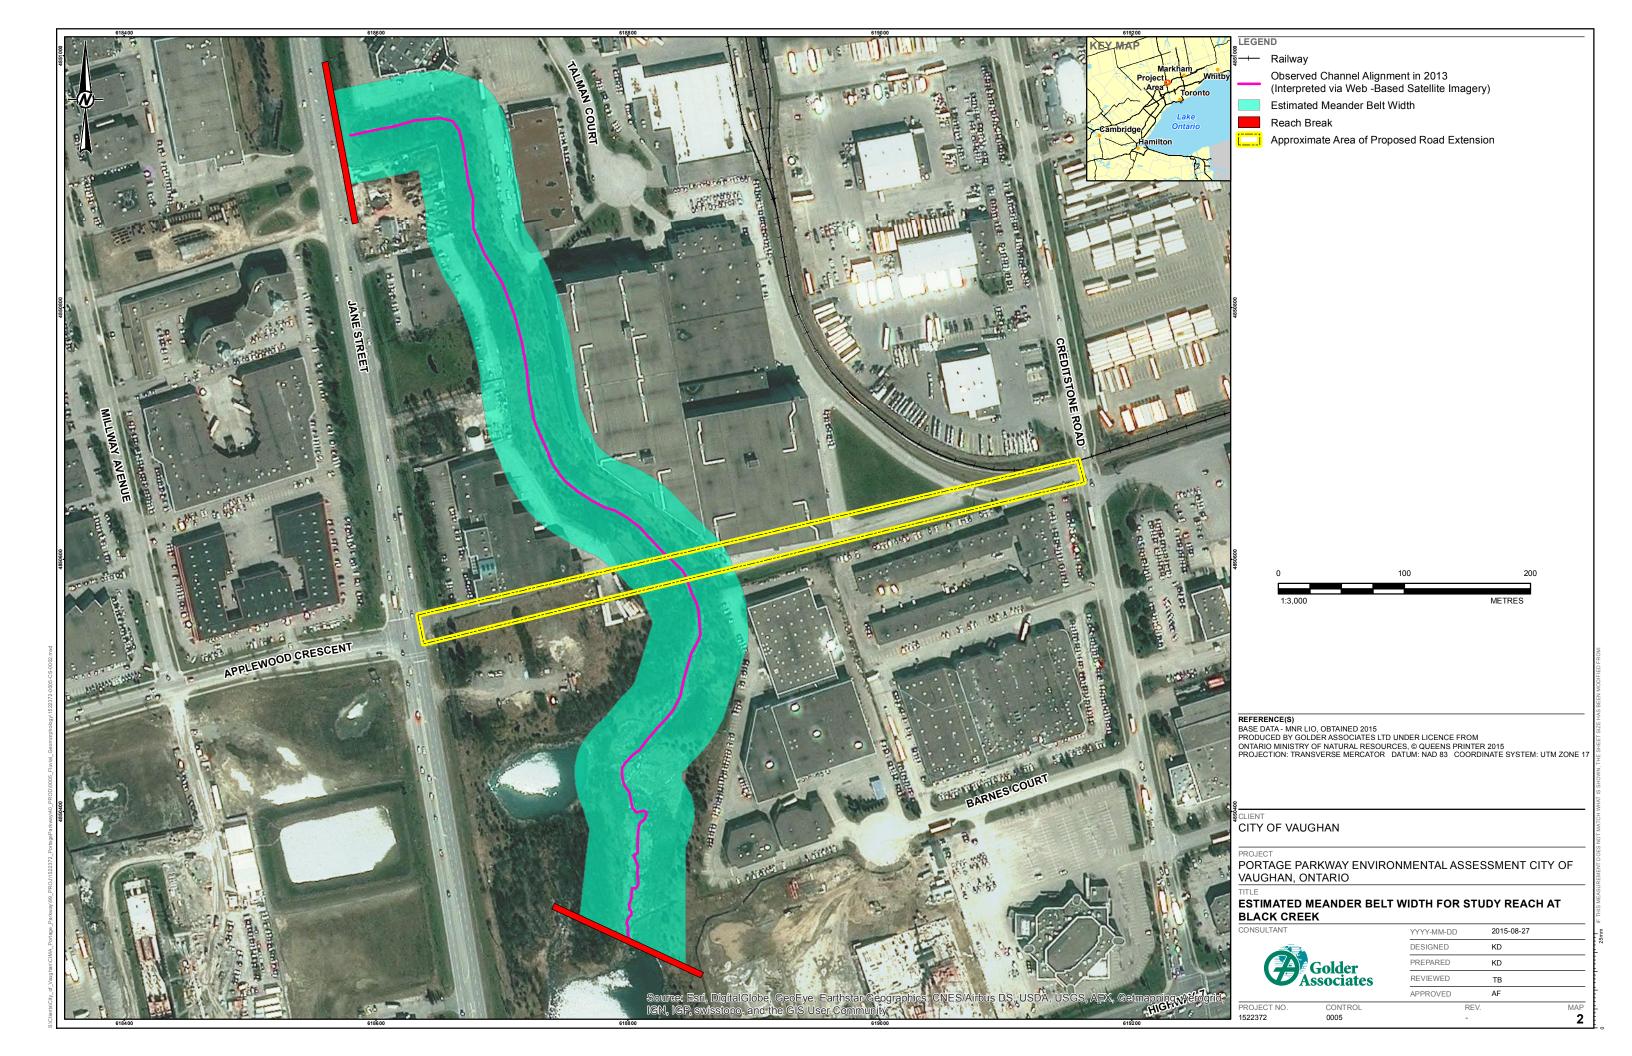
Figure 2 – Estimated Meander Belt Width for Study Reach at Black Creek

- A preliminary meander belt width was measured to be approximately 59 m. This preliminary meander belt represents the measured width between the outer-most meander bends at the study reach (i.e., perpendicular to the established meander belt boundaries).
- The existing meander belt width was estimated to be approximately 63 m. The calculation of the existing belt width combines the preliminary meander belt width with the average bankfull width of the channel, as estimated in the field (59 m + 4 m = 63 m).
- The final meander belt width was estimated to be approximately 76 m. This final belt width combines the estimated existing belt width with a safety factor of 1.2 in order to account for anticipated changes in upstream hydrology and potential channel movement (63 m * 1.2 = 76 m).

The final meander belt width of approximately 76 m was plotted on the 2013 web based satellite image (Figure 2); divided over the meander belt width axis to allow equal channel buffer on either side of the axis.

For the reasons identified above and from the standpoint of fluvial geomorphology, it is recommended that the proposed culvert at Portage Parkway include a width of at least 8 m. This suggested crossing dimension represents two (2) times the average bankfull width of the channel. The suggested span for the proposed culvert is expected to provide sufficient opportunities to maintain channel form and/or function (e.g., sediment transport and fish passage).
