HERITAGE VAUGHAN COMMITTEE JULY 16, 2014

1. PROPOSED DEMOLITION OF GARAGE/WORKSHOP, 141 CENTRE STREET – WARD 5

VAUGHAN HERITAGE INVENTORY - BUILT HERITAGE EVALUATION FORM

BUILDING/STRUCTURE ADDRESS: 141 Centre Street – Garage / Workshop only
COMMON NAME OF BUILDING/STRUCTURE: Owen McCarthy House (1844)/ garage/ workshop and Robert Jarrett and family (1846-1871)

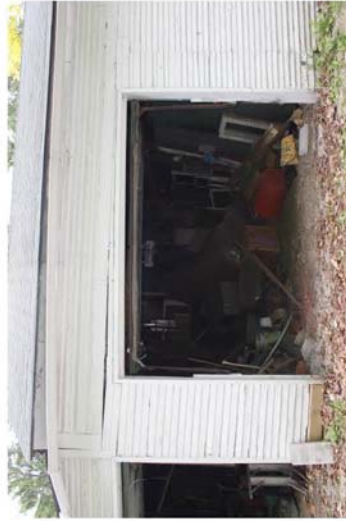
The previous garage doors are still stored within the structure. They are tongue and groove strip panel doors. There is evidence in the cladding that the door opening was altered at around the time that the current steel doors were installed.

East Elevation (partial) – view of garage door opening

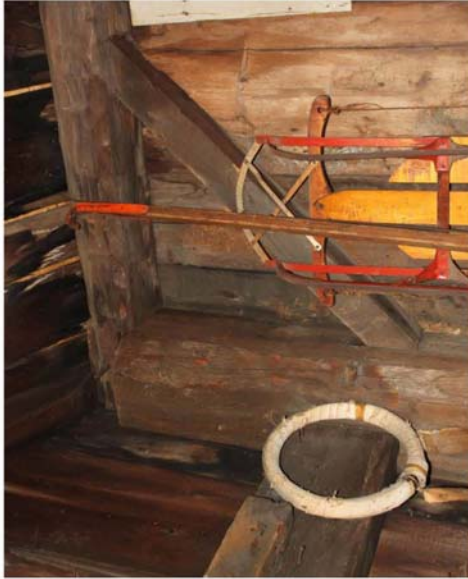
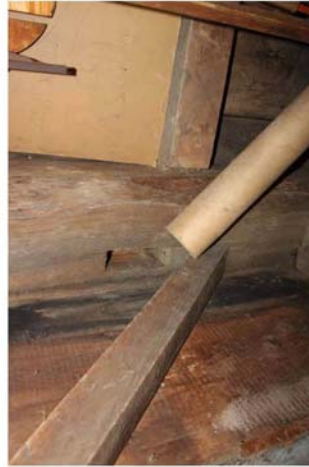
South-West corner post at west bracing detail view. Mortise and tenon joinery. Note post and girder connection with pins.

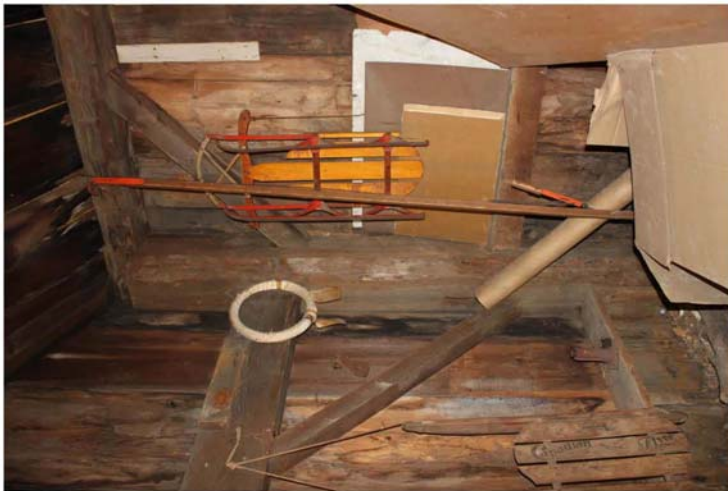
South-West corner post at south bracing detail. Nailed connection and mortise no longer in use.

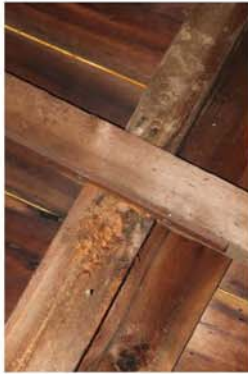
Detail of reinforced mortise and tenon joint at rafter with purlin. Note nails.

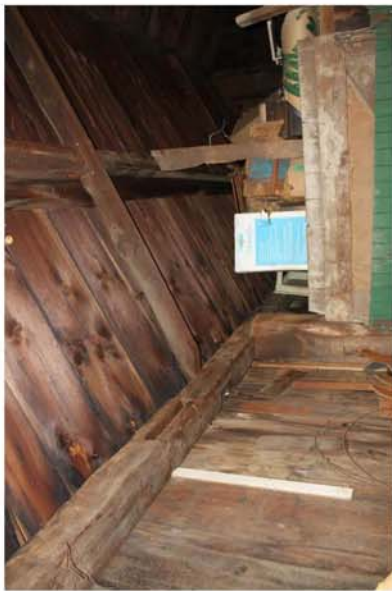
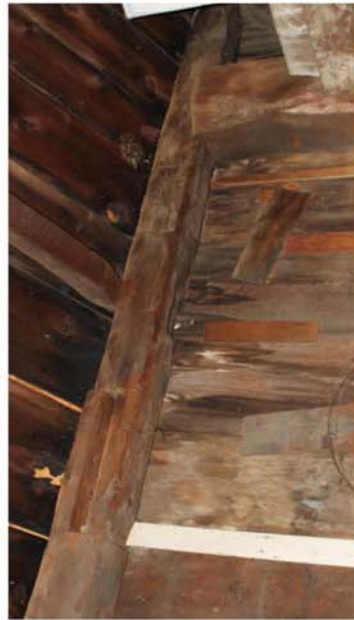
West wall. Note pinned lap joint on top plate, notched connection at post and tapered rafter at top plate.

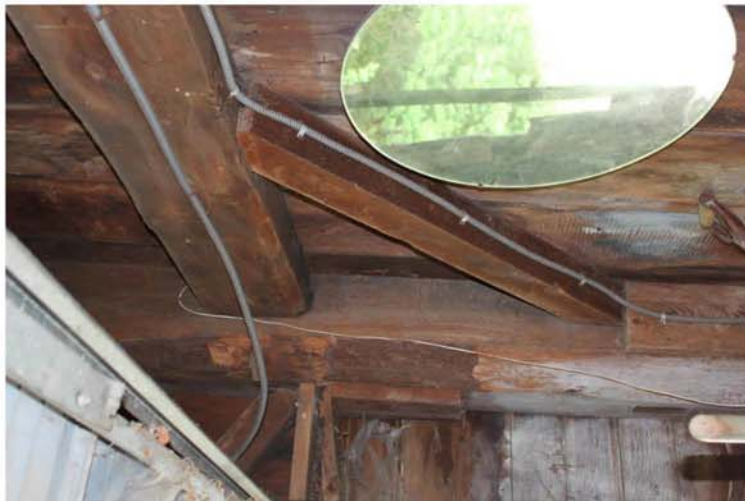
South-East corner post, bracing and girder connection. Note mortise and tenon and pin.

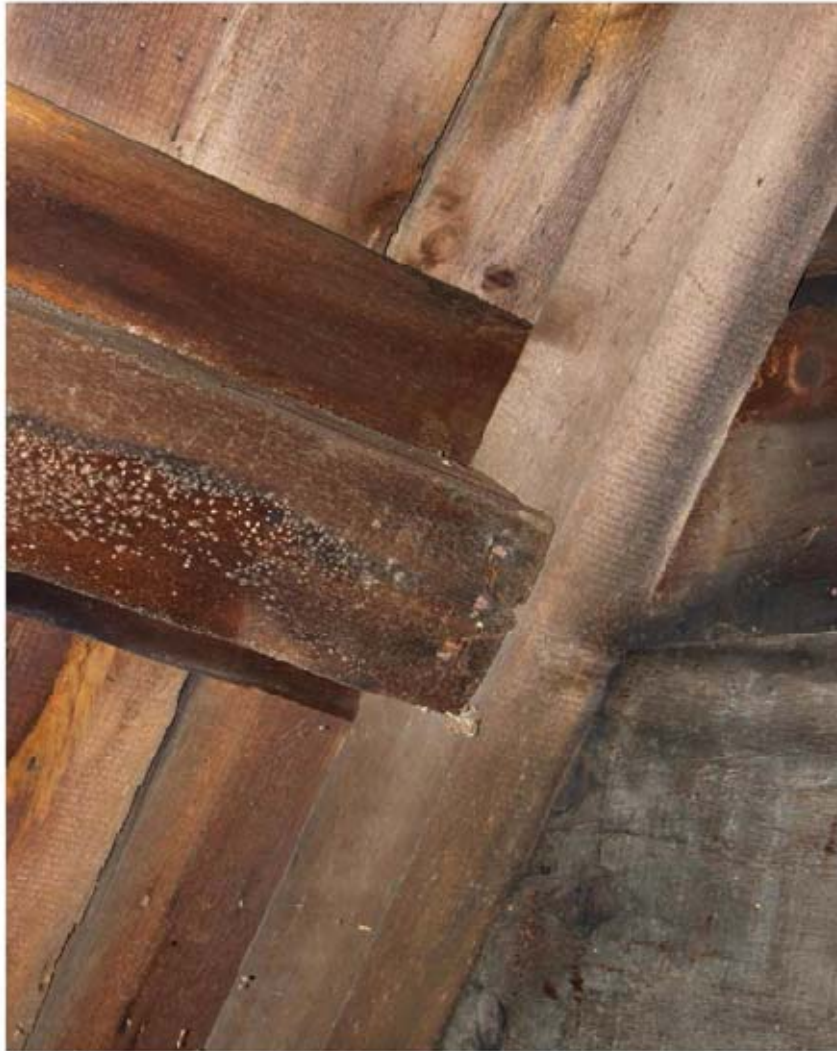
Detail showing square head, characteristic of machine cut rails used up to c.1900. Also note: circular saw blade marks on rafter, vertical saw marks on roof sheathing, flat saw marks at angle on wall sheathing, sign of mold growth on purlin, no visible saw marks on purlin.

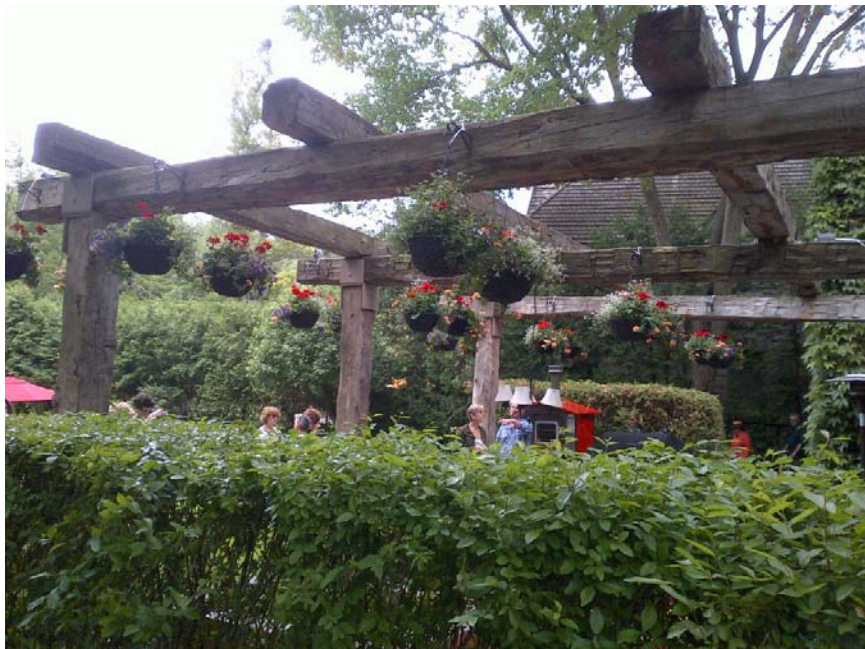
Bottom: Photo of reused hand-hewn beams, submitted by applicant
