HERITAGE VAUGHAN COMMITTEE AUGUST 21, 2013

3. HERITAGE REVIEW OF NEW DEVELOPMENT AT SW CORNER OF KEELE STREET AND MAJOR MACKENZIE DRIVE – WARD 1

To review the proposed demolition of several heritage and non-heritage structures within the Maple Heritage Conservation District and review the proposed new development for the site.

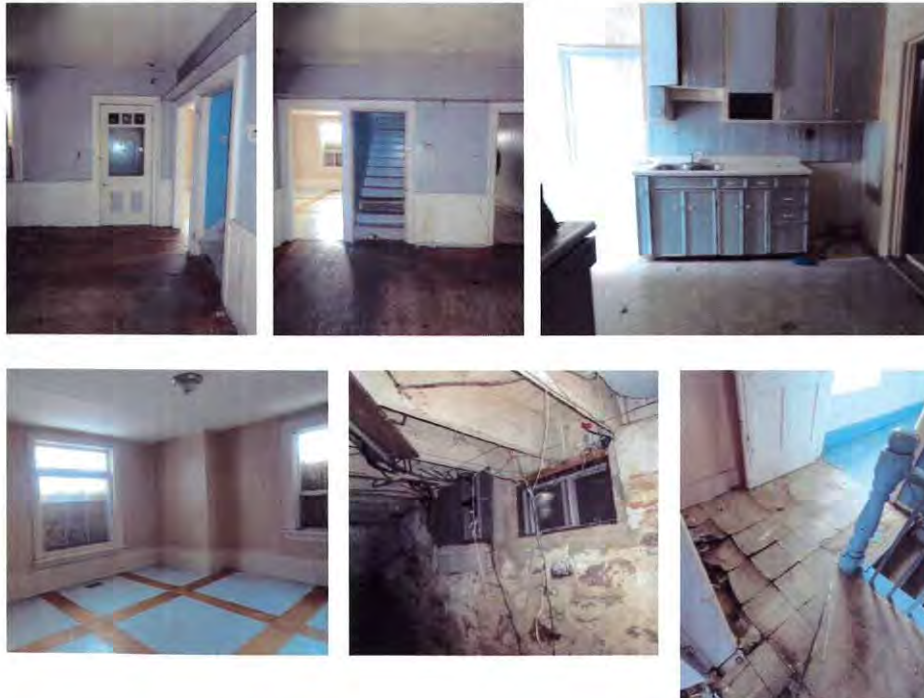
The existing home has a gable roof, and is a 1-1/2 storey building clad in horizontal aluminum siding on wood frame on a fieldstone foundation (c.1880). The entry is a small vestibule on a concrete block foundation. The exterior is horizontal aluminum siding. Shingle roof is in poor condition and needs to be replaced. Existing windows are single glazed. Wooden fence is in a state of disrepair.

Overall this house is in fair to poor condition and has been neglected.

Exterior walls and roof materials are not original. The stone foundation is original to the house but is not of any outstanding or significant importance or value. Exterior windows typically have been retrofit with aluminum and vinyl inserts and are no longer of significance.

The residence includes some wood trim wainscoting, decorative railings, wood flooring and wood doors which may date from original construction. However, most interior finishes have been replaced or modified over the life of the house and any remaining components are mismatched, damaged, altered and in fair to poor condition.

On review of the 1-1/2 storey residence at 9964 Keele Street, there are no elements of historic value worthy of preservation.

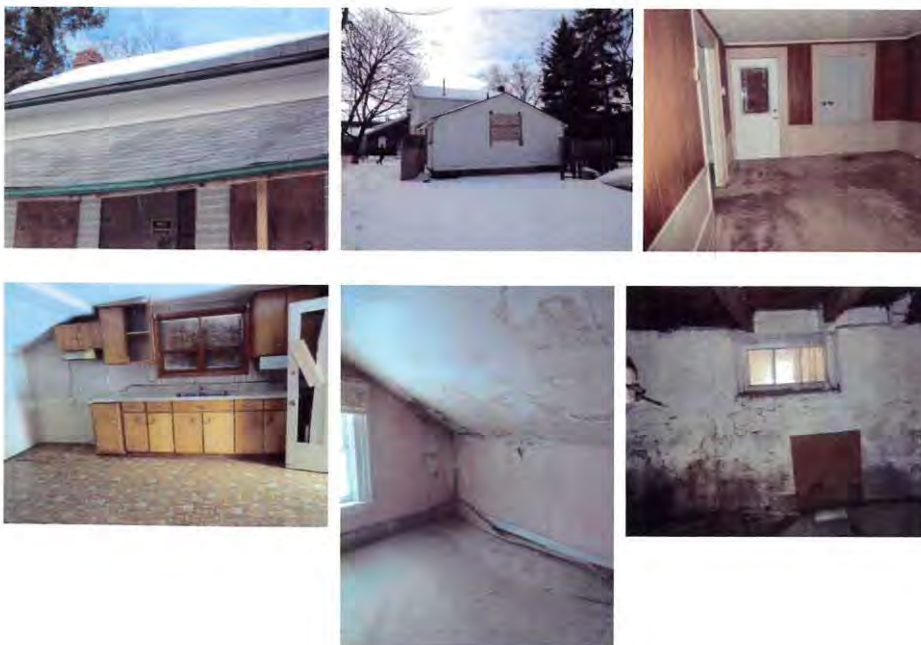
The 1-1/2 storey Georgian home has clapboard horizontal siding and a shed roof above an open verandah along the front (south) side. Concrete block foundation below the verandah has settlement cracks. The wooden posts supporting the verandah roof are not totally vertical and the roof itself has started to sag over the years. A red brick chimney seems to be in good condition. Asphalt shingle roof needs to be replaced. The home is in fair condition, but has no historical value worthy of preservation.

Overall this house is in poor condition and has been neglected. The age of the house is not known.

Exterior wall finishes may be original but are of no significant interest and are in poor condition. Roof materials are not original.

The residence includes some minor wood elements which may date from the original construction. However, most interior finishes have been replaced, modified or damaged over the life of the building and are generally in fair to poor condition. Exterior windows and doors typically have been retrofit with aluminum and vinyl inserts and are no longer of significance.

On review of the 1-1/2 storey Georgian home at 8 Church Street, there are no elements of historic value worthy of preservation.

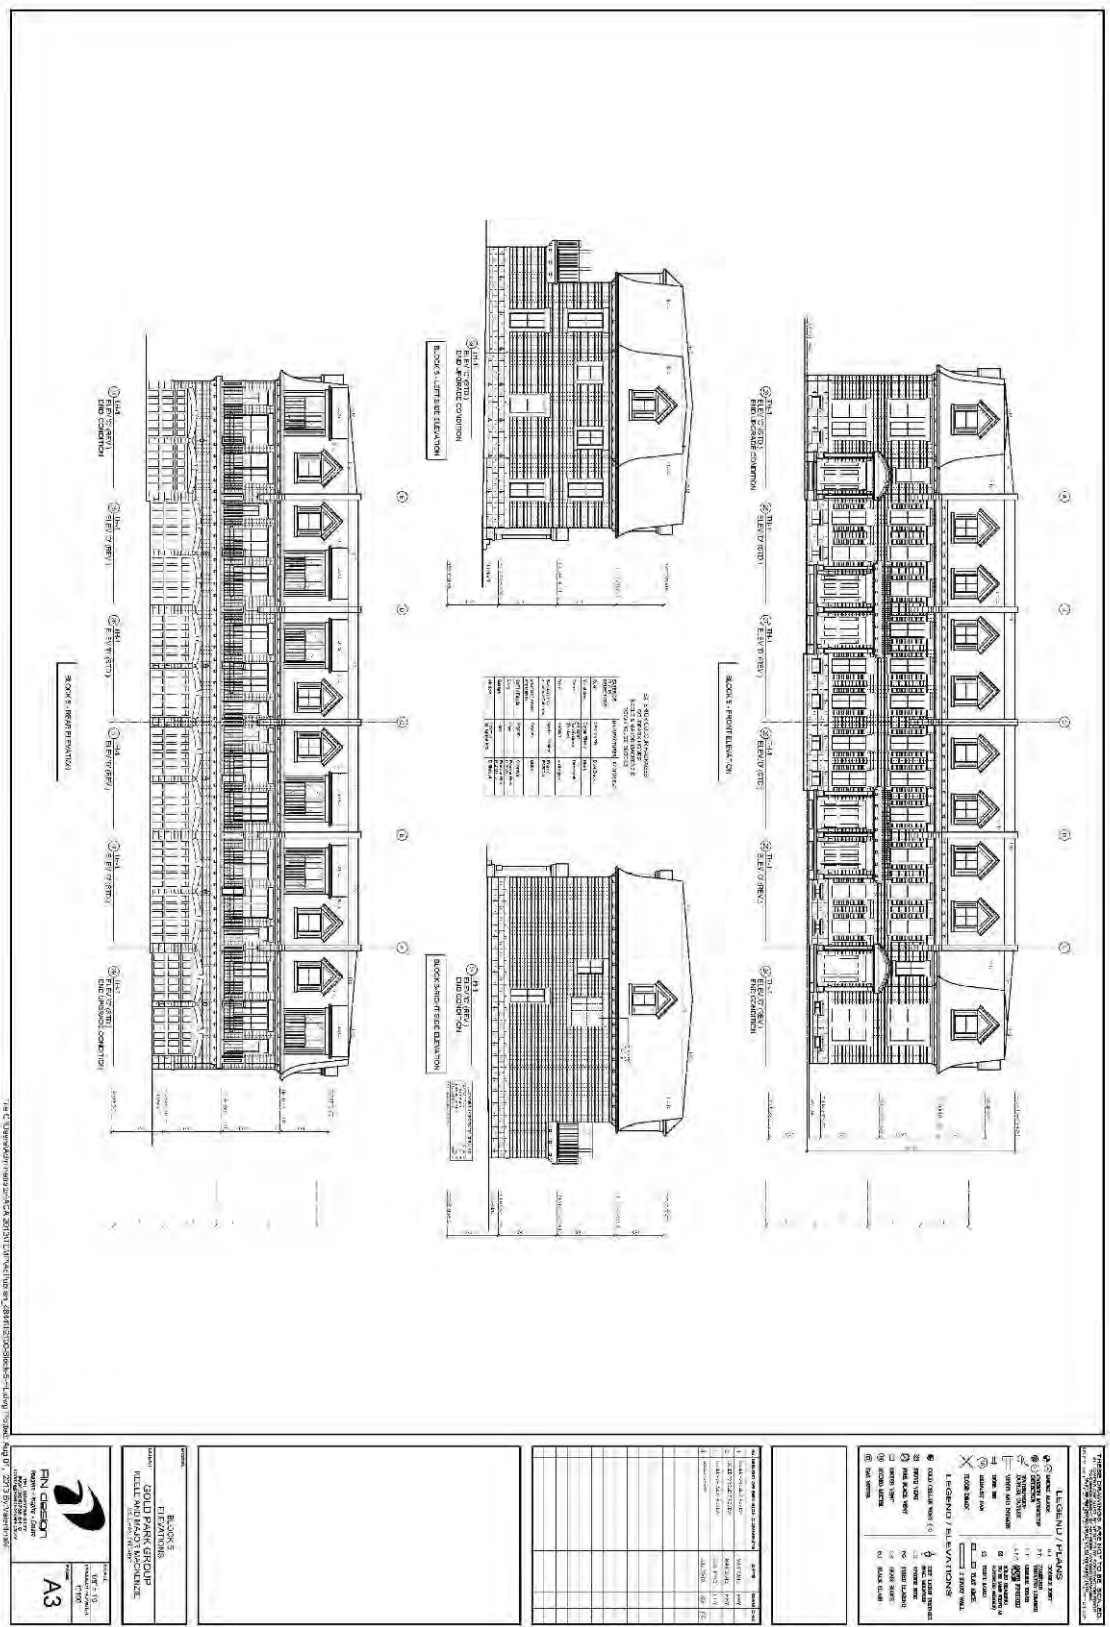
Martindale Planning Services

- Doors on third floor/attic not appropriate as there is no historic precedent for this detail – need to be removed or replaced with windows
- On Block 2, 3, 6, 8: Stone work surrounding the first storey windows are not appropriate
- Window coverage should be between 15-20%. Please confirm number and/or revise (p.82 of Maple Heritage Conservation District Guidelines)
- A larger buffer will need to be created between Block 8 and 1 Jackson Street.
