# Kirby Road Widening Environmental Assessment

Environmental Impact Study Report

Project No. 2339A | May 2022

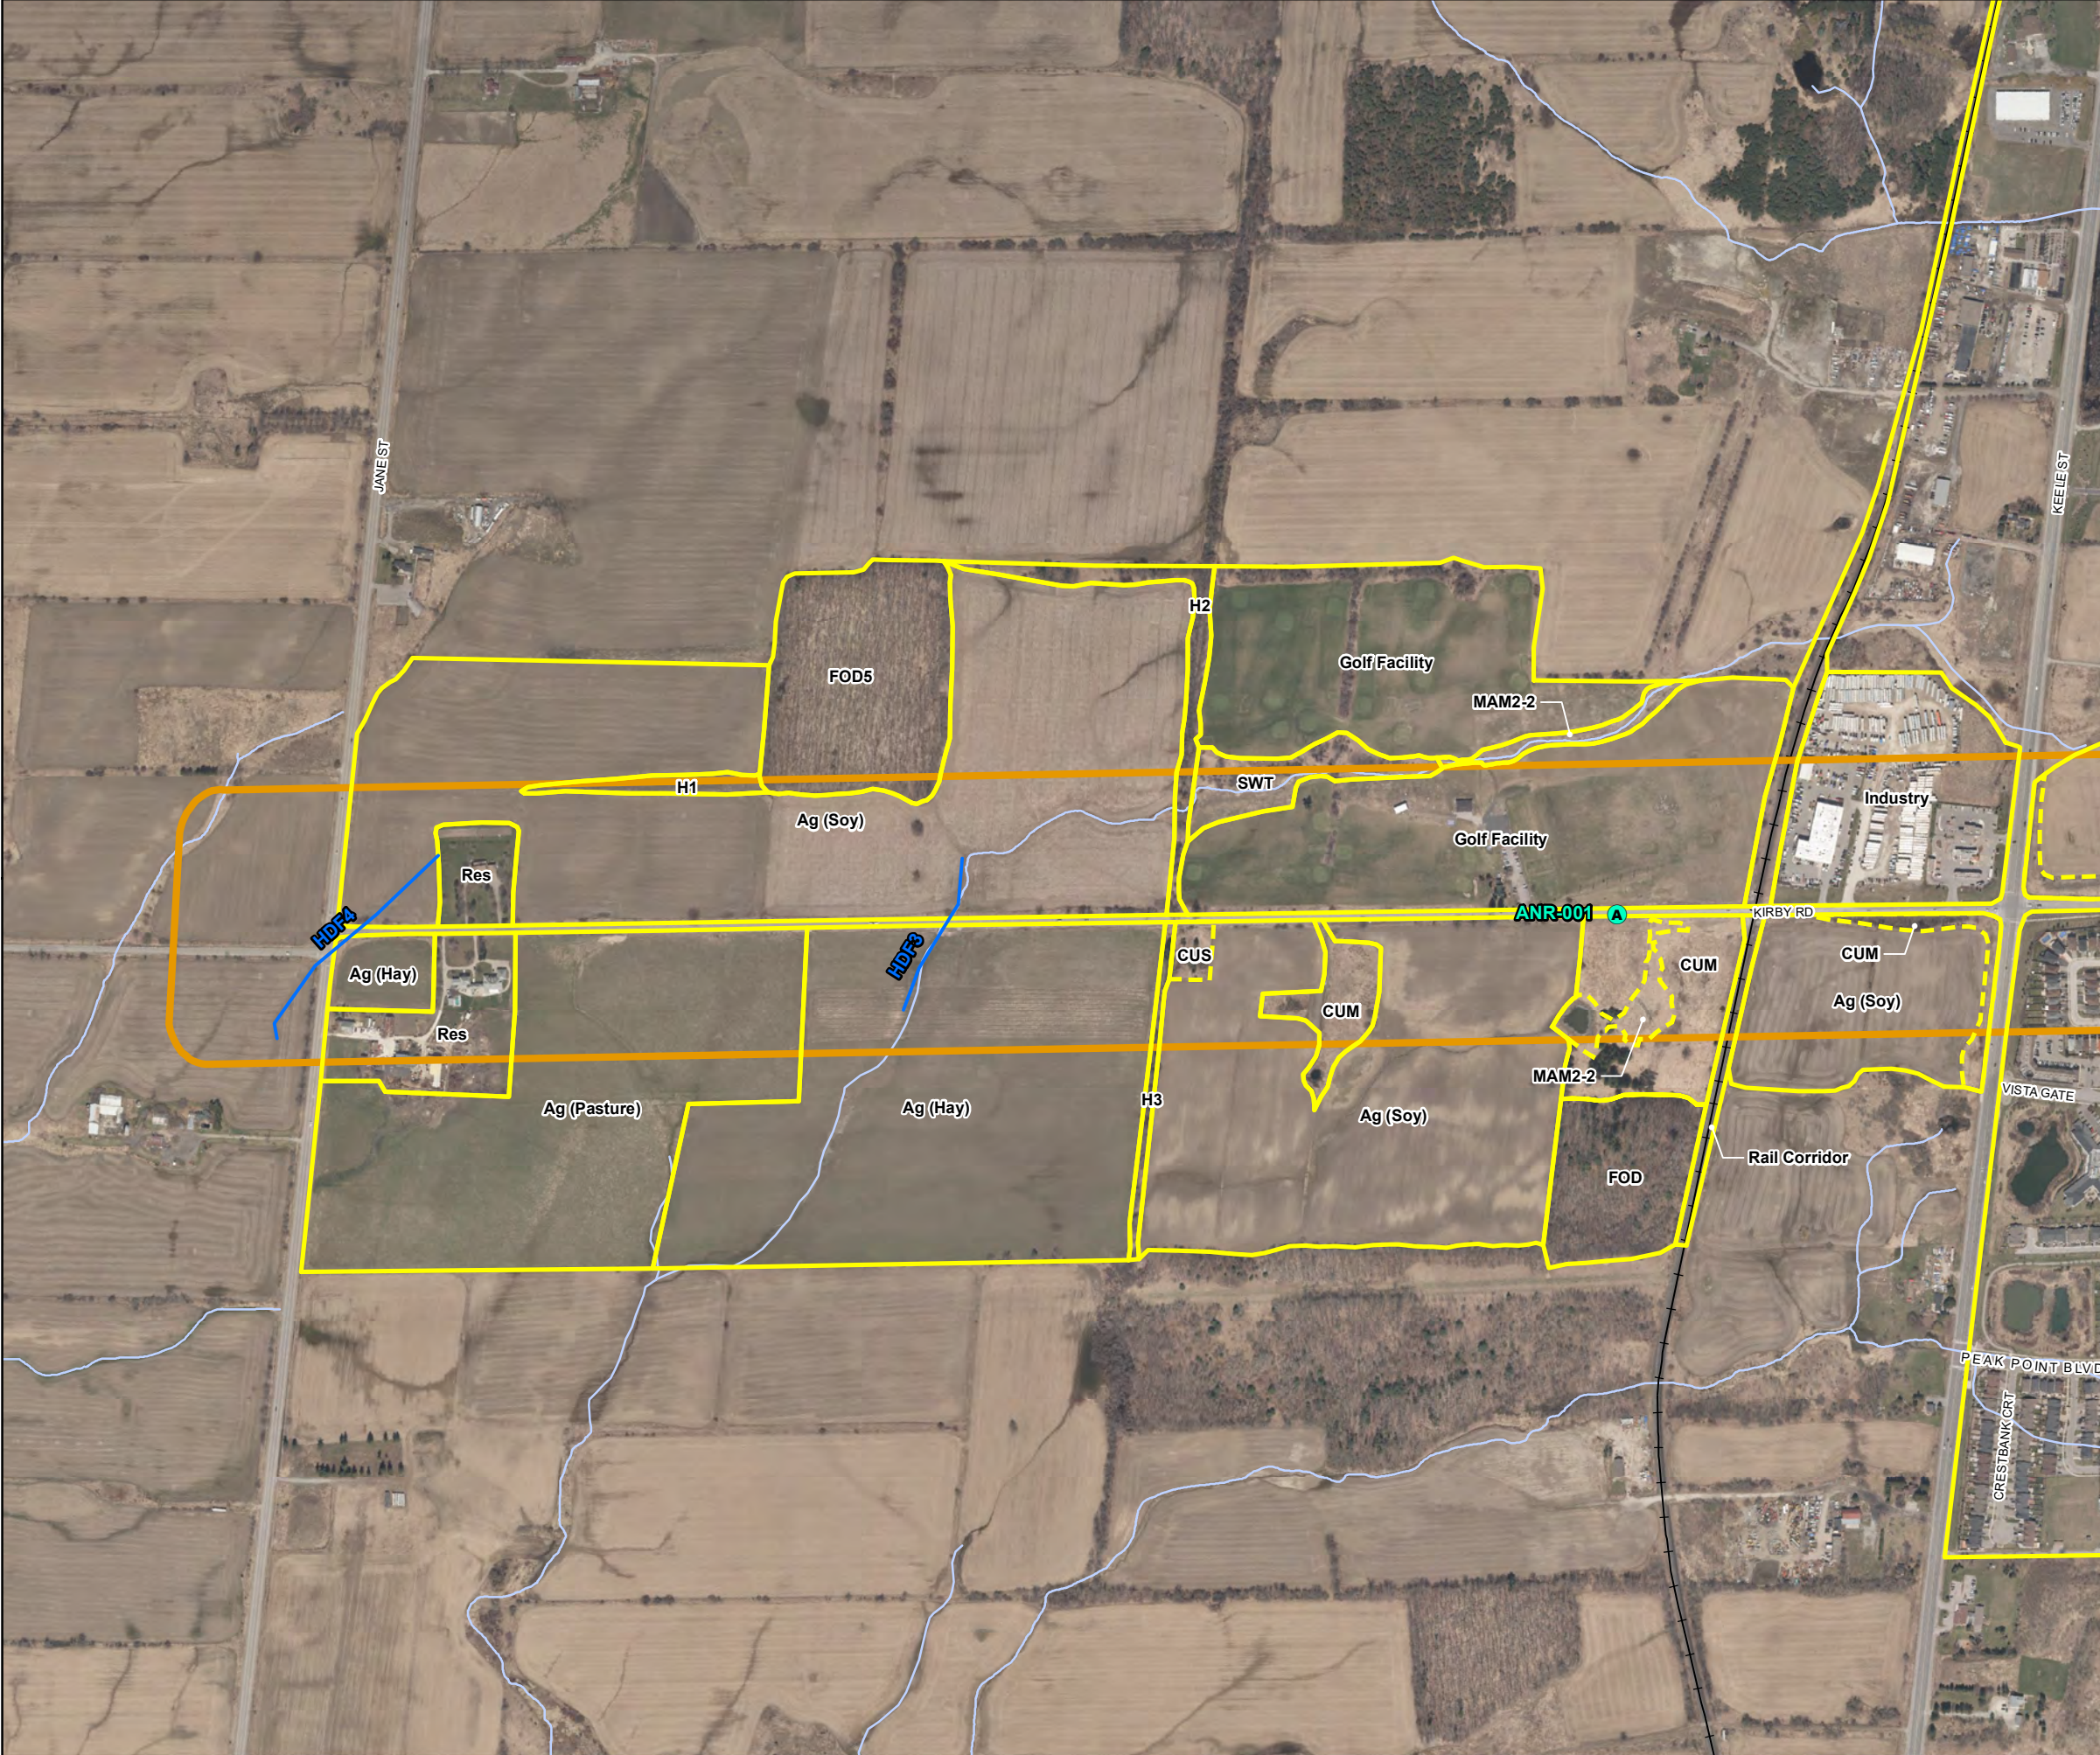
## Vegetation Communities and Monitoring Stations

- Study Area
- Headwater Drainage Feature (HDF)
- Anuran Monitoring Station (ANR)
- Ecological Land Classification (ELC)

Anuran call surveys were conducted to identify the presence of breeding frog and toad species within the subject property. Anurans were observed at both stations: ANR-001 and -002. A total of two Spring Peepers were noted on the April visit at ANR-001. A single Gray Treefrog was documented while NRSI biologists completed the May visit at ANR-002, however, this individual was noted to be >100m from the station centre.

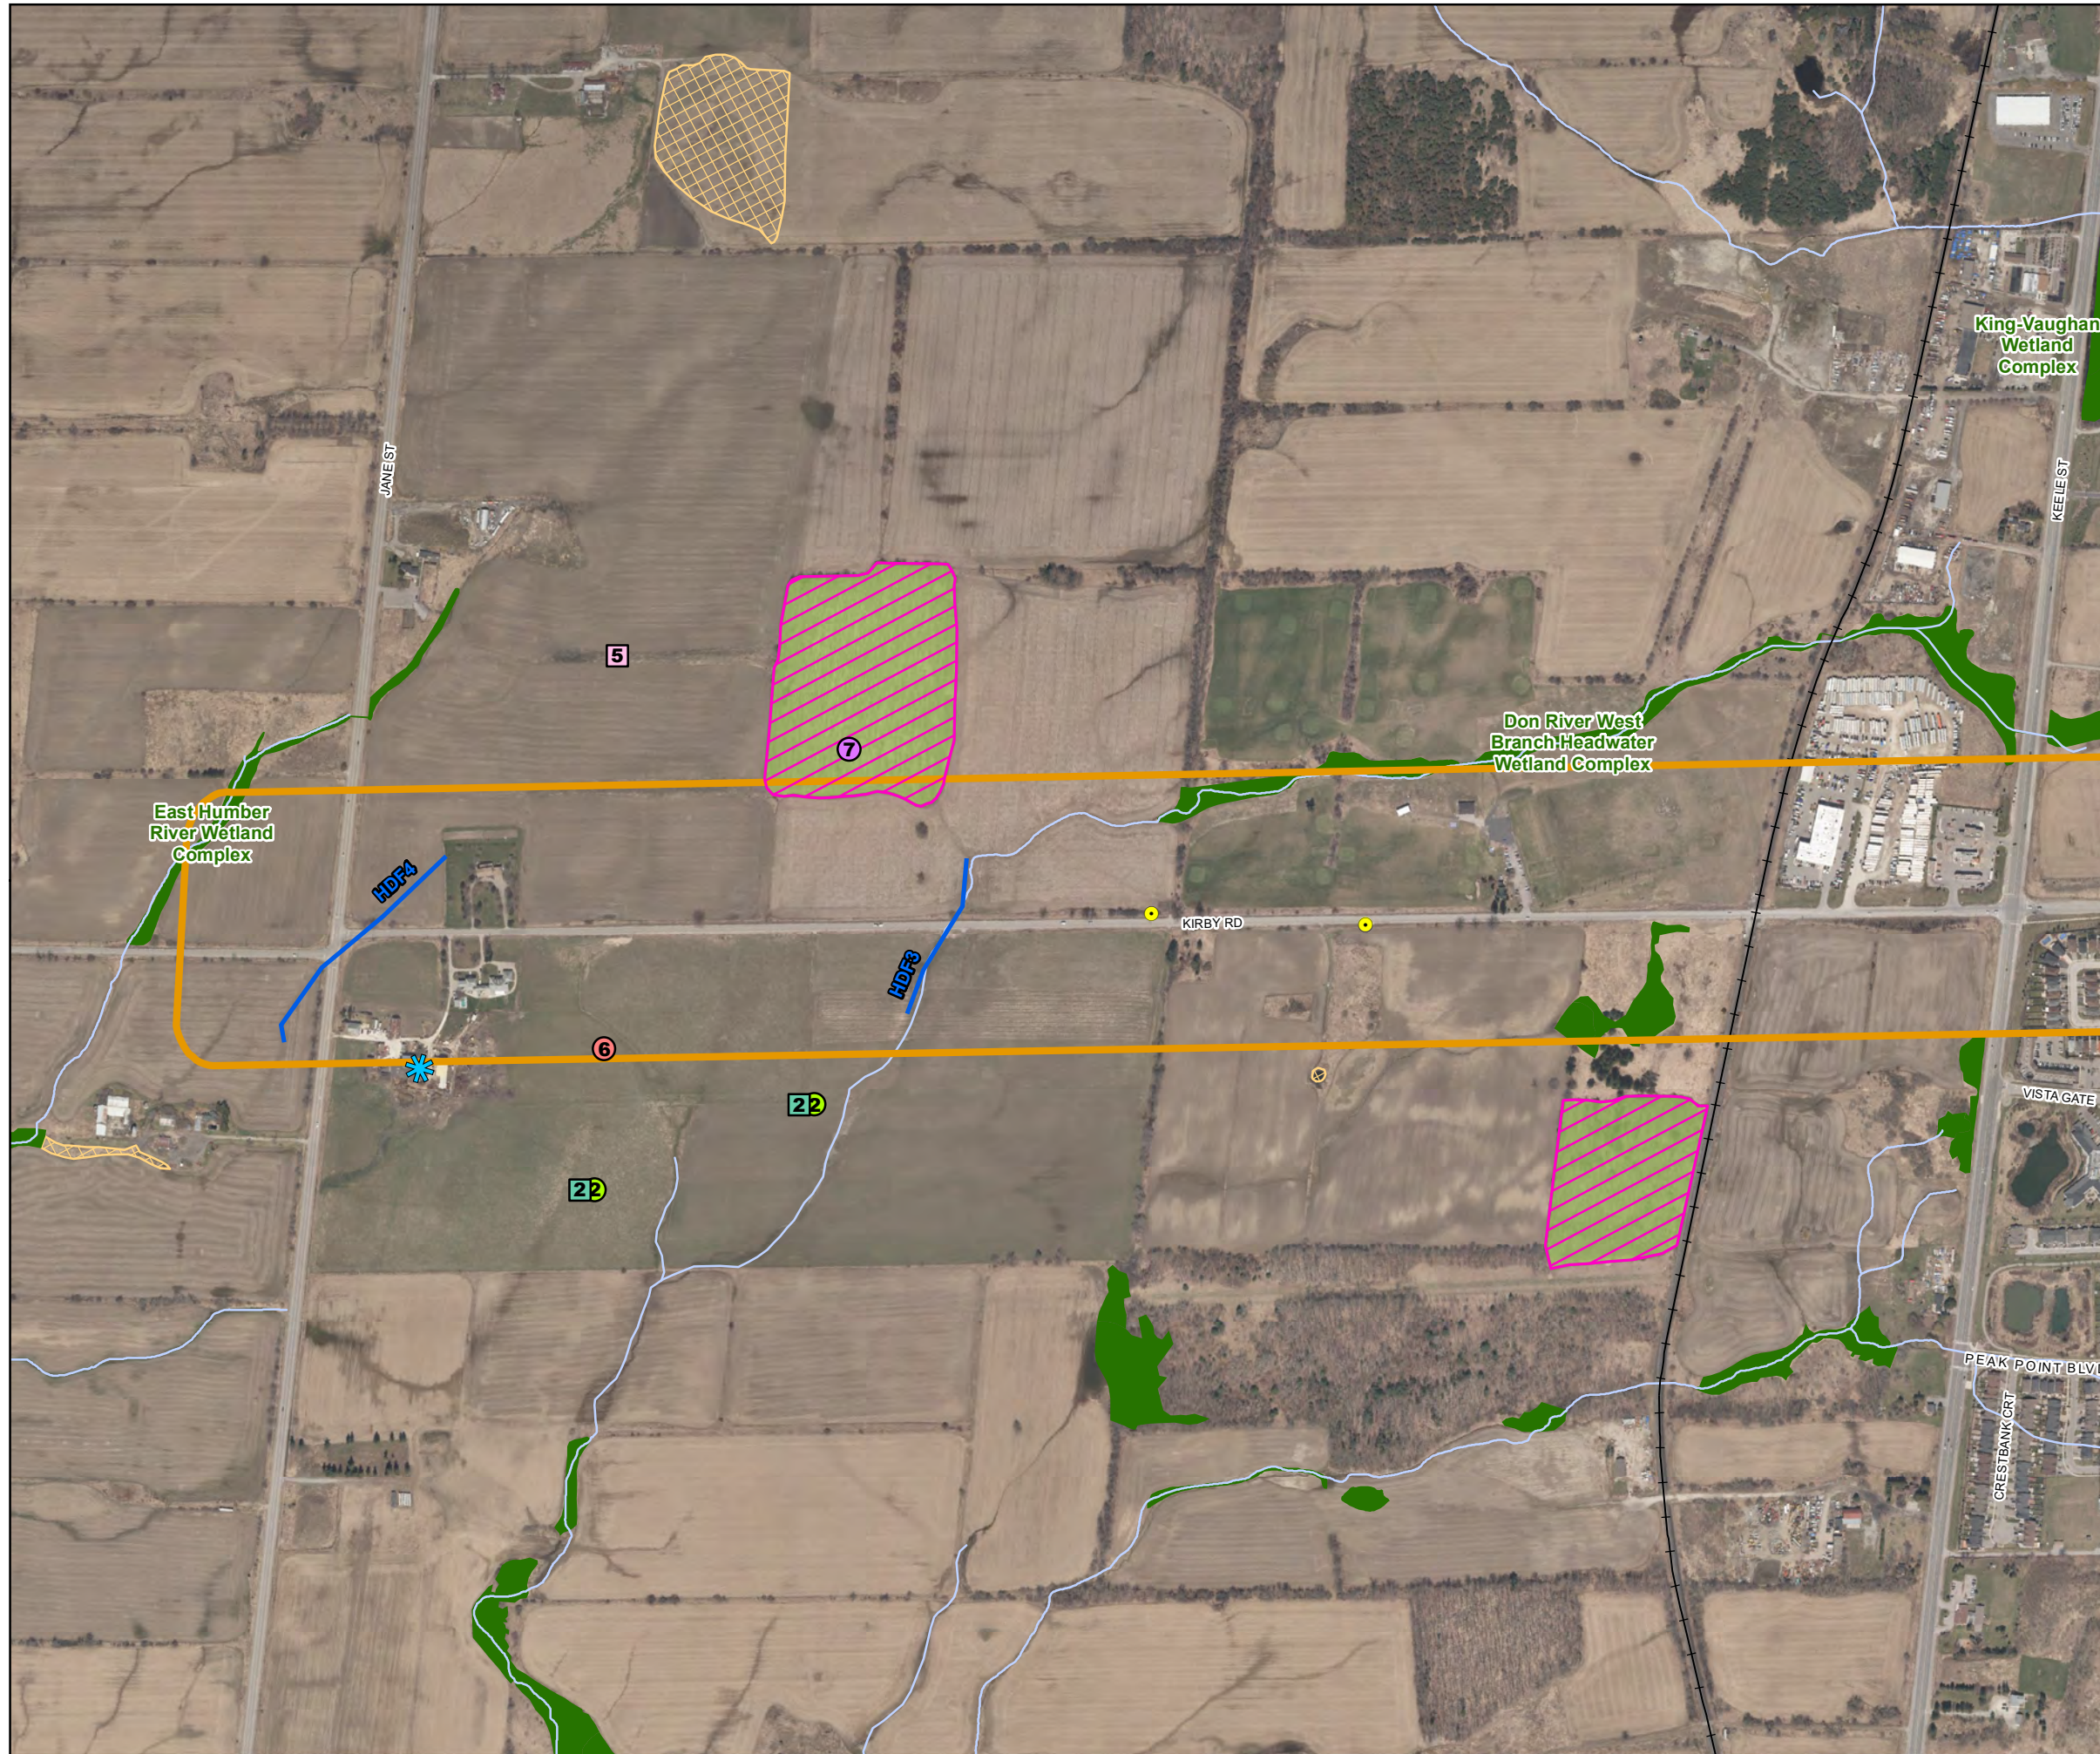
## Natural Heritage Features

- Study Area
- Provincially Significant Wetland (PSW)
- Unevaluated Wetland
- Headwater Drainage Feature (HDF) Management Recommendations
  - Mitigation
  - Protection
  - No Management Required
- Significant Wildlife Habitat
  - Special Concern and Rare Wildlife (Eastern Wood-Pewee)
  - Bat Maternity SWH
  - Potential Bat Cavity Tree
  - Suitable Barn Swallow Nesting Location
- Regionally Significant Bird Species
  - Bobolink
  - Vesper Sparrow
- Species at Risk (SAR) and Species of Conservation Concern (SCC)
  - Bobolink
  - Barn Swallow
  - Eastern Wood-Pewee

Barn Swallow is ranked as Threatened provincially; the species is noted to be common throughout Ontario, however, it has experienced widespread declines. Barn Swallows were noted at 3 locations within the study area on May 30 (Map 3), comprising single individuals at each location (i.e. BARS-001 – 003). At least 6 individuals were documented on the second breeding bird visit (July 9) at BARS-001 (Map 2). All individuals documented throughout the study area were of individuals foraging over open fields and meadow habitats. Suitable nesting locations, in the form of an active barn with livestock is present at the extreme western end of the study area. Access to this property was not granted during the course of fieldwork; however, observations indicate that nesting is likely occurring within the barn, given excellent foraging areas (i.e. pasture) immediately adjacent to the barn, and the barn providing an ideal nesting location for the species. Observations of Barn Swallows at BARS-001 and -002 were not in the vicinity of suitable nesting locations.

Bat maternity colonies are typically found in cavity trees with a DBH of >25cm and older buildings within forested vegetation communities. Any ELC ecosite that is determined to contain a bat maternity colony is considered SWH. Given that the FOD, FOD1-1, FOD5, FOM2, and SWD3 communities contain the most ideal habitat and largest number of potentially suitable trees for bat maternity colonies, these have been designated as candidate bat maternity colony SWH. The location of this candidate SWH is shown on Map 3.

As described in Section 4.3.1, Barn Swallows were observed foraging throughout the study area and are anticipated to be nesting within the active farm at the western end of the study area (Map 3). Given that the development of Kirby Road is sufficiently distant from the presumed nesting location of Barn Swallows within the active barn, and that the existing pasture lands are largely outside of the developable lands associated with the Kirby Road widening, there are no negative impacts on this species. There are no suitable culverts for Barn Swallow nesting underneath Kirby Road.

Bobolink was observed in the active pasture lands, located in the far western portion of the study area (Map 3). Field surveys documented the presence of a single individual on May 30 and two birds on July 9. Based on the observations documented, along with the presence of suitable habitat in this location, it is presumed that nesting occurred within the pasture south of Kirby Road. Given that the development of Kirby Road will be located within the ROW, and that the existing pasture lands are largely outside of the developable lands associated with the Kirby Road widening, there are no proposed negative impacts on the species.

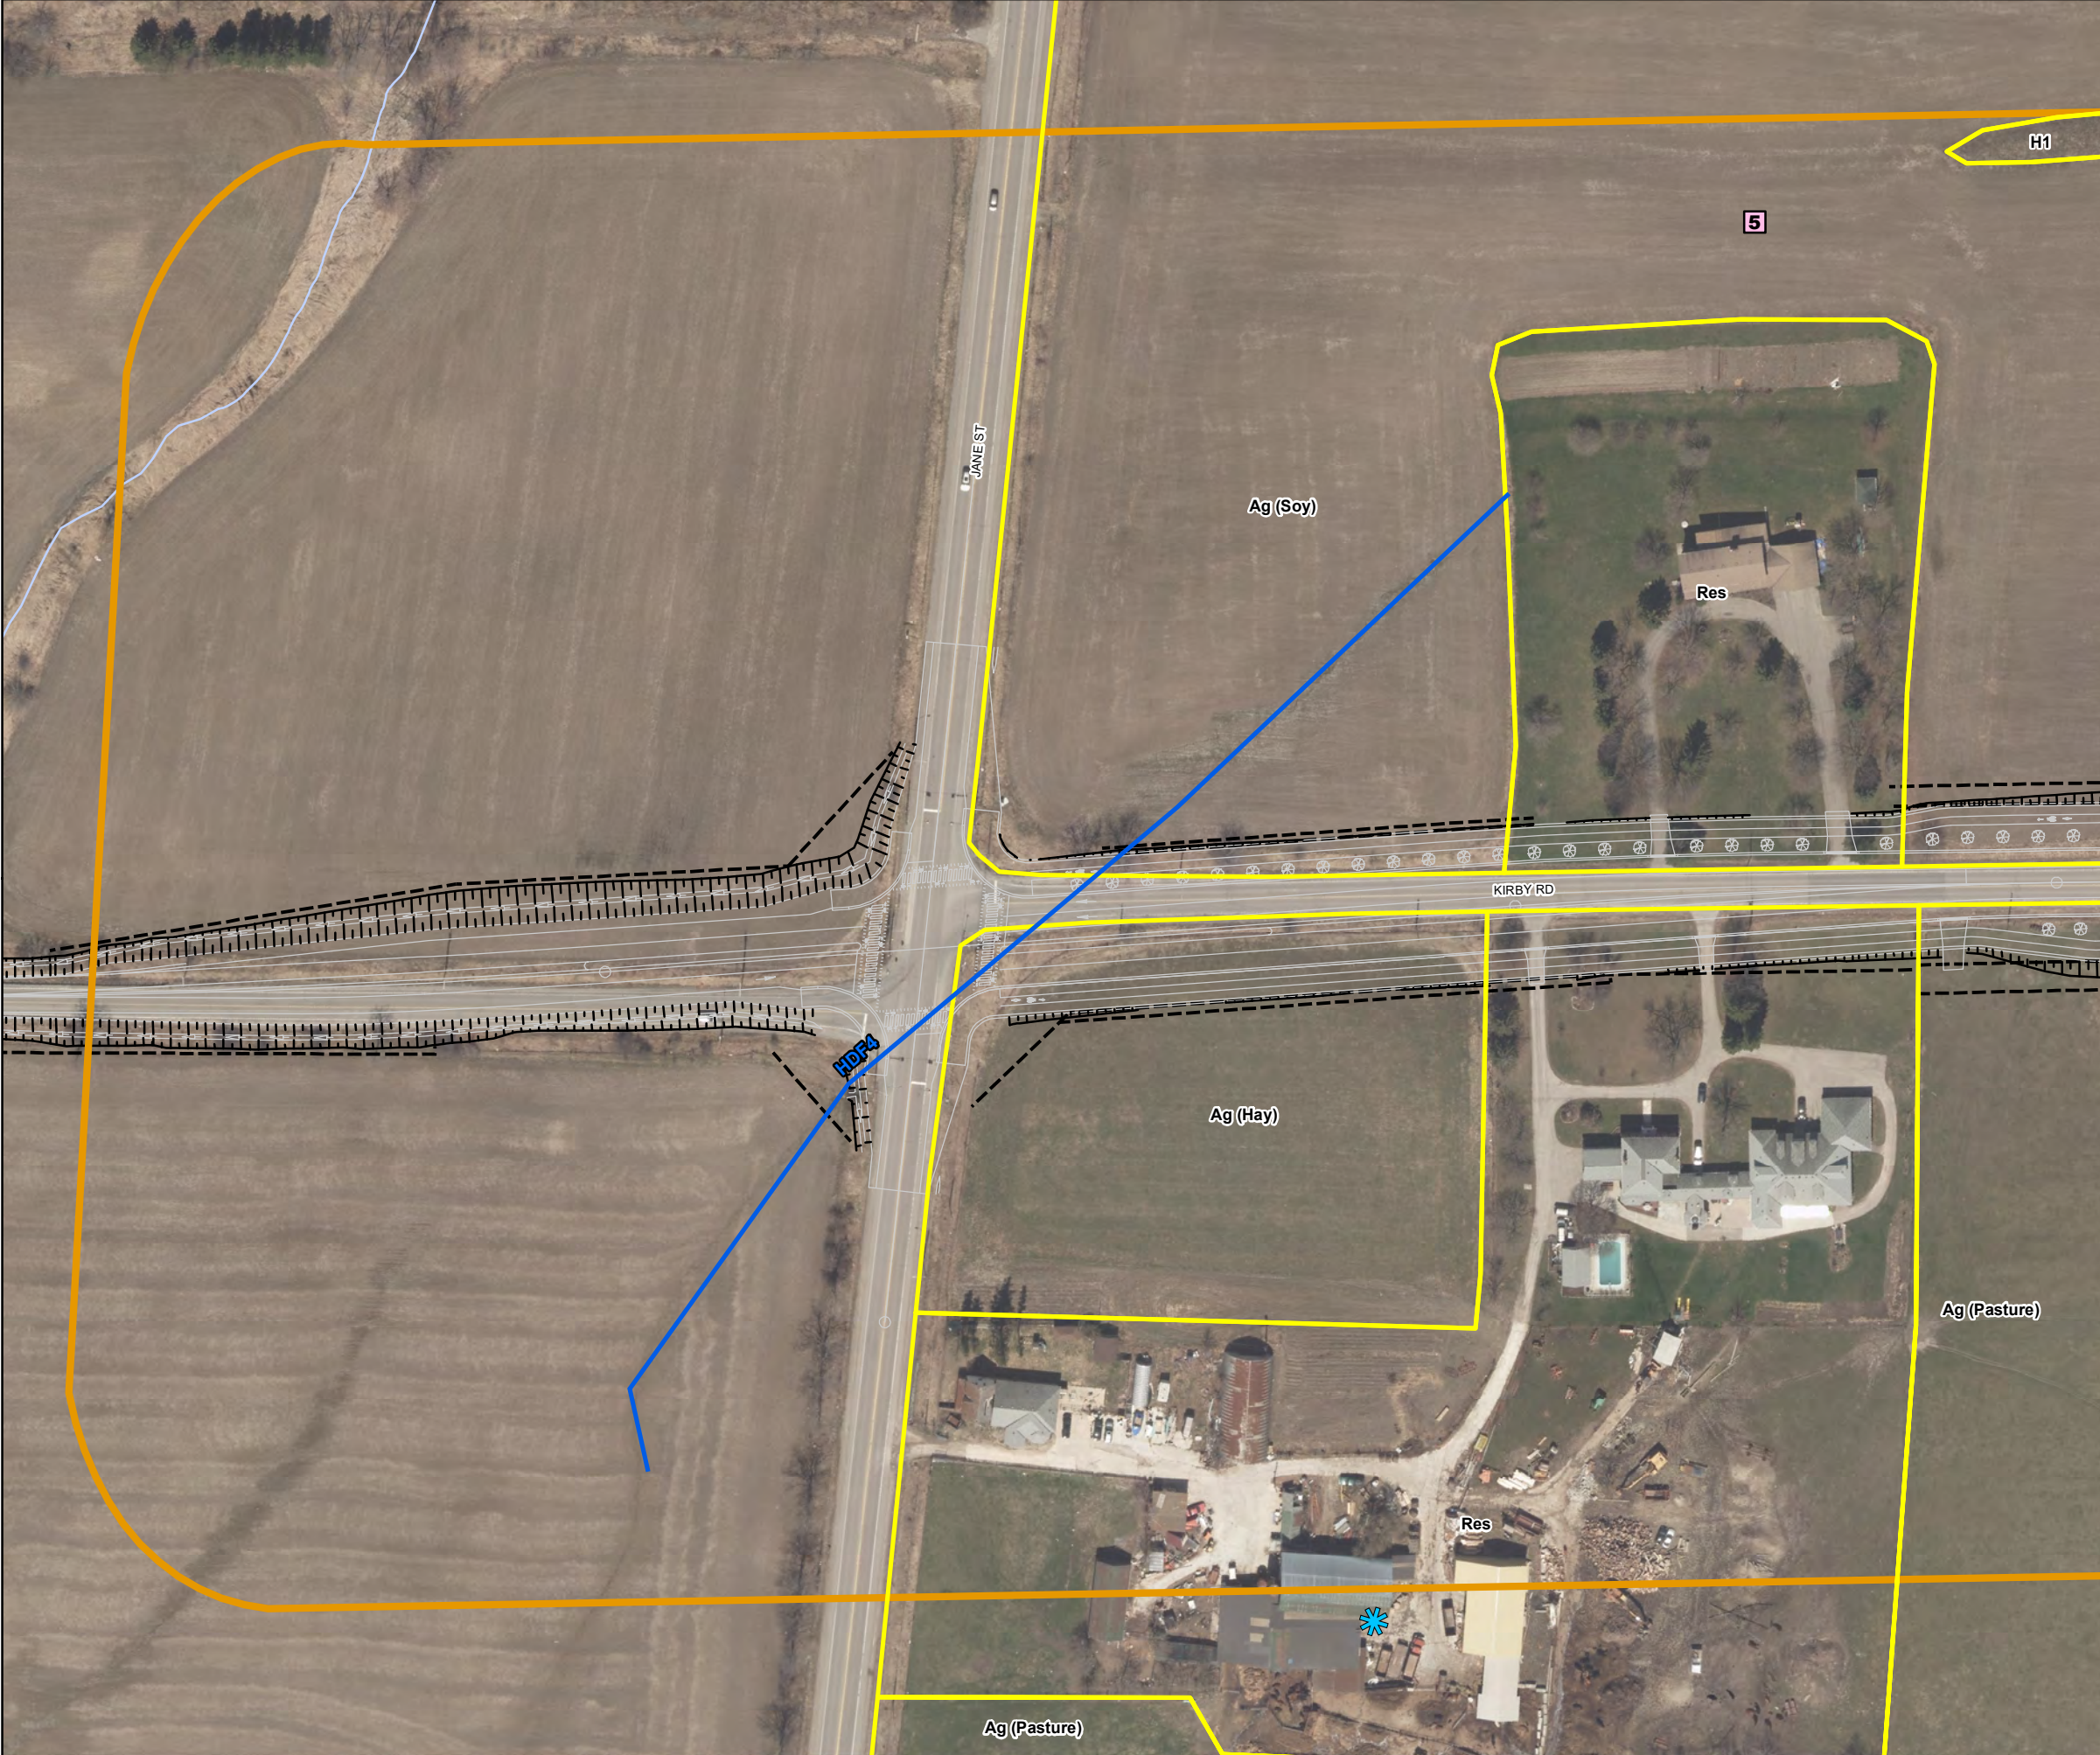
# Kirby Road Environmental Assessment Preliminary Design

- Study Area
- Right of Way (ROW)
- Grading
- Preliminary Design
- ★ Suitable Barn Swallow Nesting Location
- Ecological Land Classification (ELC)
- (Ag) Agriculture
- (H) Hedgerow
- (Res) Residential
