# BASS PRO MILLS DRIVE, FROM HIGHWAY 400 TO WESTON ROAD MUNICIPAL CLASS ENVIRONMENTAL ASSESSMENT

Black Creek at Bass Pro Mills Drive, From Highway 400 to Weston Road, Vaughan, Ontario, Fluvial Geomorphological Assessment

May 10, 2022

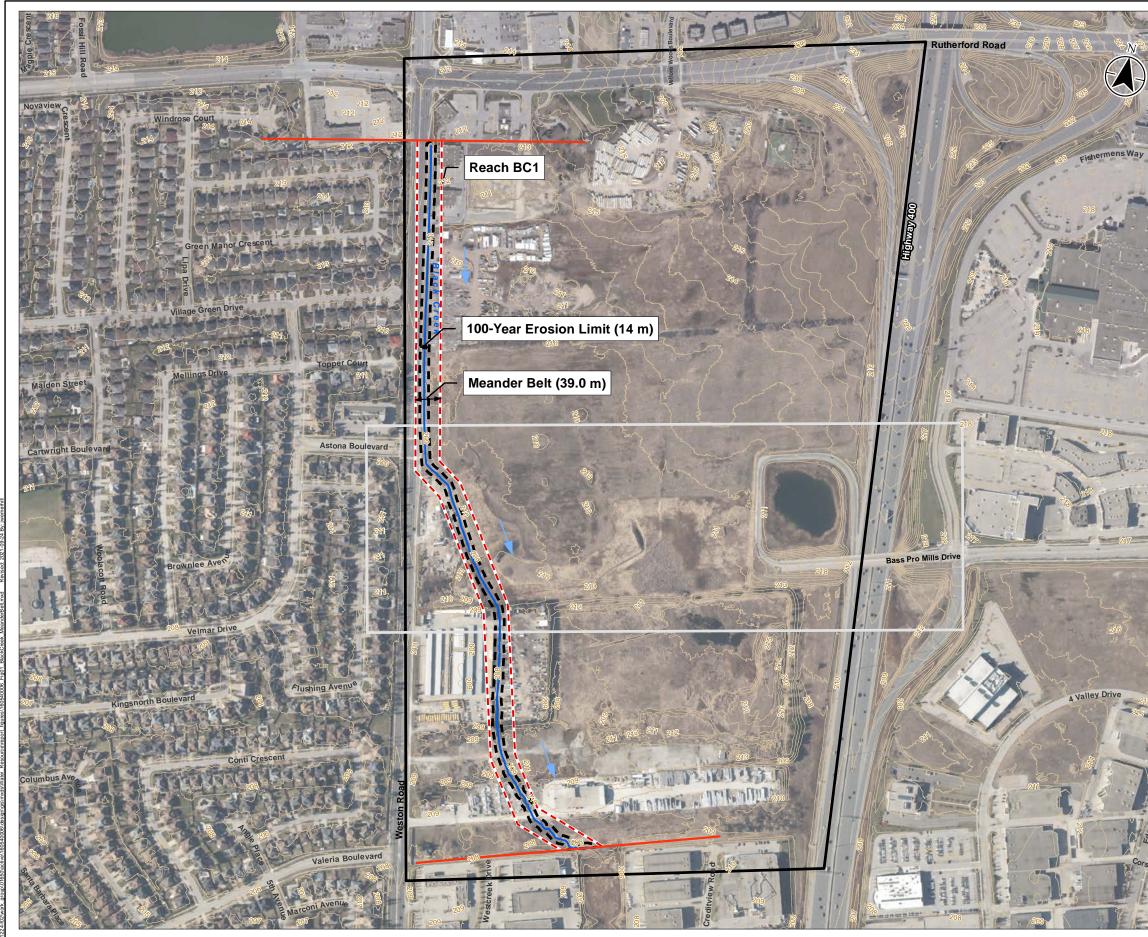
The Study Area is generally bounded by Rutherford Road to the north, Weston Road to the west, Highway 400 to the east, and Valeria Boulevard to the south. Black Creek enters the Study Area through a culvert at the intersection of Rutherford Road and Weston Road flowing south as a roadside ditch along Weston Road to a point opposite Astona Boulevard, after which it flows southeast to the southern limit of the Study Area. South of the Study Area, Black Creek has been realigned and restored. The Study Area for this assessment is larger than the EA Project Site. The location of the Study Area and the Project Site is presented in Figure 1, Appendix A.

Reaches are lengths of channel that have physical constraints (e.g. geology, slope, discharge, vegetation, sediment input) that remain nearly constant along their length and subsequently exhibit similar physical geomorphic characteristics (e.g. channel form, sinuosity, physical dimensions). As a result, the controlling and modifying influences of channel form in a reach are similar (TRCA, 2004). This partitioning of a channel into reaches guides the desktop and field analyses, in that it considers the influence of localized channel patterns and processes. Based on the information available, Black Creek within the Study Area is one reach (Reach BC1). Reach BC1 begins at the outlet of the culvert under Rutherford Road and extends 1,240 m to the restored and realigned reach downstream of the Study Area. Reach breaks are outlined on Figure 1.

A one-dimensional HEC-RAS model of Black Creek was obtained from the TRCA (2019\_11\_15 – Updated Humber River Submission 6) which was updated to ensure accurate existing conditions within the Study Area. The 2-year flow of 2.22 m<sup>3</sup>/s and channel slope of 0.376% were extracted from the existing conditions HEC-RAS model. The drainage area included the contributing external drainage area north of the Study Area of 1.93 km<sup>2</sup> (Stantec, 2004), as well as 0.73 km<sup>2</sup> which was the portion of the Study Area draining to Bass Pro Mills Drive (Cole Engineering, 2013) for a total drainage area of approximately 2.7 km<sup>2</sup>. The resulting meander belt width for BC1 using the TRCA empirical relationship is 39 m. This meander belt width is illustrated on Figure 1 in Appendix A.

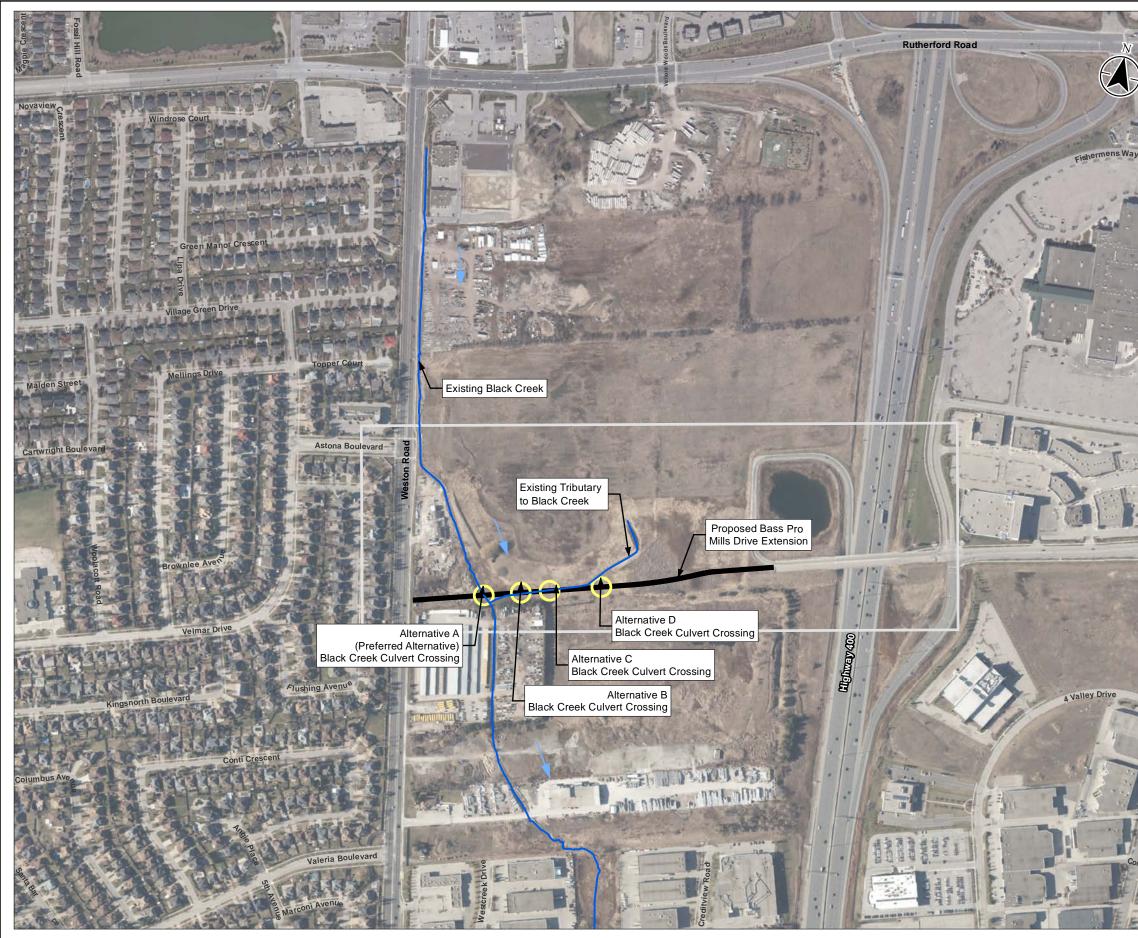
Figure No. 2

Title Black Creek Culvert Crossing Location Alternatives

- Alternative A kept Black Creek in its current location with only a minor realignment at the upstream end; and
- Alternatives B, C, and D would involve moving the crossing location progressively further east requiring a more extensive realignment and potentially a reduced channel slope.

Crossing location alternatives are shown in Figure 2, Appendix A.

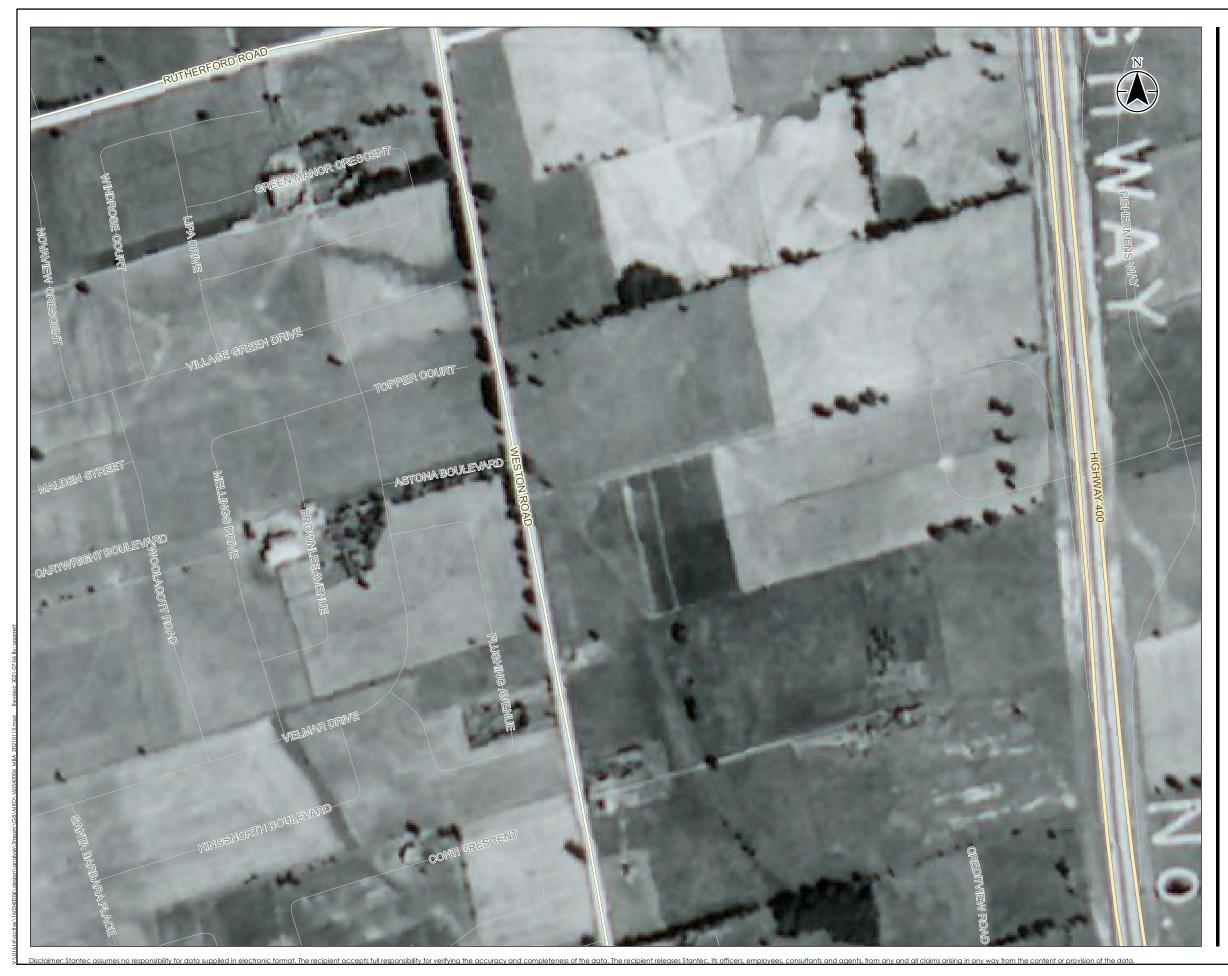
1954 Aerial Photo Source: Ontario Department of Lands and Forests (Air Photos of Southern Ontario)

A sequence of historic aerial photographs (1954, 1978, 1999, 2005, and 2020) and topographic mapping (1 m contours available from York Region Open Data) were reviewed to gain insight into channel form, surrounding land use/cover, and to identify any changes that have occurred during the period of record. The historical aerial photographs that were reviewed are included in Appendix B. The current predominant land use within the watershed is industrial/commercial with a growing proportion of residential in more recent years. Prior to 1999 the predominant land use within the Study Area Black Creek was straightened along Weston Road prior to 1954 and has remained in a similar orientation throughout the period of record with the channel being realigned eastward downstream of Astona Boulevard to accommodate development between 1978 and 1999. This type of channel modification is common within urban areas in the Greater Toronto Area. Culvert crossings were added at the entrances to businesses along Weston Road between 1978 and 1999. The current and historical riparian corridor consists of mostly grasses and other herbaceous vegetation.

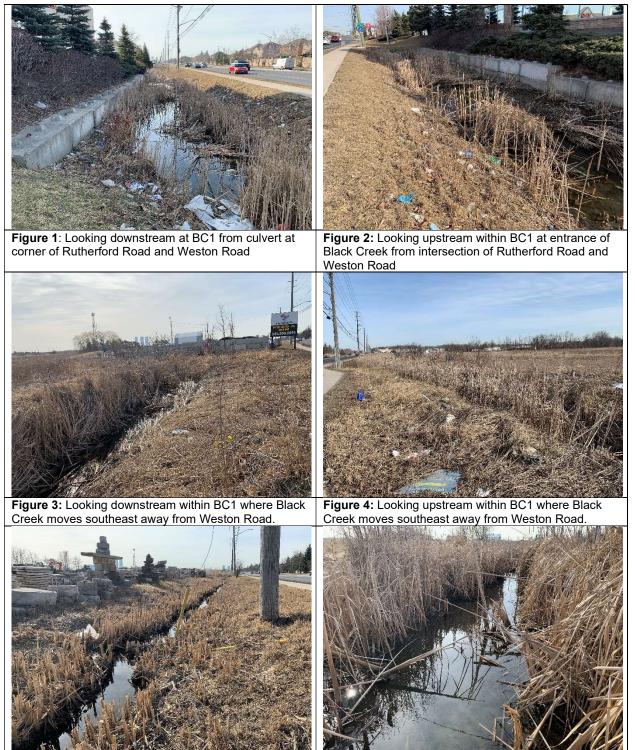
**Figure 5:** Looking downstream within BC1 as Black Creek travels parallel to Weston Road.

**Figure 6:** Looking downstream within BC1. Note heavy cattails on banks with small low flow channel.

Existing site conditions were observed during a site visit completed by Stantec on March 23, 2021. As site access was not permitted at the time of the field investigation, the site observations were made from the public right-of-way. Reach BC1 exhibited a straightened planform within an unconfined valley. The channel cross-section was trapezoidal with a small low flow channel present within cattails and phragmites. The bank slopes in this reach were moderate, and bank material was soft and cohesive. The bed morphology was homogeneous and featureless, and bed material in the accessible areas was mostly silt/clay with some sand and gravel which may have washed in from the roadway. The bank and riparian vegetation on the left bank consisted of herbaceous and flood tolerant vegetation. The right bank was vegetated with herbaceous and non-woody plants, and the right riparian area was mostly a roadway or other development. The bankfull width was estimated to be 4.0 m based on the measurements of a single cross-section accessible alongside Weston Road. Additional cross-sections should be evaluated during a detailed field assessment to confirm bankfull dimensions. The channel was generally stable with no significant aggradation, degradation, or areas of bank erosion. The physical attributes of Reach BC1 and the results of a Rapid Geomorphic Assessment (RGA) are summarized in Table 1 below. A photographic inventory of Reach BC1 is included as Appendix C and RGA included as Appendix D.

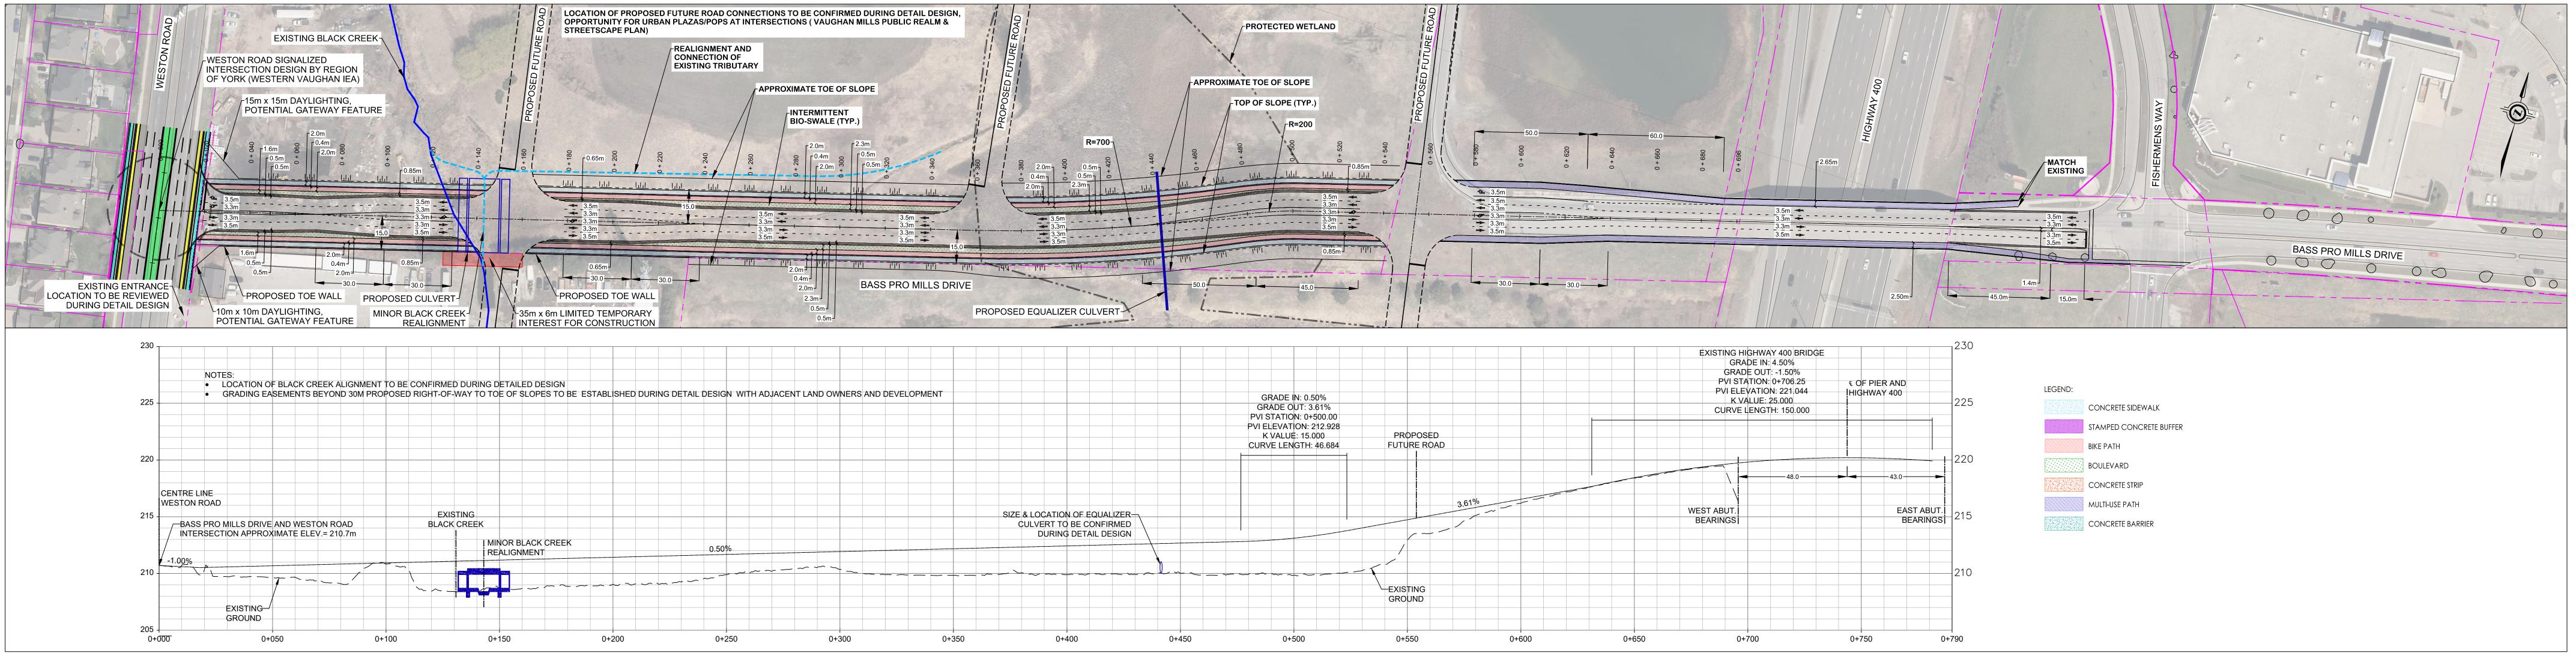
# **Bass Pro Mills Drive Extension Plan and Profile**

The preferred proposed realignment and road profile are included as Appendix E. The culvert is oriented perpendicular to the road stationing which will require a minor realignment of Black Creek. This orientation minimizes channel length within the culvert, which in turn minimizes habitat loss. It also allows Black Creek to tie into the existing watercourse downstream of the crossing without impacting the property to the south and allows for the incorporation of flows from the existing tributary east of Black Creek upstream of the crossing.

The existing tributary east of Black Creek shown in Appendix E was not observed during this assessment as site access was not permitted during the field investigation. The tributary appears small in dimension,
