BASS PRO MILLS DRIVE, FROM HIGHWAY 400 TO WESTON ROAD MUNICIPAL CLASS ENVIRONMENTAL ASSESSMENT

Geotechnical and Hydrogeological Desktop Review

Bass Pro Mills Drive Extension
Between Highway 400 and Weston Road
City of Vaughan, Ontario

GeoPro Project No.: 17-2162GH04

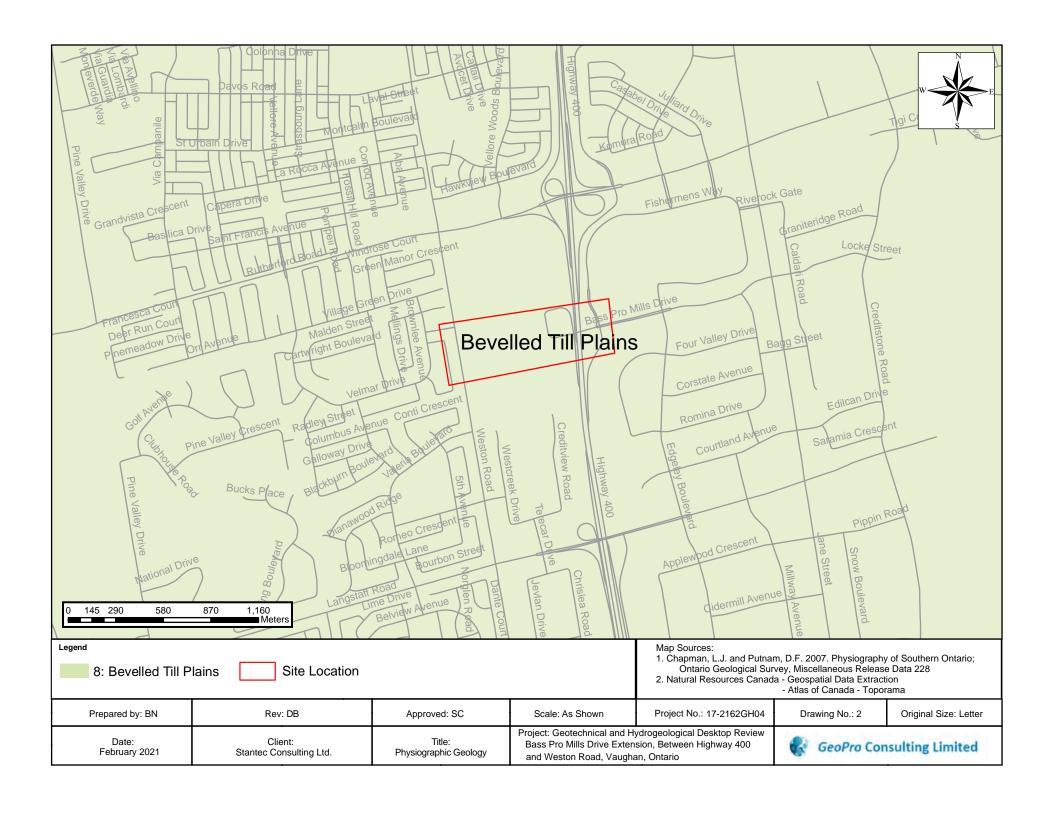
As shown on Drawing No. 2, the Site is located within the physiographical regions of the Peel Plain in an area comprised of Bevelled Till Plains according to the "Physiography Map of South Central Portion of Southern Ontario" prepared by the Ontario Department of Mines and Northern Affairs, and based on the database maintained by Ontario Geological Survey ("OGS").

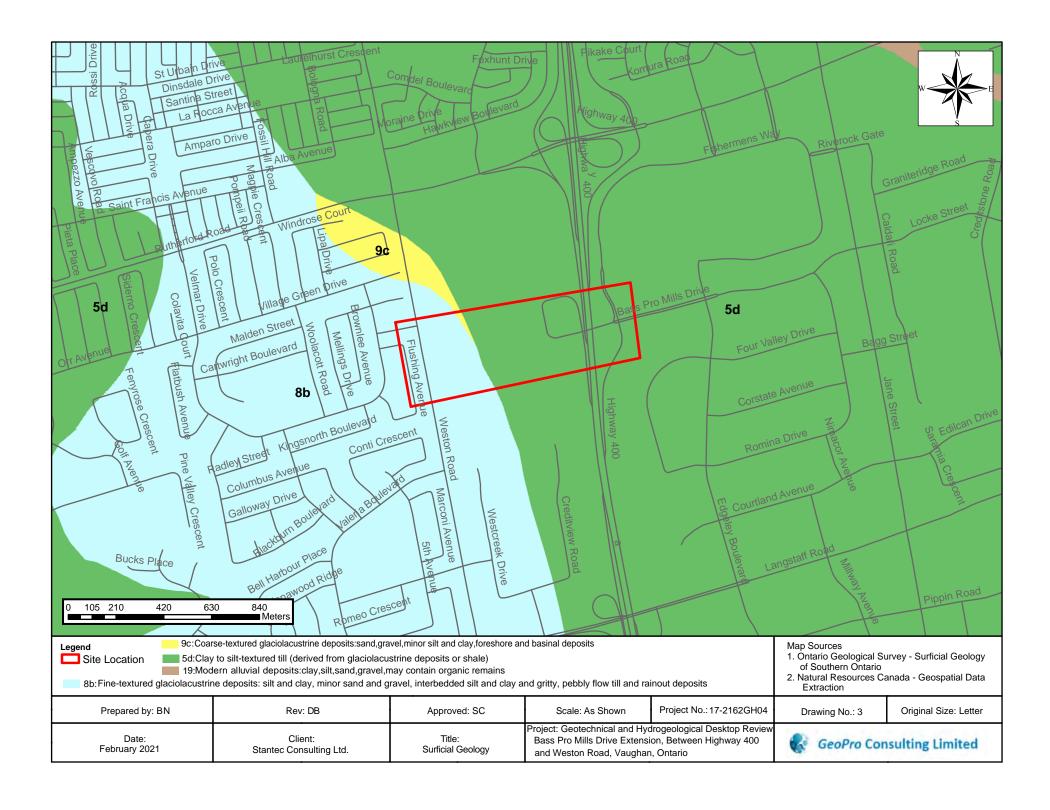
Surficial geology of the Site and the surrounding area is shown on Drawing No. 3, obtained through the surficial geology information database maintained by OGS. The Site and its surrounding area are located in an area covered with clay to silt-textured till, coarse- and fine-textured glaciolacustrine deposit and modern alluvial deposits.

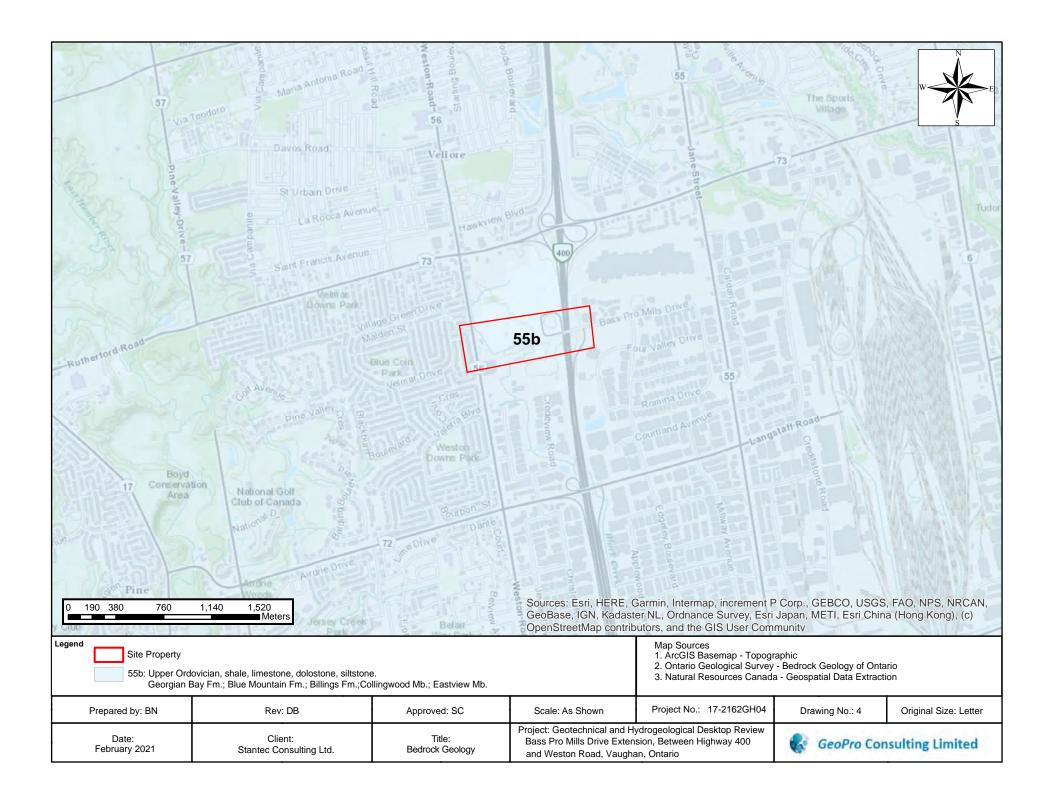
Based on the "Bedrock Geology of Southern Ontario", and the database maintained by OGS, the bedrock beneath the Site consisted of the Upper Ordovician shale, limestone, dolostone and siltstone, as shown on Drawing No. 4.

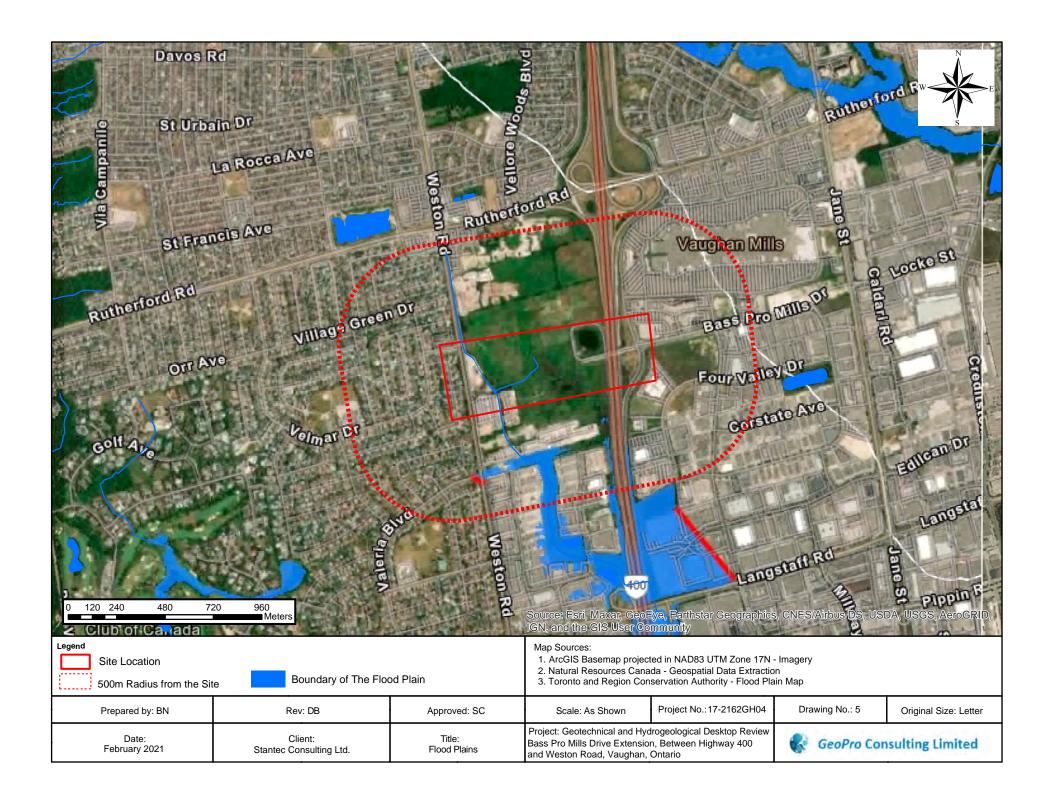
The Site is located within the boundary of the Black Creek Subwatershed in the Humber River Watershed, under the jurisdiction of Toronto and Region Conservation Authority ("TRCA"). Black Creek, located within the west central portion of the Site, runs southerly and drains into Lake Ontario about 22 km southwest of the Site. In addition, a tributary of Black Creek runs approximately east/west across the center of the Site. A copy of the watershed and subwatershed maps are included in Appendix A. The flood plain of the Black Creek is shown in Drawing No. 5.

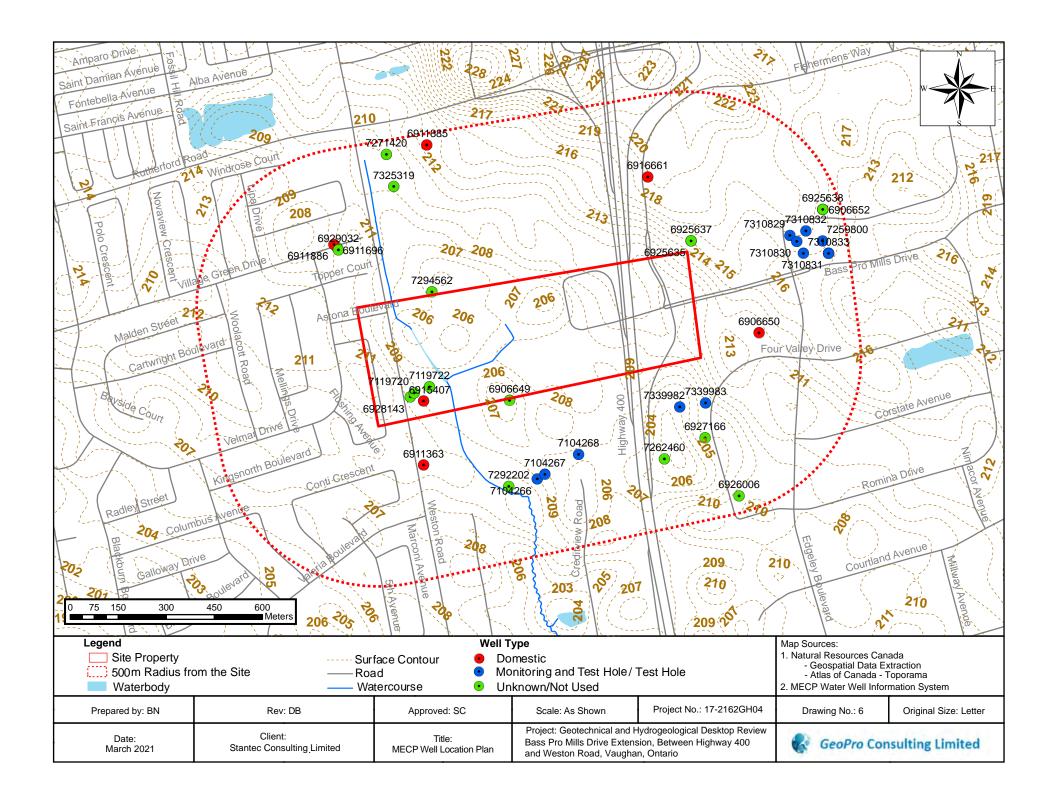
As shown on Drawing No. 6, the east portion of the Site slopes towards the southwest with the elevations changing from 214 m above sea level ("mASL") to 206 mASL. The elevation of the west portion of the Site ranges from 211 mASL to 206 mASL. The shallow groundwater flow at the Site is expected to flow in a general direction of southwest, towards Black Creek.

Based on the water well records, water was found at the depths ranging from about 3.0 meters below ground surface ("mBGS") (Well ID 7339982) to 61.0 mBGS (Well ID 6911886 and 6915407) in overburden deposits or bedrock. The soils in the Study Area generally consist of a loam topsoil and or fill materials underlain by cohesive clayey soils, cohesionless silty/sandy/gravelly soils, and till deposit. Shale bedrocks were encountered at the depths ranging from 55.5 mBGS (Well ID 6911696) to 56.4 mBGS (Well ID 6915407). No wells were presented in close proximity to the Ministry of Transportation bridge over Highway 400 based on the MECP WWR; as such, the localized water levels and stratigraphy may vary. In addition, the MECP WWR coordinate data may not be accurate based on our previous experiences, as such, the wells plotted on the drawing should be considered as reference only.

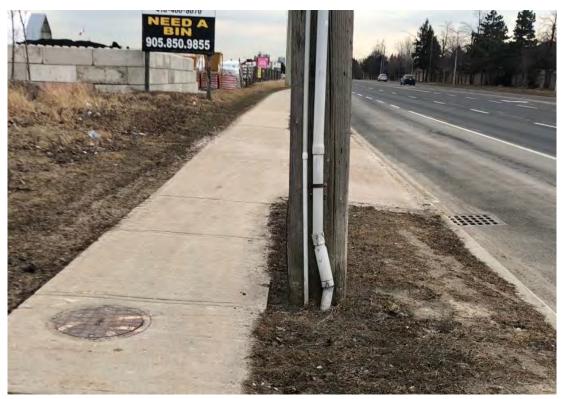
Catch basin and manhole observed along Weston Road in the vicinity of Weston Road and Astona Boulevard intersection.

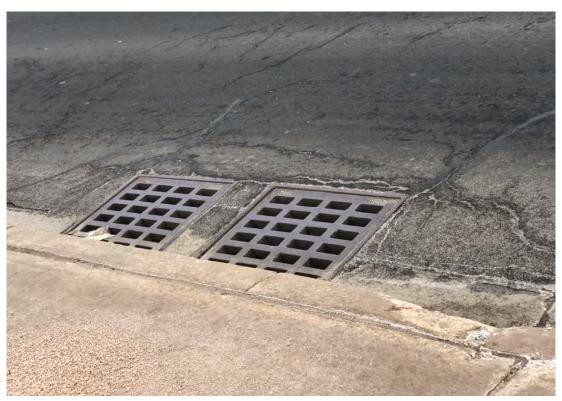
Catch basins observed along Weston Road.

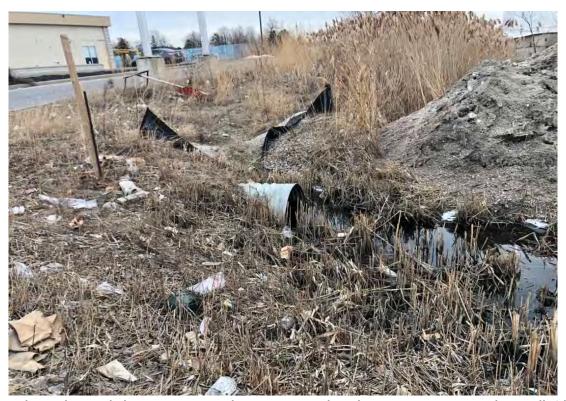
Pipe culvert observed along Weston Road near RBC Royal Bank at 9101 Weston Road, Woodbridge.

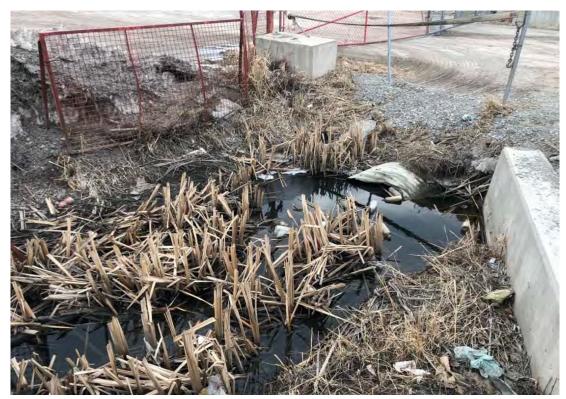
Pipe culvert observed along Weston Road in the vicinity of Weston Garden Center.

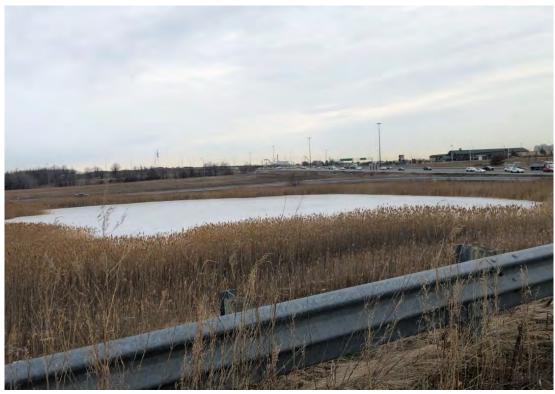
Pond at the Northwest corner of Bass Pro Mills Drive and Highway 400.

Based on the Ontario Source Protection Information Atlas and aerial photographs for the Site, two ponds without names are located within the Site, one at the southern central portion of the Site and the other at the northwest corner of Bass Pro Mills Drive and Highway 400. However, only the pond located at the northwest corner of Bass Pro Mills Drive and Highway 400 was observed at the Site during the Site walk-by.
