# Part 2 - The Heritage Conservation District Plan

# 5.0 HERITAGE CONSERVATION DISTRICT PLAN

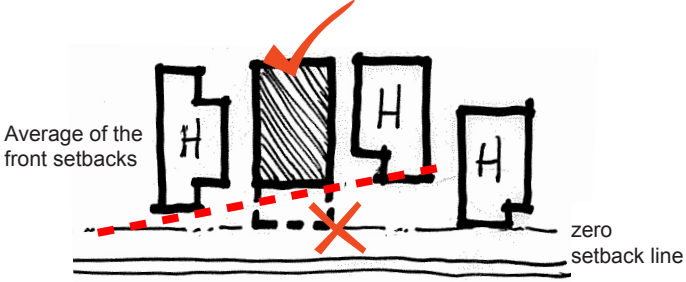
Diagram A

- 4. Where heritage contributing buildings are located on either side of a new development site, and are set further back from the zero setback line; the setback for the development site will be the average of the front yard setbacks of the two properties on either side.

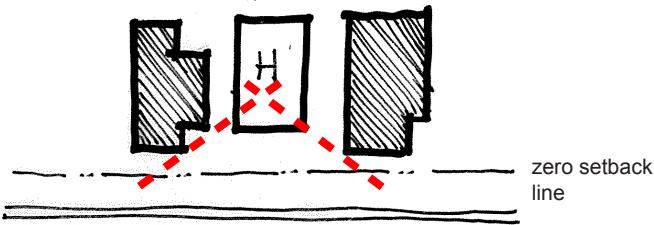
Diagram B

- 5. Where heritage contributing buildings are set further back from the recommended zero setback line, any new development adjacent to the heritage contributing building must be set back, at a minimum, to a line measured at 45 degrees from the front corner of the existing heritage contributing building.

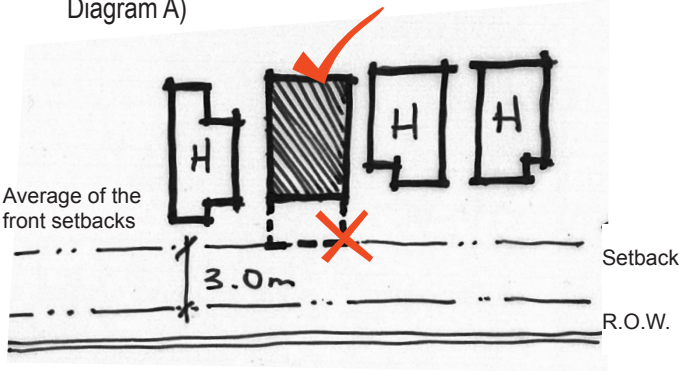
Diagram A

- 2. Where heritage contributing buildings are located on either side of a new development site, and are set further back from the 3.0m minimum building setback line; the setback for the development site will be the average of the front yard setbacks of the two properties on either side. (See Diagram A)

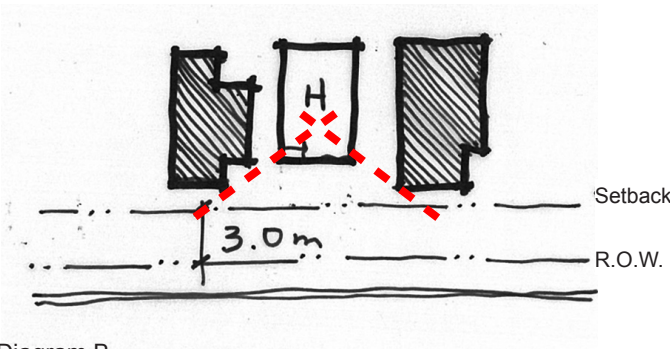
Diagram B

- 3. Where heritage contributing buildings are set further back from the recommended 3.0m minimum building setback line, any new development adjacent to the heritage contributing building must be set back, at a minimum, to a line measured at 45 degrees from the front corner of the existing heritage contributing building.

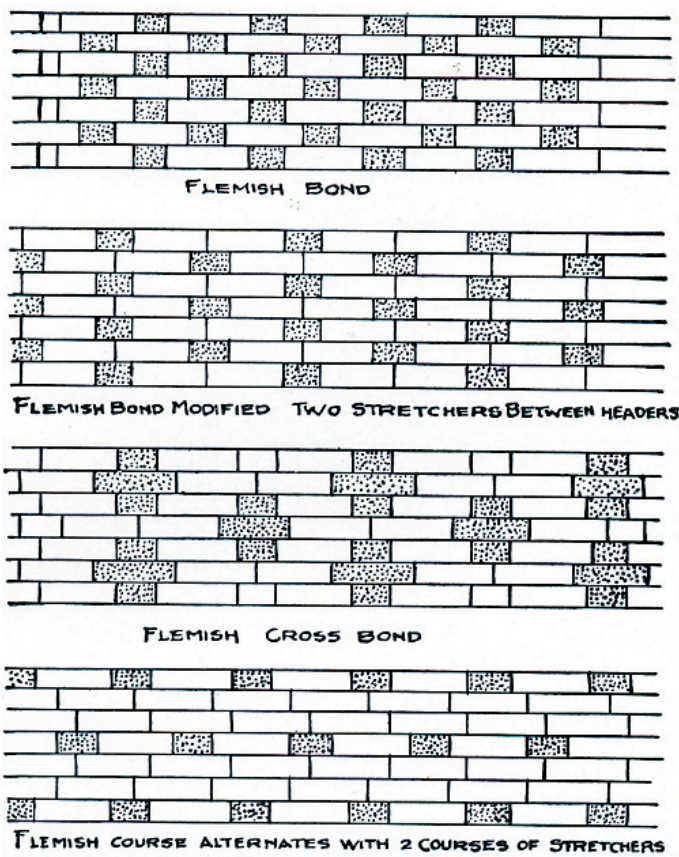
Flemish Bond

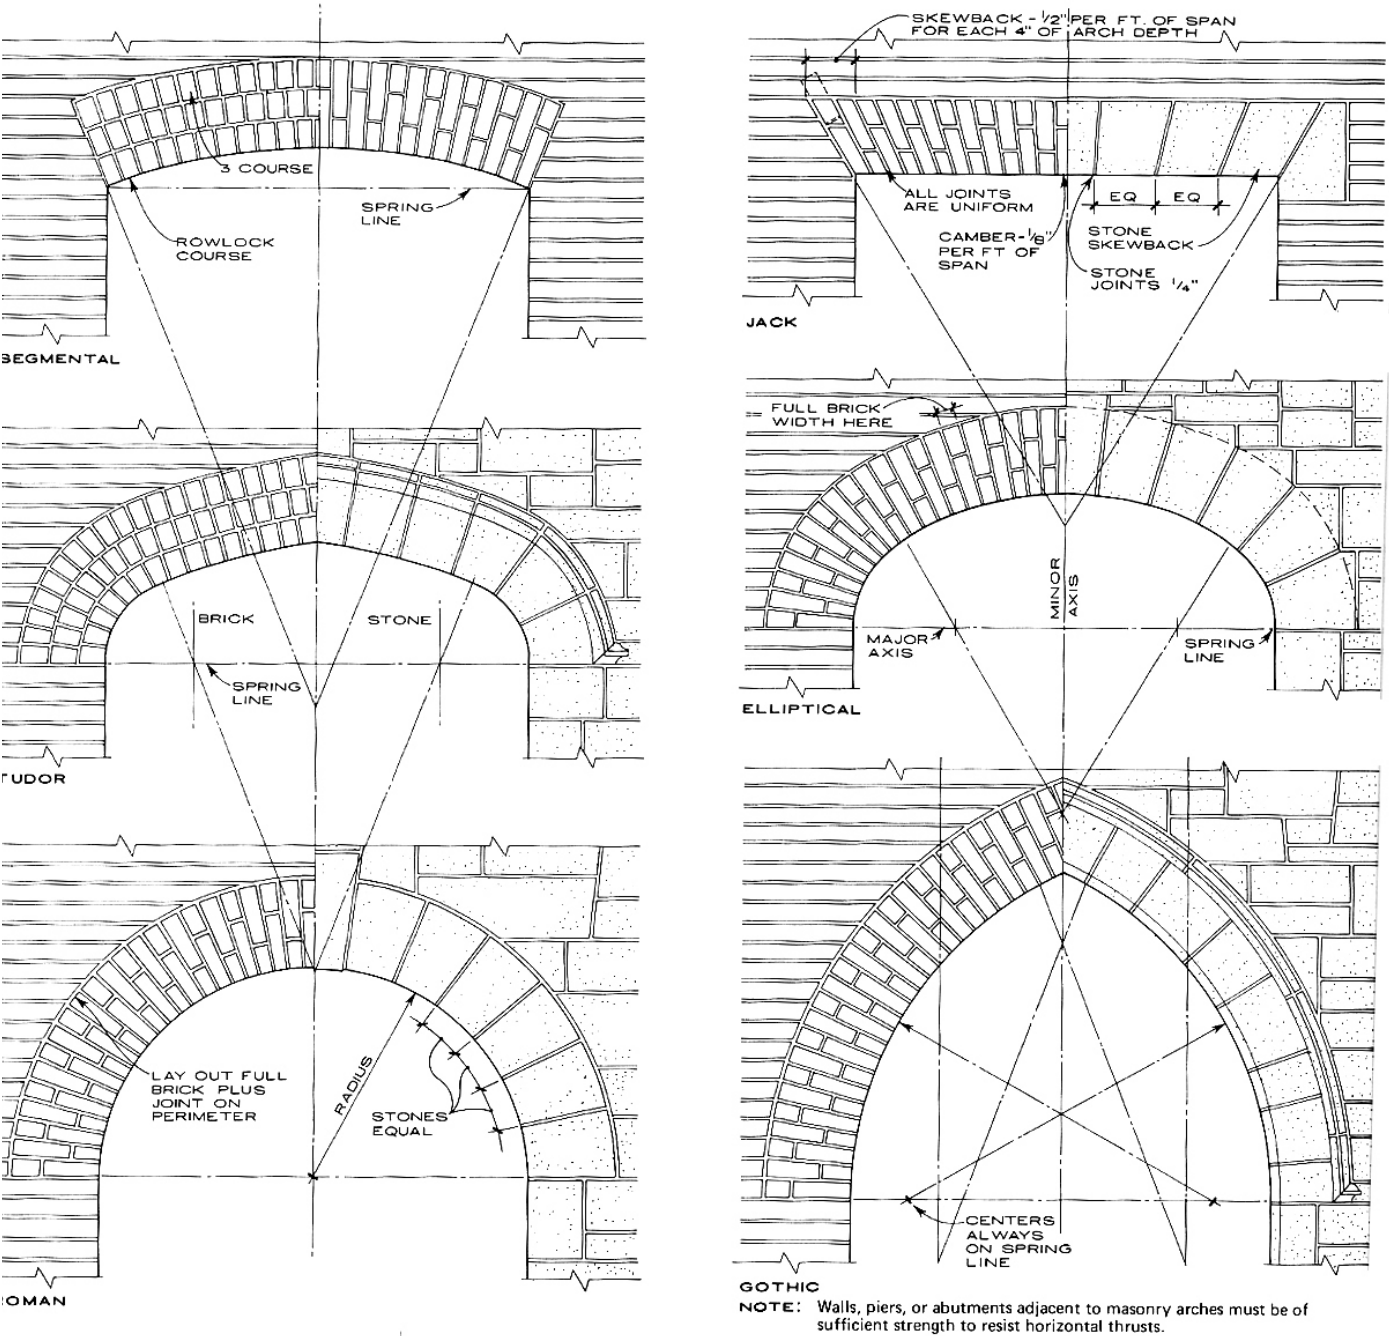
Masonry Arches

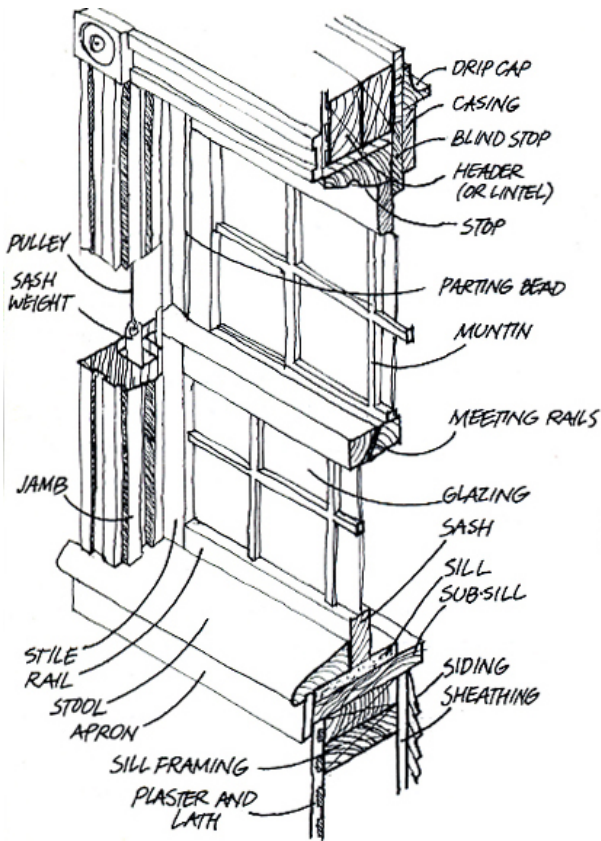
Some Elements of A Double-hung Wood Window

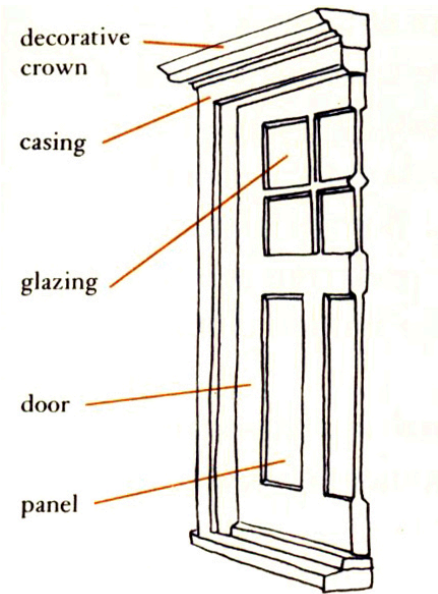
Doorway Components

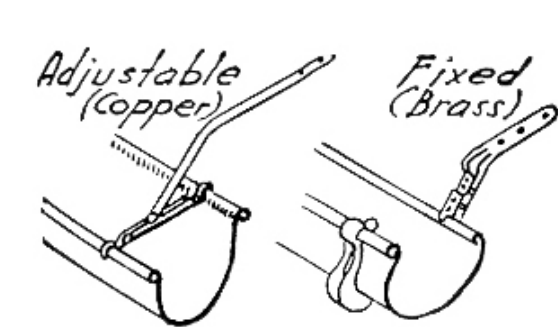
Stock Strap Hangers Copper & Brass

Rainwater leaders (RWLs) are the vertical pipes that take water to the ground. These for the most part have always been metal (lead, copper, iron or galvanized steel). This piping is often connected directly to the guttering but in some styles, a decorative hopper is included as a filter and overflow device at the top of the pipe just below the roof.
