7.0 HERITAGE BUILDINGS

7.1 A Conservation Plan

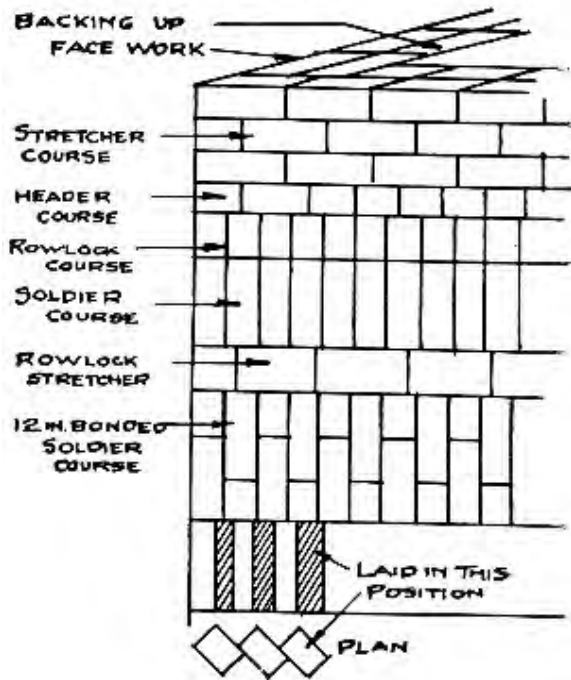
Brick Course

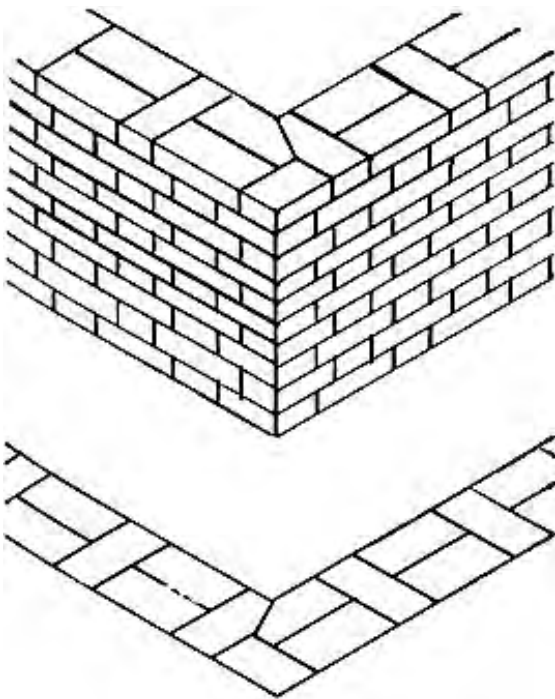
Flemish Bond

Surface patterns in brick walls are the result of this bonding. Bonding patterns fall into types by common usage (common bond, English bond, Flemish bond and so on). Further decorative work such as diaper work (diamond patterns on a brick wall) or brick shapes add interest to more sophisticated brick buildings.

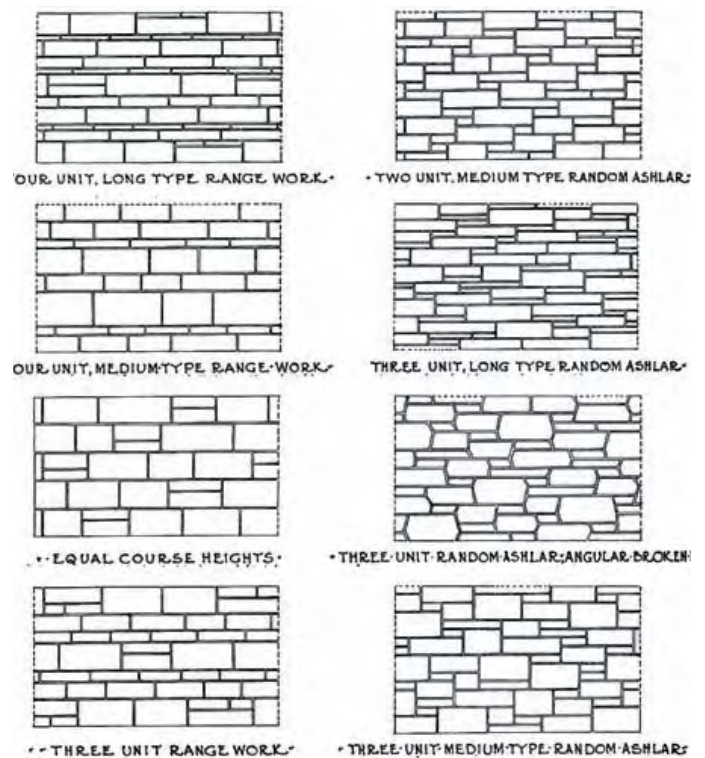
Stone Work

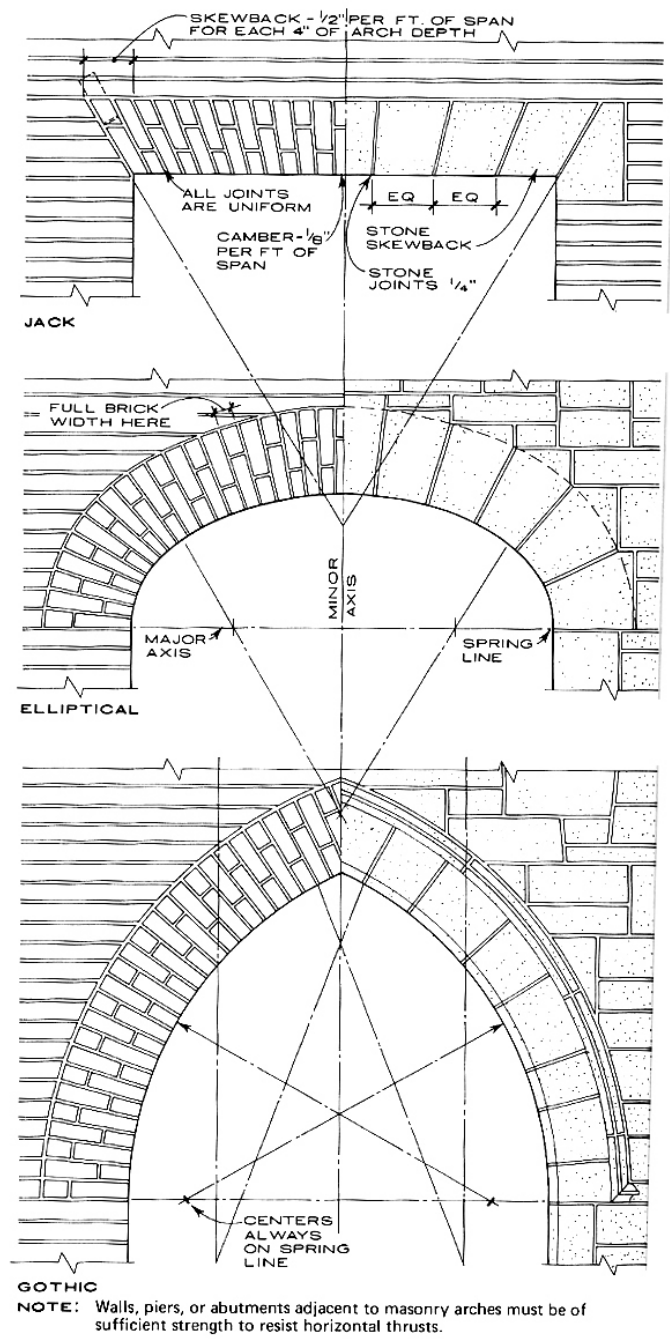
Masonry Arches

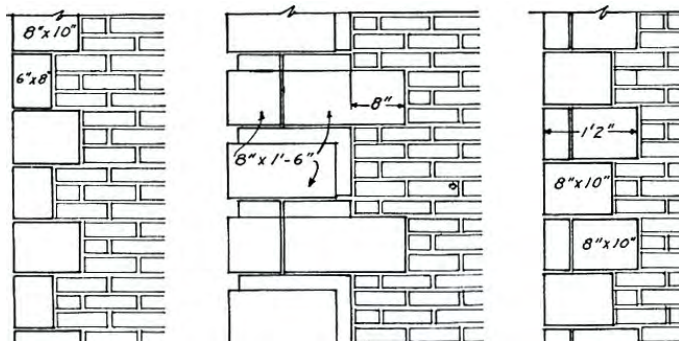
Types of Cut Stone Quoins for Use with Brick

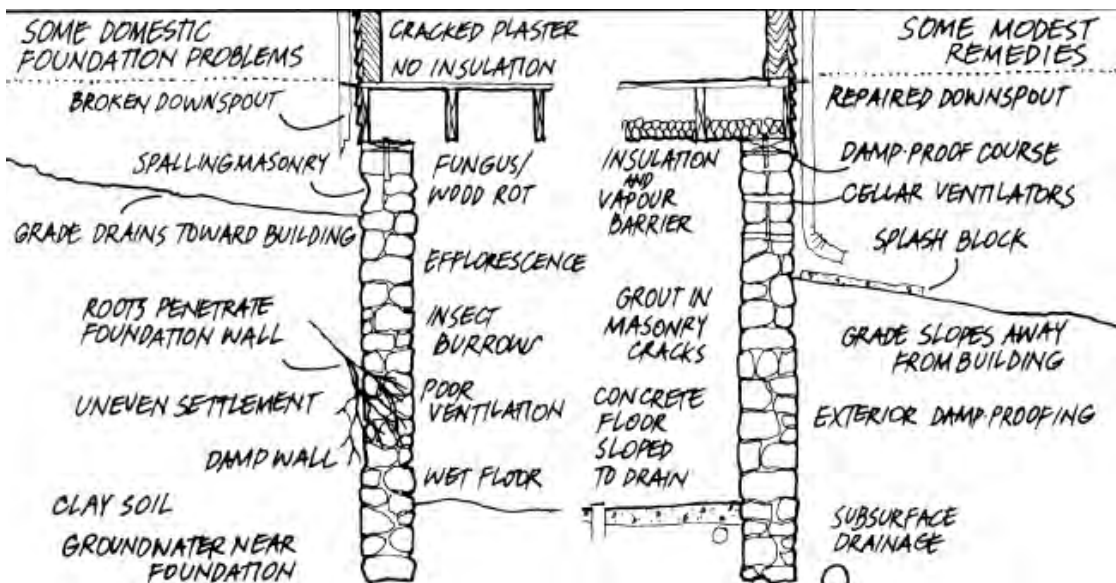
Some Domestic Foundation Problems

Foundation walls are similar to stone walls but are subject to more demanding conditions. They are subject to freezing and thawing, are often wet, must hold out ground water from rain above or soils beside, and hold up the building at the same time. In older walls waterproofing or damproofing may not exist and years of dampness may have washed out binders from the mortars rendering the foundation water permeable, or even structurally unstable.

- excavating around the building perimeter,
- pointing the foundation inside and outside,
- low pressure grouting of the wall cavity, if necessary
- parging the exterior below grade and applying a good dampproofing or waterproofing.

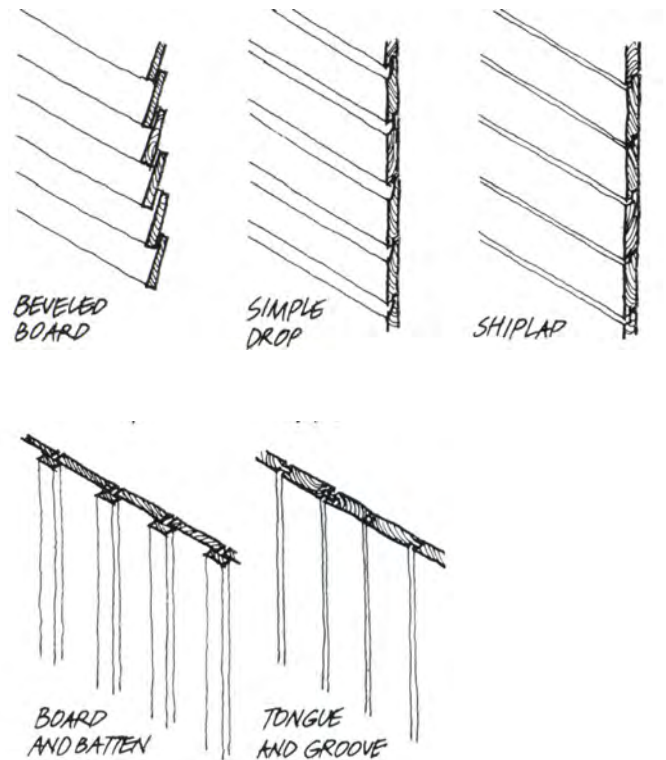
Some Types of Wood Siding

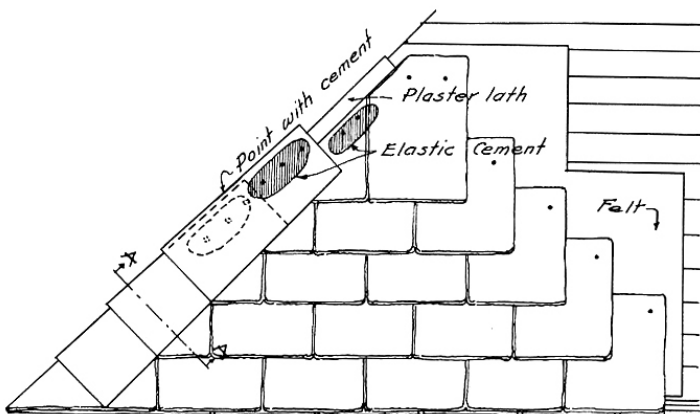
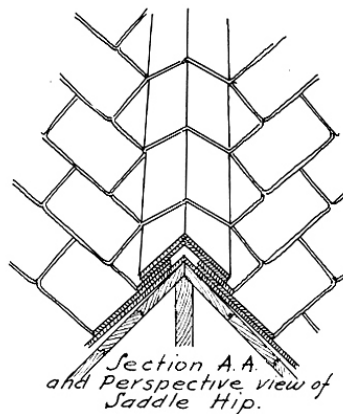
Slate Roofing, Image Credit: Page 66, Architectural Graphic Standards, 1932, Ramsey/ Sleeper

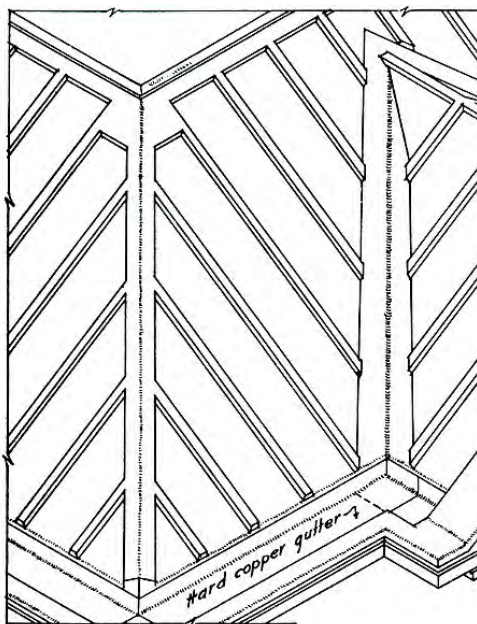
Coper Roofing

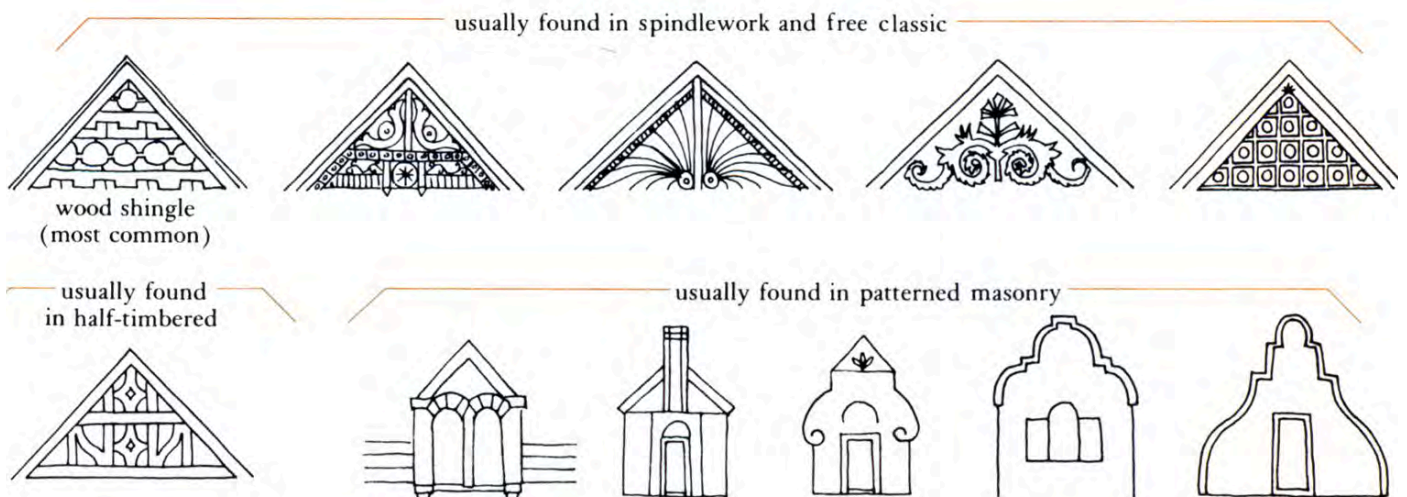
Typical Queen Anne Revival Gable Detailing

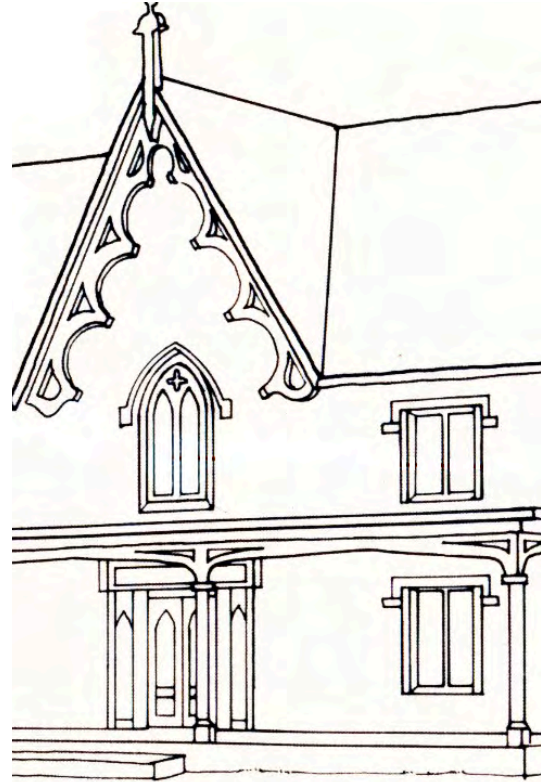
Typical Gothic Revival Gable Detailing

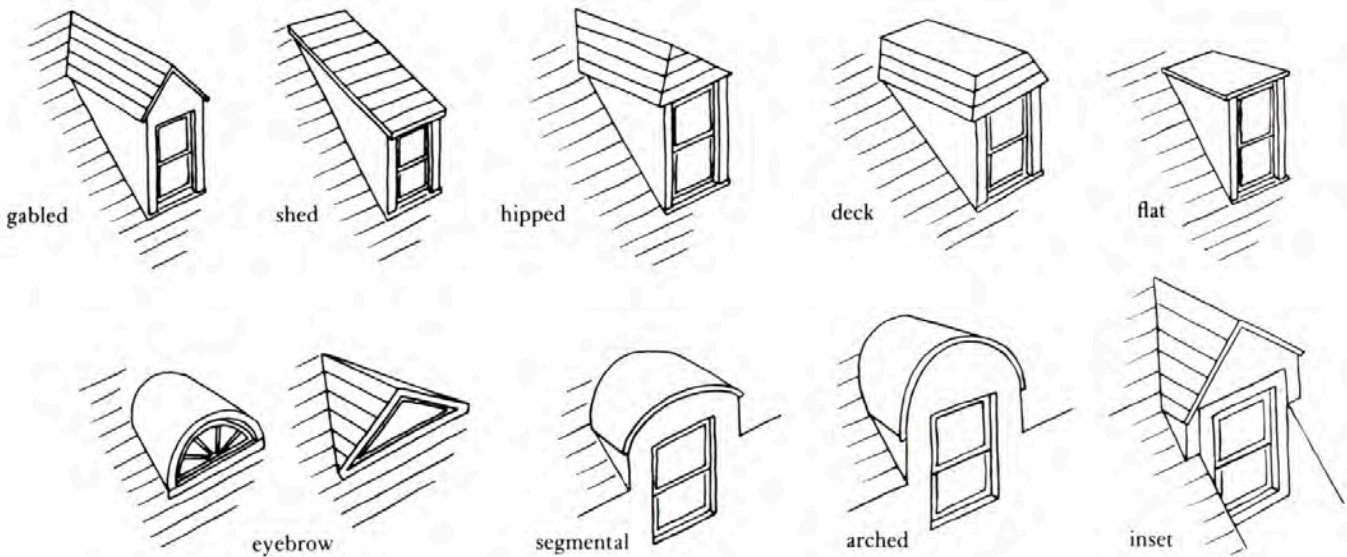
DORMERS & GABLES DISTINGUISHED

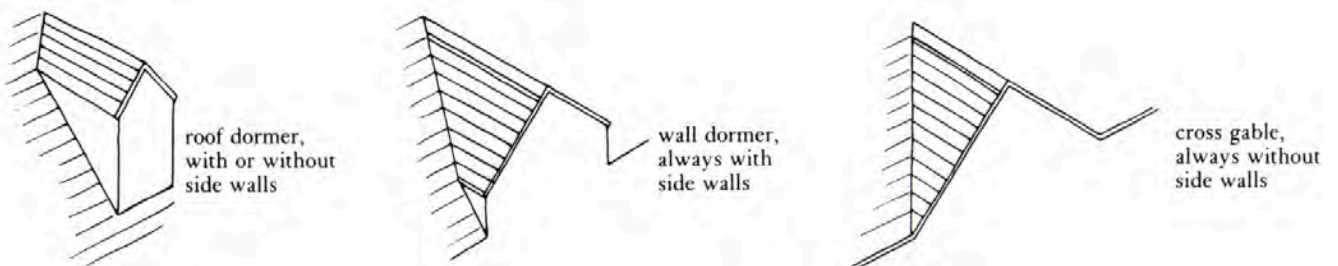
Dormer Types

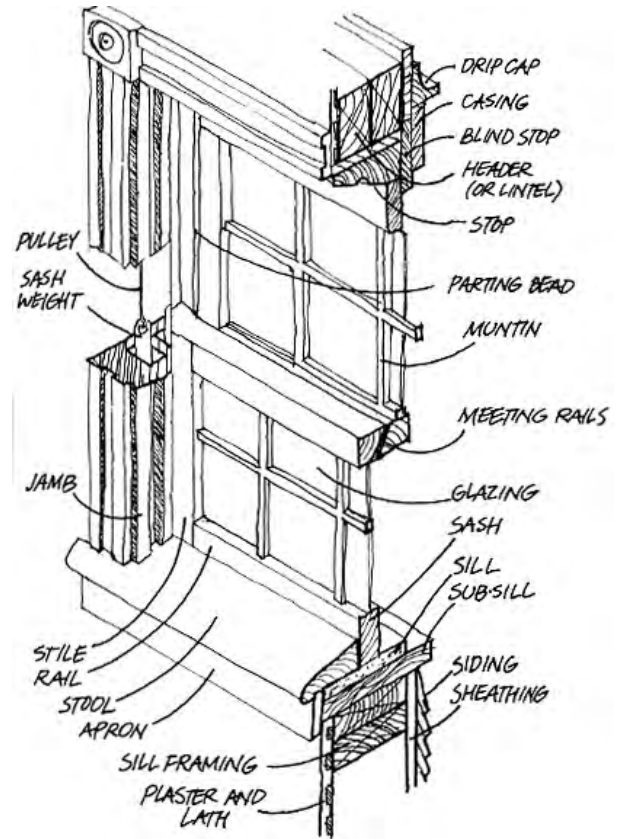
Some Elements of A Double-hung Wood Window

Each style has a window design fundamental to that style. In most historic buildings in Ontario, windows are a variation of double hung or vertical sliders. However, in the Arts and Crafts period and in some Gothic Revival styles, casement windows were employed. In Art Moderne buildings windows are often horizontal pivot or awning types, but casement windows are also found. Double hung windows, and vertical slider windows are generally counterbalanced by a weight system with cotton cord and a pulley at the head of the window.

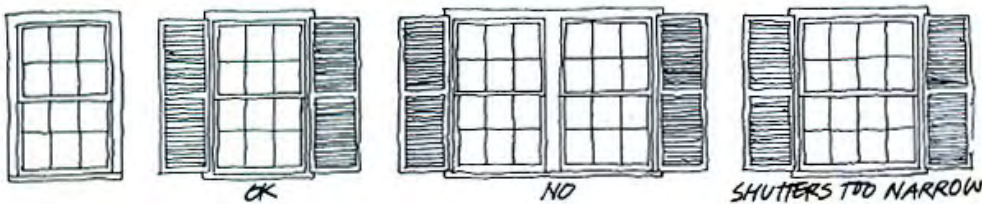
Shutters Must Befit Windows

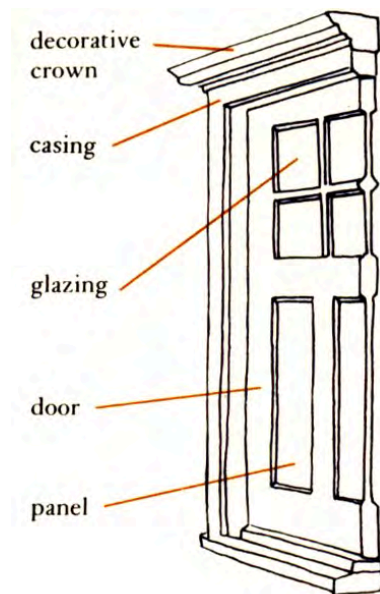
Doorway Components

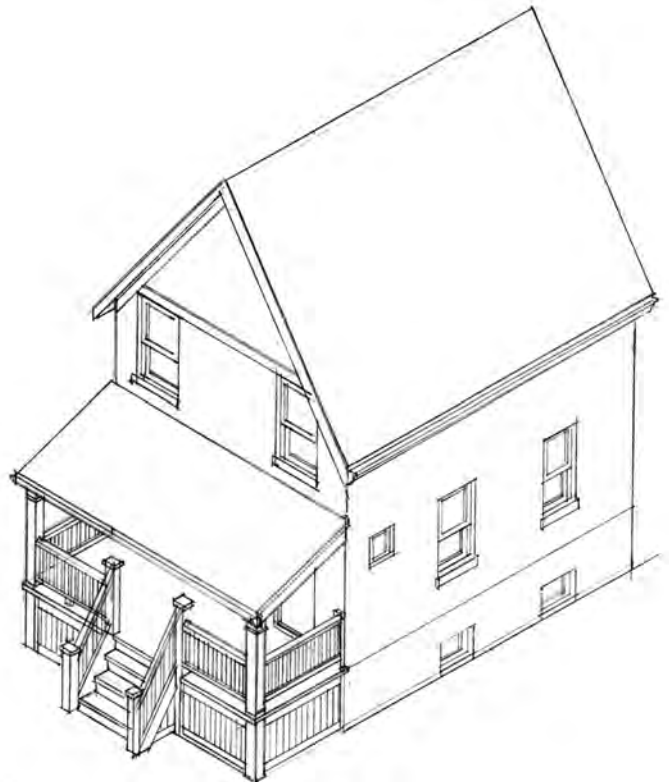
Sketch diagram of a Simple Porch Design that is typical to the Woodbridge Area

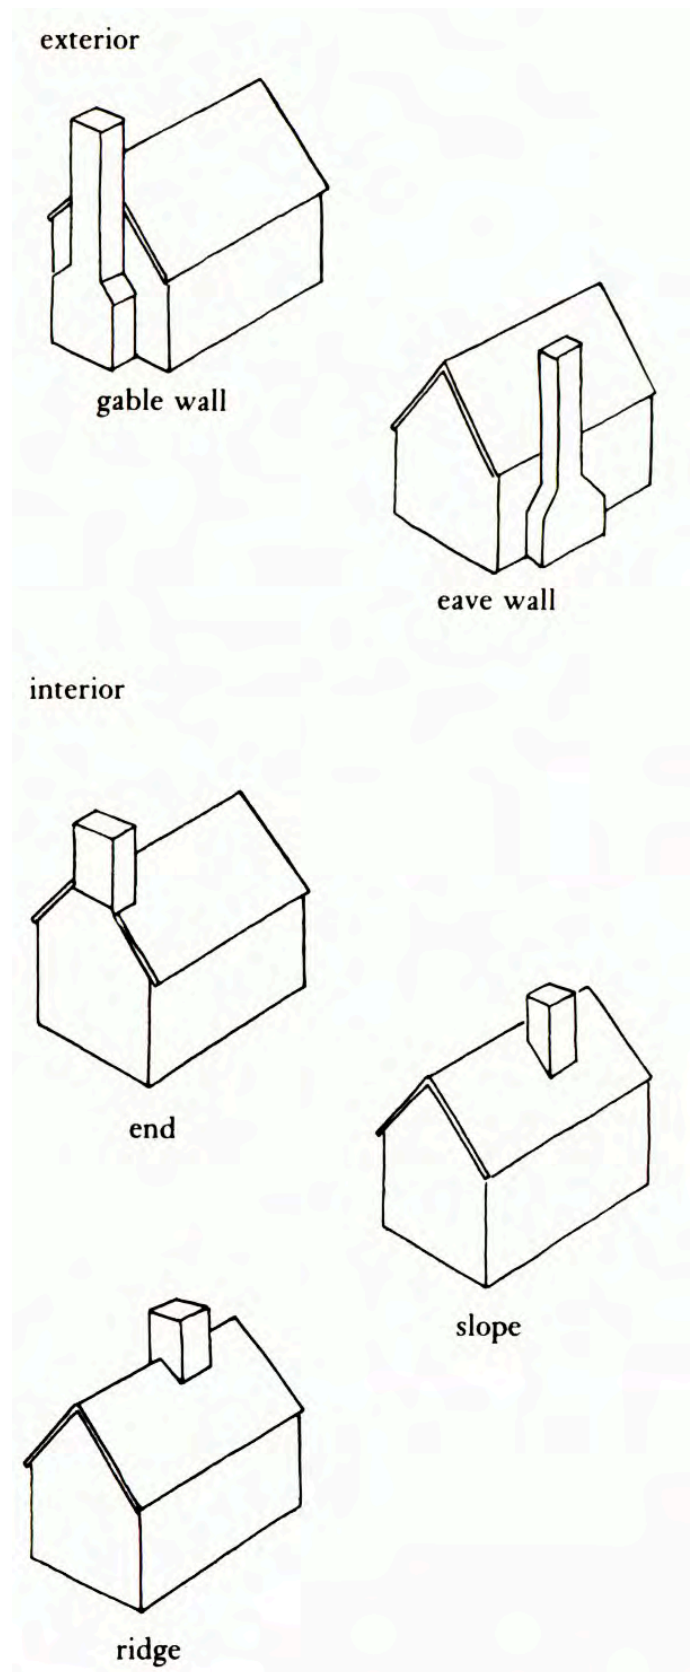
Placement of Chimneys

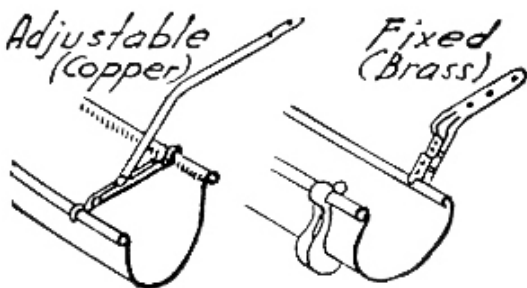
Stock Strap Hangers Copper & Brass

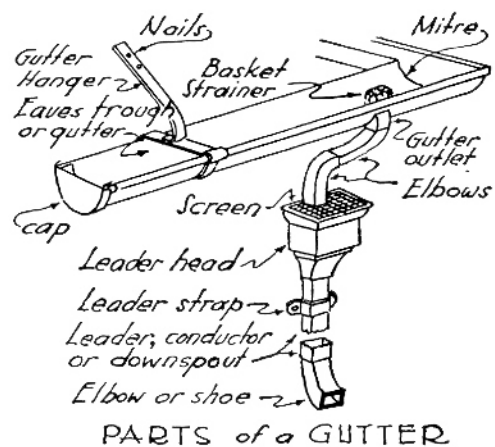
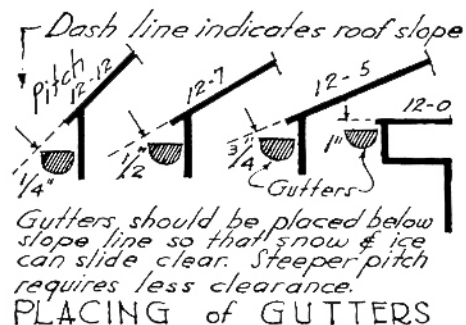
Gutters

Rainwater leaders (RWLs) are the vertical pipes that take water to the ground. These for the most part have always been metal (lead, copper, iron or galvanized steel). This piping is often connected directly to the guttering but in some styles, a decorative hopper is included as a filter and overflow device at the top of the pipe just below the roof.

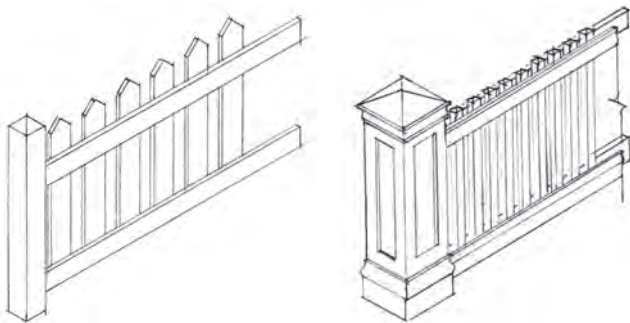
Classic “Picket” Fences - Simple and Decorative

Historic fences were installed in wood, most commonly in the form of the classic “picket” fence. They were often quite substantial with decorative built up wood piers at corners and gates, with and heavy posts in between. Pickets were often 2”x2” but were also found in 1”x3” to 2”x4” sizes.

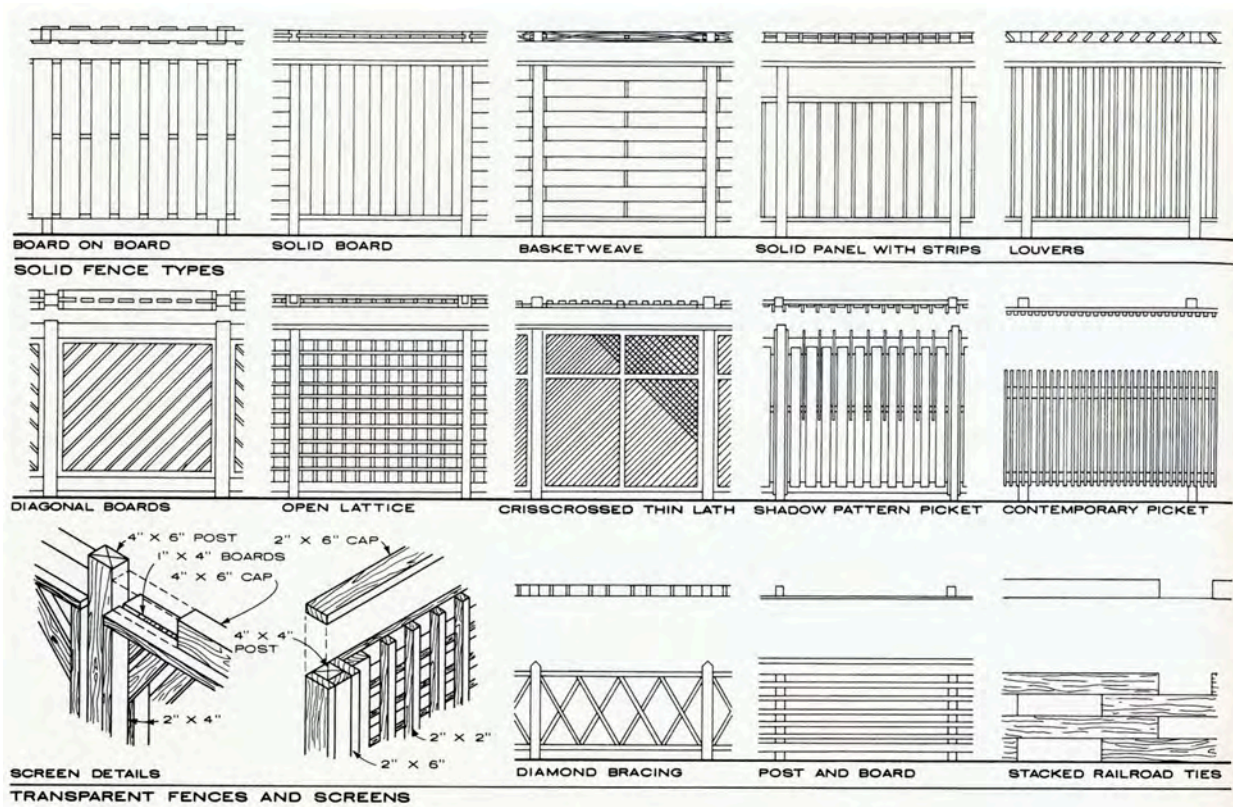
Wood Fences

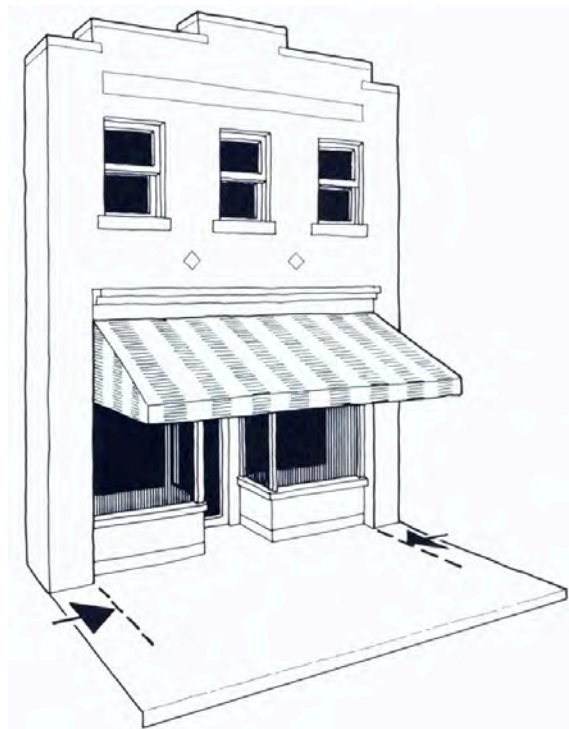
Awnings should always be located below the storefront cornice and between the storefront piers or pilasters.
