#### **17 ALTERATIONS TO EXISTING HOME AND DEMOLITION OF EXISTING OUTBUILDING 148 WALLACE STREET WOODBIDGE HERITAGE CONSERVATION DISTRICT WARD 2 - VICINITY OF WALLACE STREET AND HIGHWAY 7**

**Re: Barn Review, 148 Wallace Street, Toronto, Ontario**  
**Our Project No. ADM-02017020-00**

## Attachment #5 - Proposed Veranda

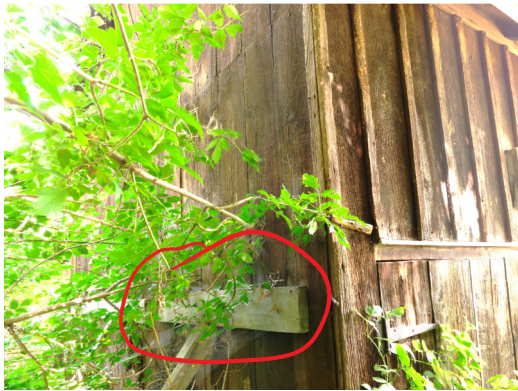
At the rear of the building on the west side, a series of diagonal braces has been installed, attached to the siding of the west wall, sloping west back to the ground, presumably in an attempt to prevent further movement towards the west. It does not appear that these braces or the connections to the exterior wall were engineered and they did not appear to be supported on properly designed foundations where they meet the ground.

South West Corner – Wood braces installed on west wall. The building is also experiencing a significant amount of vertical settlement particularly on the west end, indicating that its foundations are inadequate and failing.

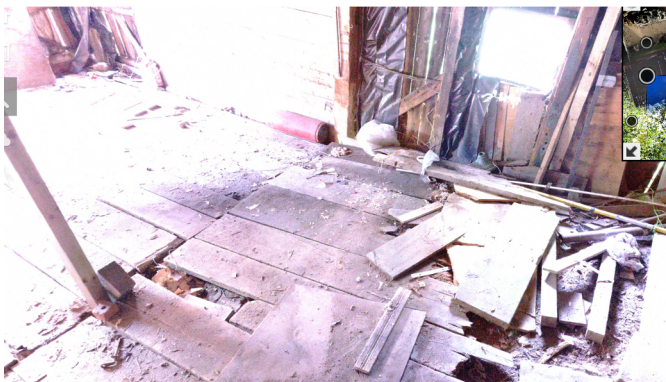
The ground floor of this barn is comprised of wood planks that are showing signs of rot, that deflect significantly under the weight of the average person, and these planks are neither flush nor level. This poses a significant tripping hazard for anyone entering this building.

Typical ground floor condition

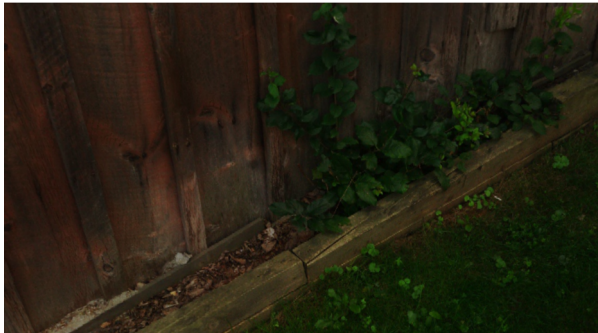
The wood siding that provides that primary lateral support for the building is in direct contact with the ground. Wood in direct contact with the ground is extremely susceptible to rot, which is also a likely contributing factor to the leaning that is happening.

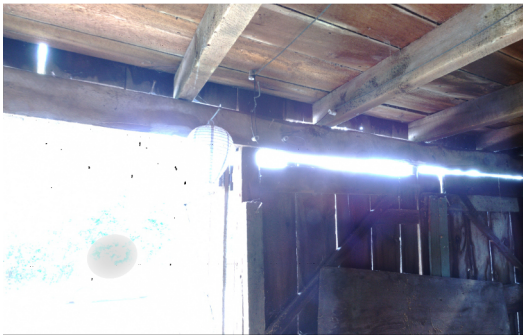
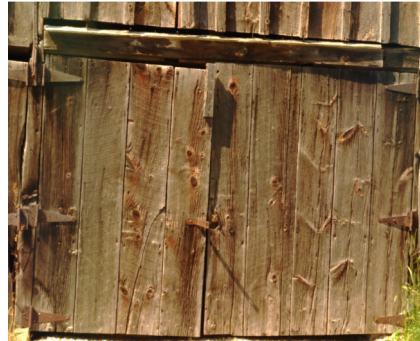
The lintel beams over the main entry doors on the east wall are sagging. These lintels are also the primary support for the east end of the 2<sup>nd</sup> floor mentioned above. The sagging of these lintels is a clear indication that they were not designed properly.

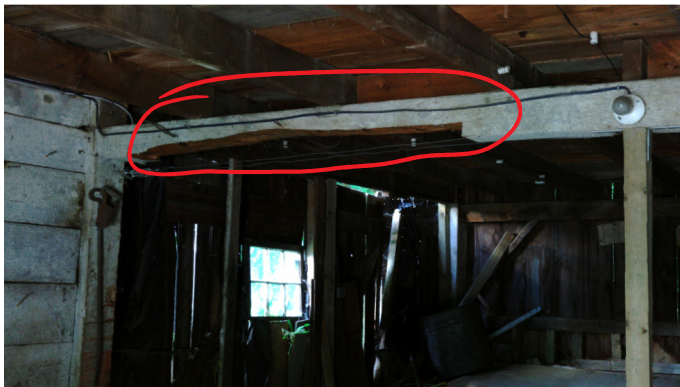
The structural integrity of the interior wood girder supporting the 2<sup>nd</sup> floor has been severely compromised as it has been split horizontally, losing approximately 50% of its depth. If this beam were to fail completely, total collapse of structure is possible as the collapse of the 2<sup>nd</sup> floor structure would likely pull down the entire structure. In our opinion, if this building is to remain for any length of time, this girder should be adequately shored immediately.
