**CITY OF VAUGHAN**

**KIPLING TRAIL FEASIBILITY STUDY  
WARD 2**

### Kipling Feasibility Study Area

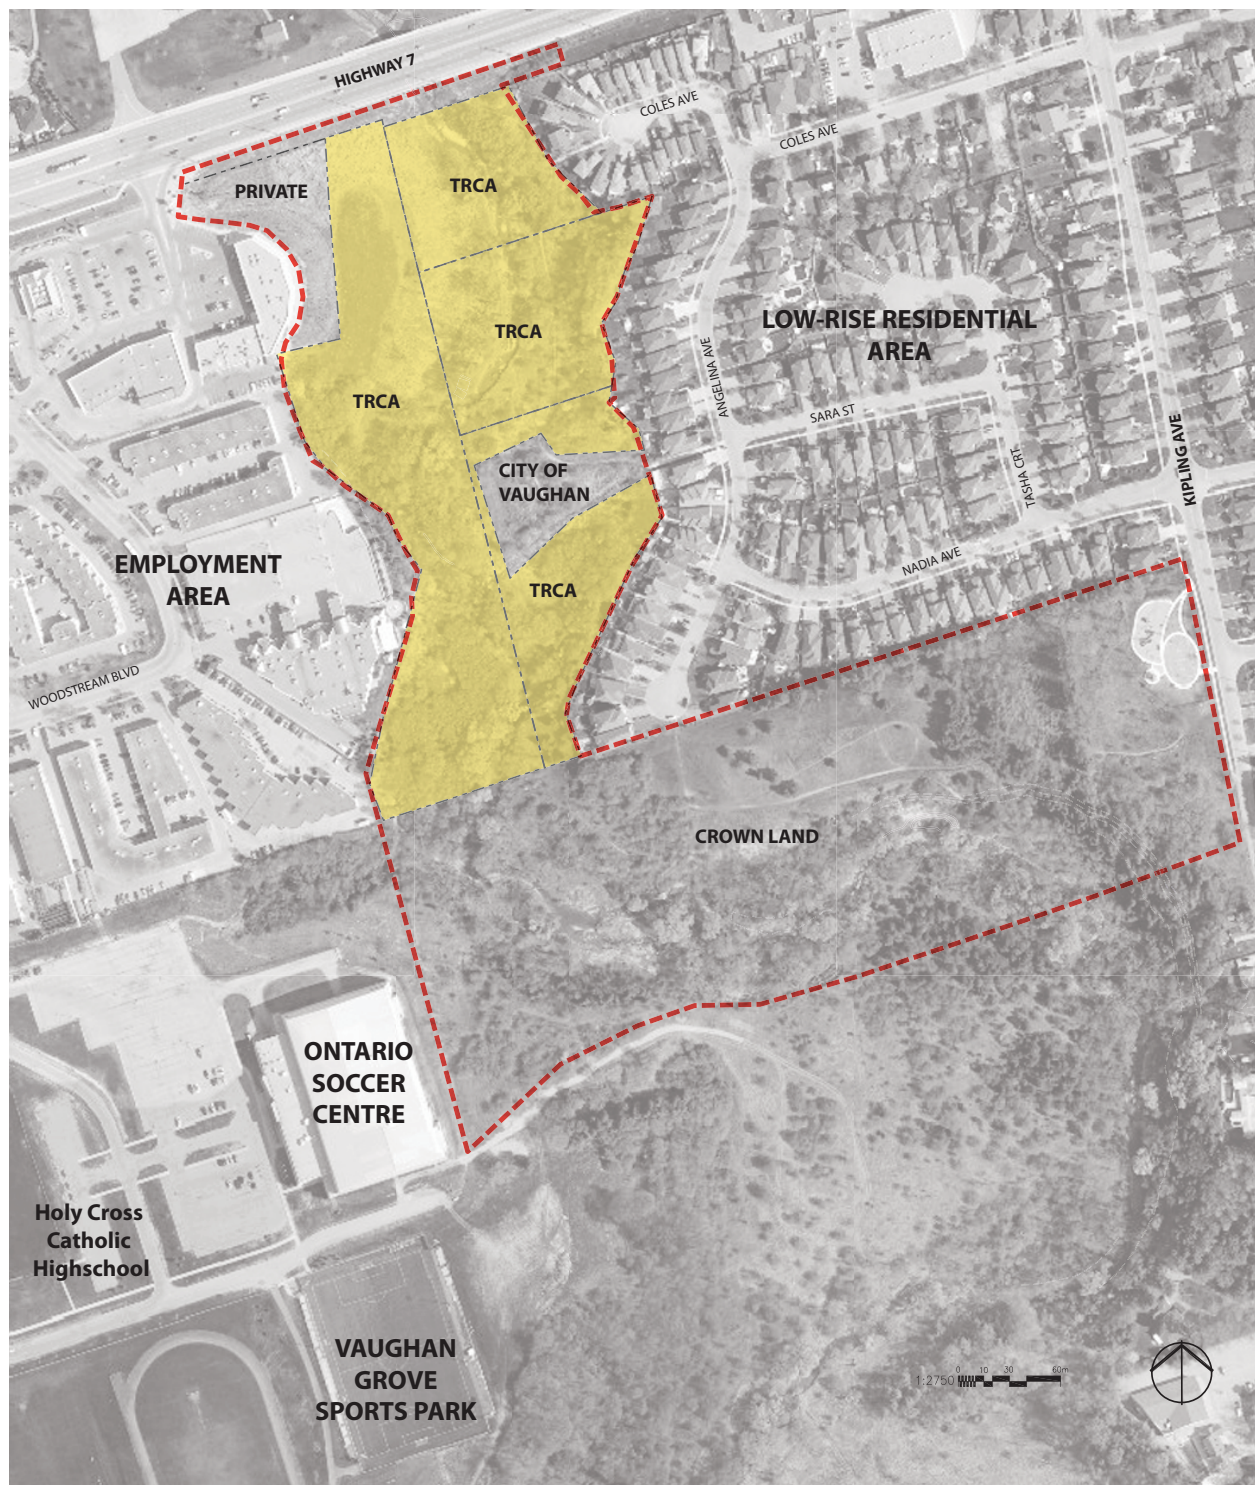
FIGURE-1 PROJECT STUDY AREA, OWNERSHIP & ADJACENT LAND USES

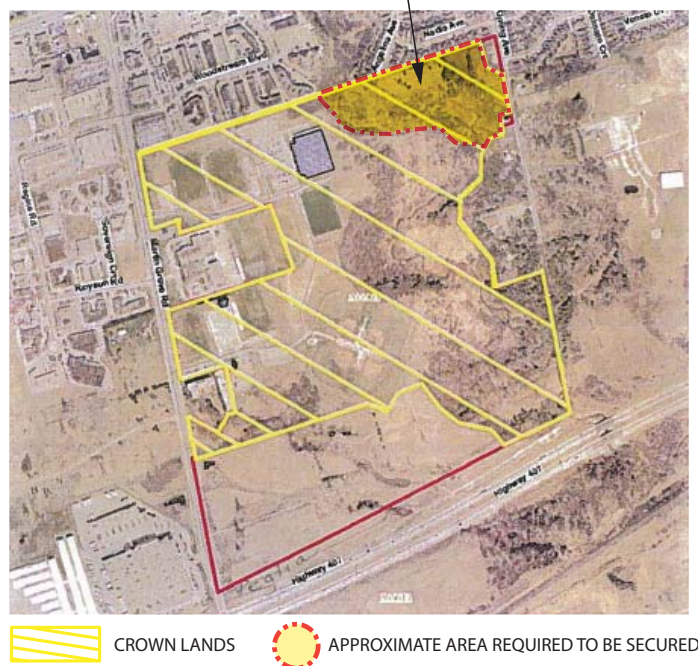
**APPROXIMATE LOCATION OF CROWN LANDS  
WHICH WOULD REQUIRE AN ACCESS  
AGREEMENT BETWEEN CITY OF VAUGHAN  
AND THE CROWN**

FIGURE-4 APPROXIMATE LOCATION OF CROWN LANDS TO BE SECURED

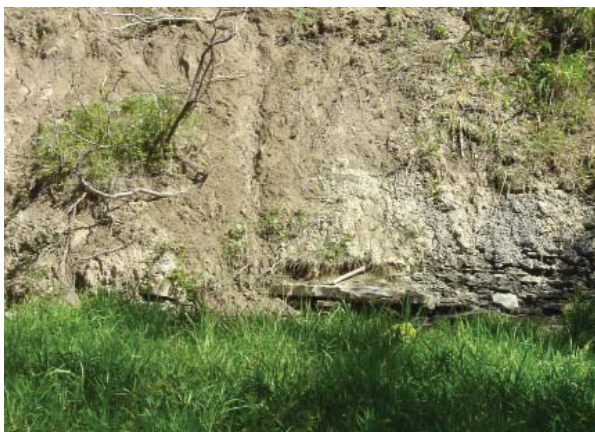
VIEW 1 - STEEP SLOPES WITHIN THE STUDY AREA

- There are some areas with steep slopes that have issues with erosion. These areas would limit the development of trails in their vicinity.
- Steep slopes, in some cases are inaccessible and exceed 30% (1:3) rise to run ratio and limit access.

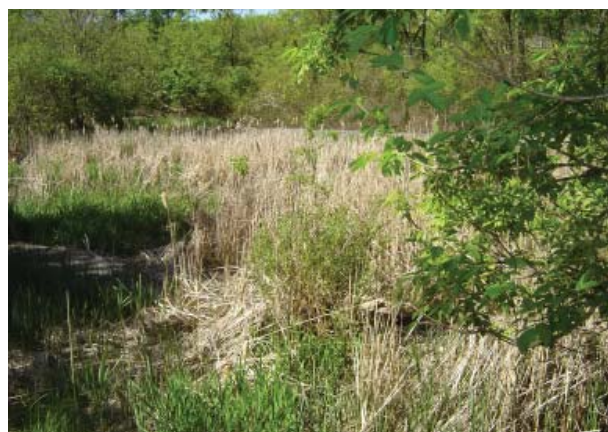
VIEW 2 - VERNAL POOL AREA

- Natural features within the site include an area to the north east with Butternut trees (*Juglans cinerea*), a vernal pool area to the south west of the creek and a seep area to the south east. These features are identified in Figure 6 and discussed further in section 3.3.2 below.

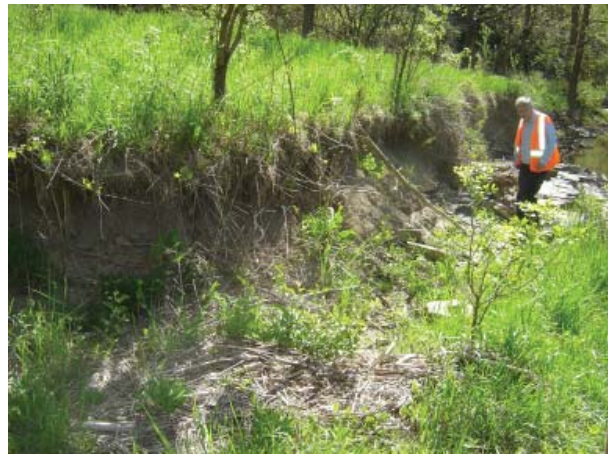
*VIEW 4 - STEEP SLOPES AND EROSION ISSUES.*

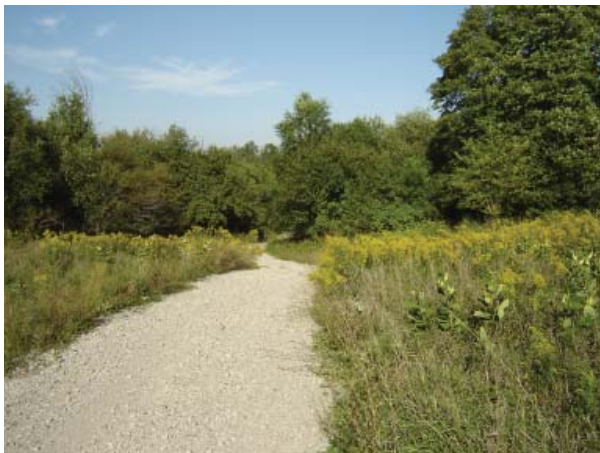
*VIEW 5 - EXISTING GRANULAR PATH*

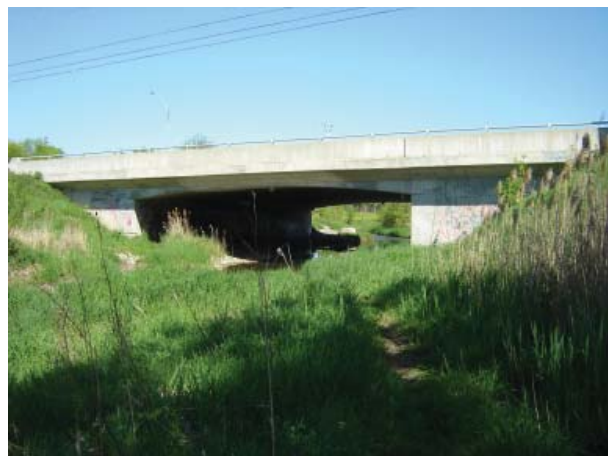
*VIEW 8 - LOOKING NORTH AT THE HIGHWAY 7  
UNDERPASS*

- Existing sidewalks within the residential neighbourhood along Angelina Avenue end just south of Nadia Avenue.
- Access via the underpass under Highway 7 does not have enough vertical height to allow safe pedestrian access, however north-south connections for community trails may be accommodated within the Highway 7 Right-of-way by use of existing sidewalks crossing at signalized intersections in order to connect to Rainbow Creek Park.

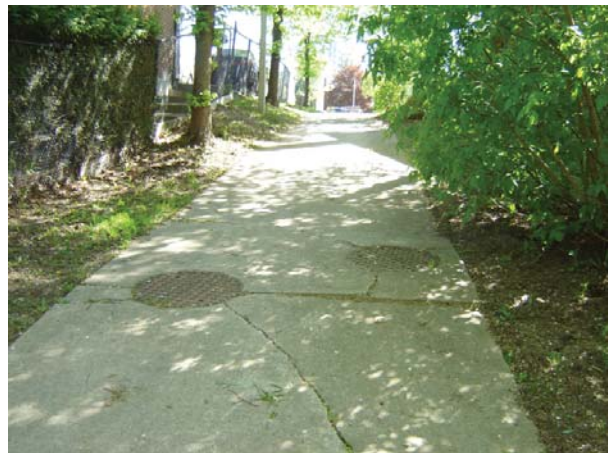
*VIEW 10 - CONDITION OF EXISTING CONCRETE SIDEWALK WITHIN RESIDENTIAL NEIGHBOURHOOD.*

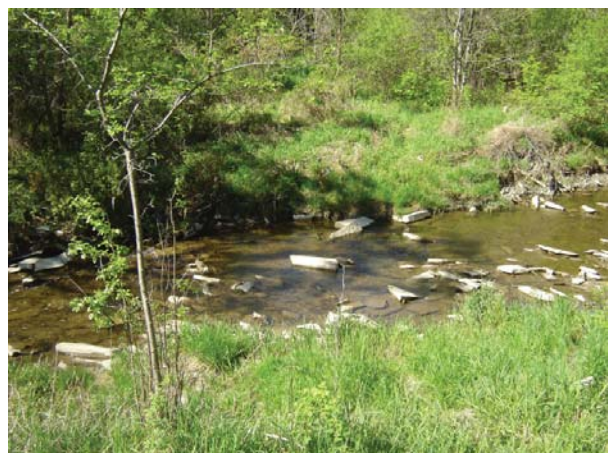
*VIEW 12 - POTENTIAL CREEK CROSSING LOCATION.*

The location of the proposed creek crossing was chosen based on the stability potential. Further studies would be required outside the delineated scope of work, however, to determine the stability of the creek within 30 metres south of the study area to verify the stability of the chosen location of the creek crossing.

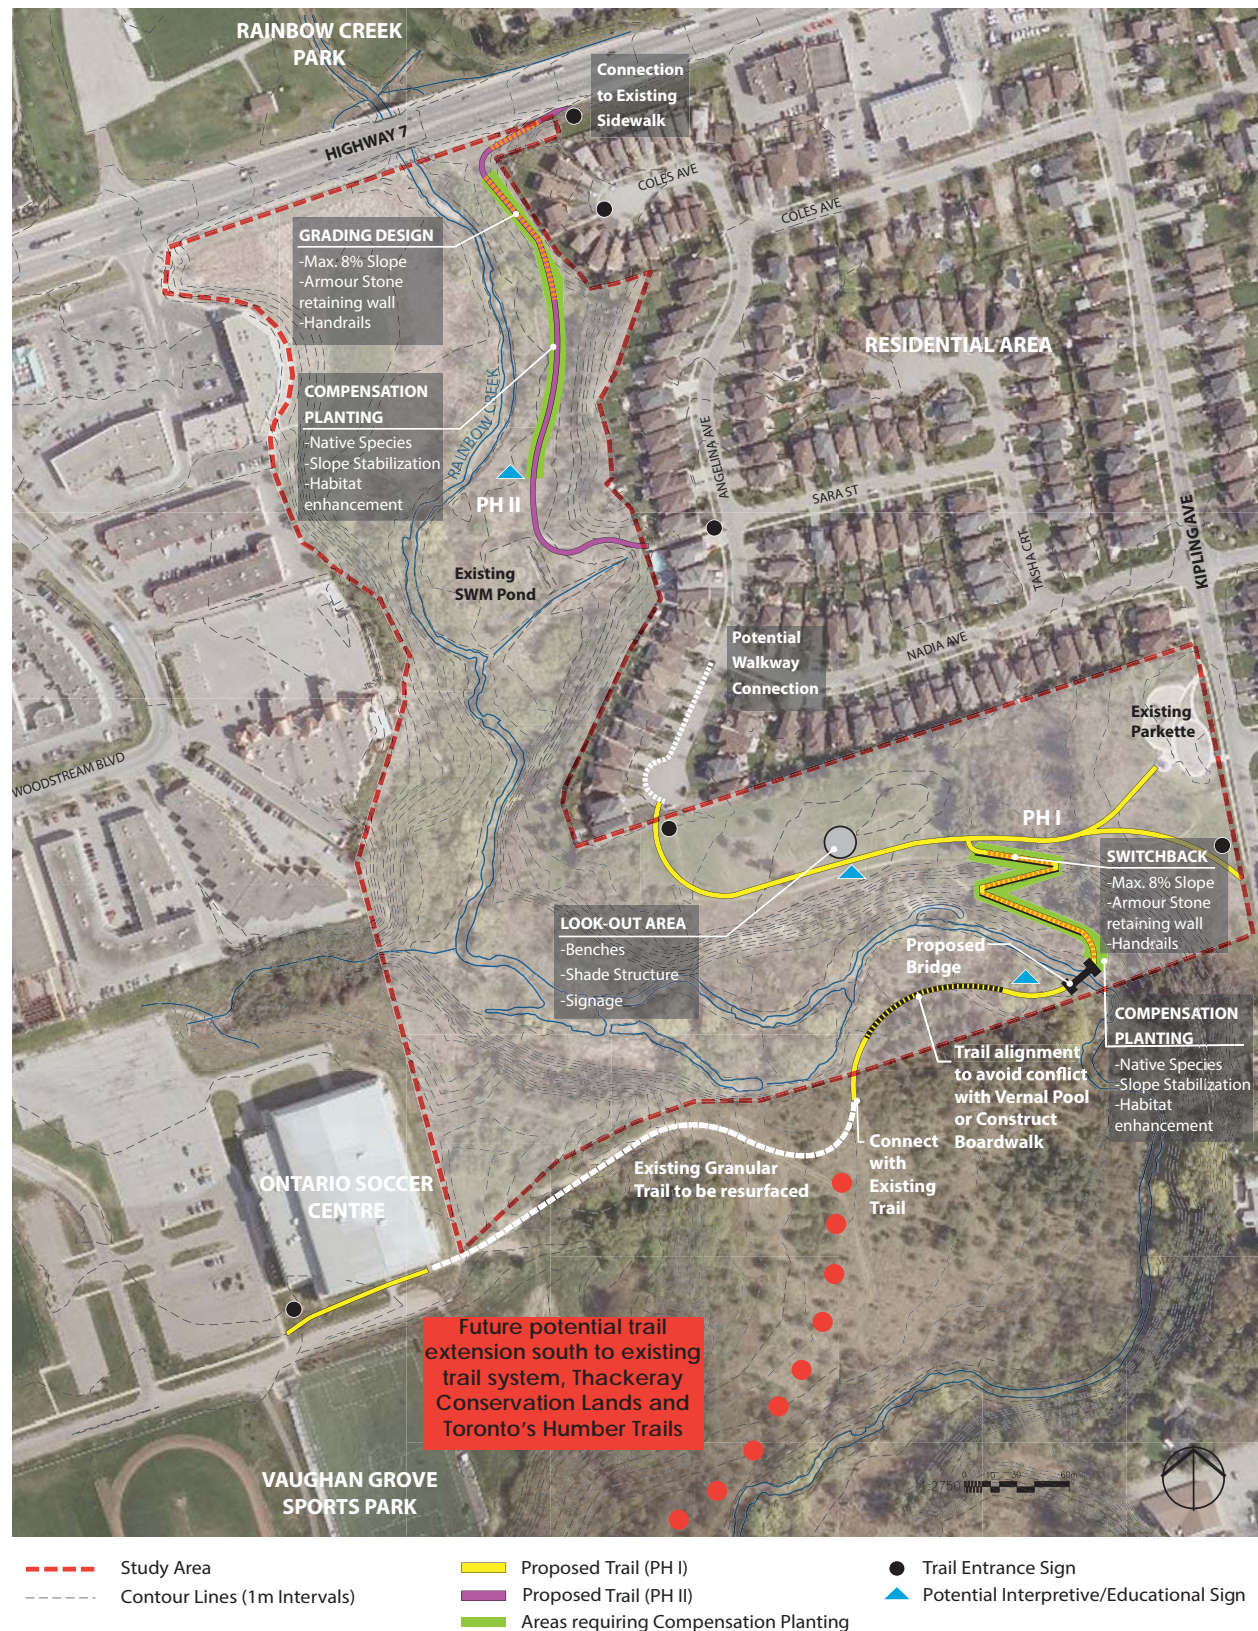
FIGURE-9 CONCEPTUAL TRAIL LAYOUT

As for accessibility, the steep slopes that characterize the area make it difficult to select a route that does not involve significant grading to allow pedestrian access from the tableland to the valley. The recommended trail alignment would achieve the least amount of slope stabilization requirements, although a switch-back with retaining walls and guardrails along the steep incline would be required to achieve the accessible path slope.

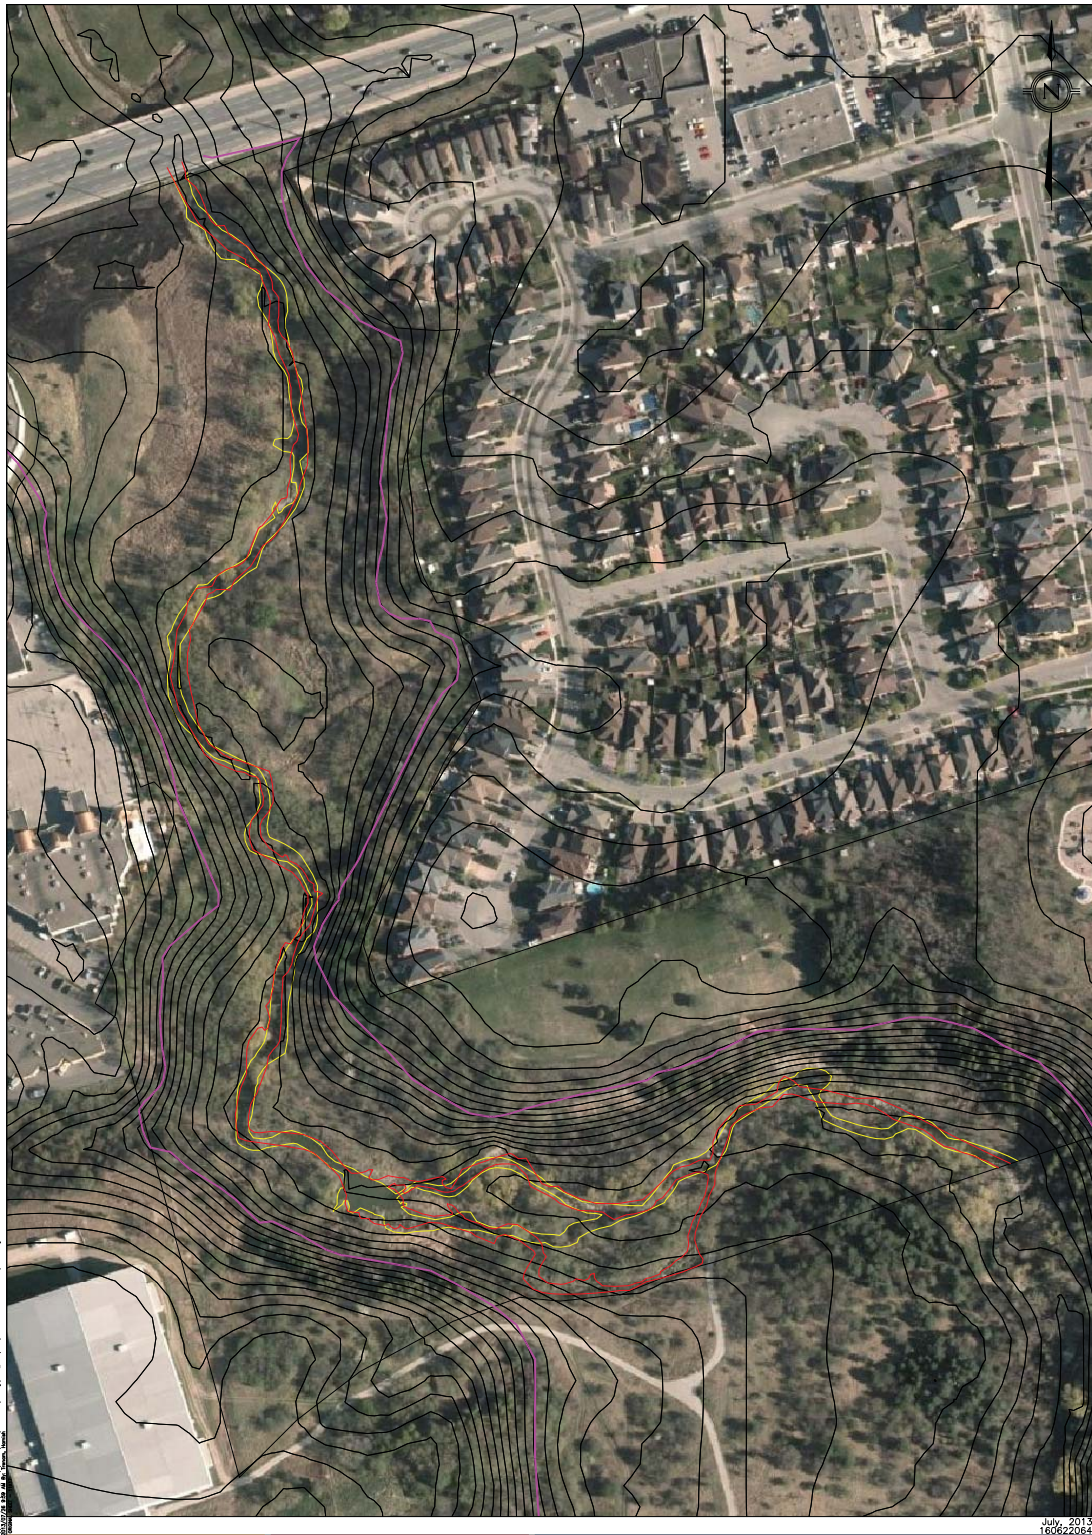
**LEGEND**  
— 2002 Top of Bank  
— 2012 Top of Bank  
— Meander Belt  
— 2012 Contours
