**1. PROPOSED RENOVATION OF EXISTING REAR COTTAGE AT 25 ELIZABETH STREET –
WARD 5**

To consider the background and analysis portion of this report in order to review the proposal for renovation of the existing rear cottage at the subject property.

**25 Elizabeth Street Coach House
PROJECT DESCRIPTION**

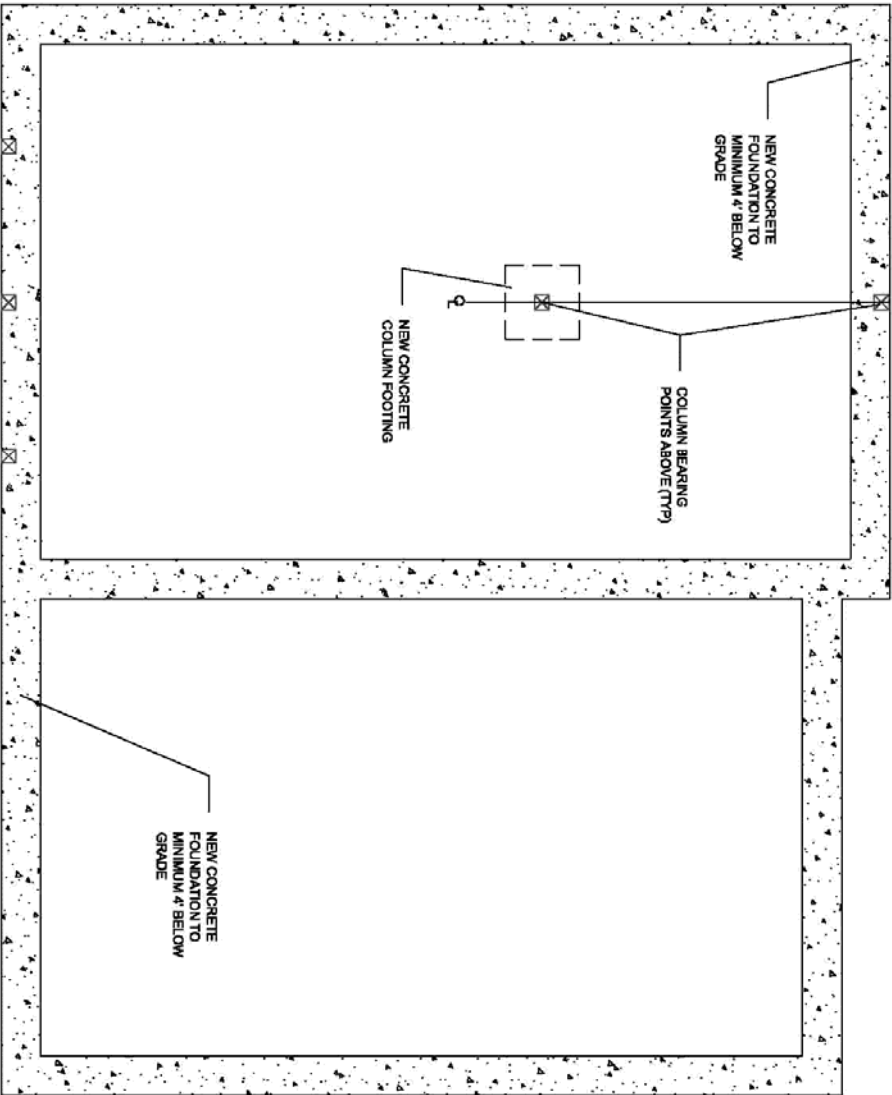
2. EXCAVATE FOR NEW FOUNDATION TO DEPTH OF 4' MINIMUM BELOW GRADE;
CONSTRUCT NEW FOUNDATION WALLS AND COLUMN FOOTING;

2. A new foundation is to be excavated and poured, as shown and detailed in the foundation drawings.

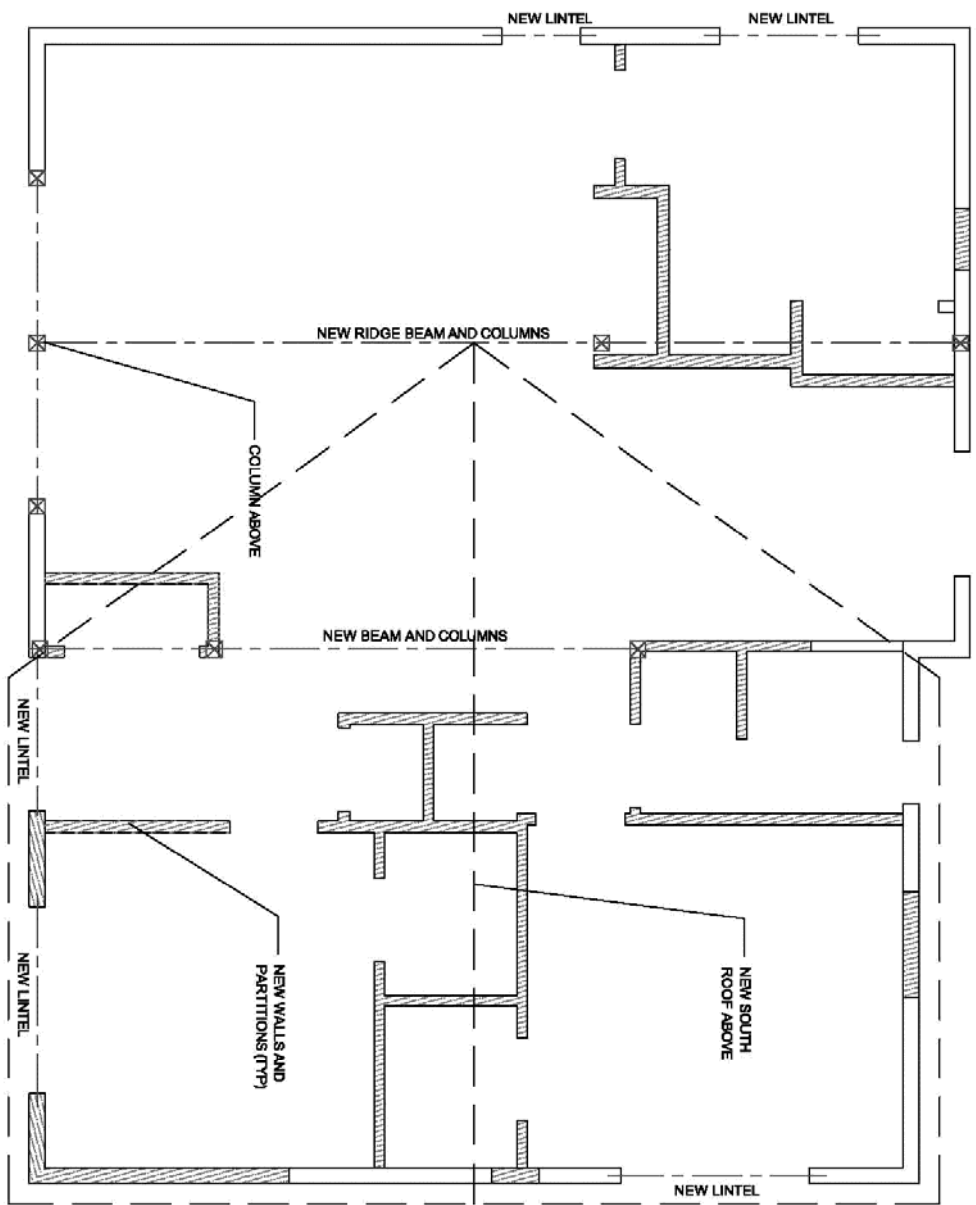
- 3. SET BUILDING ONTO NEW FOUNDATION;
- INSTALL NEW STRUCTURAL COLUMNS AND BEAMS;
- CONSTRUCT NEW WALLS AND PARTITIONS;
- FILL IN EXISTING OPENINGS AS SHOWN;
- CREATE NEW OPENINGS AS SHOWN;
- INSTALL NEW SOUTH ROOF.

3. The building is to be set on the new foundation. New exterior walls and interior partitions are to be constructed, and existing opening that are scheduled to be closed are to be filled in. New and enlarged openings are to be created, with lintels installed as shown in the drawings. New exterior sheathing is to be installed. A new roof, which will include the area previously covered by the flat roof of the porch, is to be installed. A schematic roof plan is provided at the lower right of sheet A1 of the drawings, showing the revisions to the building roof.

Note: Examination of existing timber for rot, and recommendations for replacements and/or sistering of members to be performed by a structural engineer in good standing with the Professional Engineers of Ontario (POE).

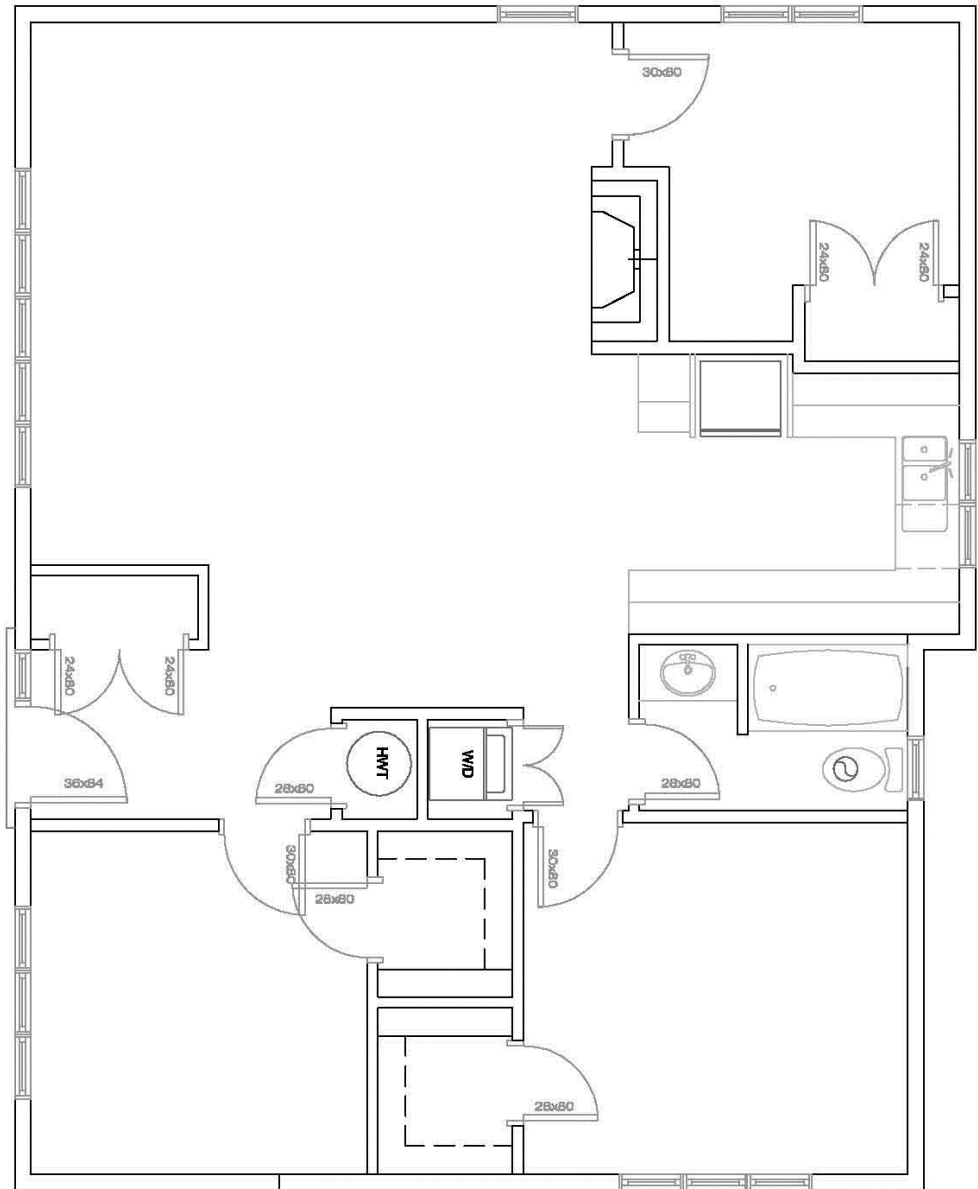
4. COMPLETE CONSTRUCTION:
INSTALL THERMAL INSULATION
SYSTEM;
INSTALL PLUMBING, ELECTRICAL
AND HVAC SYSTEMS;
INSTALL DOORS AND WINDOWS;
INSTALL INTERIOR AND EXTERIOR
FINISHES;
INSTALL ALL FIXTURES AND
FITTINGS.

4. Construction is to be completed including installation of insulation, plumbing, electrical, and hvac systems; doors and windows; exterior and exterior surfaces and finishes; fixtures, fittings, and cabinetry.

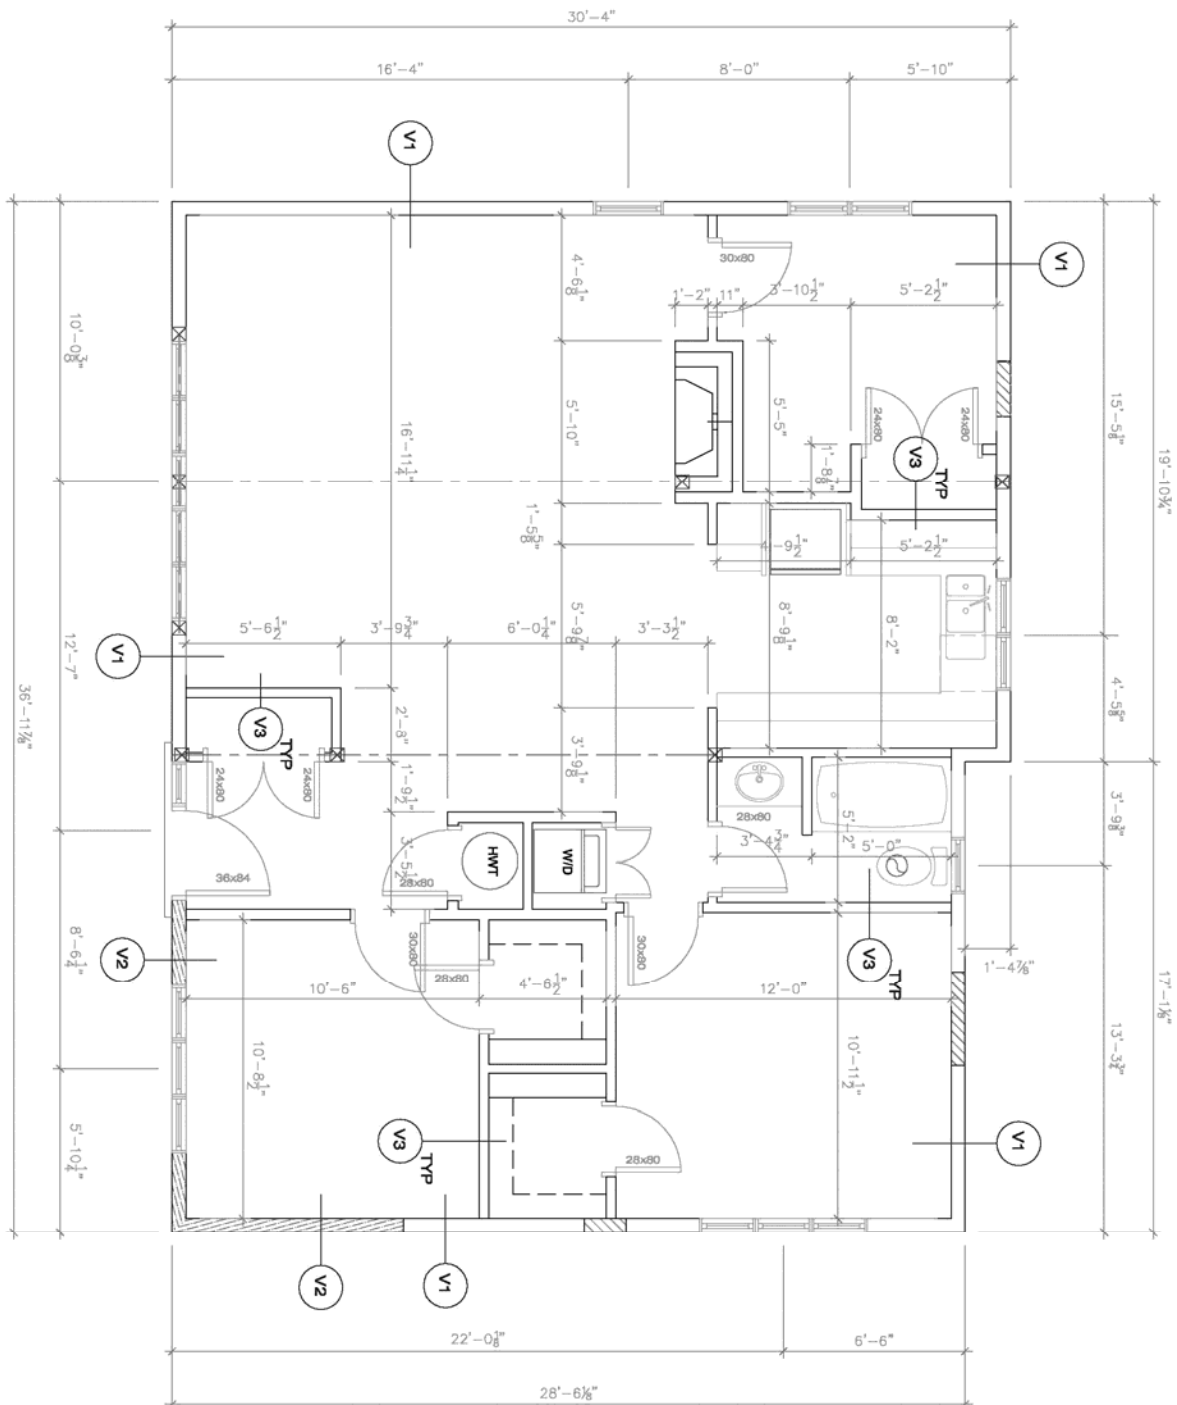
Proposed Plan

- New sturdy foundation of appropriate depth
- Inspect and replace as needed rotted wood structure members
- Replacement of front sunroom area walls and replacement of floor structure as required
- New cladding and windows with adjusted sizes as per drawings
- New sloped roof on south portion of cottage and elimination of flat roof area
- Interior renovation

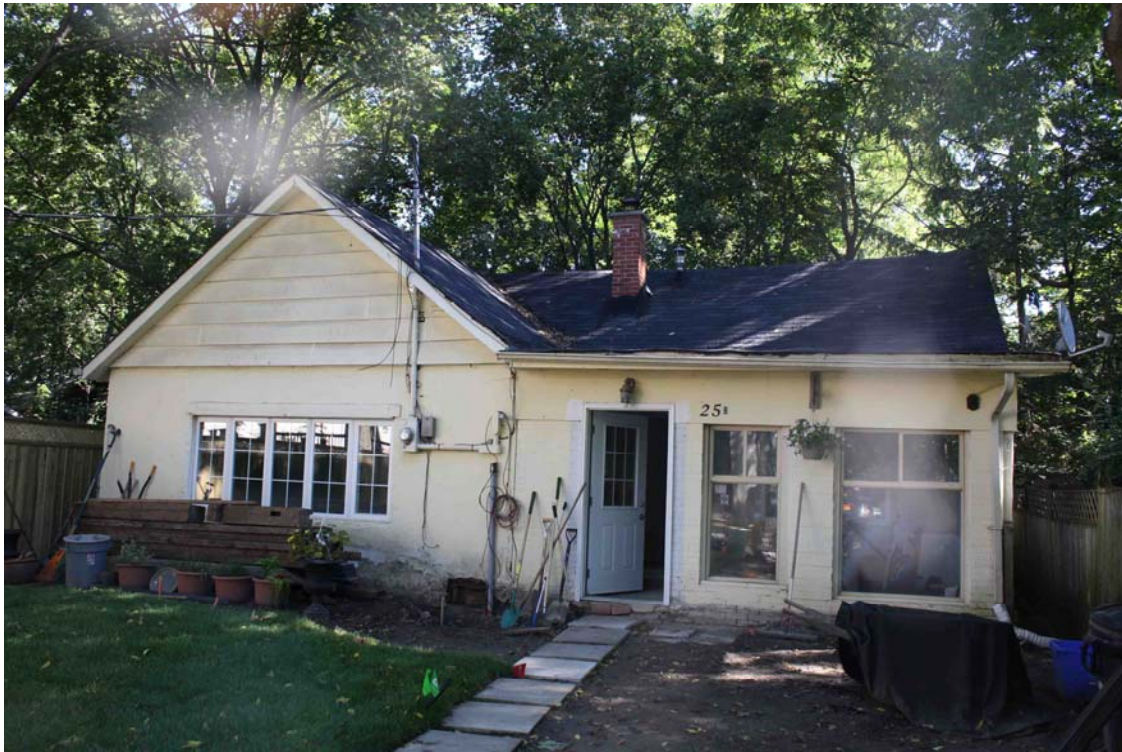
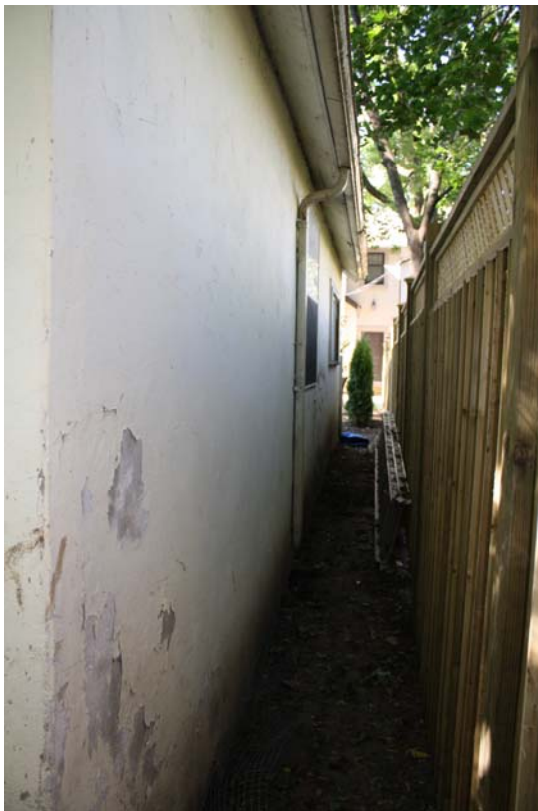
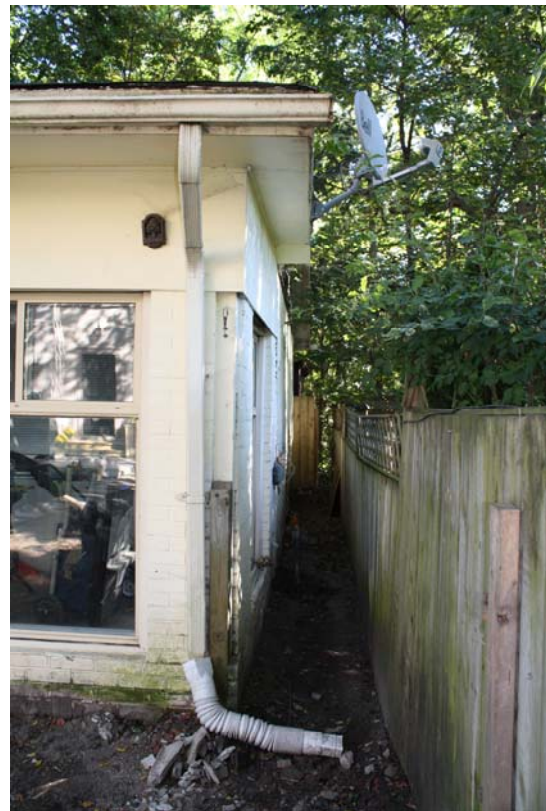
- Stucco cladding on metal lath (20's and 30's or could be as late as 1940's)
- Gable ends clad in wide exposed horizontal siding (painted wood composite)

- Gable end clad in worn asphalt shingles (style: 20's and 30's)
- Wide multi-pane feature window with divided lights - presently a recent vinyl type- however the style suits well as a replacement of a possible previous colonial revival style (20's and 30's)

Photos, Sept, 18, 2013
Top: West side
Bottom R: South side
Bottom L: North side

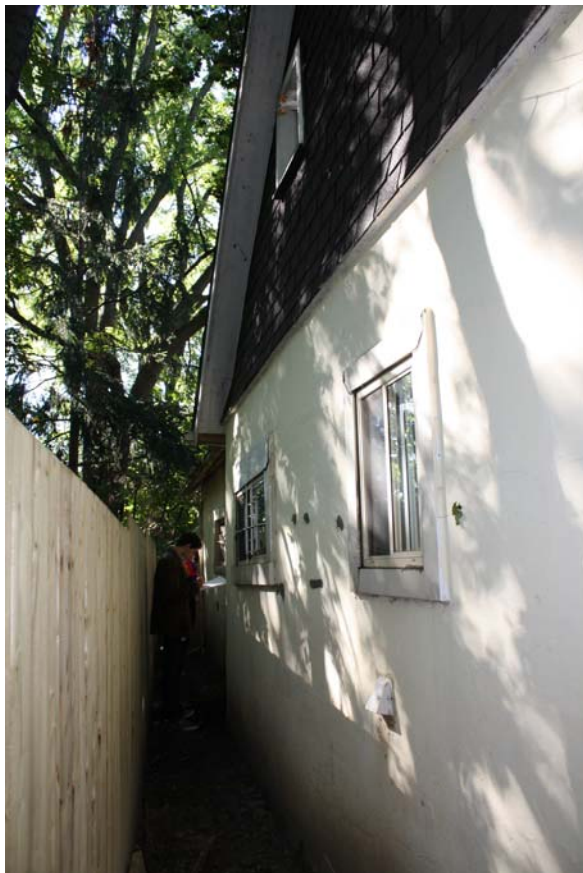
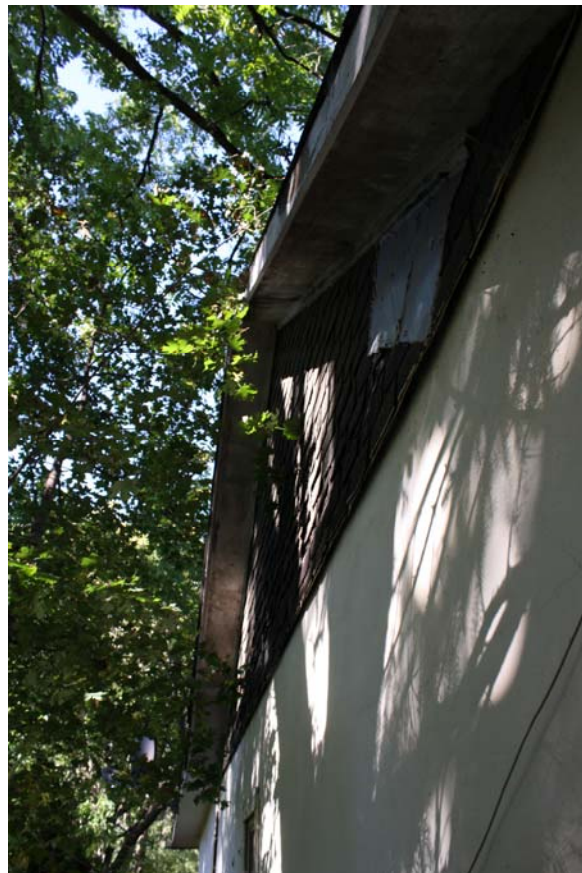
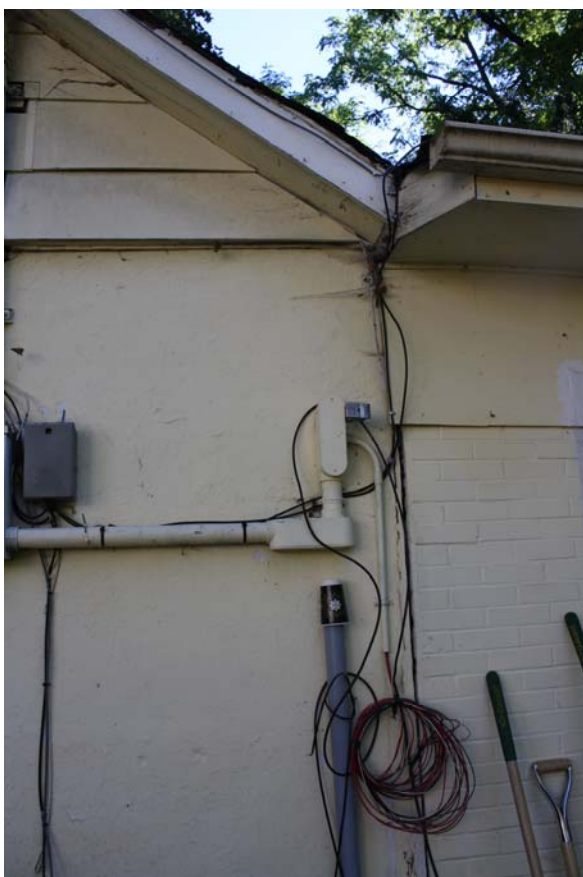
Photos, Sept, 18, 2013
Top R: South side
Top L: East side
Bottom L: East side detail

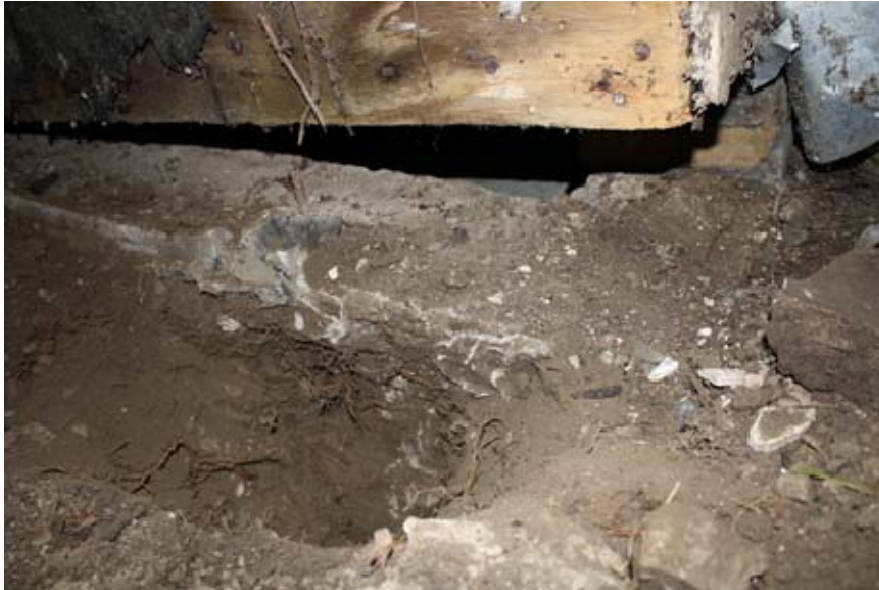
- The wood structure and construction is modest, machine sawn lumber. It was built as a wood frame structure on very shallow, earth-formed, poured concrete foundations. Some parts of the foundation on the inside of the sunroom, show signs of wood plank form work which could have been done only in that area when the sunroom/front porch was renovated near the middle of the 20th century. The shallow foundations reflect a structure that was built as a modest or seasonal structure.

- There is rot present in some foundation sill wood members.
- Windows have been replaced with vinyl, except for a one of the side windows which is a single hung, 6 over 6, wood sash style window.

North-east corner foundation at framing condition.

As a result of this construction, the building has suffered from the elements over its 90-year life. The footings have suffered from frost heave and some of the timbers are suffering from rot where they are close to grade. These deficiencies require correction. Provision of a proper foundation is the first priority.

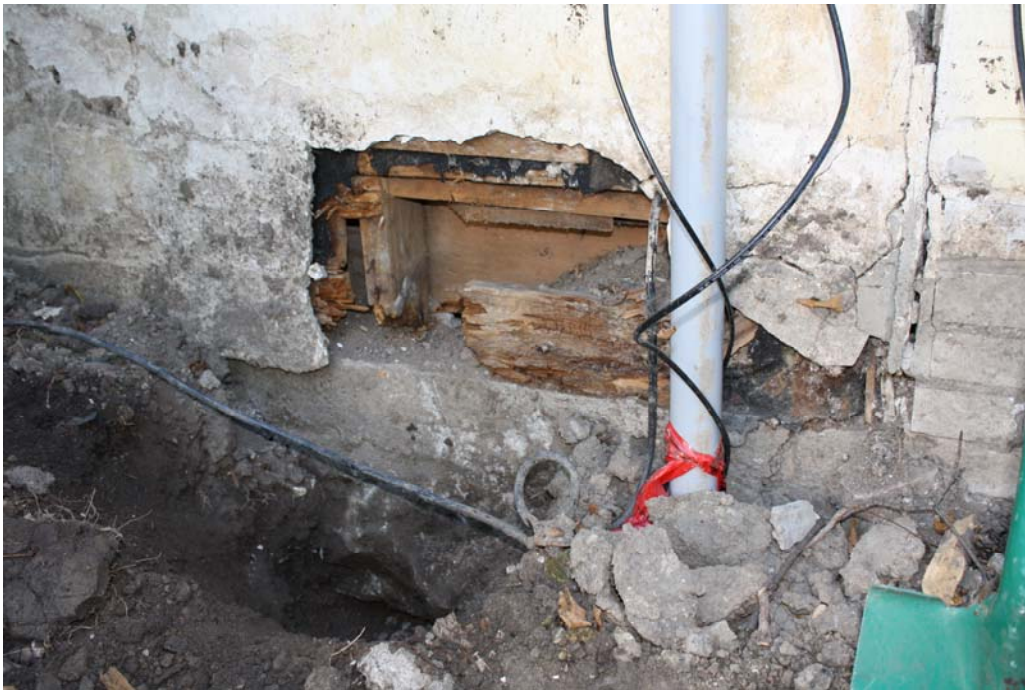
West elevation: foundation at framing condition.

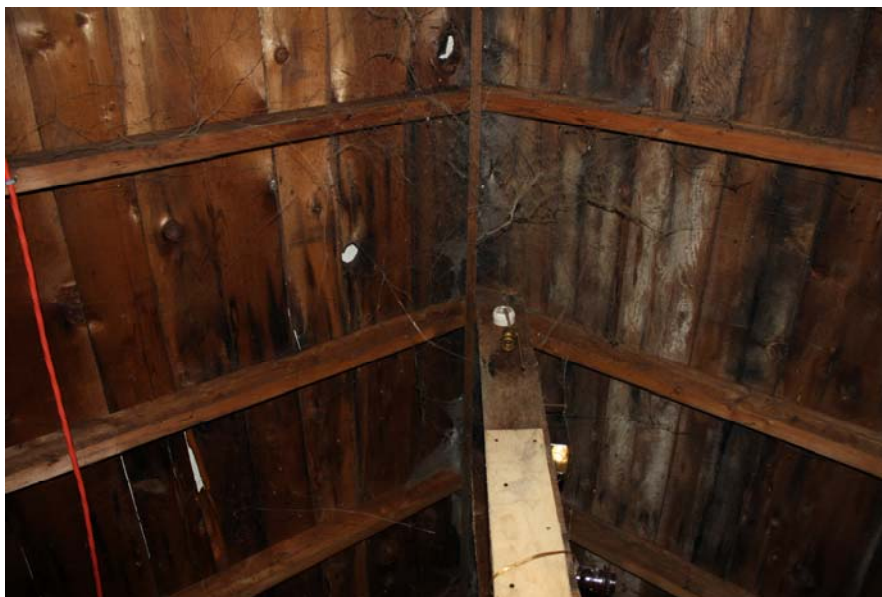
North section interior attic.

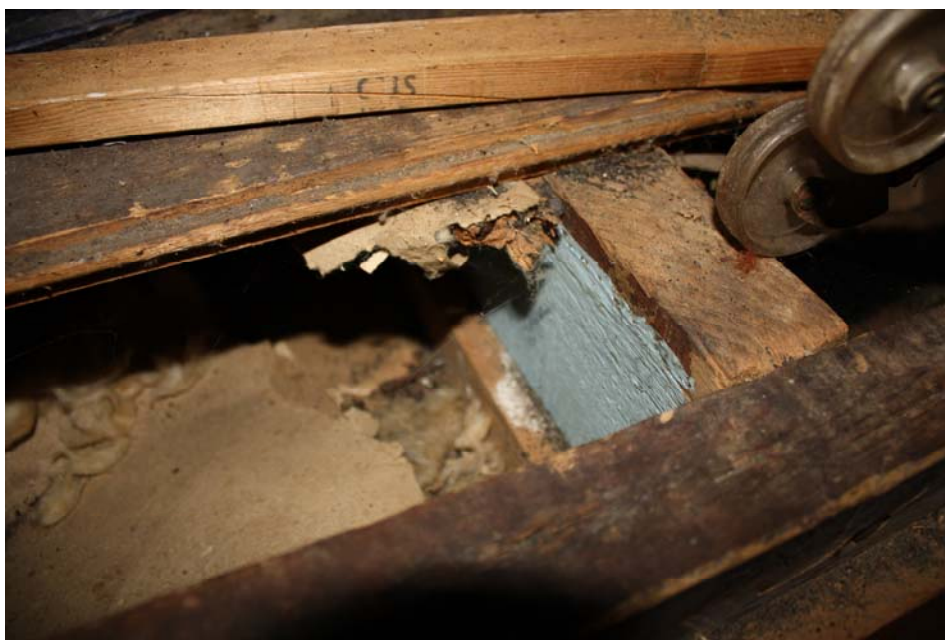
North section attic, tongue and groove floor boards.
