**ALTERATION TO AN EXISTING BUILDING AND THE DEMOLITION OF OUTBUILDINGS
872 NASHVILLE ROAD, KLEINBURG-NASHVILLE HERITAGE CONSERVATION DISTRICT,
DESIGNATED UNDER PART V, ONTARIO HERITAGE ACT
WARD 1 – VICINITY OF HUNTINGTON ROAD AND NASHVILLE ROAD**

Heritage Impact Statement
872 Nashville Road
In the Kleinburg-Nashville Heritage Conservation District
City of Vaughan

Phillip H. Carter Architect and Planner
& Paul Oberst Architect
June 2017

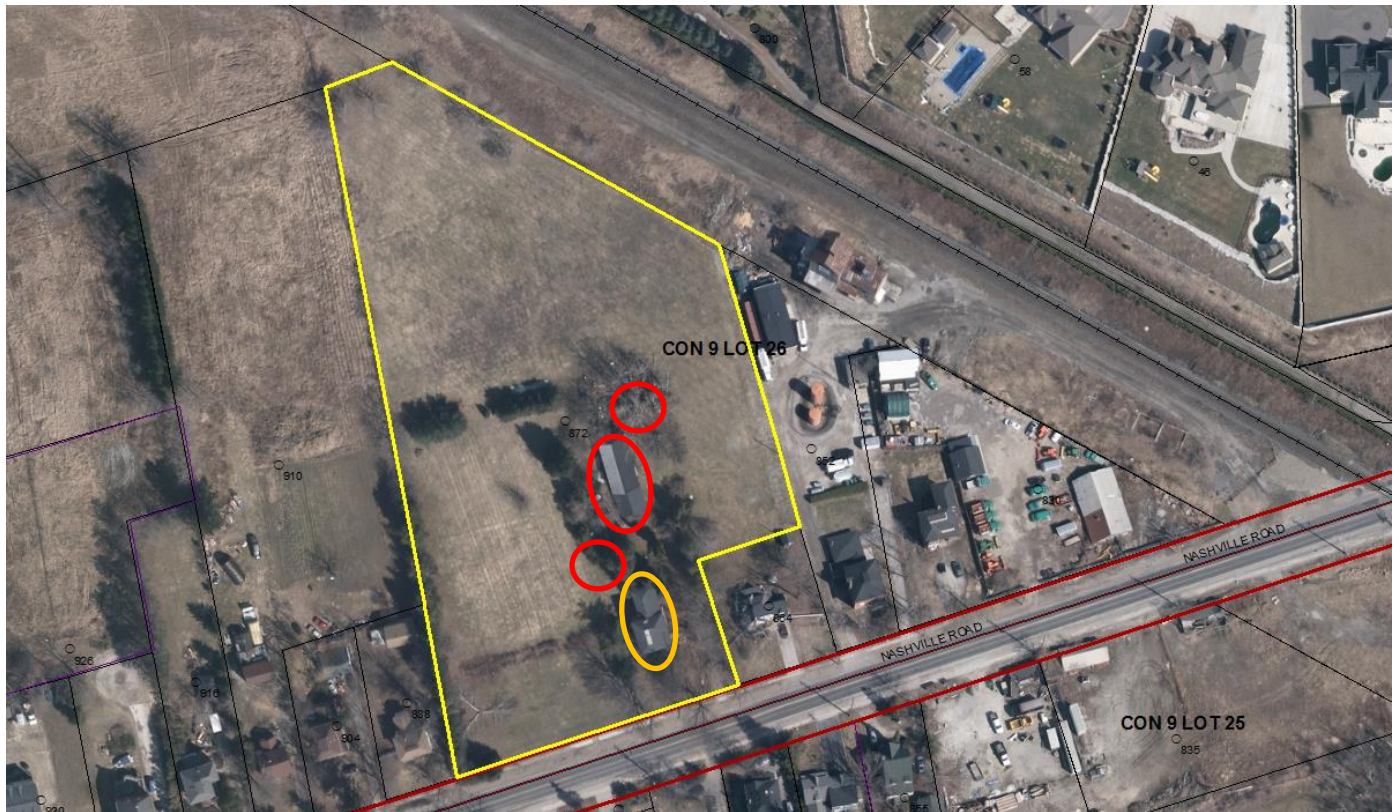
Site Map

**Victorian Brick House to be restored
(outlined in orange)**

**Outbuildings to be demolished
(outlined in red)**

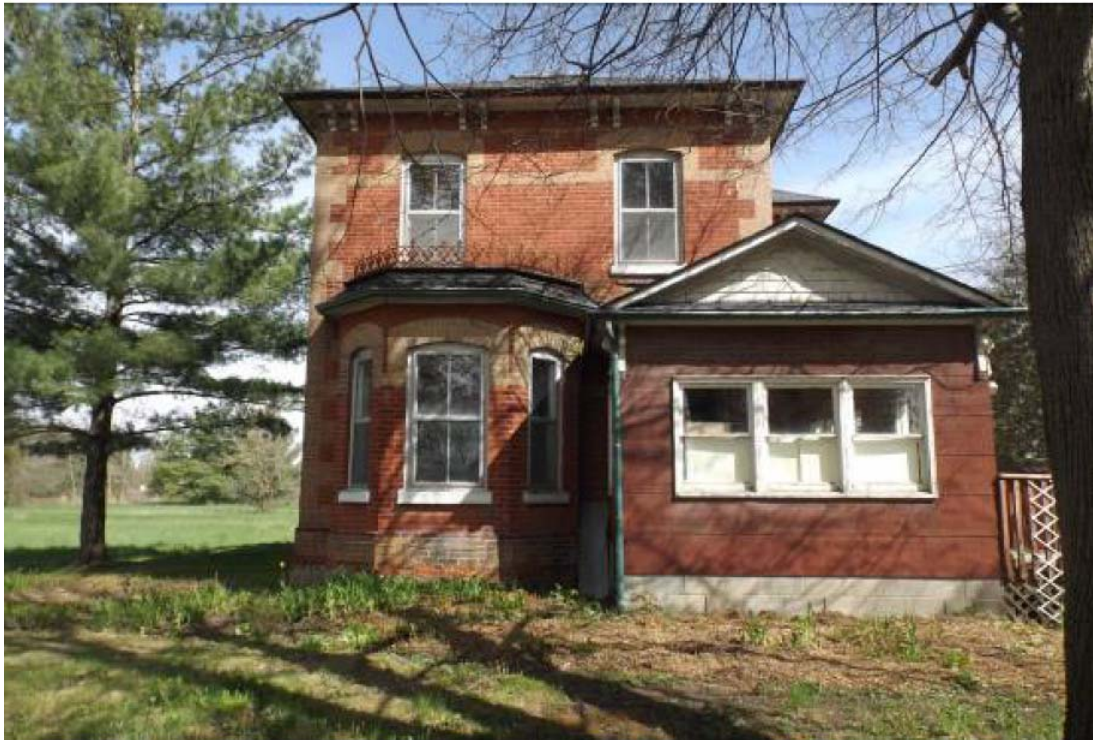
The Victorian house (front elevation) (from HIA)

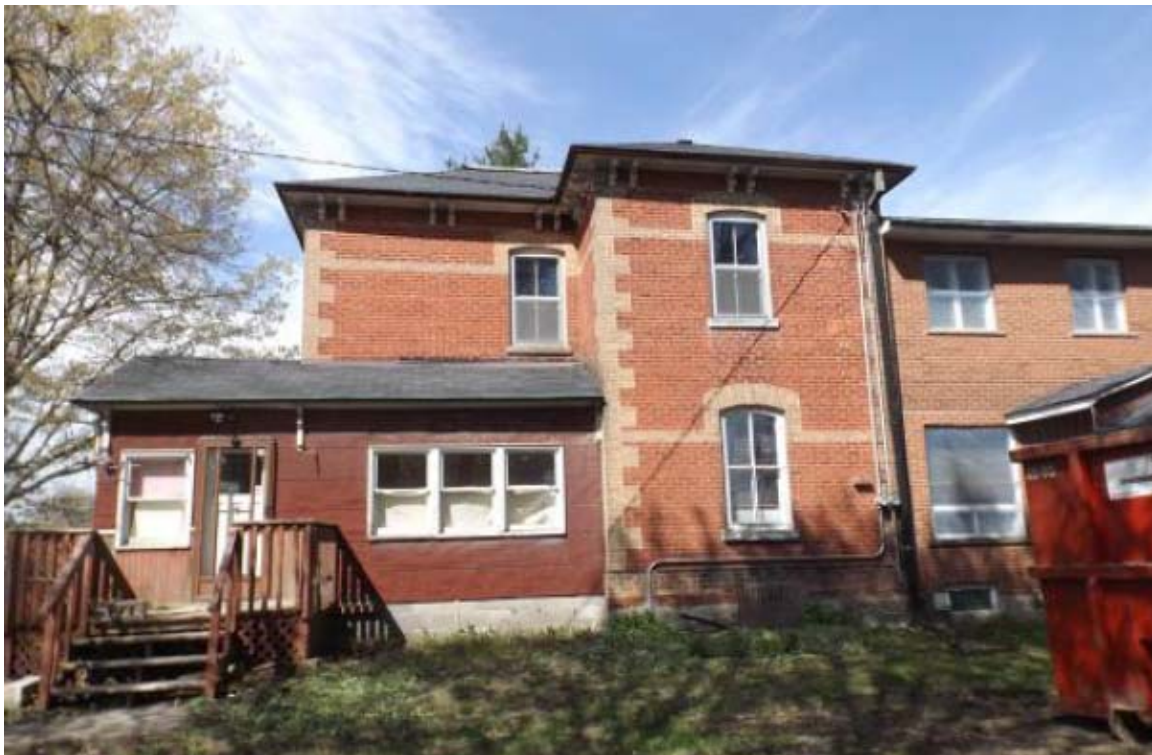
The Victorian house (side-east elevation) (from HIA)

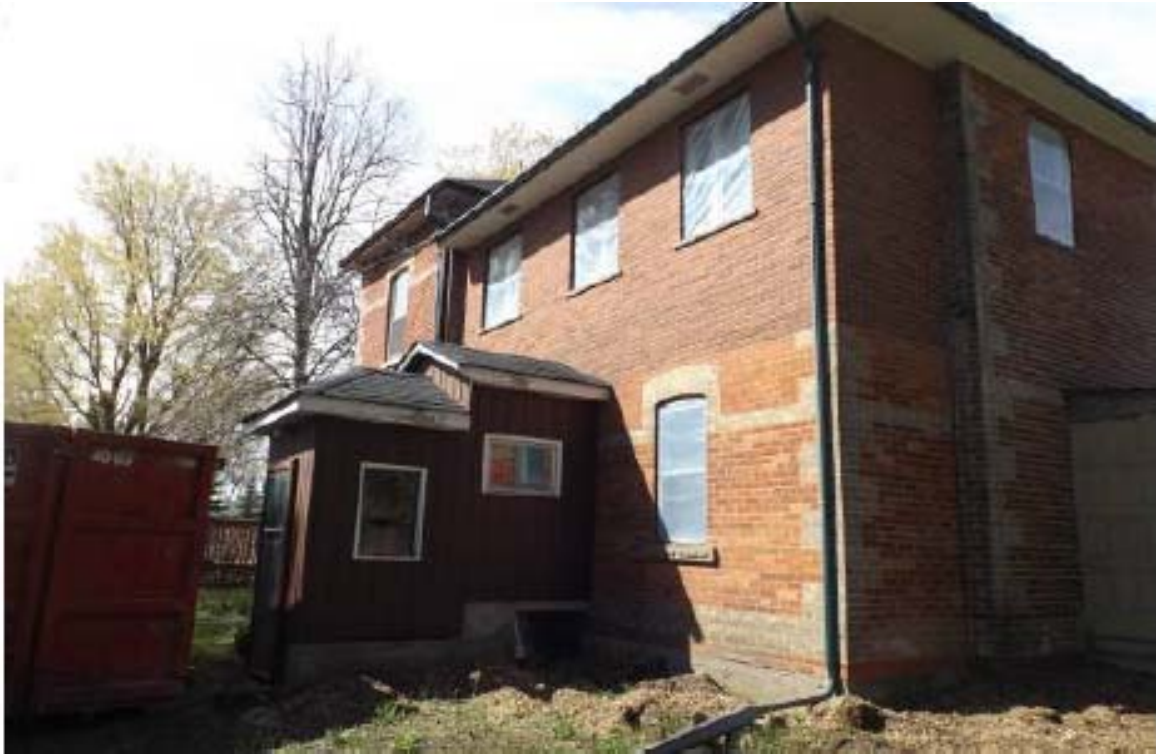
The Victorian house (side-north-east elevation) (from HIA)

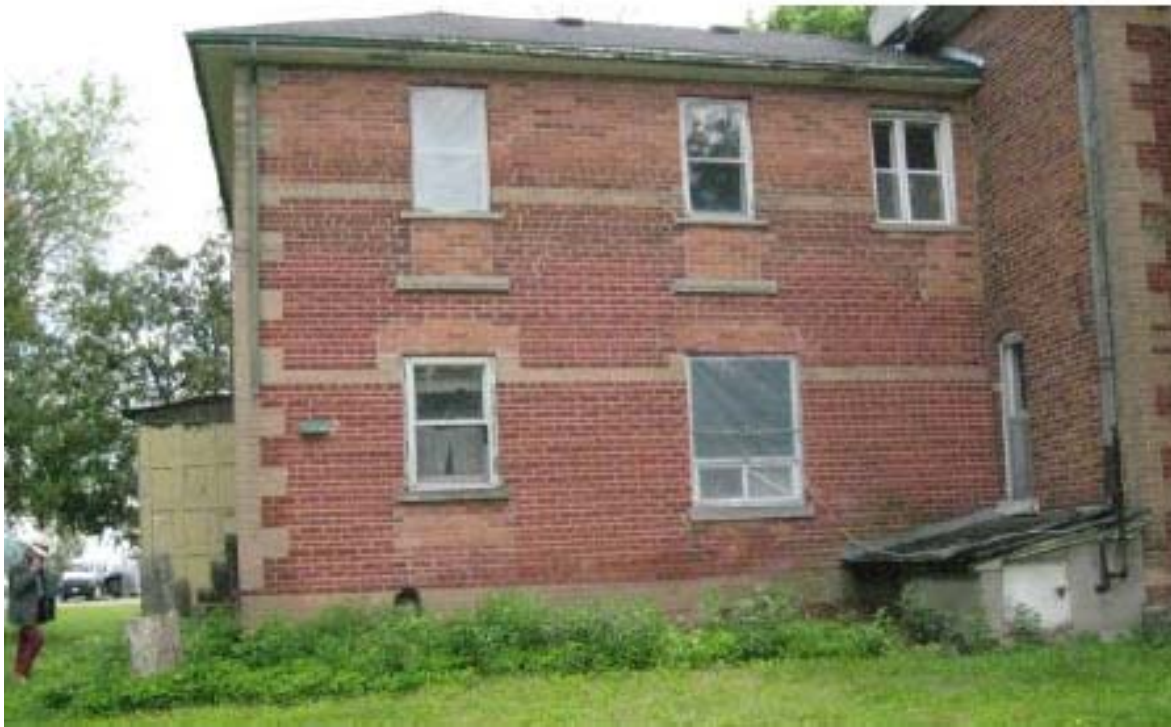
The Victorian house (side-west elevation) (from HIA)

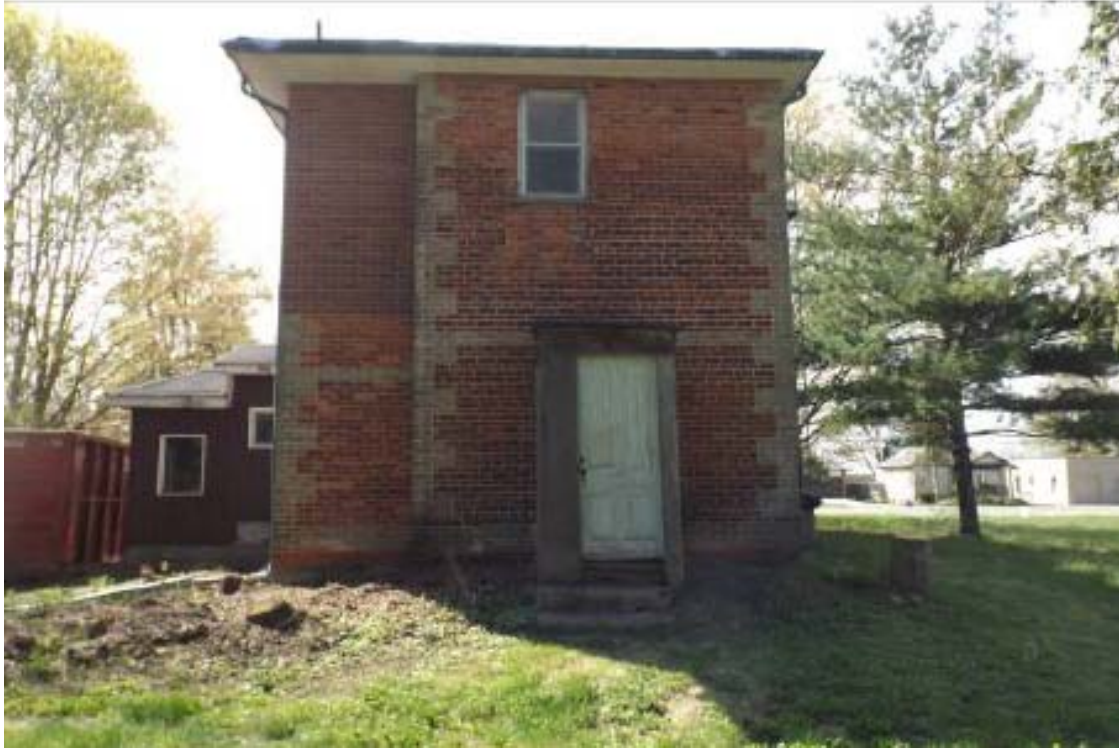
The Victorian house (side-north elevation) (from HIA)

- The later unsympathetic, heavily-altered kitchen tail will be removed and the north elevation masonry will be restored. It is noted that the plan for this work cannot be provided until such time the kitchen tail is removed.

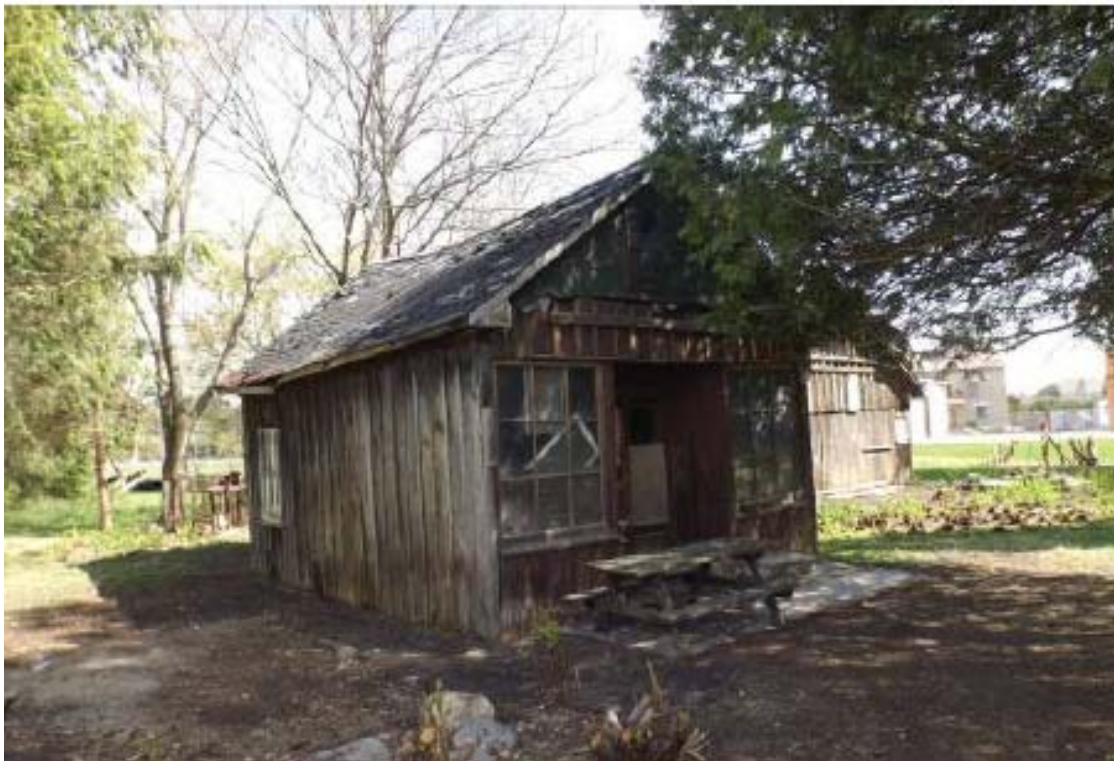
Small Outbuilding (from HIA)

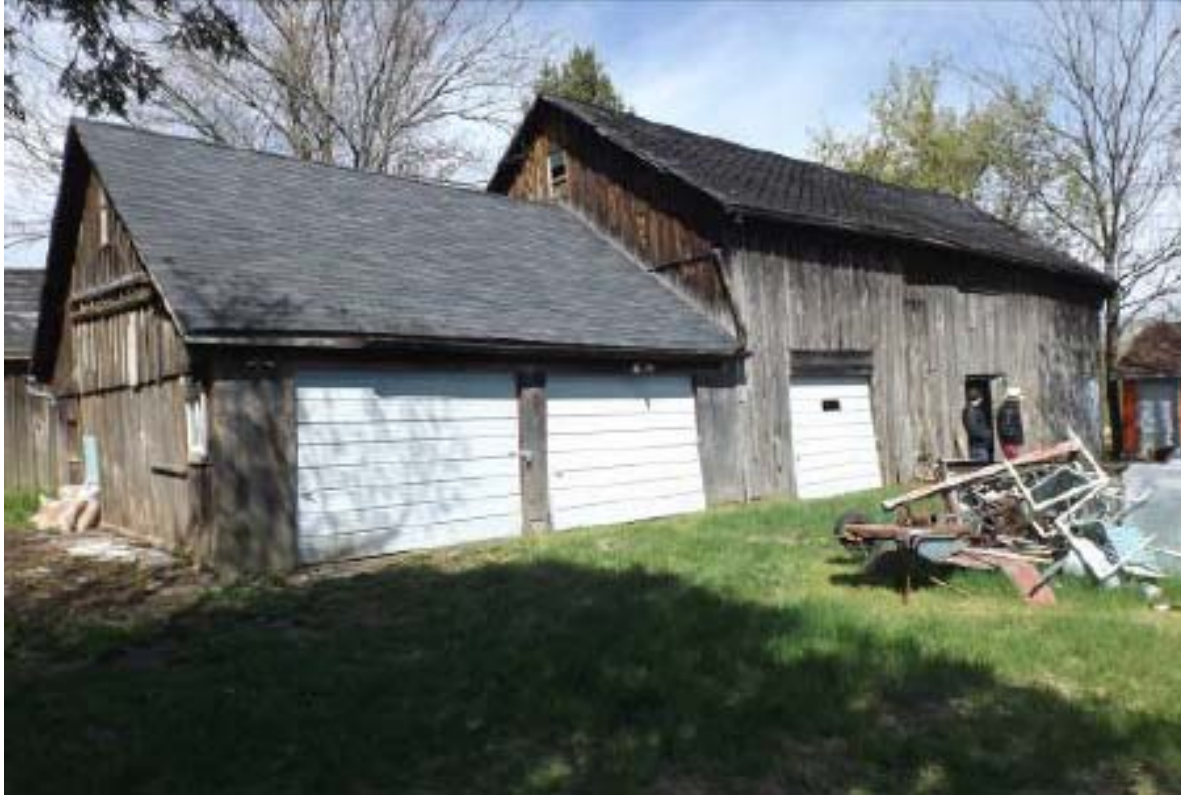
The Barn (from HIA)

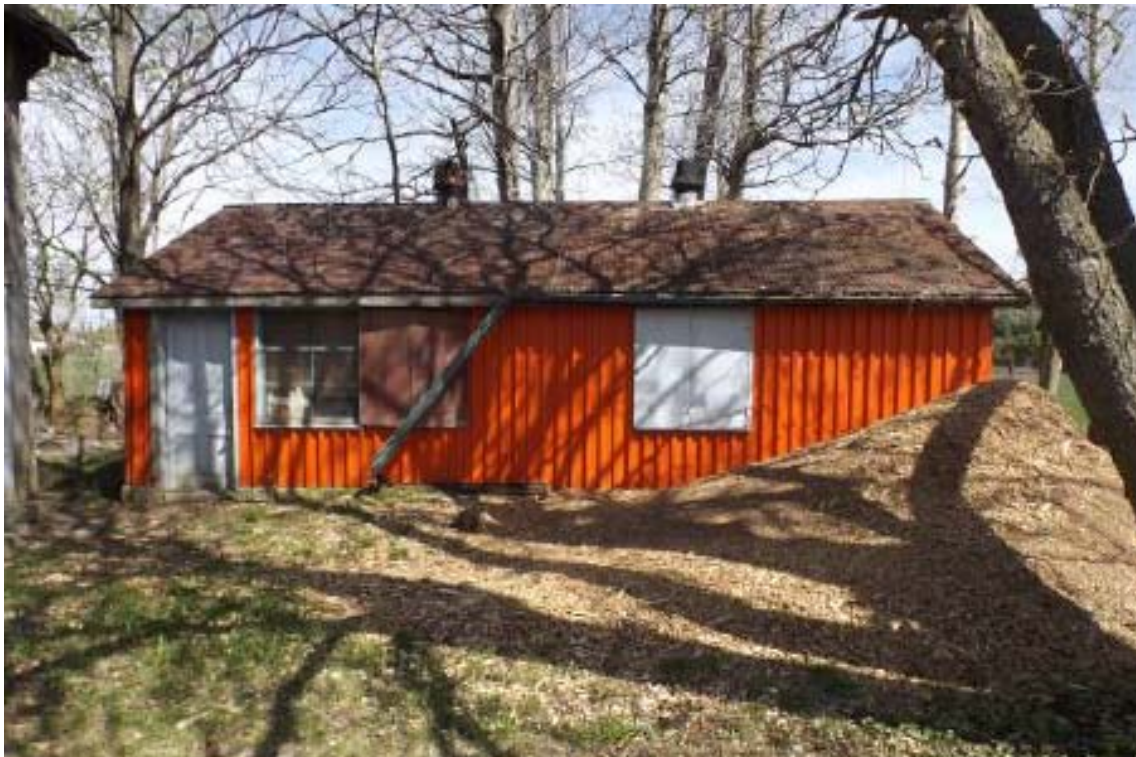
The Steel Shed (from HIA)

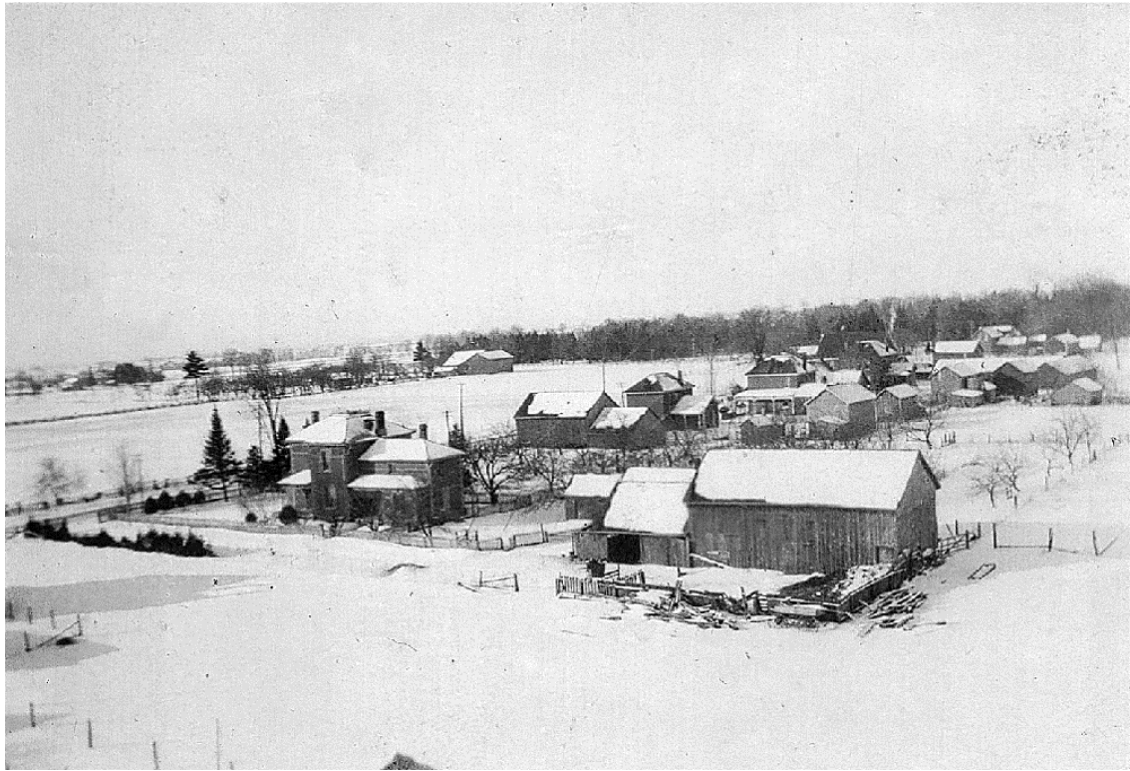
Undated Aerial Photograph of the property from the City of Vaughan. House to the left, with outbuildings to the right. The house shows a smaller, open, front verandah, and the original tail with a one-storey pantry (?) at the northeast corner and a rear kitchen verandah under an extension of the pantry roof. Note that there is no building to the northeast of the barn, where the current steel shed sits. Compare with the 1942 aerial photo in figure 5, which suggest that this image predates that aerial photo.

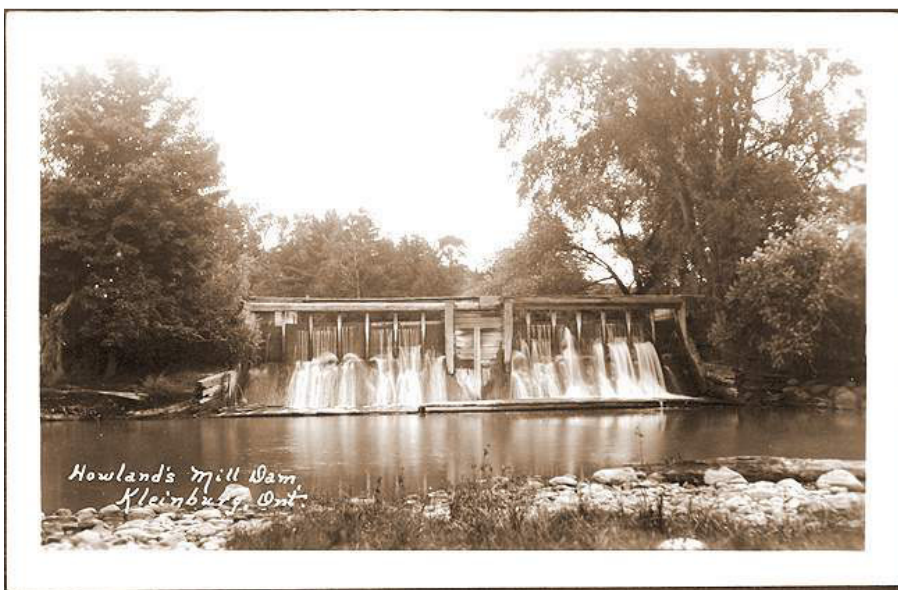
Figure 1. Kleinburg's original development was supported by its mills. This is the dam for Howland's Mill, originally John Klein's.

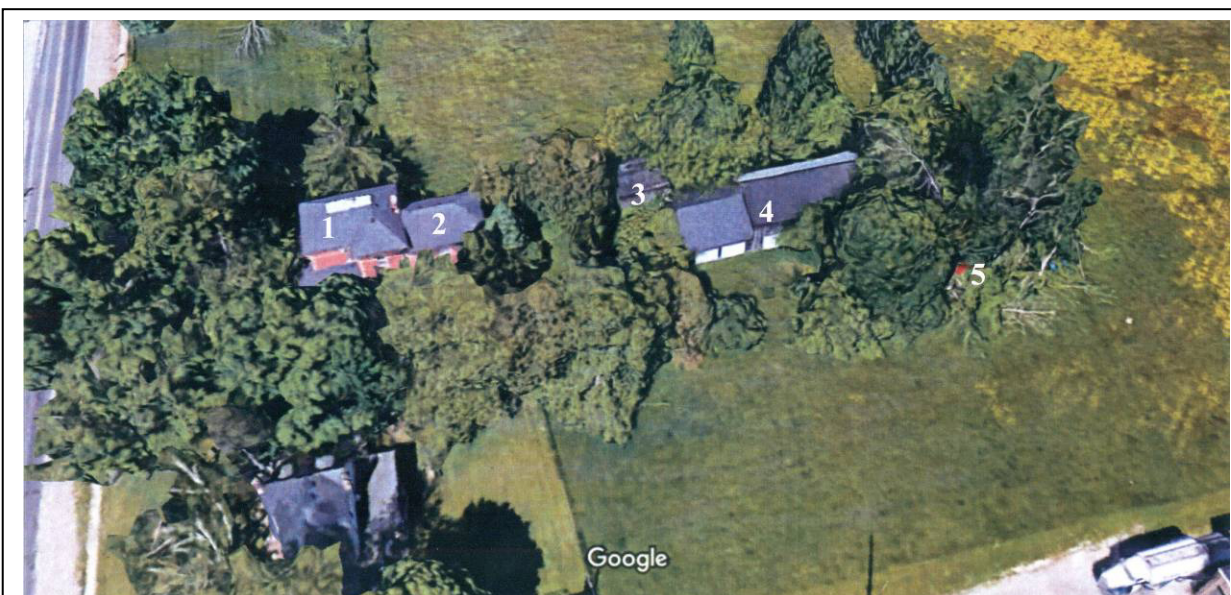
Figure 4. Aerial view showing the existing buildings on the property.

There are 5 structures on the property, shown in the Google satellite view above.

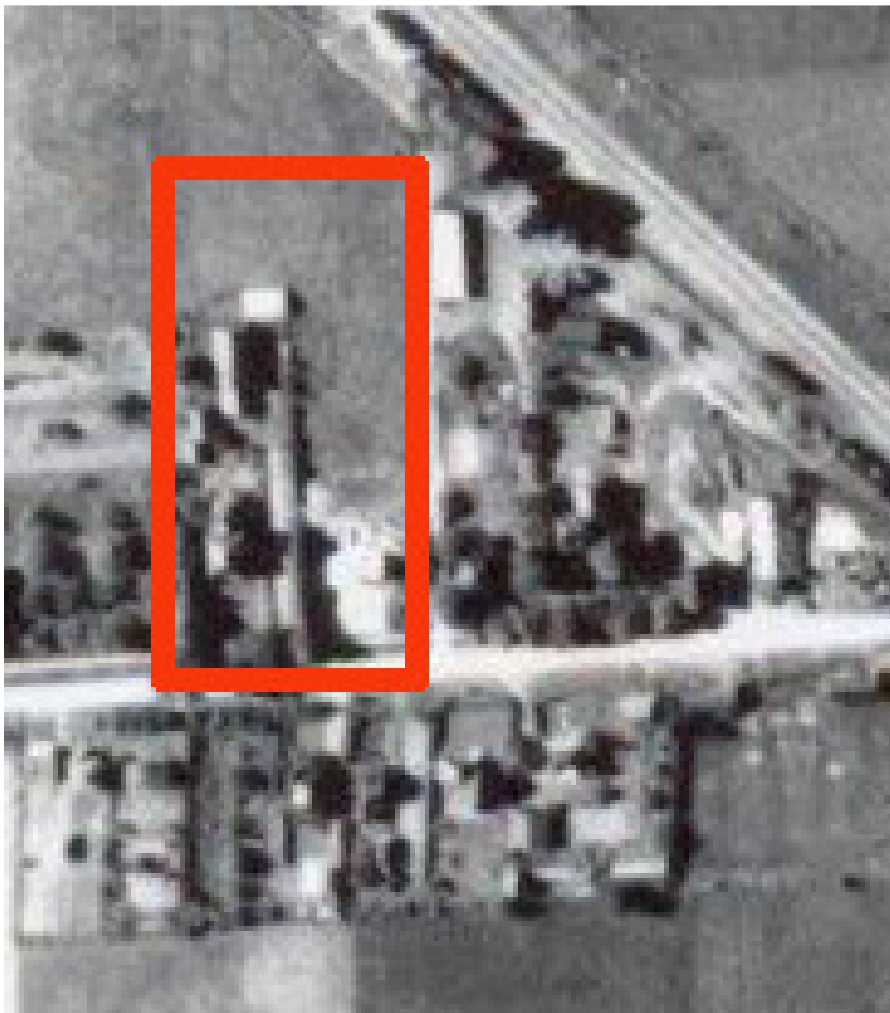
Figure 5. Detail from aerial photo, April 1942, from the Vaughan Archives. The house and outbuildings are visible. There appears to be a smaller building to the left front of the small outbuilding. We believe that the rear-most building is an older building, not quite of the same size and location as the current red steel shed. See drawing in Figure 24. See also survey in Figure 4 in Su Murdoch's Ownership Chronology, Appendix A.

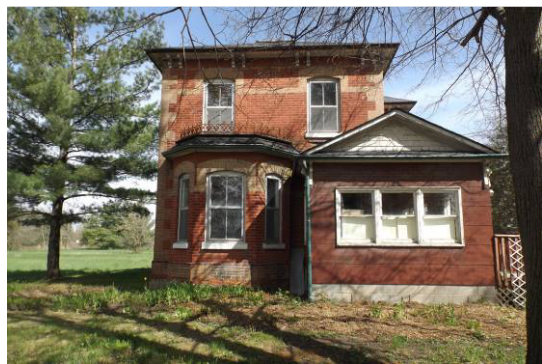
The farmhouse is a two-storey polychrome brick vernacular Victorian house with both Gothic and Italianate aspects. The walls are of red brick, with quoins and hooded segmental window arches in contrasting buff brick. There are two-course buff bands on both storeys at the level of the bottom of the window hoods. There is a 4-course band of buff brick at the level of the ground floor, topped by a dark projecting water-table course. The foundation is shaped field stone.

The overall condition of the masonry is good, with some spalling and mortar erosion.

Figure 6. Front (south) elevation.

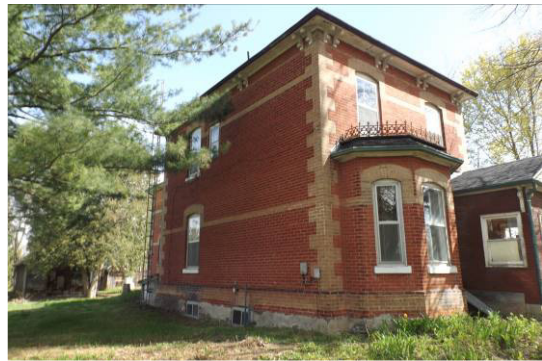
Figure 7. View from the northwest.

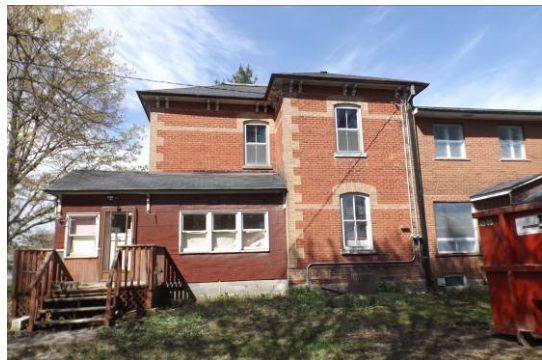
Figure 8. View from the east.

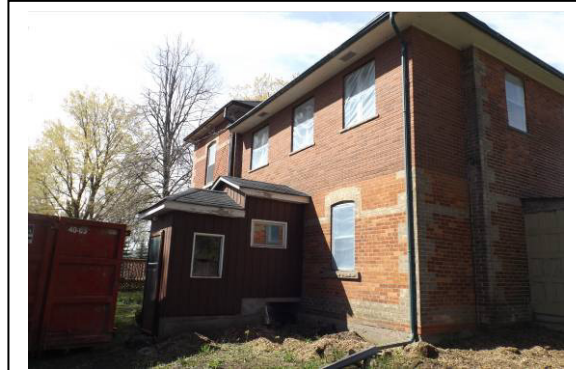
The house originally had a kitchen tail, which has since been altered and added to. The original brick remains on the west and parts of the north (rear) and east exteriors. Only one of the original arched window openings remains—the rest being altered to square headed openings housing replacement windows. The roof is hipped asphalt shingles. Large overhang, but any original brackets have been removed.

The masonry is in good condition, but greatly defaced by alterations to the window openings.

Figure 9. View from northeast. Window at lower right is the only original opening in the tail. The frame entry porch is recent.

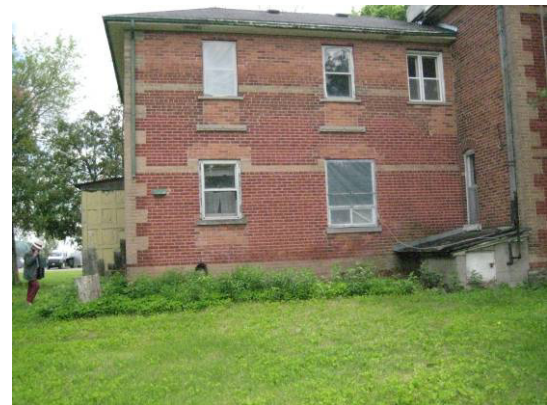
Figure 10. View from west. Original brick, but no original window openings.

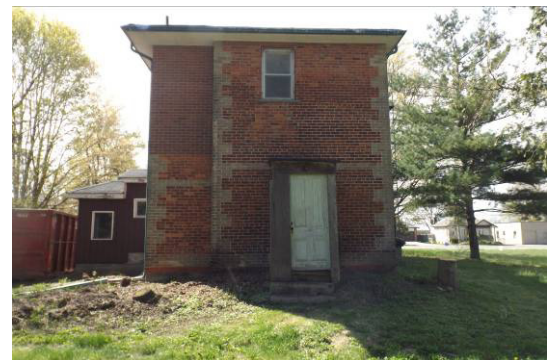
Figure 11. View from the north. Ad-hoc frame rear vestibule. Original brick on the right, and at ground floor on the left. Window opening not original.

- Replace existing windows with modern units matching original design.
- Restore the masonry on the north elevation, where the tail is to be removed. Until the removal, it's not possible to specify the work. We will provide a plan for this work once it is visible. Historic masonry units from the tail should be kept on site for re-use in this work.

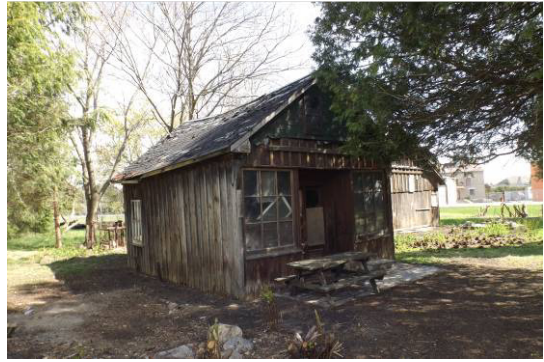
The small outbuilding is located about 15m behind the west side of the farmhouse. It is about 16 ft wide x 20 ft deep, with a steep front-facing gable roof in asphalt shingles. It has been fitted out with a shopfront facing the farmhouse. It is in poor condition, with a great deal of structural sagging in the west wall and the roof. This building appears in historic aerial photos dating from 1942 to the late 60s, and had an additional small building to the left front.

Figure 12. Front (south) side of the small outbuilding. Large 6-pane windows flank a recessed glazed entry door. Sagging wall and roof are evident.

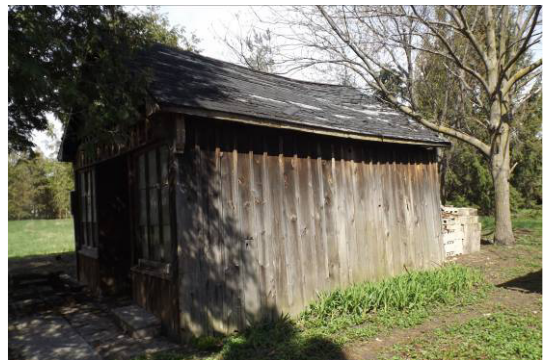
Figure 13. East side of small outbuilding.

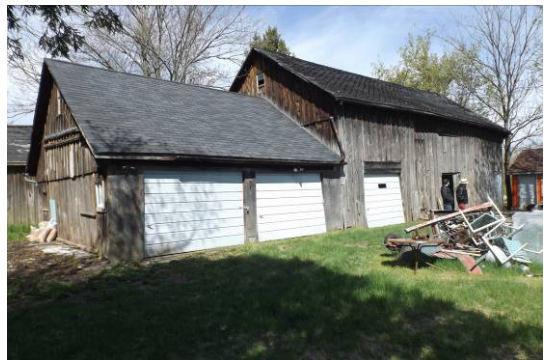
The barn is in poor condition, sagging to one side, with sagging 2nd floor joists, and signs of rot. It is framed in studs, not barn framing.

Figure 14. The barn from the southeast. The large openings have been fitted with metal overhead garage doors. Pictures of the barn continue on the next page.

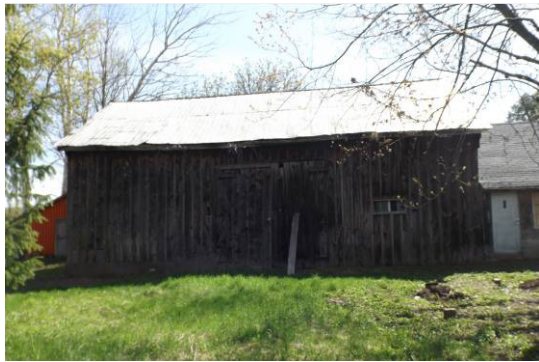
Figure 15. West side of the barn. This roof slope is in metal.

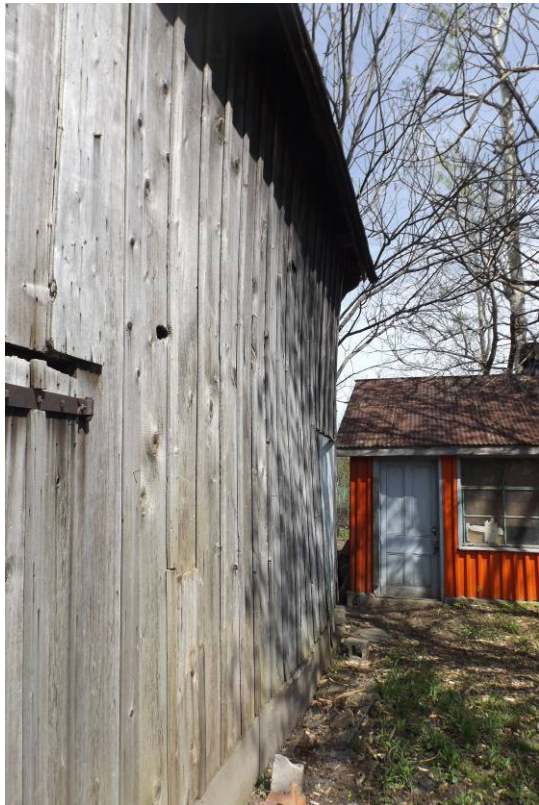
Figure 16. East side of barn showing bowed wall. Steel shed to the rear.

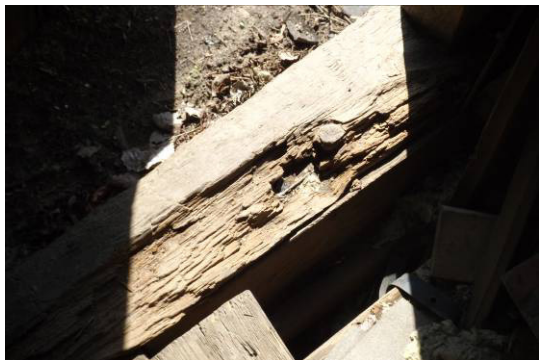
Figure 17. Rot in the timber sill of the barn.

In our professional opinion, the outbuildings—due to their structural deficits and poor condition should not be considered worthy of retention for heritage reasons. They are hazardous as they stand, and do not have a viable future use. We find no heritage reasons to prevent their removal.

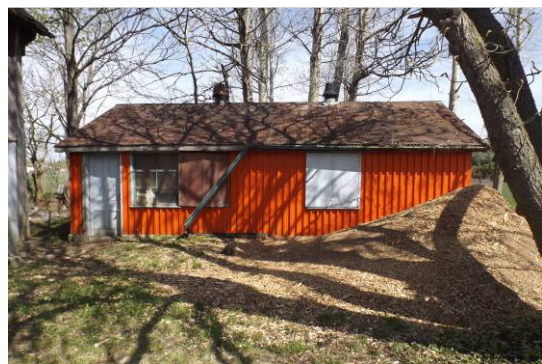
The steel shed is located to the immediate right rear of the barn. The medium sloped roof is of galvanized steel, heavily rusted. A tree has fallen against the middle of the north side. There is a building in this location in the historic aerial photos, but this building is certainly more recent than 1942.

Figure 18. South side of steel shed..

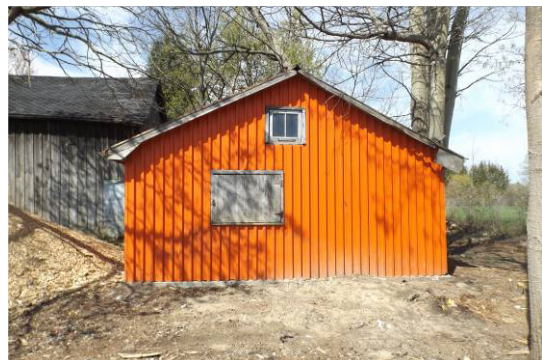
Figure 19. East side of steel shed. Barn is to the rear..

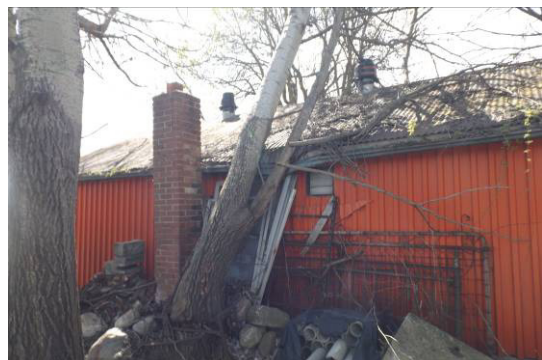
Figure 20. Tree fallen against north wall and roof of the steel shed.

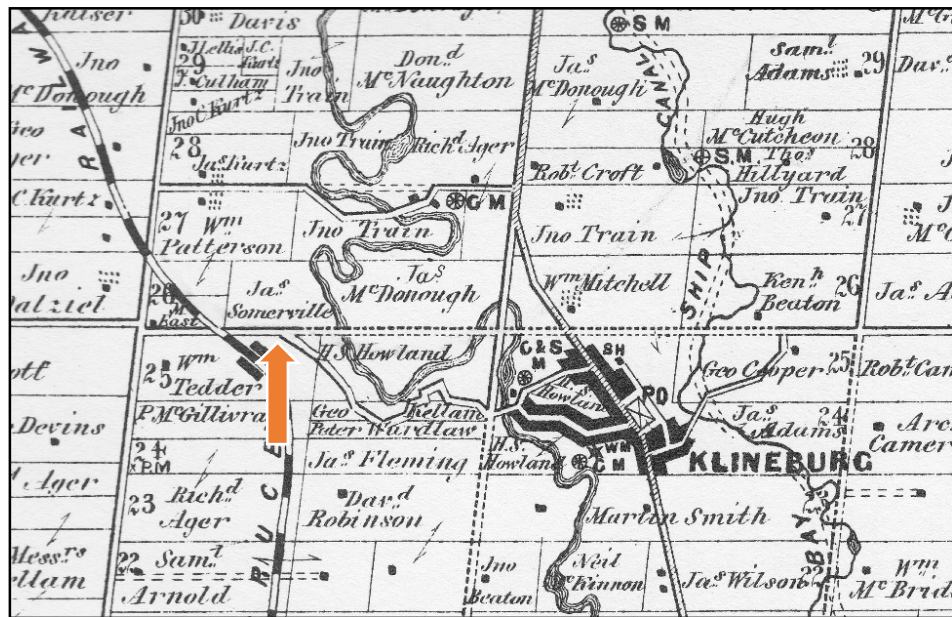
Figure 2: Extract of 1878 *Illustrated Historical Atlas* County of York

On March 31, 1877, the 60 acres of Lot 26 were sold to Robert and James Somerville for \$1,000. The 1878 *Illustrated Historical Atlas County York* (Figure 2) plots a "Jas Somerville" on the 60 acres of the east part of the west half of Lot 26. The atlas may not have been updated subsequent to the 1877 sale and may still refer to James, Sr., as the owner. No dwelling is plotted but this is not definitive proof that none existed.

The 1878 *Historical Atlas* (Figure 2) plots John Train on Lot 27, Concession 9, and on Lot 27, Concession 8. There are several dwellings and a grist mill plotted on those lots. This suggests that the 60 acres of Lot 26, as with the Somervilles, were adjunct to their main farm.

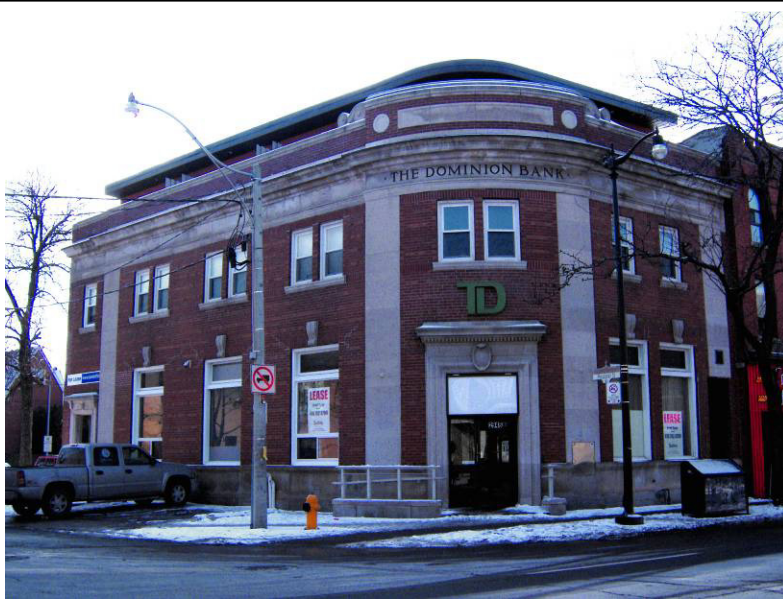
Setting back the third-floor addition allowed the restored bank building to retain its street presence, and maintain the detail significance of the cornice and entry-bay decoration. Preservation Services provided oversight for work under the façade improvement program.

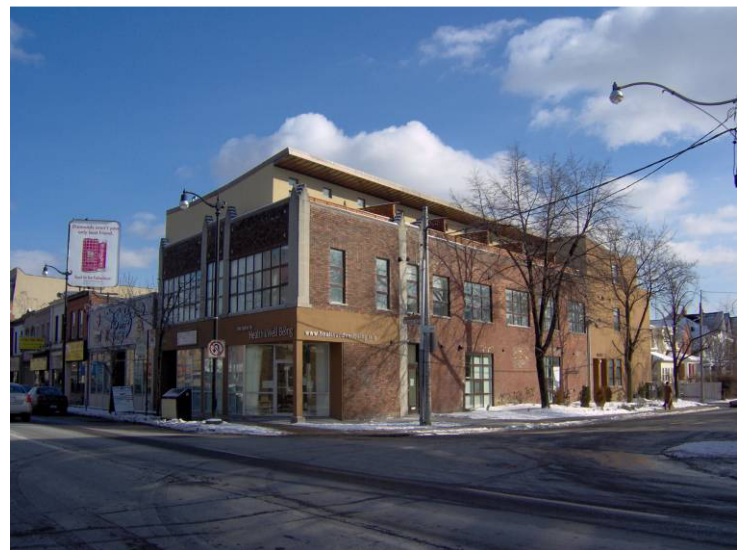
This building has a set-back addition similar to the one at the Dominion Bank across the street. In this case the penthouse has a Moderne design, reflecting the Art Deco style of the original building.

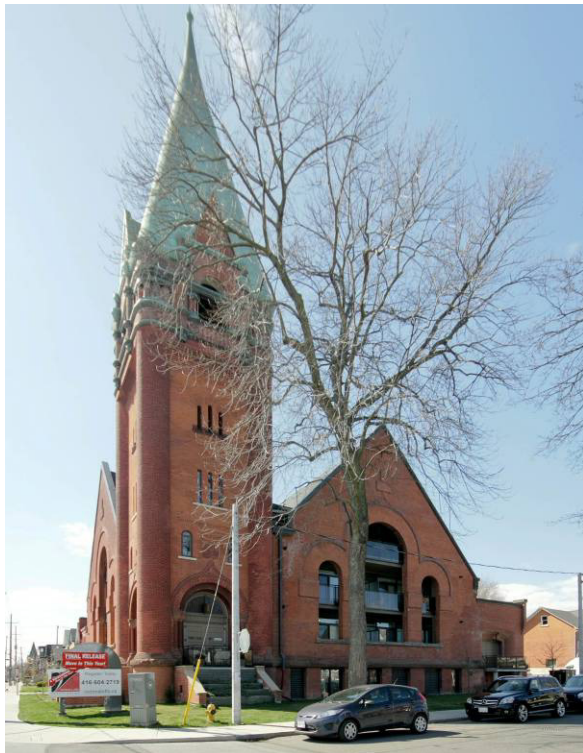
Balconies behind the original arches double the window area to meet the requirements of residential use, without cutting new openings in the historic masonry structure.
