**2.     PROPOSED FRONT PORCH STEPS AND DEMOLITION OF EXISTING REAR GARAGE AT 7827 KIPLING AVENUE – WARD 2**

To consider the background and analysis portion of this report in order to review the proposal for renovation of the existing rear cottage at the subject property.

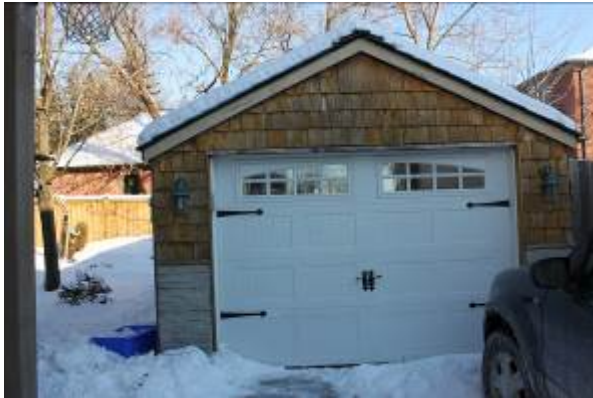
West (Front elevation)

- Gabled roof clad in cedar shingles
- Horizontal wood cladding, painted finish on the south elevation. This cladding may date from as late as 1950's based on the width of the boards that is exposed to the weather, and the lack of a vertical board finishing detail at the corner that would have been more typical in early 20<sup>th</sup> century.

- Recent, cedar shingle cladding on other three sides, artificial stone wash course on front elevation
- Modern, recently updated roll-up insulated garage door

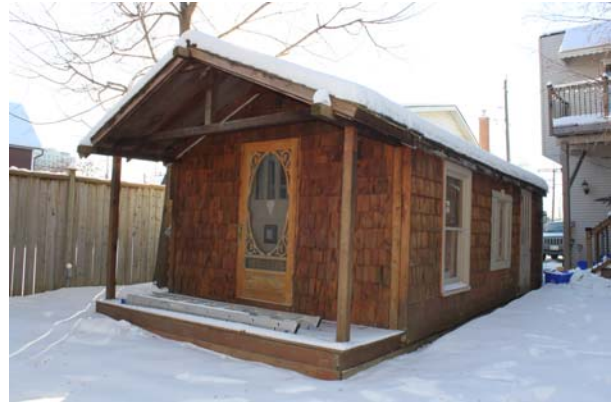
View from rear

- Structure in good condition
- Windows on the north side may have been reclaimed and incorporated from another site.
- In the rear elevation, the structure has been re-clad in cedar shingles and a reclaimed front door; wood paneled with three beveled glass top lights (c.1910-1940) has been installed. A porch has also been constructed. These are alterations dating from c. 10 to 5 years ago, done by the previous owner, who ran a photography studio.

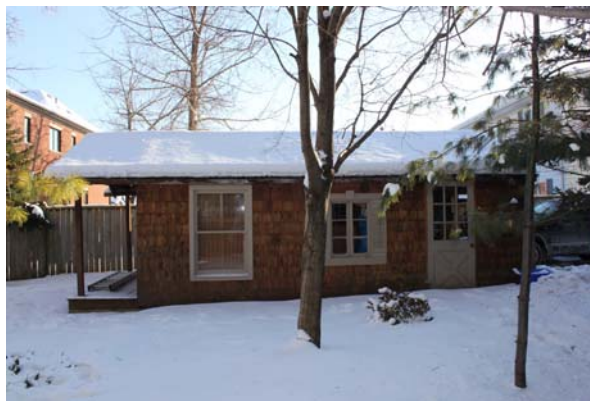
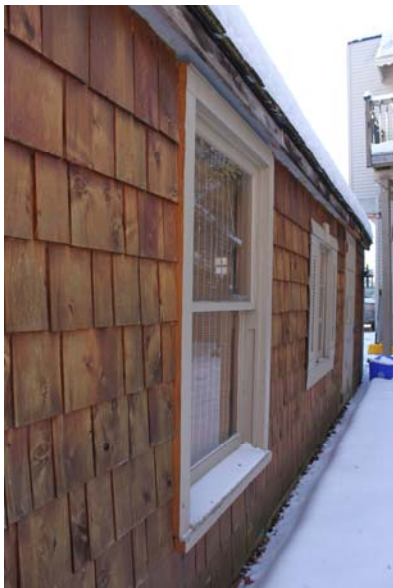
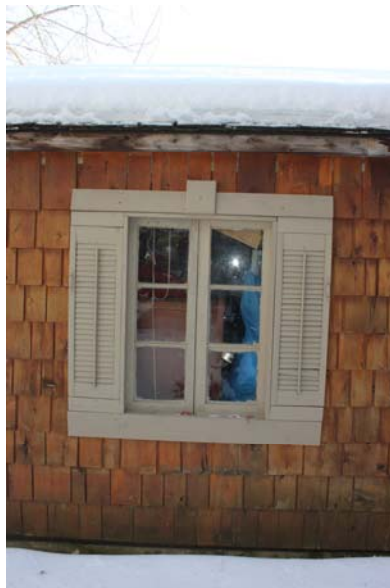
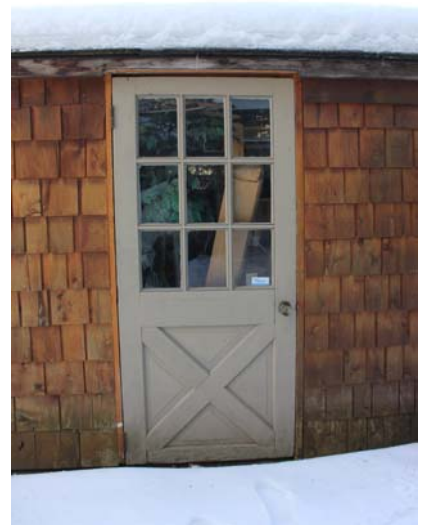
North Elevation (above) and details (below)

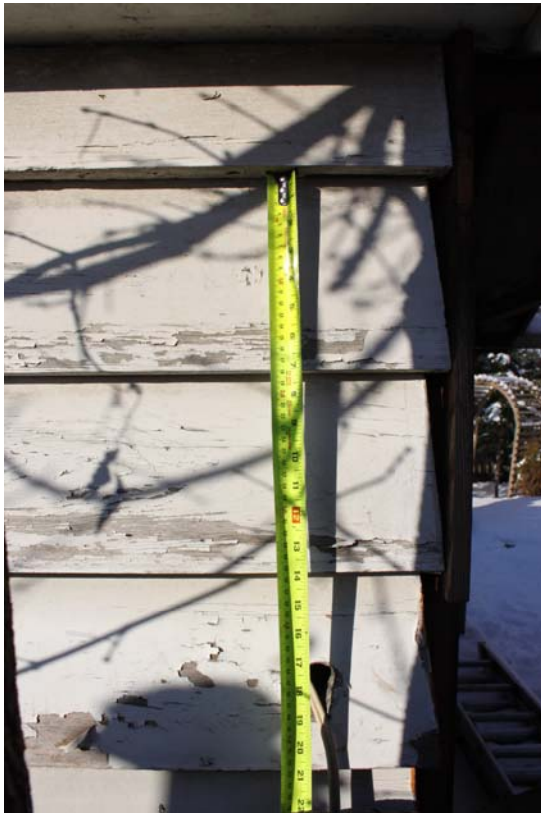
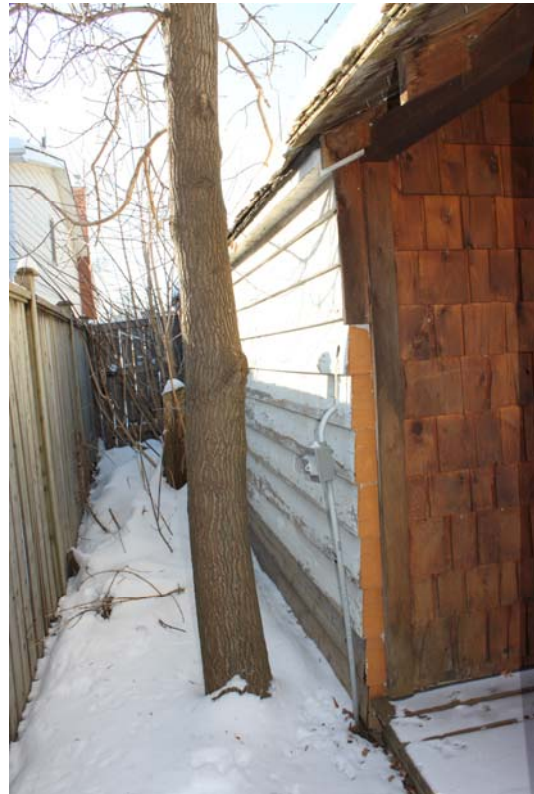
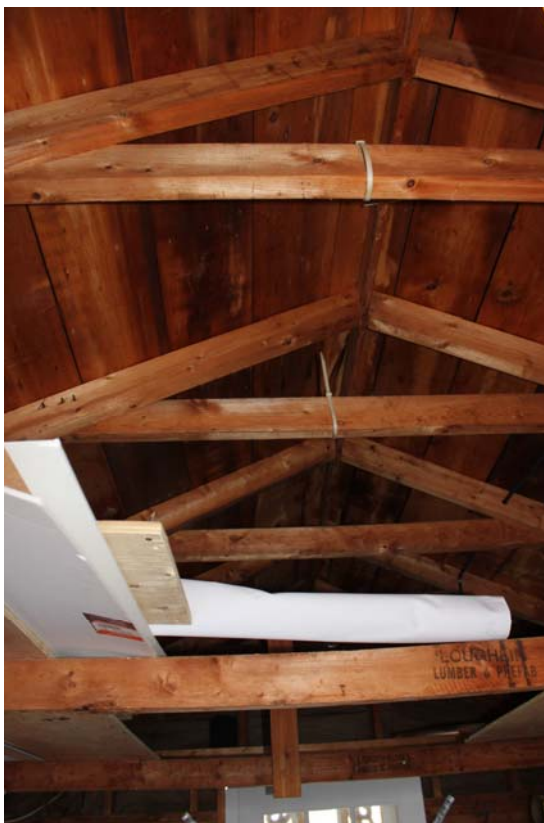
**Attachment 6**

Top left: South Elevation  
Top right: South elevation overall view.  
Bottom: interior of roof structure.

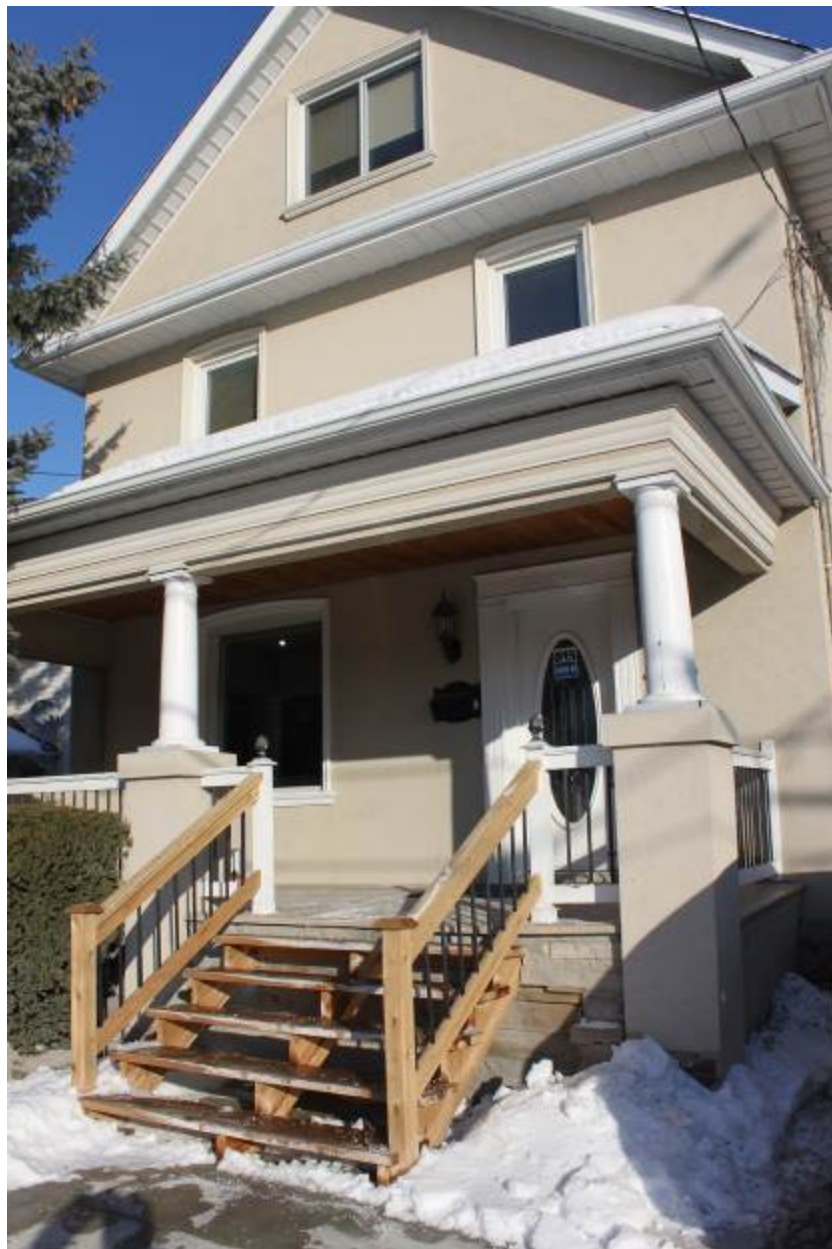
**Attachment 8**

Front view of house on Kipling Avenue, front steps.

- a)     That the new front steps to the house be painted and that the owner submit paint colours to Cultural Services staff for approval, and;
  - b)     That the applicant submit two copies of a finalized set of architectural building permit drawings for review and approval by Cultural Services staff, including site plan, plans elevations; and,

During the site visit it was noted that the owner has replaced the previously existing dry-laid front steps with wooden steps of a style more in accordance with the style of the main house and its existing front porch railing. The painting of the steps is pending.
