**24 CENTRE STREET – HERITAGE REVIEW FOR ADDITION TO EXISTING BUILDING**

The applicant is proposing to construct a one-storey rear extension addition to an existing house that will replace an existing rear extension. The proposal also includes an accessibility ramp for the front entrance and an extension to a pathway along the east side of the building.

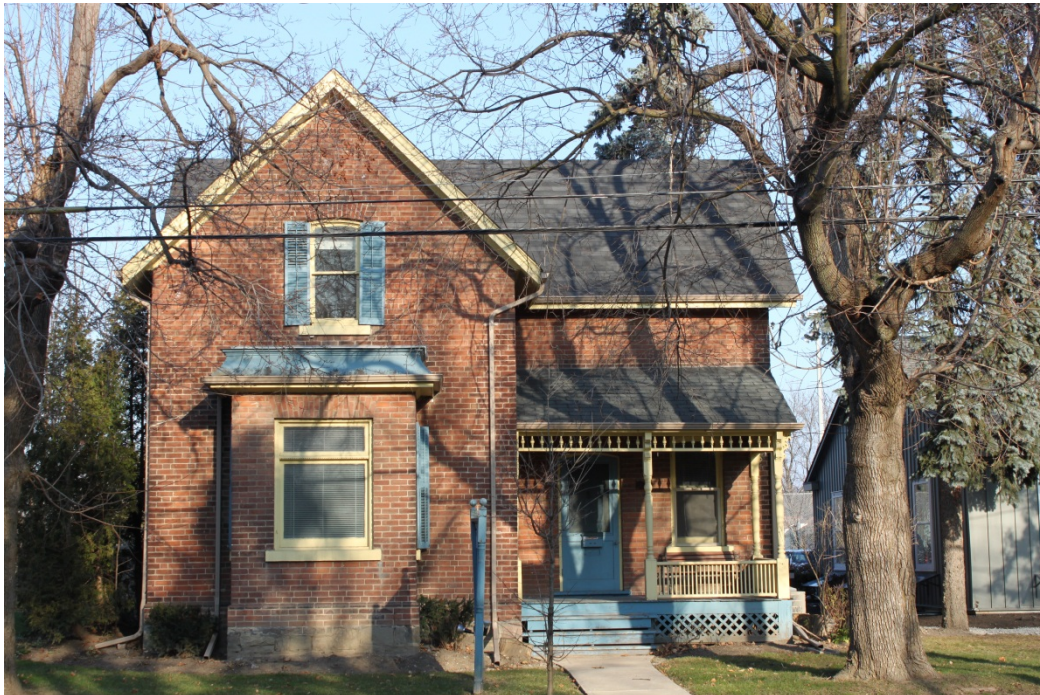
Front (south) Elevation, November 29, 2012

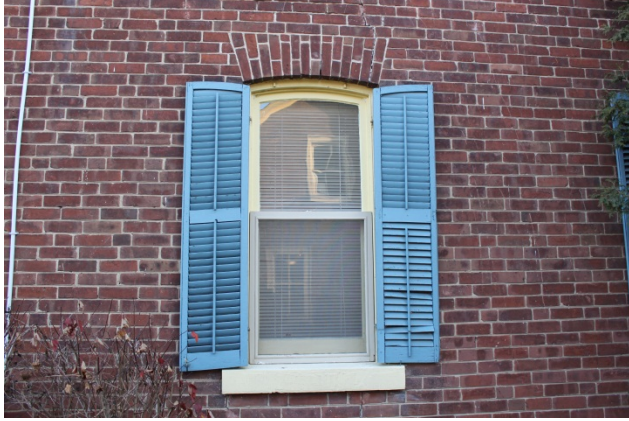
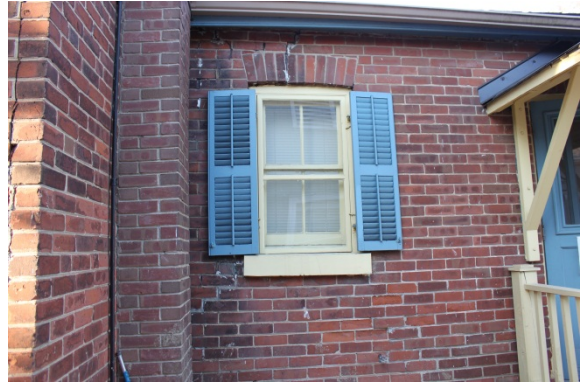
## Attachment 2

The existing structure is an L-shaped one and half storey brick house constructed in 1894 in the Victorian Vernacular style (p.59 of THCD Guidelines) with a one-storey rear extension built shortly after followed by an additional board and batten rear extension. The original L-shape portion was constructed in common bond, with a header-stretcher course repeating every sixth row. The brick portion of the rear extension was constructed in running stretcher bond, just a

Detail of front L-shaped portion (west) and back addition (east). November 29, 2013

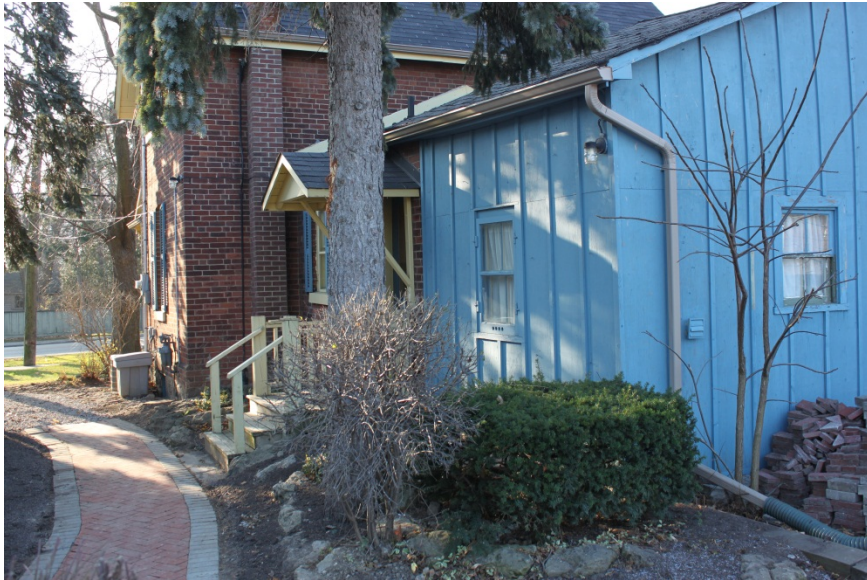
Comment: The proposal will require the removal of one tree.

East side of property. Note walkway and existing tree. November 29, 2013

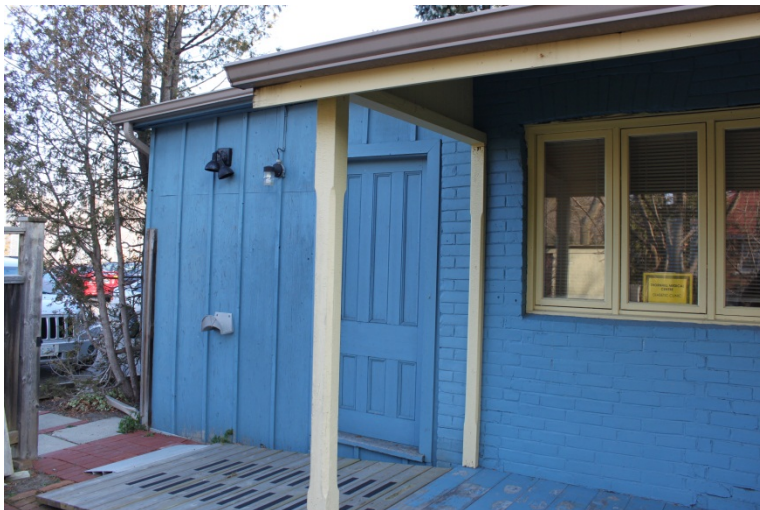
veneer, unlike the main portion of the house. The rear extension has undergone several poor repairs and alterations throughout the years. The existing extension contains unsympathetic replacement windows on the west elevation and brickwork that is cracking and in need of repair.

West side of property. Note unsympathetic windows and sunken bricks. November 29, 2013

Demolition of contributing heritage resources is generally not supported in the Heritage District Guidelines, however, Cultural Services staff has determined that the rear extension does not contain significant cultural heritage value as it is a later addition to the building and does not contain the same degree of craftsmanship as the main portion.
