HERITAGE VAUGHAN REPORT

**TITLE: DEMOLITION OF TWO DETACHED BUILDINGS AND NEW
DEVELOPMENT
9560 AND 9570 KEELE STREET
MAPLE HERITAGE CONSERVATION DISTRICT**

9560 and 9570 Keele St., Vaughan, ON
Cultural Heritage Resource Impact Assessment

SEPTEMBER 2015 with revisions up to December 2015

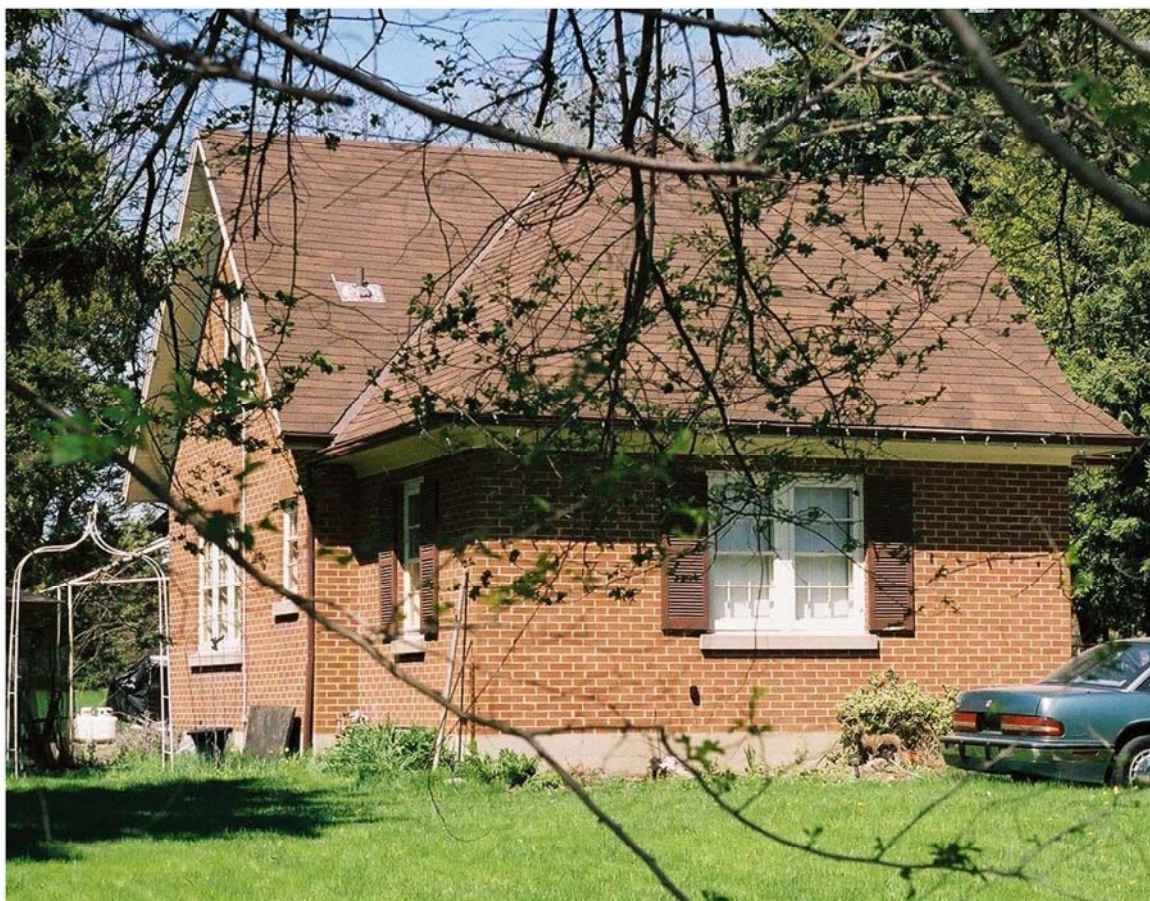
9560 Keele Street

- Tall, 1½ storey, red-brick house with large gabled block between hipped-roof wings (1950s).
- **Description** – South-facing house appears to be late interpretation of Arts-and-Crafts style, with variety of multiple-pane, double-hung wooden windows and storm windows, and with wooden trim throughout. East elevation faces Keele Street, and consists of one-storey, hipped-roof pavilion with central, paired 6/6 windows (behind 2-pane storms). Apertures have pre-cast sills, decorative wooden shutters, and header bricks over steel lintels (except at paired windows, which may be later). Entrance is to north, consisting of solid, panelled door (behind metal storm). Principal elevation is south façade, which is symmetrical composition of large, gabled central block and slightly recessed, hip-roofed wings to either side, in ABA rhythm. Central, gabled block has asymmetrical fenestration at ground floor, with triple, 6/6 windows to left of centre, and smaller, 3/1 unit to right; all with pre-cast sills and decorative shutters and, in this location, with header-course of red bricks over metal lintel. Windows in south elevation, side pavilions are single, 6/6 units, with other elements as described. All windows have multiple-pane wooden storms. Soffits are trimmed with v-jointed boards, and gable has narrow wooden fascia with simple batten as shingle-moulding. Roof is clad in asphalt shingles and there are no chimneys. A single-bay, flat-roof, red-brick garage is built against north wall of house.

- **History** – unknown; post-George Garrow.
- **Comments** – An unusual house, in good original condition and attractive in a variety of ways. House might be considered last-gasp Arts-and-Crafts, or even precursor to Post-Modernism; but using traditional materials throughout, with exception of concrete block at prominent foundation level. House is well screened from roads by combination of coniferous and

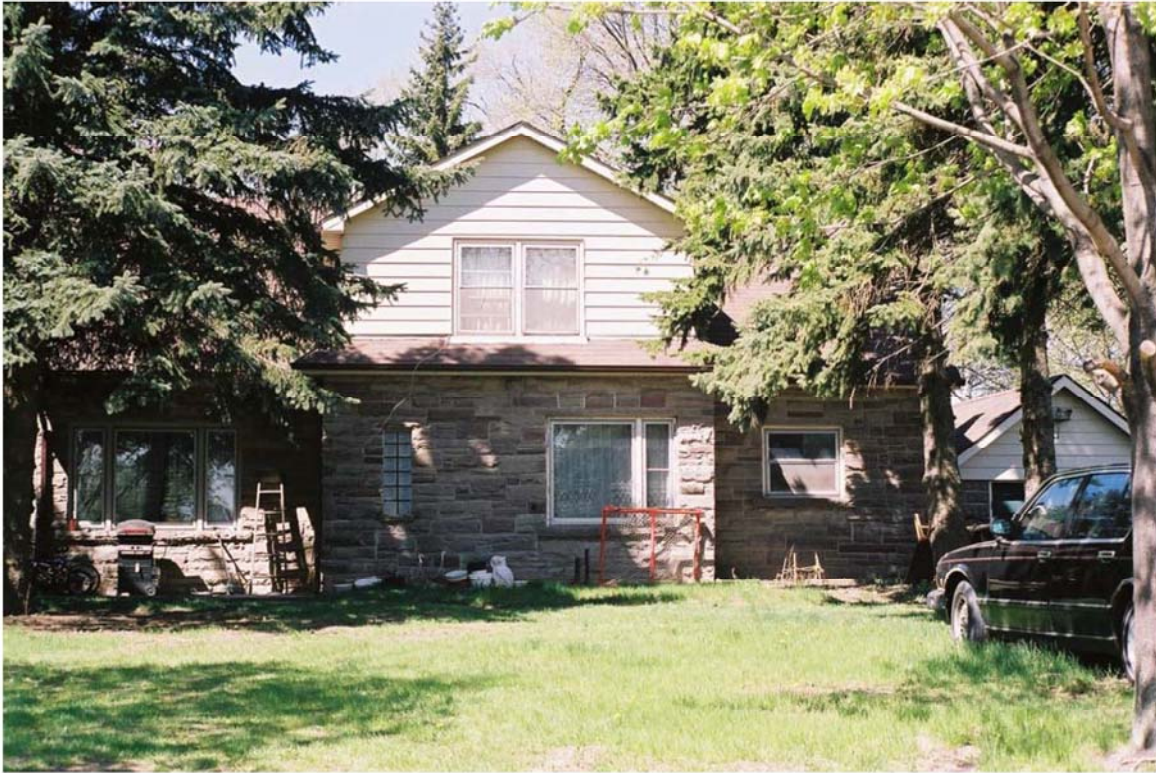
9570 Keele Street

- 1½ storey, stone-clad house with central large, gabled, second-floor dormer (1950s).
- **Description** – Modest, pitched-roof house has split-faced, random-course-rubble sandstone cladding throughout ground floor. Building is roughly symmetrical, with entry invisible from street, set in gabled north elevation. Ground floor has projecting central block, with large, asymmetrical window at north and small, tall window at south. North window consists of large, wooden, single-pane fixed sash, with 1/1 unit to right, while south window is unusual be 12-pane unit with metal muntins. At north wing, window is wide 1/1 unit (with metal storm), and at south wing, fenestration consists of 1/1 units flanking large, single-pane fixed sash (all behind single-pane wooden storms. Windows throughout robust stone sills and modest stone lintels, suggesting steel lintels behind. Large, gabled, second-floor dormer exists at central block, set above small asphalt-shingled roof. Dormer and is clad in horizontal aluminium siding, presumably over similar wooden siding. Soffits and eaves are clad throughout in aluminium, again assumed to hide original wooden trim beneath. Roof is clad in asphalt shingles. A pitched-roof, stone-clad, single-bay garage, with aluminium gladding at front gable, exists to north of house.

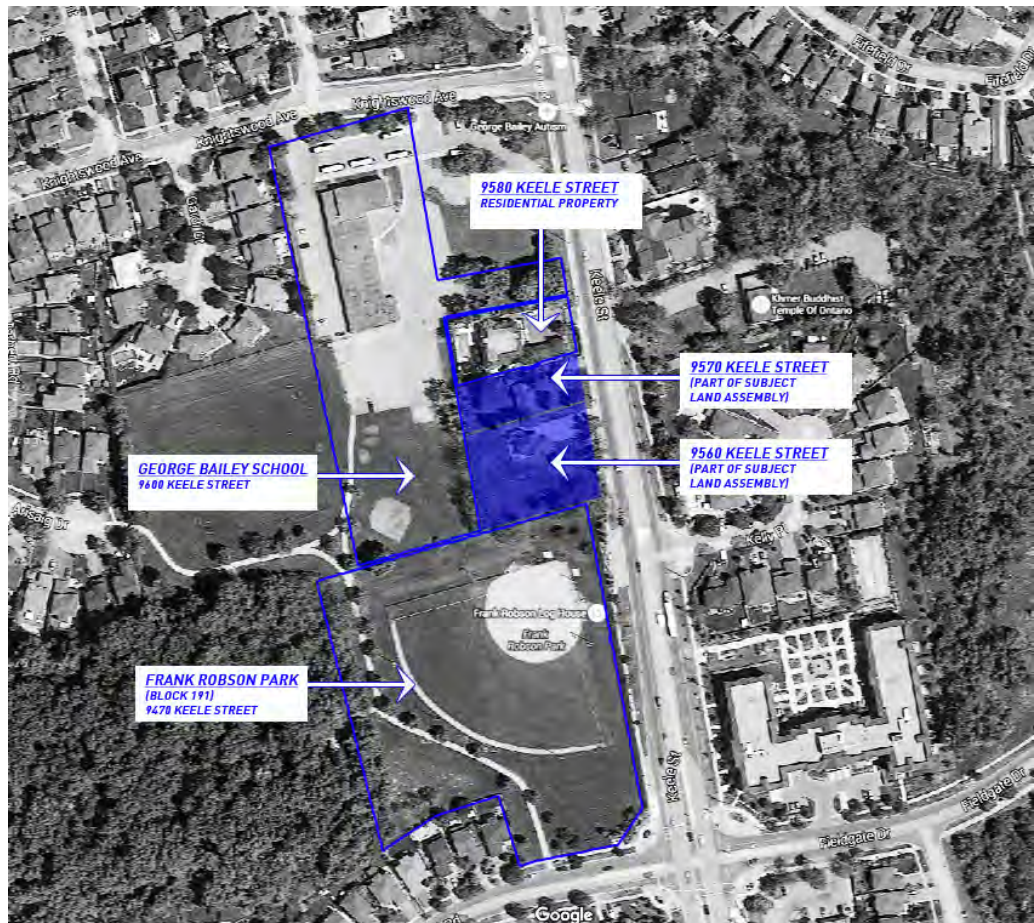
Figure 1 – Aerial Photo of 9560 and 9570 Keele St. and their context (Google Maps) annotated by AREA to show the boundaries of the subject land assembly.

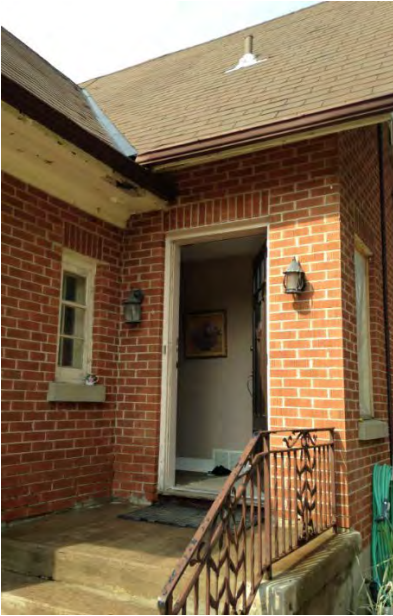
'Photo E-3', Spalling Bricks at Entry Porch

A concrete porch was installed on the south side of the structure in 1971. This porch would have been semi-enclosed, as indicated by traces of two former posts. Another concrete porch that is smaller in size, currently serves as the main entry, on the east side of the structure. This smaller concrete porch would have been constructed the same time as the rest of the building, as it accounts for the height difference of the main floor and the exterior grading. It is only on this side of the structure, where the wall assembly displays spalling and mortar failure.

The type of disrepair found between the eastern concrete porch and the brick wall is a result of the stresses caused by the two adjoining components. Their differences in material and assembly subject them to varying reaction to changes in temperature, moisture, structural loading, or foundation support, and when joined, without sufficient elasticity, can cause cracks and failure. The installation of this concrete slab contiguous to and connected to the brick masonry wall may have been poorly constructed. Typically, both materials should have been joined by box ties (rectangular ties) or ladder-type ties.

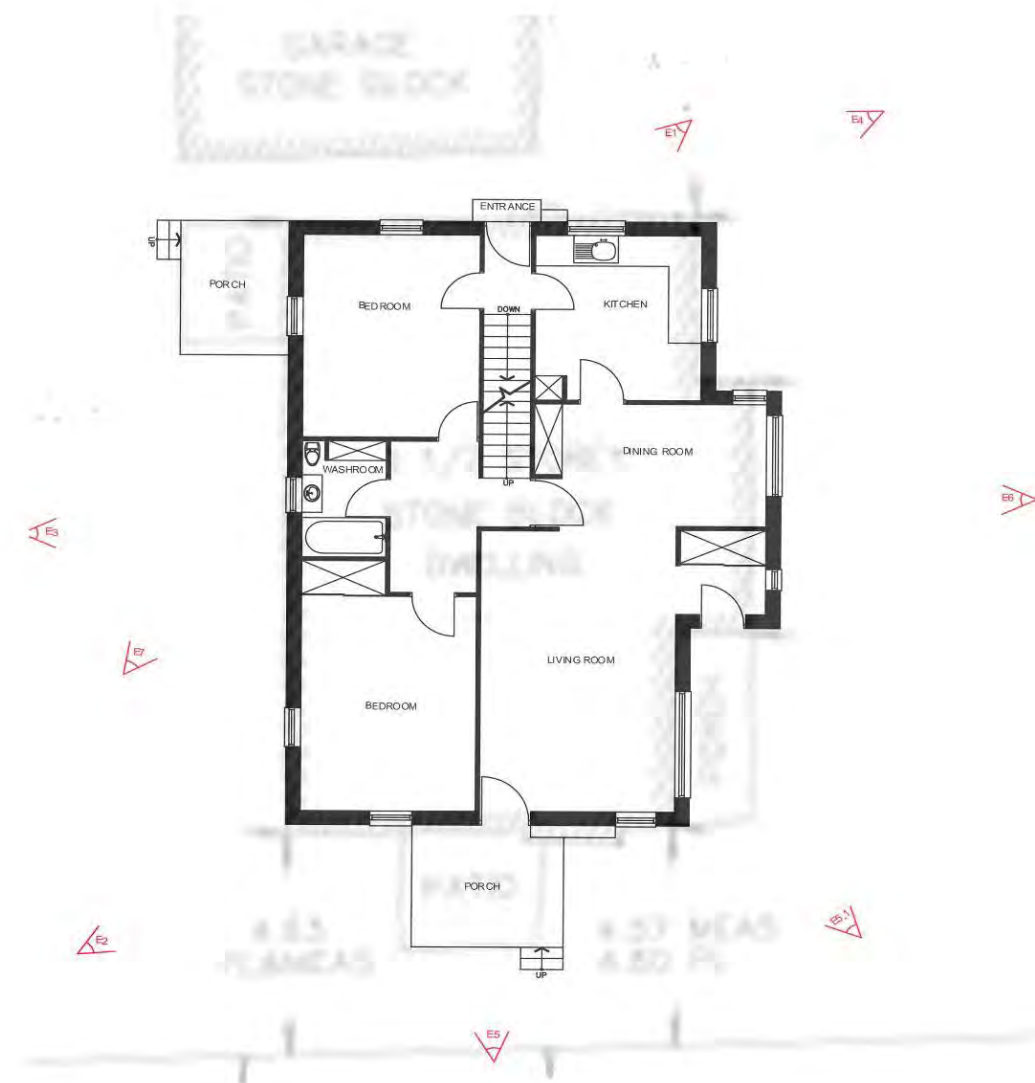
Figure 30 — First (Main) Floor Key Plan, not to scale, sketch by AREA, annotated to refer to Photos E-1 to E-7

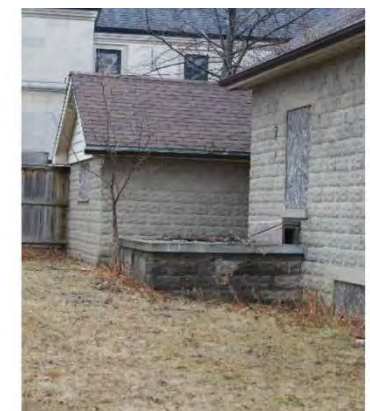
'Photo E-8', West Elevation Concrete Deck

The type of disrepair found between the west concrete deck and the stone-rubble base walls as well as at the bottom part of the south-west corner walls and basement's concrete block walls is a result of the stresses caused by the two adjoining components. Their differences in material and assembly subject them to varying reaction to changes in temperature, moisture, structural loading, or foundation support, and when joined, without sufficient elasticity, can cause cracks and failure. The installation of this concrete slab contiguous to and connected to the stone masonry wall may have been poorly constructed. Typically, both materials should have been joined by box ties (rectangular ties) or ladder-type ties.

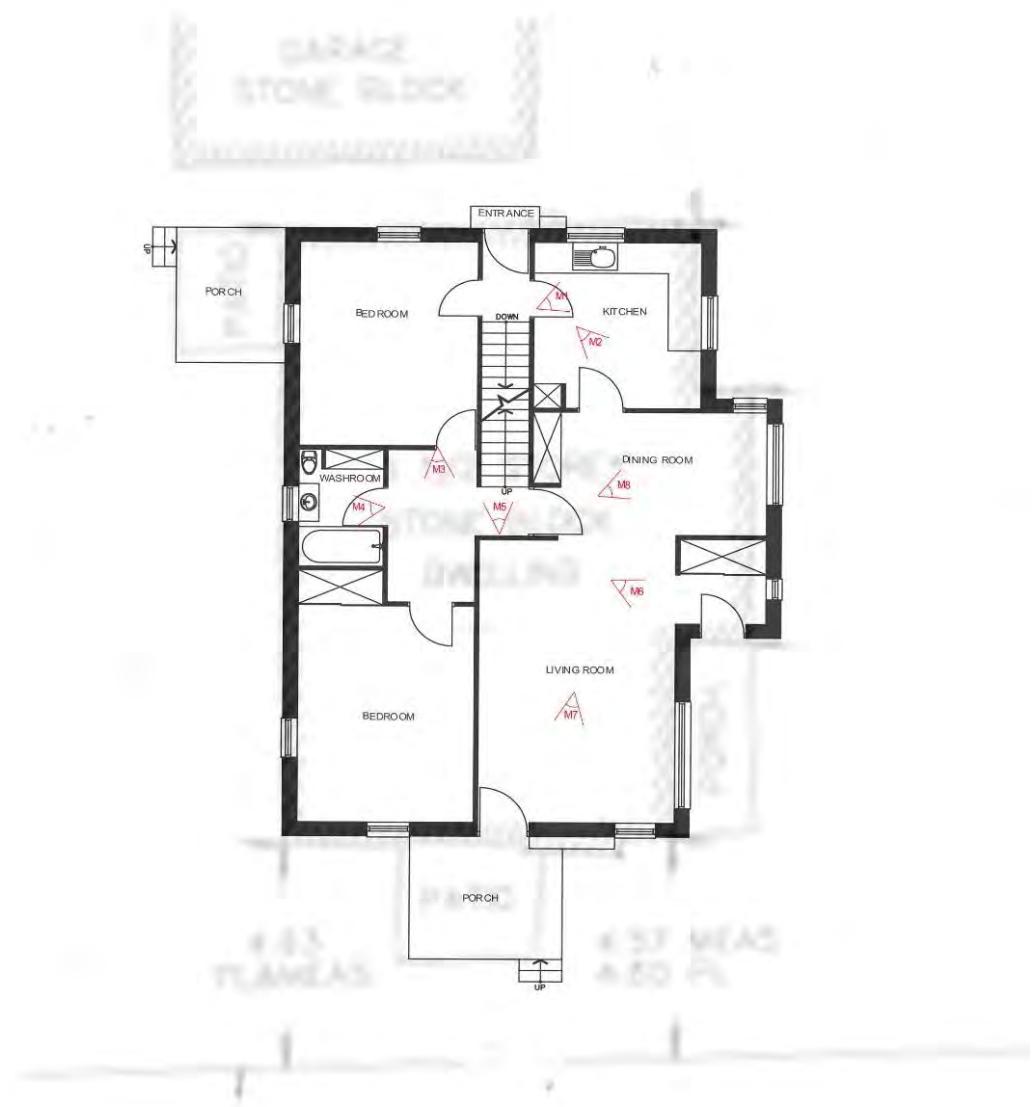
Figure 31 – First (Main) Floor Key Plan, not to scale, sketch by AREA, annotated to refer to Photos M-1 to M-8

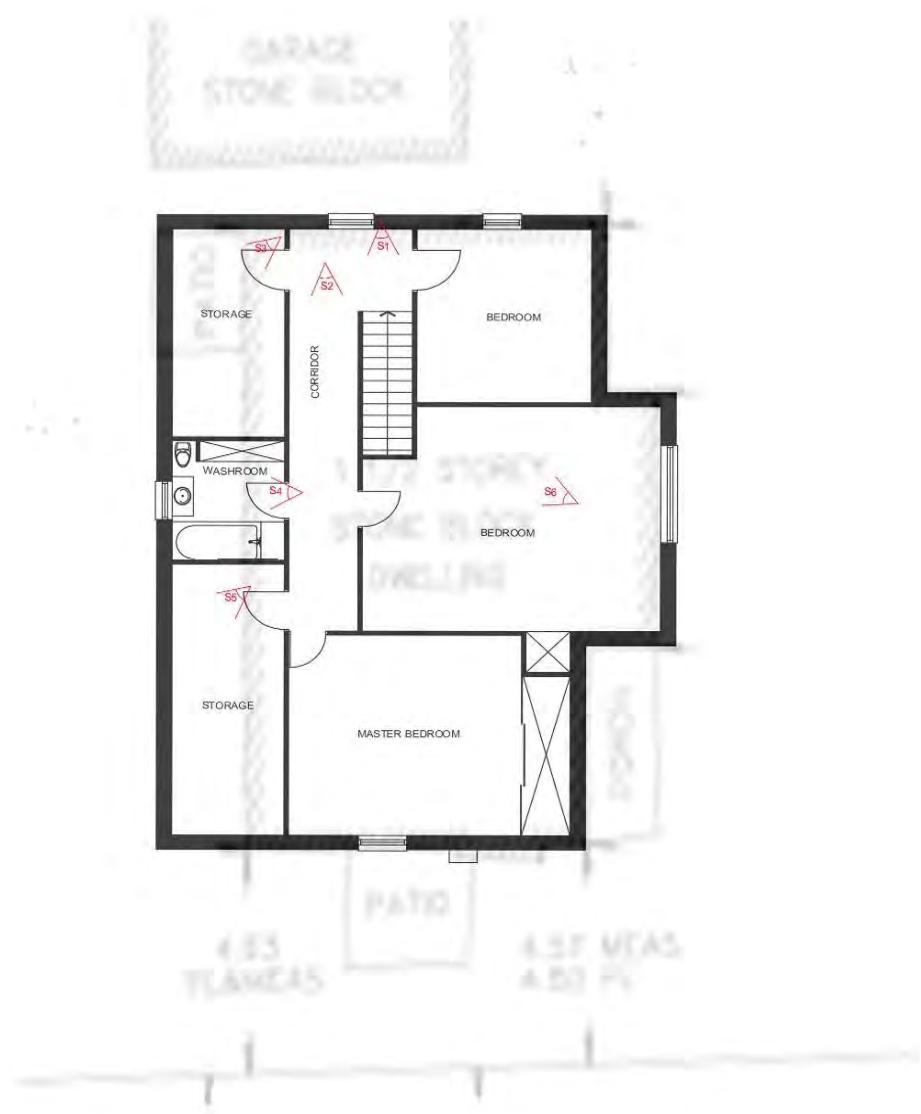
Figure 32 — Second Floor Key Plan, not to scale, sketch by AREA, annotated to refer to Photos S-1 to S-6

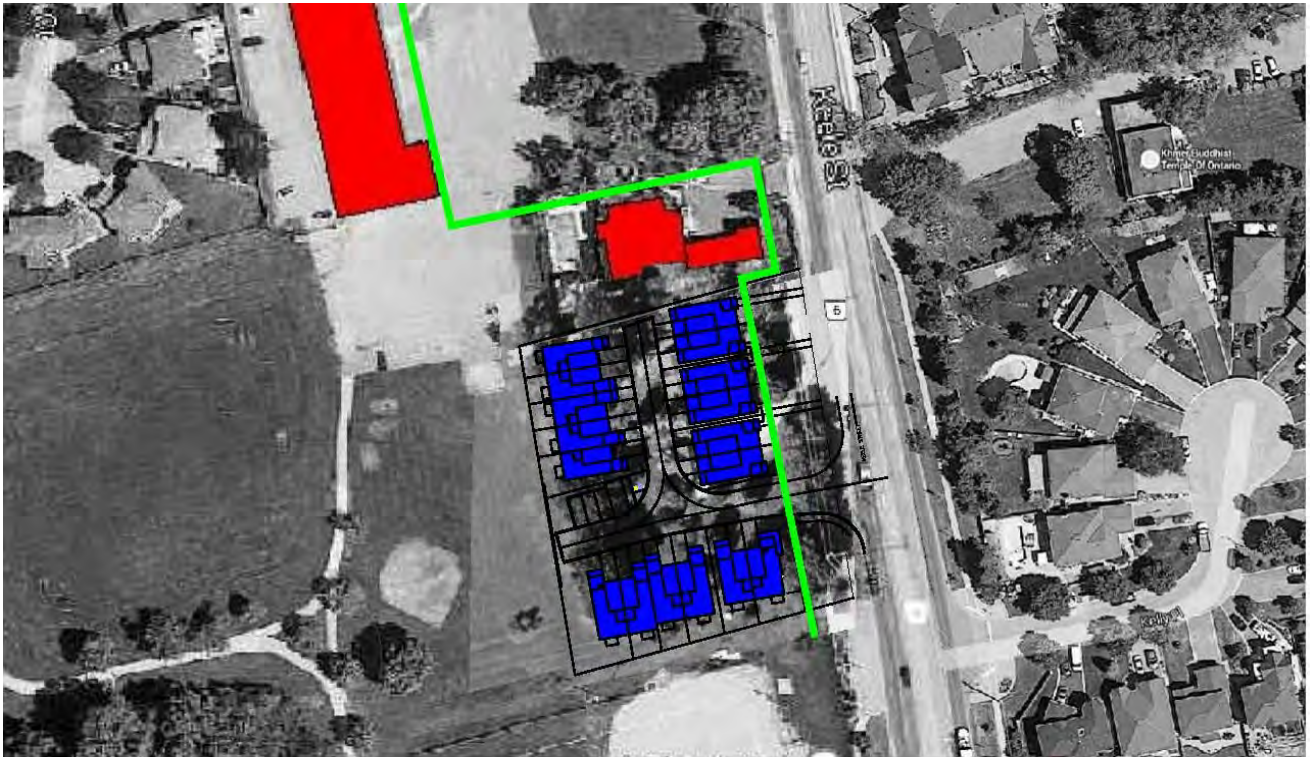
Figure 36 - Setbacks of Neighbouring Buildings (North of Land Assembly) and Proposed Setback of Subject Development, from Google Maps 2015, annotated by AREA to show proposed development (blue) & neighbouring buildings (red).

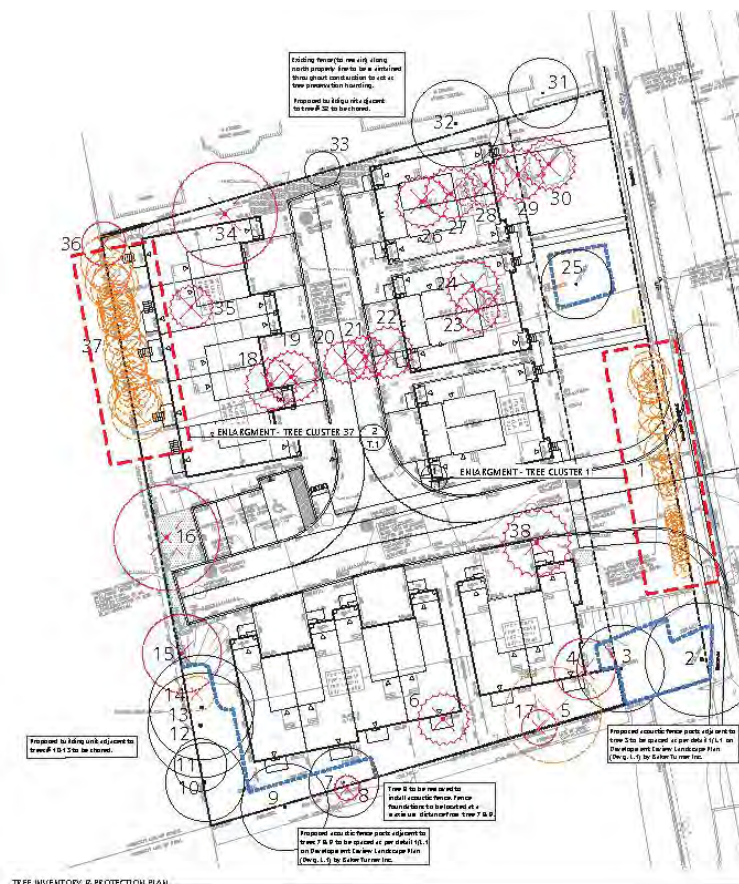
Figure 42 – Tree Preservation Plan, BTi Landscape Architecture, July, 2018

| Landscaping | Heritage Staff caution against the potential impact to reduce the "existing cultural heritage landscape of mature trees and green space, and erode the streetscape connection of the park to the District..." | Developments should be designed, in their site layout, to preserve trees, especially in its setbacks: "Site new houses to preserve existing mature trees..." (9.5.2.1) | The development's site layout has been adjusted by deleting two units on the south side of the property. The reduction of units – from 8 to 6 – in the southern portion has created larger setbacks at the front and rear yards at the street (east) and the park (west) respectively. In so doing, these more generous yards have five more mature trees (nos. 3, 10, 11, 12, 13) since the previous design. Altogether, of the mature trees there will be four (nos. 2, 3, 25, 30) in the front (east) yard (Keele St.) and six (nos. 7, 9, 10, 11, 12, 13) in the side/rear (south/west) yards (on Frank Robson Park). See Figure 42. |

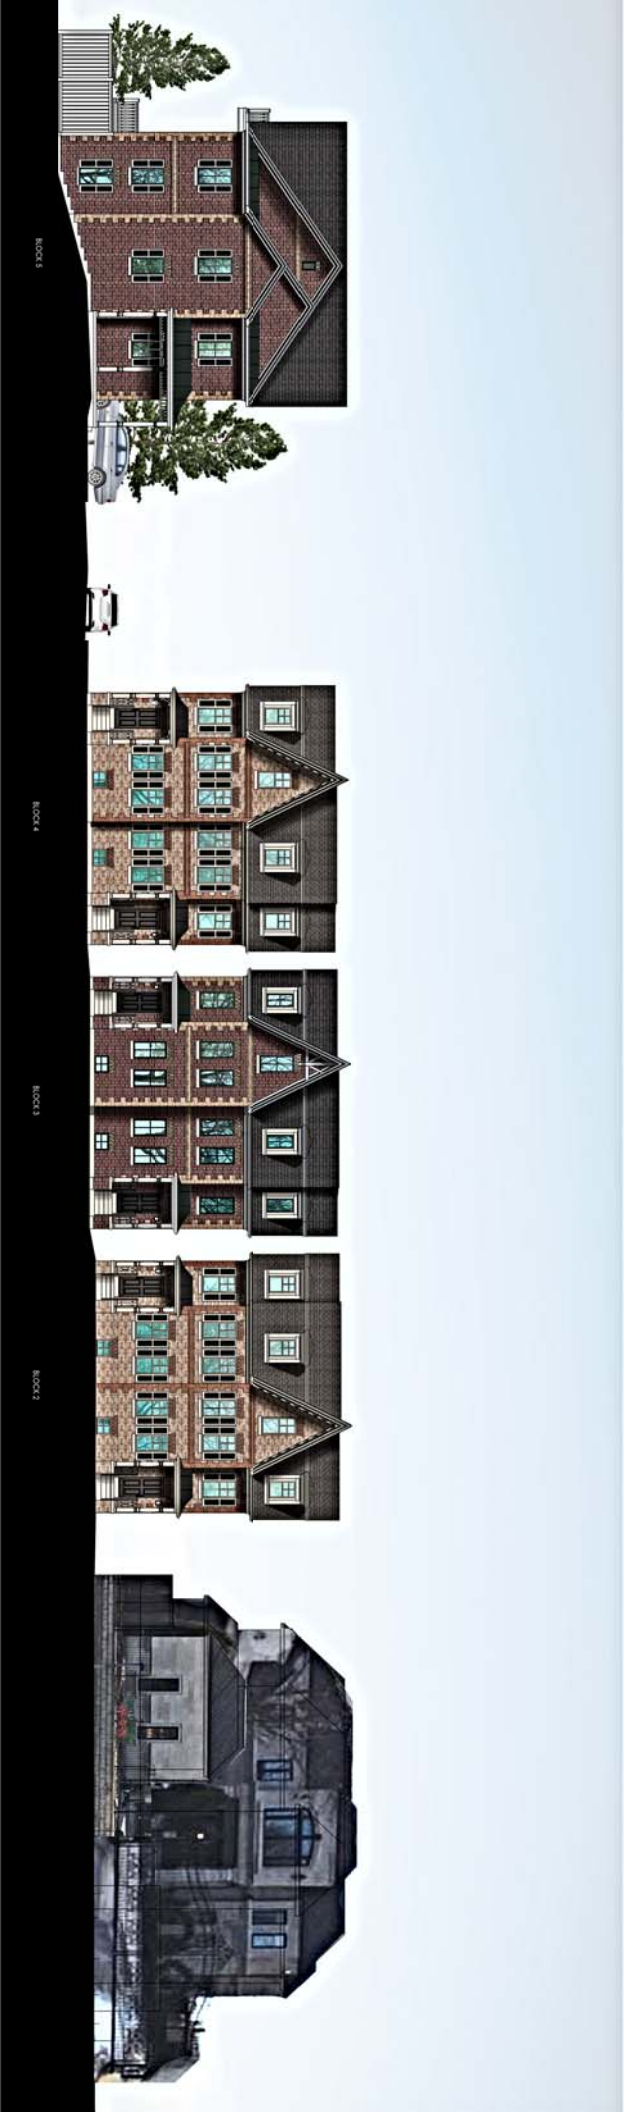
FRONT ELEVATION @ KEELE STREET

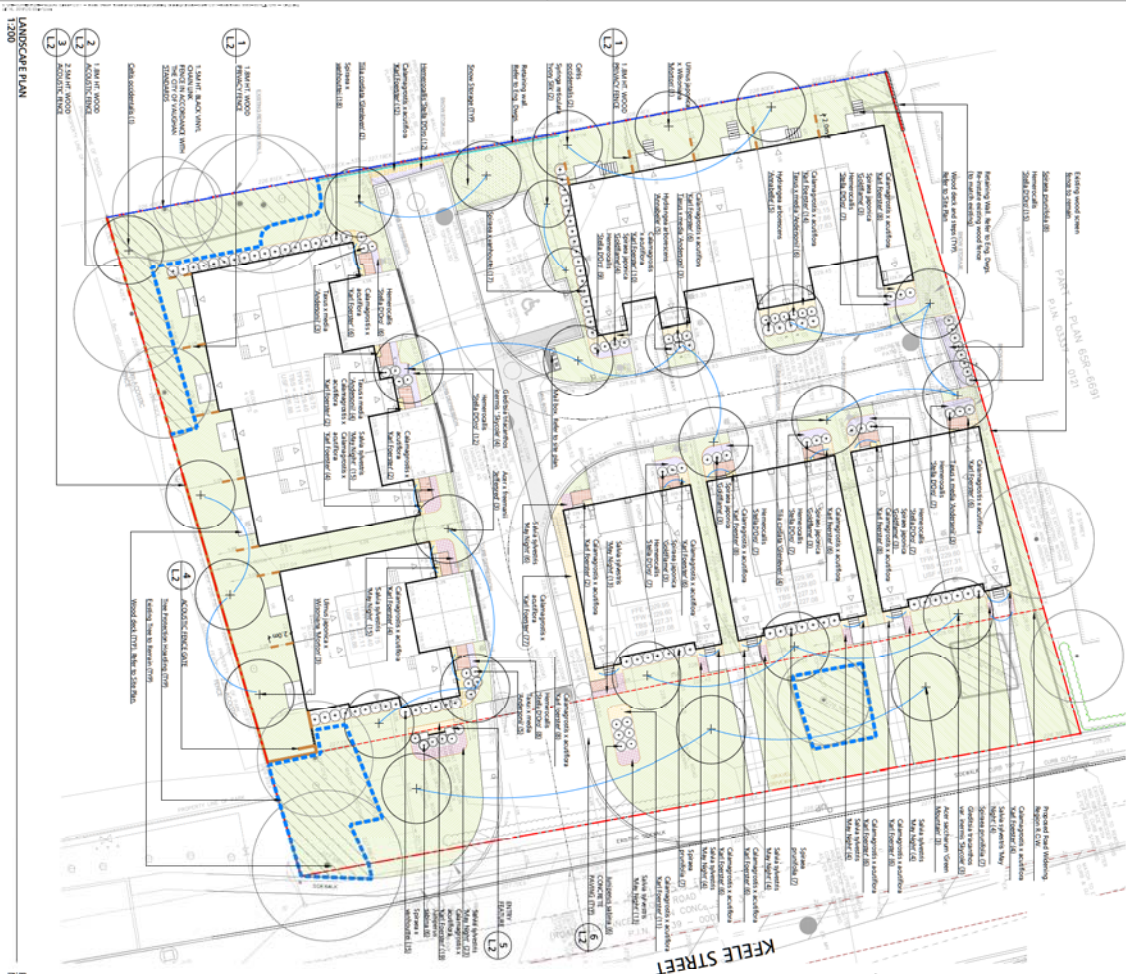
FENCE POST SPACING AT EXISTING TREE LOCATIONS
