HERITAGE VAUGHAN REPORT

DATE: Wednesday, October 17, 2018

**TITLE: NEW CONSTRUCTION – SINGLE DETACHED DWELLING
75 VALLEY ROAD, KLEINBURG-NASHVILLE HERITAGE
CONSERVATION DISTRICT**

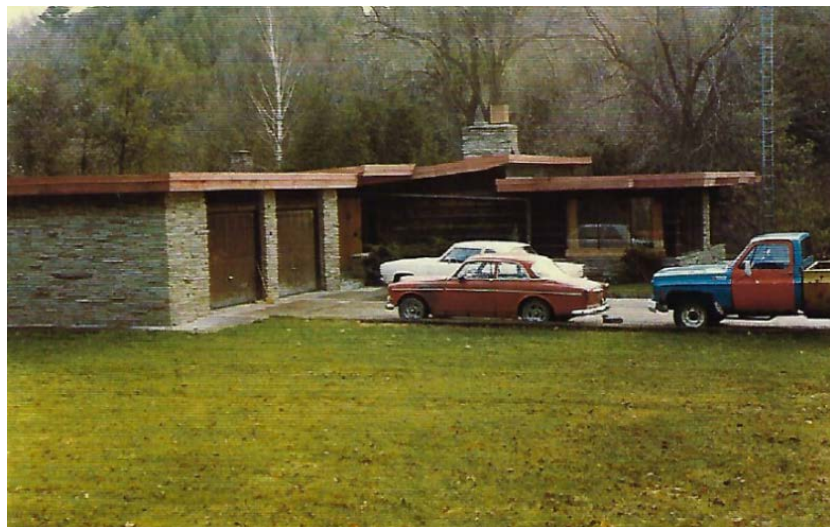
75 Valley Road as constructed (photograph c. early 1980's)

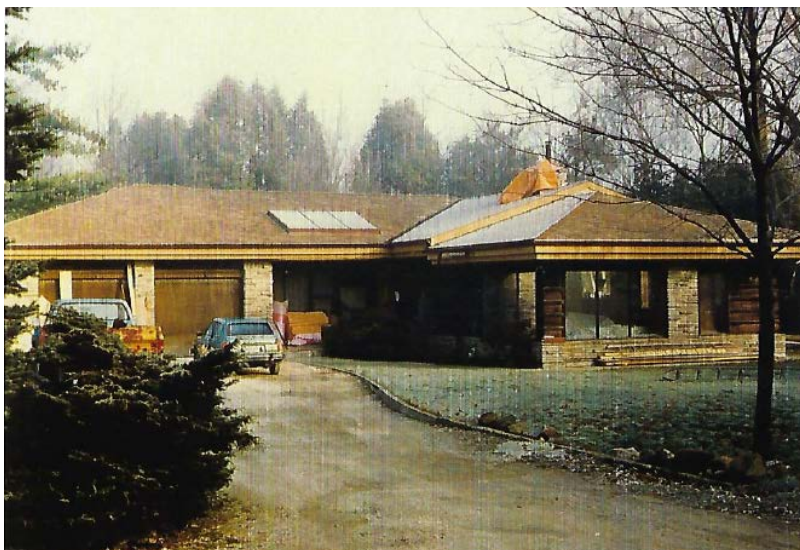
75 Valley Rd. undergoing renovation late 1984. New roof and skylights are installed. Garage conversion to living space has not been started.

In late 1984, prior to the creation of the Kleinburg-Nashville Heritage Conservation District, the house was significantly modified with the addition of peaked roof and skylights. This transformed the house into something resembling a typical suburban bungalow. Later the two garages seen in the photographs were converted to living space and small windows installed in place of the garage doors.

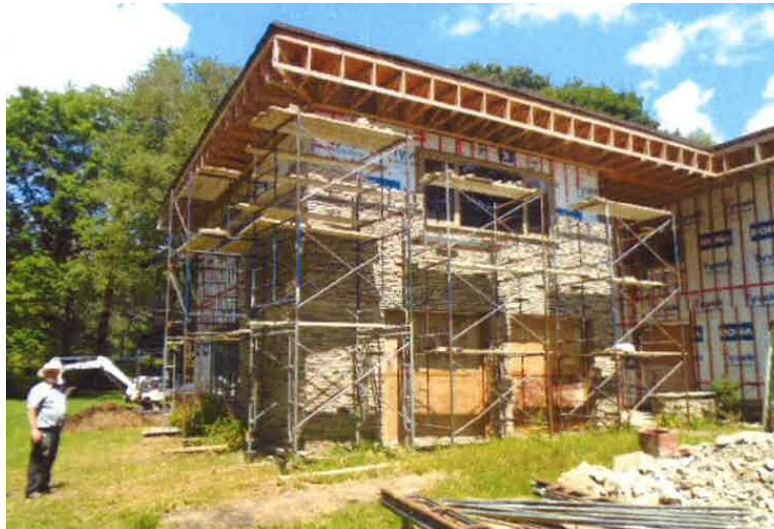
75 Valley Road undergoing construction summer 2016

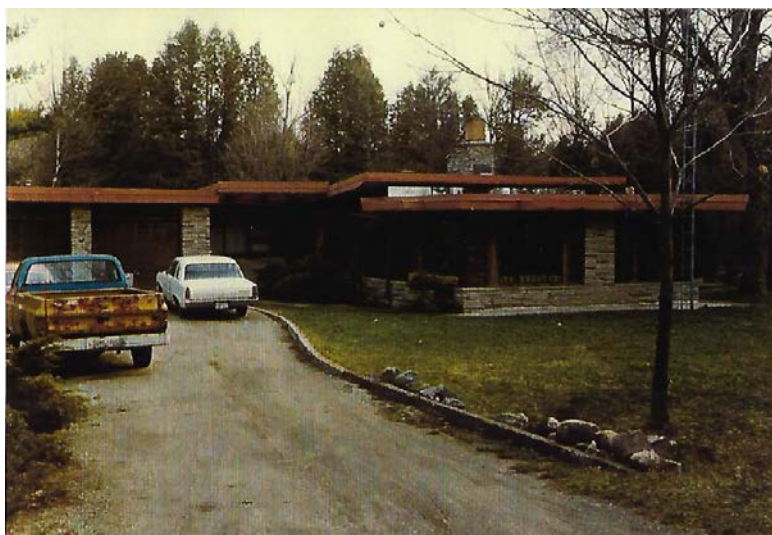
Front Elevation as-built (photograph c. early 1980’s)

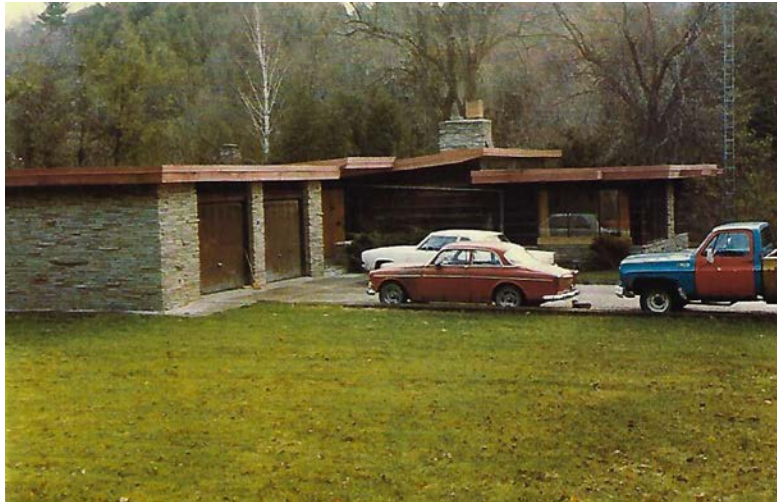
Oblique Elevation as-built (photograph c. early 1980's)

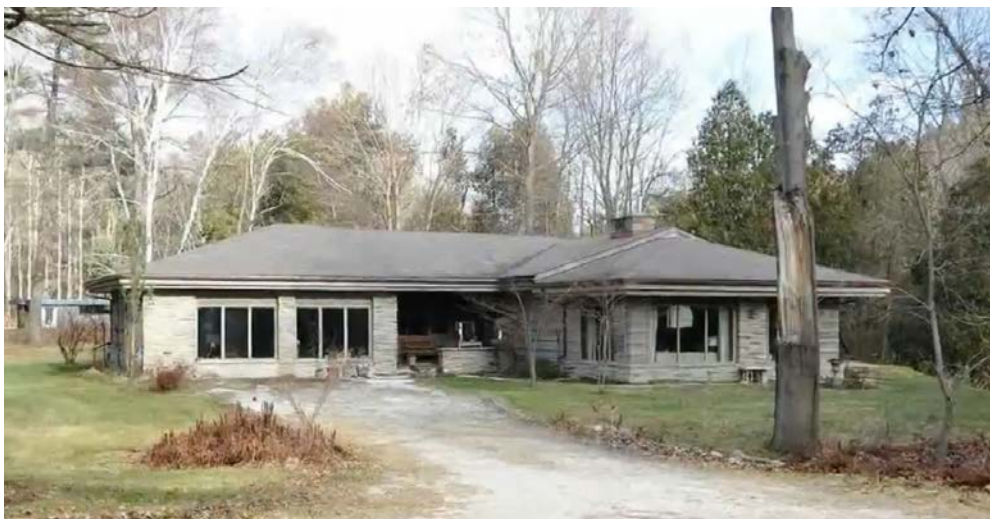
Front Elevation showing pitched roof and garage conversion to living space (photograph c. 2015)

On or about June 21, 1984 the then property owner (not the current owner) renovated the house by overbuilding the flat roof structure, adding an approximately 4/12 pitch low-slope peaked roof and skylights and also reorganized the interior spaces and finishes of the home. This may have been done because of concern regarding persistent leakage through the flat roof, according to the memory of long-time neighbour and resident.¹³ The attached integral-to-the-house garage was eliminated and the space converted to living space. The low-sloped hip roof was a typical of residential subdivision construction in the 1960's and '70's and the effect of this renovation was to significantly alter the visual appearance of the building and to transform it into something much more similar to an ordinary suburban bungalow than was the original design intent.

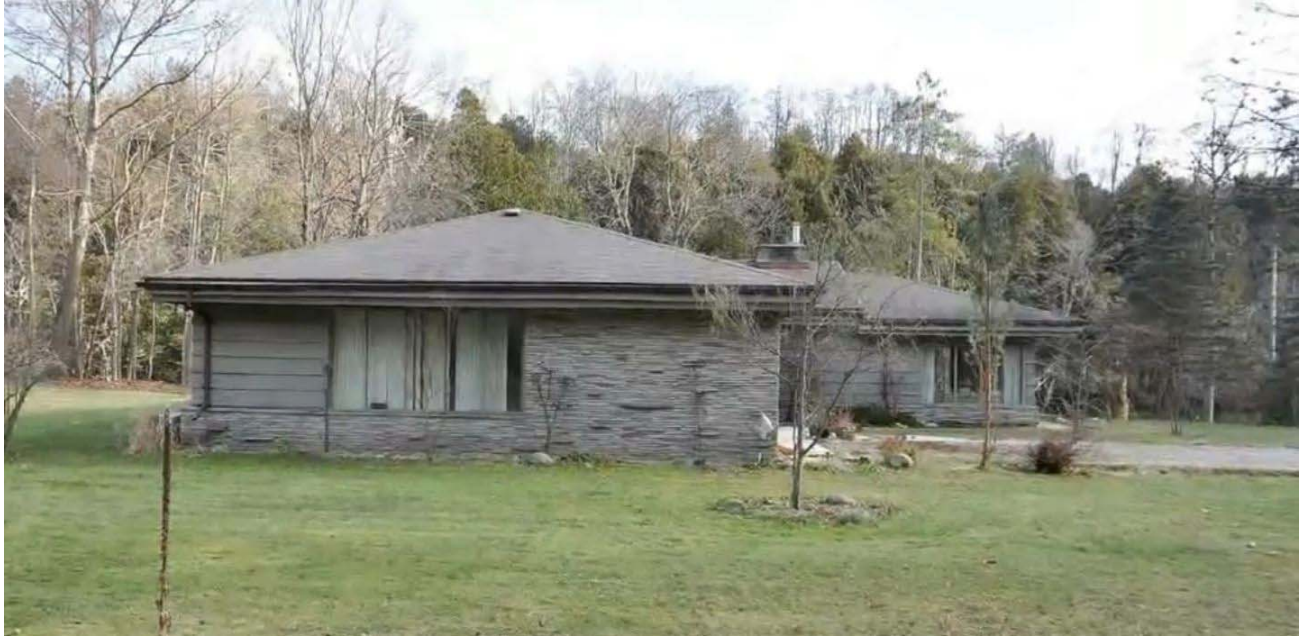
Side Elevation showing pitched roof and garage conversion to living space (photograph c. 2015)

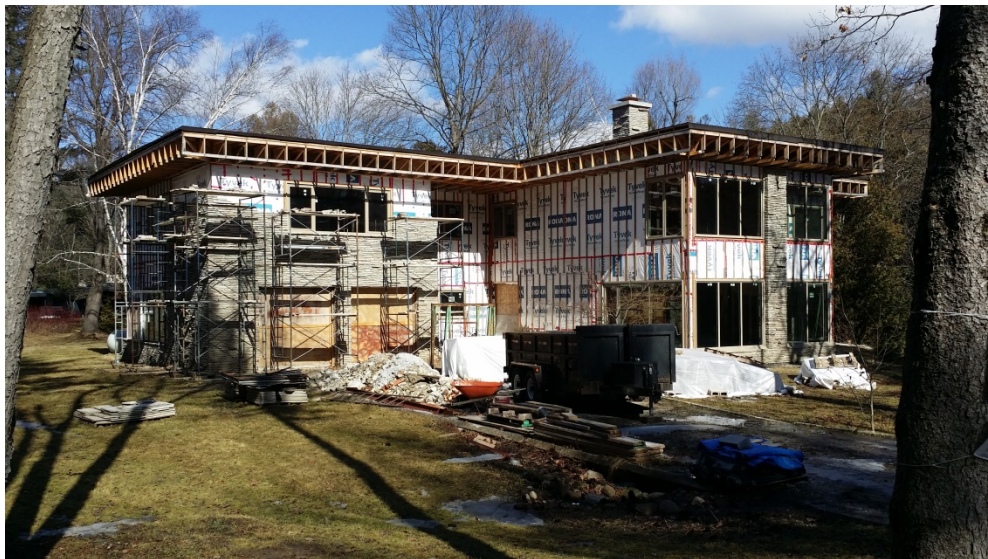
Front Elevation showing renovations underway (photograph February 2018)

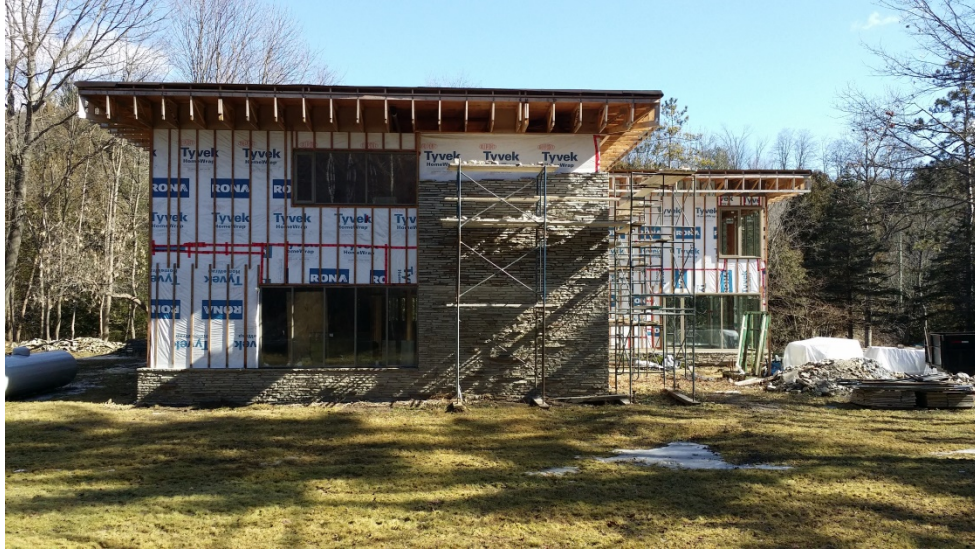
Side Elevation showing renovations underway (photograph February 2018)

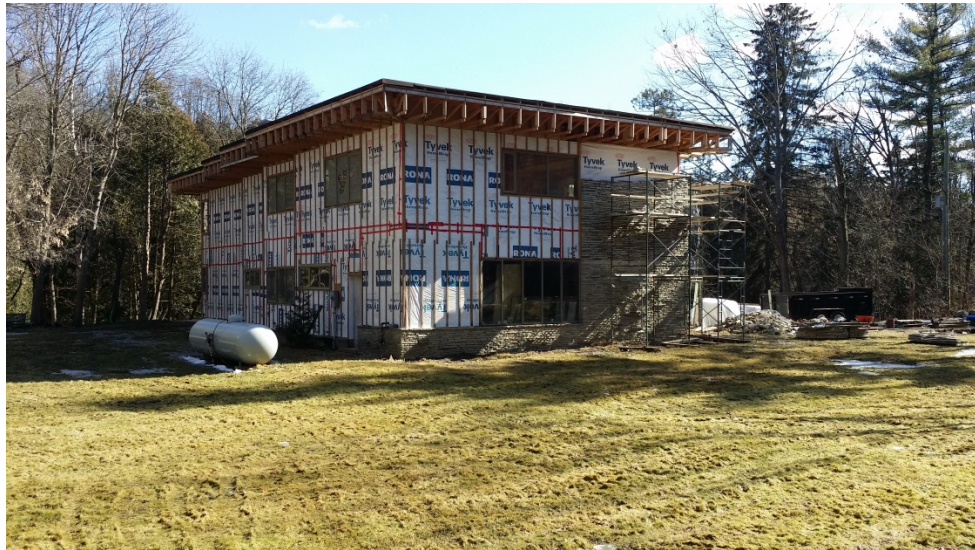
Oblique Elevation showing renovations underway (photograph February 2018)

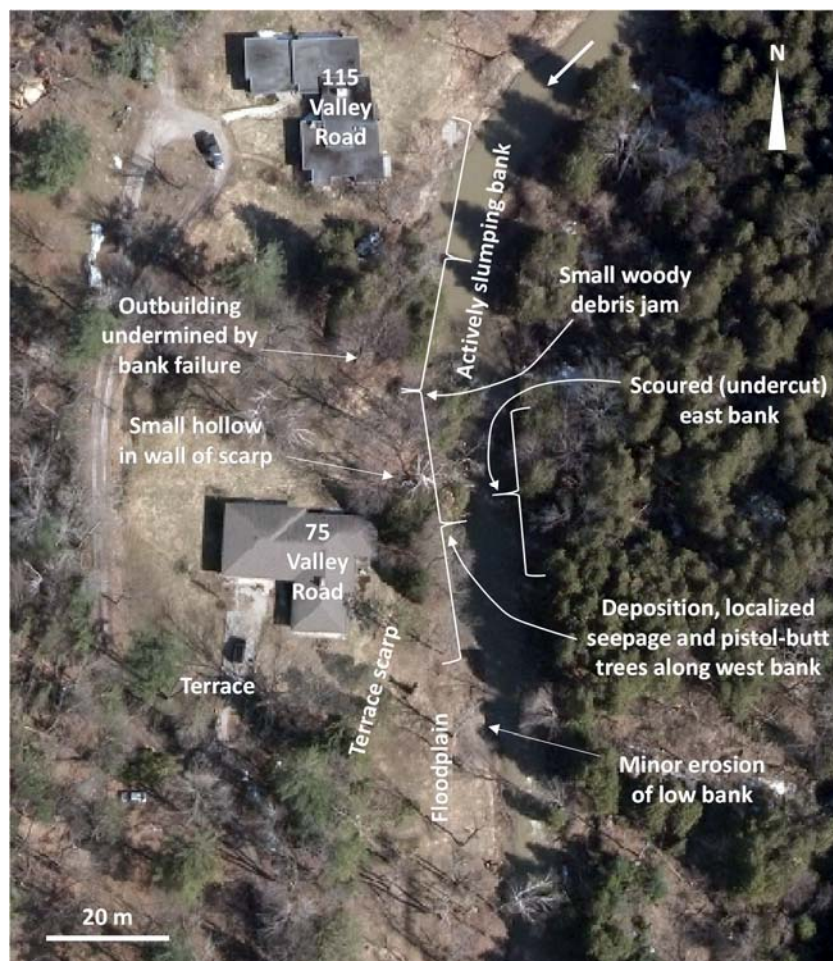
Figure 1. Key features and fluvial processes alongside 75 Valley Road

Figure 1 (below) illustrates key features and fluvial processes alongside 75 Valley Road, which is situated downstream of the apex of a meander along East Humber River. Active slumping along the west bank extends from the residence at 115 Valley Road downstream to just beyond the outbuilding at the northern limit of the 75 Valley Road property (**Photo 1**). The slumping is driven by fluvial undercutting of the toe of the terrace scarp, surface runoff from a shallow swale (concentrated through a drainage pipe), and localized groundwater seepage. The downstream limit of active erosion along the west bank is marked by a small woody debris jam (**Photo 2**), which deflects flow toward the east bank. Alongside the house at 75 Valley Road, bank scour predominates along the east bank, while deposition is more evident along the west bank (**Photo 3**). A low bench with localized groundwater seepage occurs along the base of the terrace scarp, immediately upstream of the house (**Photo 4**). Its downstream limit coincides with a small hollow in the wall of the scarp (**Photo 5**). Several mature, ‘pistol-butt’ trees growing along the scarp alongside the house provide evidence of a scarp position that has remained stable for decades albeit with minor, near-surface creep of soil or a winter snowpack (**Photo 6**). Downstream of the house, minor erosion is occurring along a low, west bank of the river, where it is first able to access and spill into its floodplain (**Photo 7**).

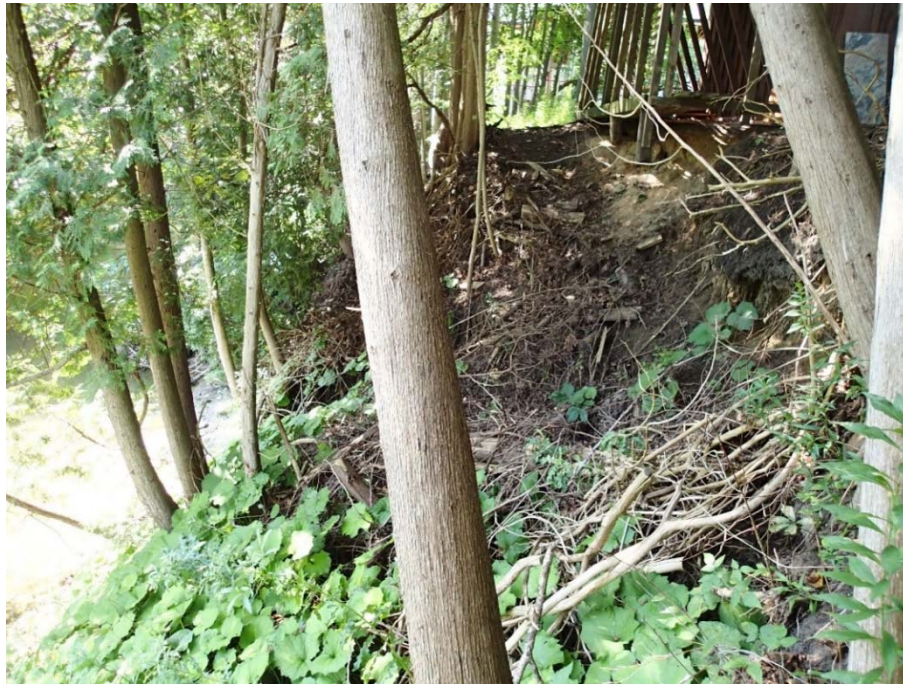
Photo 1. Active slumping along west bank below outbuilding at 75 Valley Road

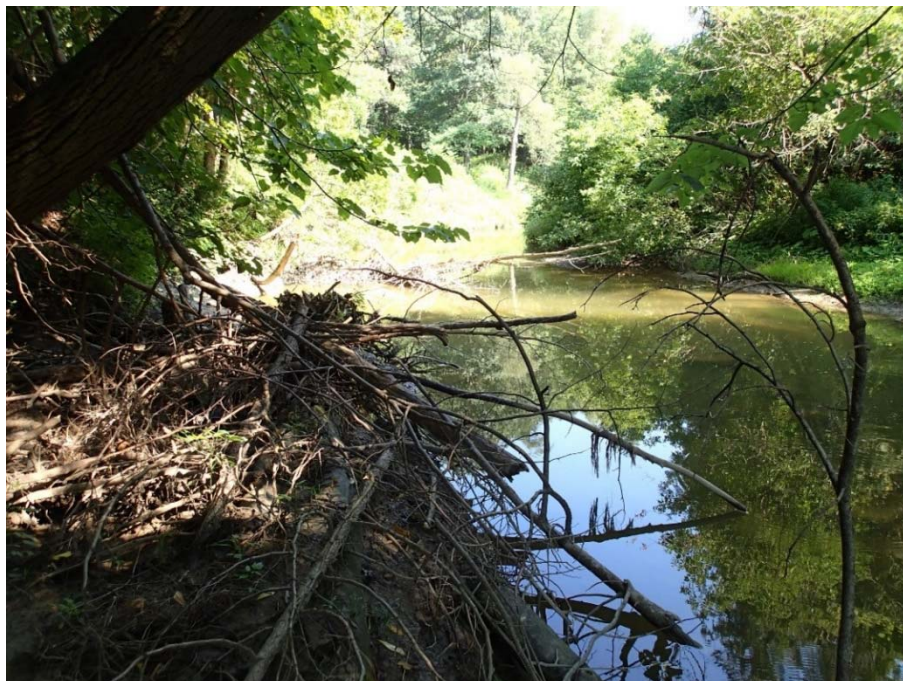
Photo 2. Upstream view of woody debris jam at downstream limit of active slumping along west bank, upstream of the house at 75 Valley Road

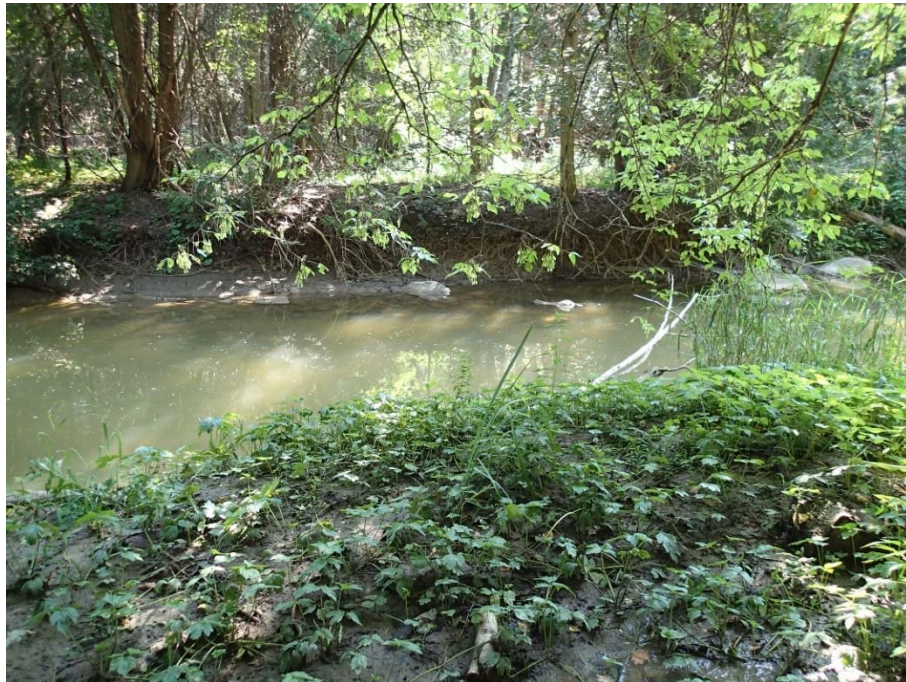
Photo 3. Scoured east bank (background) and deposition along west bank (foreground) immediately upstream and opposite the house at 75 Valley Road

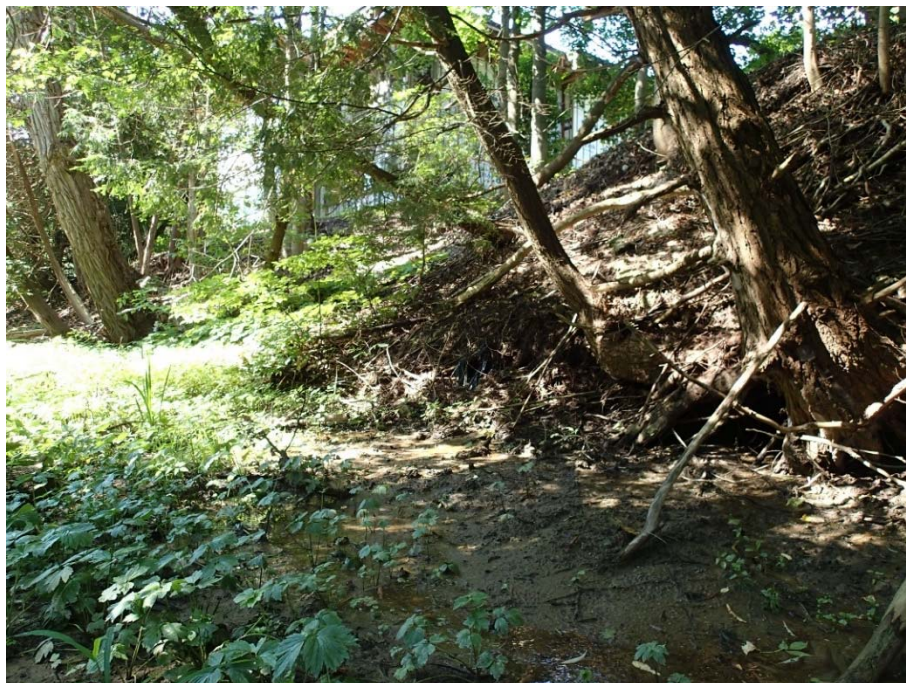
Photo 4. Groundwater seepage area along base of west bank, immediately upstream of the house at 75 Valley Road

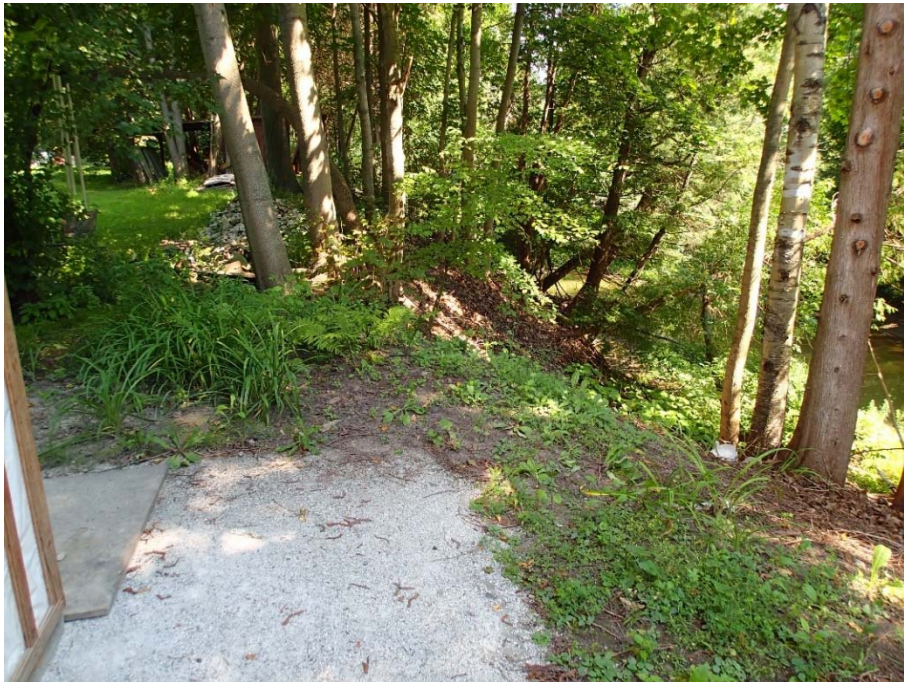
Photo 5. Small hollow in wall of scarp just upstream of northeastern corner of the house at 75 Valley Road

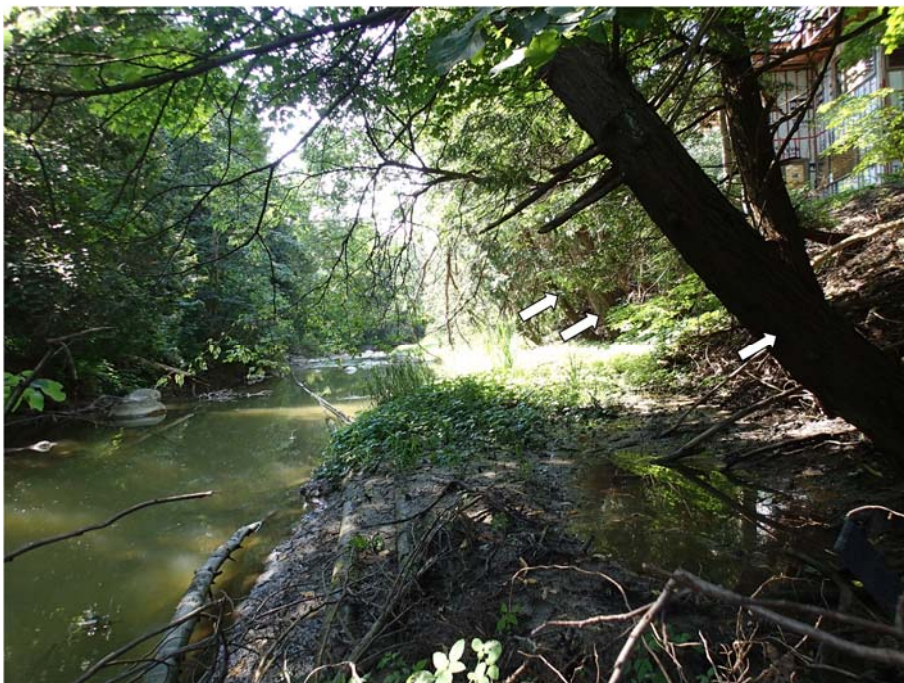
Photo 6. 'Pistol-butt' trees growing along the base of the western bank adjacent to the house at 75 Valley Road

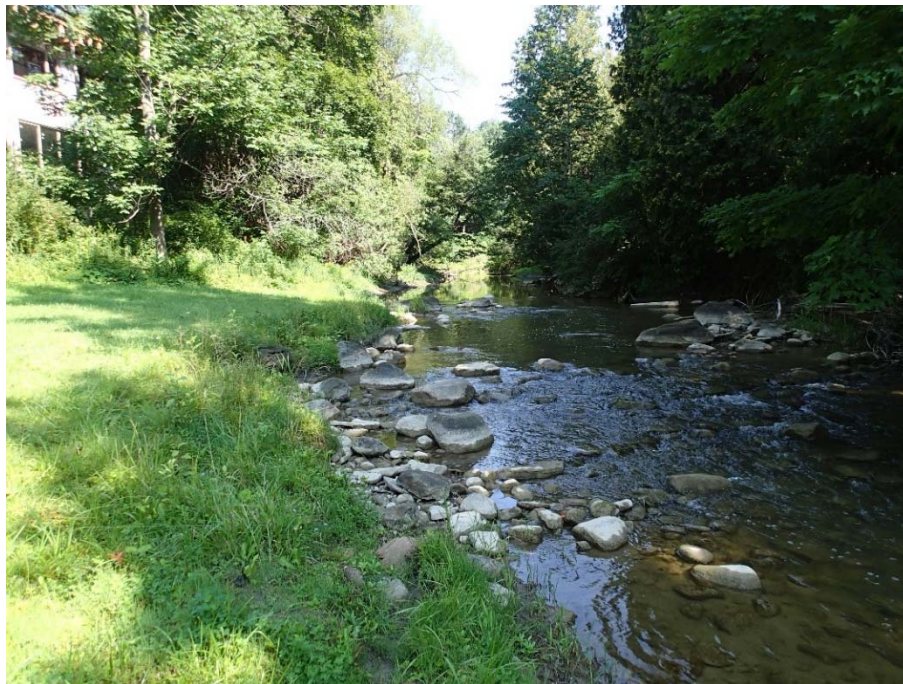
Photo 7. Minor erosion along the low, western bank immediately downstream of the house at 75 Valley Road

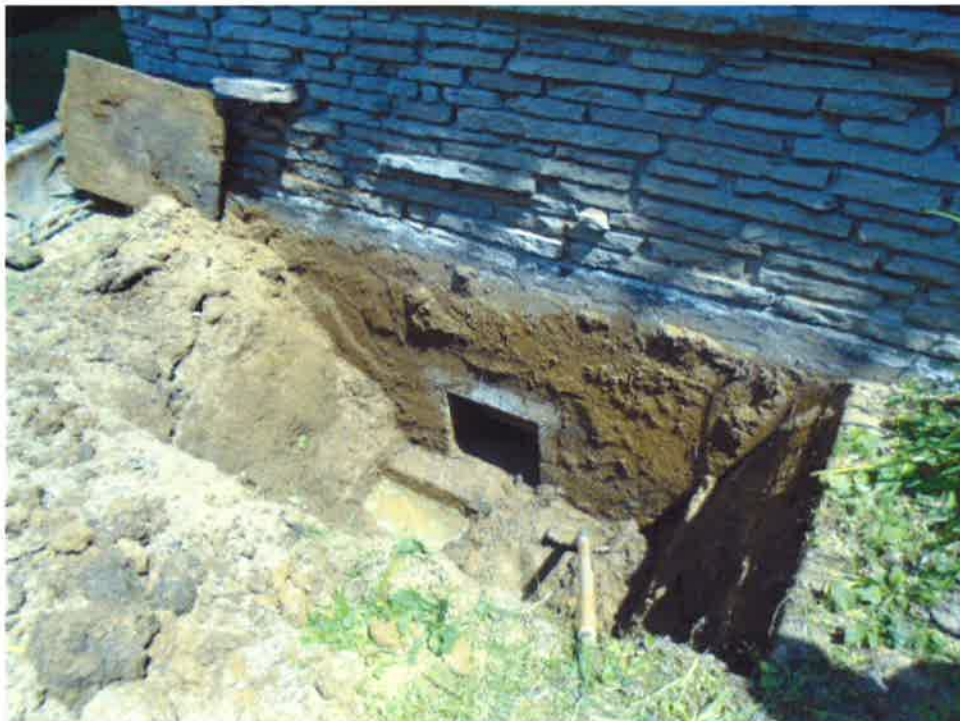
Photo # 7: Overview of Test Excavation,

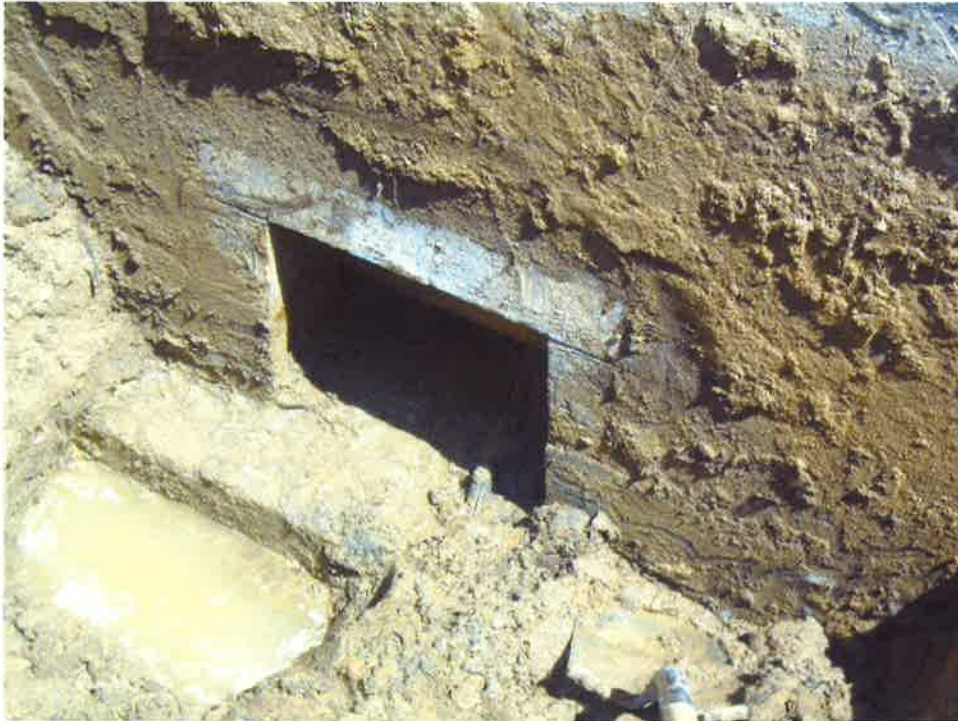
Photo # 8: Overview of Test Excavation.

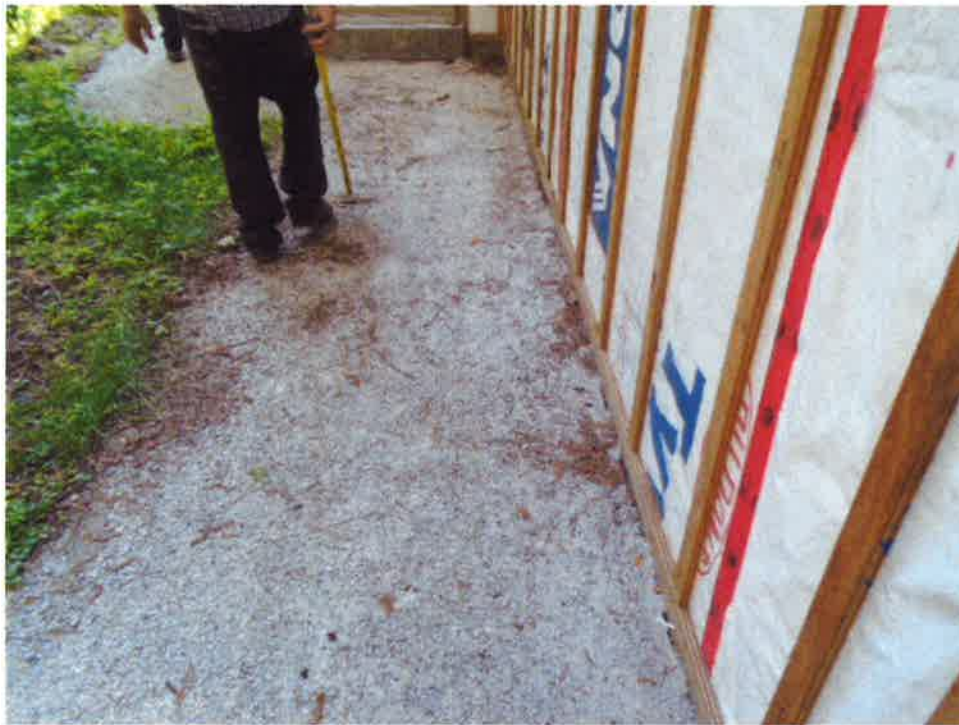
Photo # 10: Overview of Exterior Grade at East Side of Home.

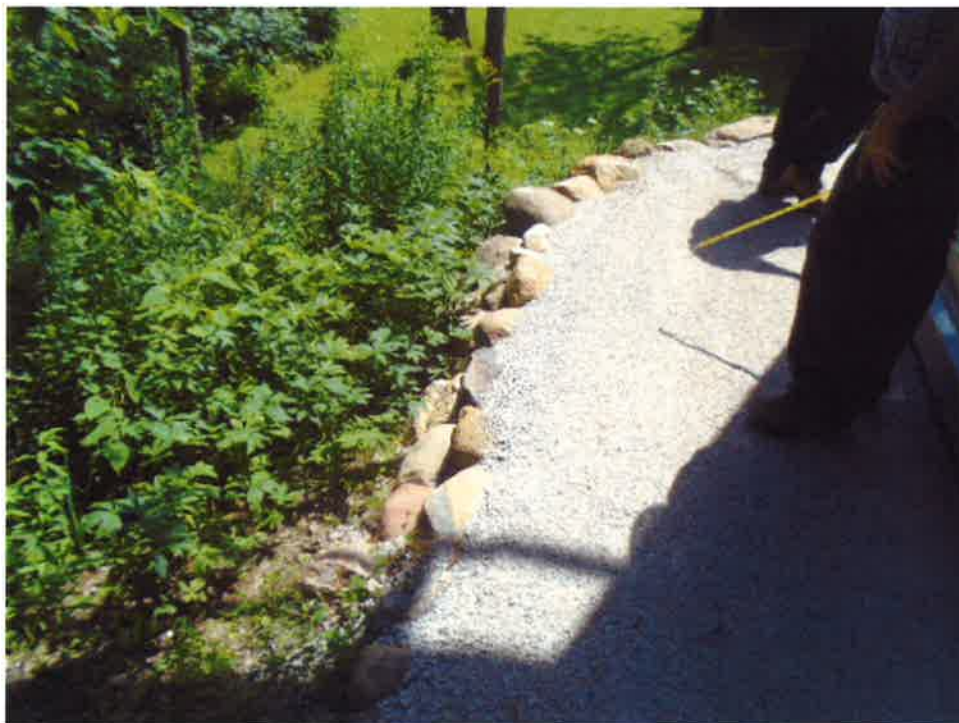
Photo # 11: Overview of Exterior Grade at East Side of Home.

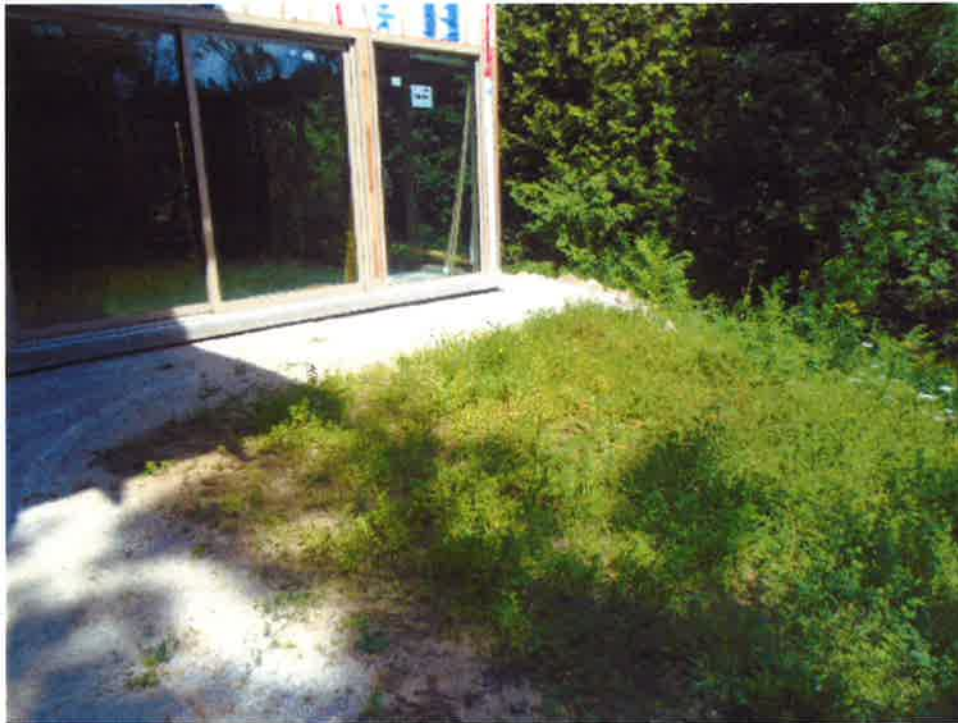
Photo # 12: Overview of Exterior Grade at East Side of Home.
