HERITAGE VAUGHAN COMMITTEE NOVEMBER 19, 2014

2. DEMOLITION OF OUTBUILDING AT 9000 BATHURST STREET – WARD 4

VAUGHAN HERITAGE INVENTORY - BUILT HERITAGE EVALUATION FORM

BUILDING/STRUCTURE ADDRESS: 9000 Bathurst – outbuilding

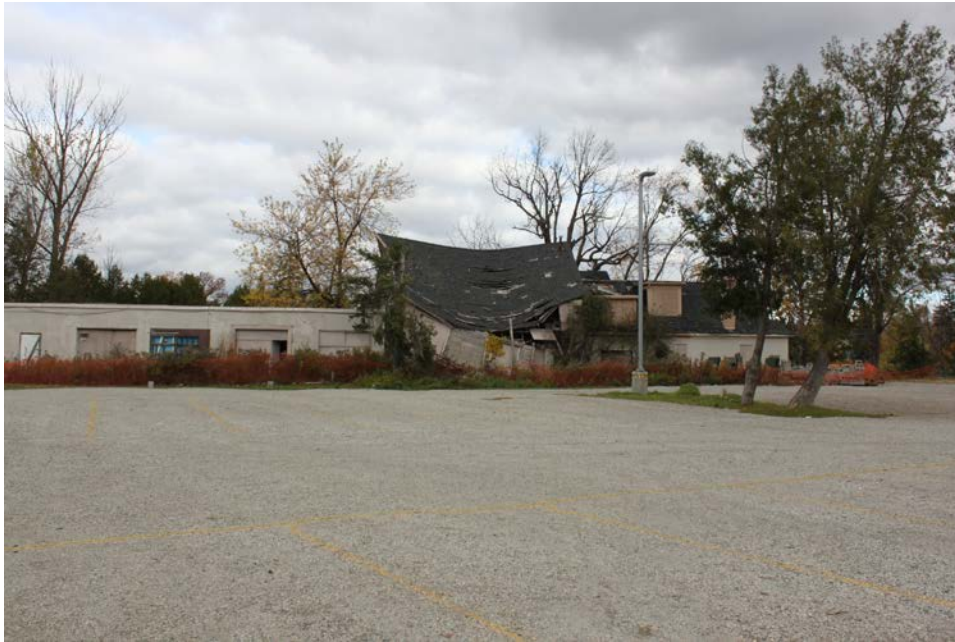
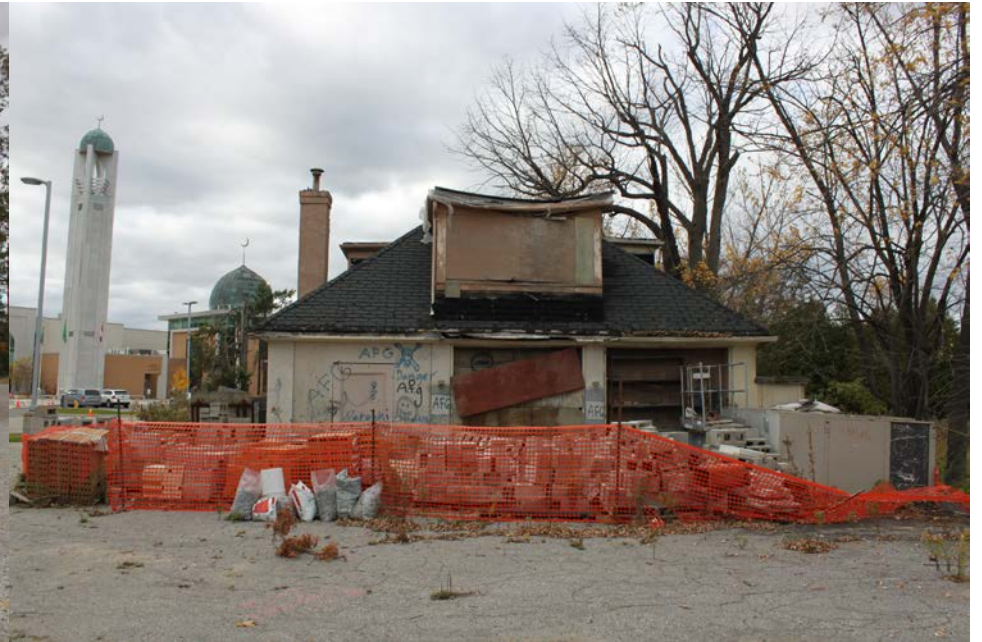
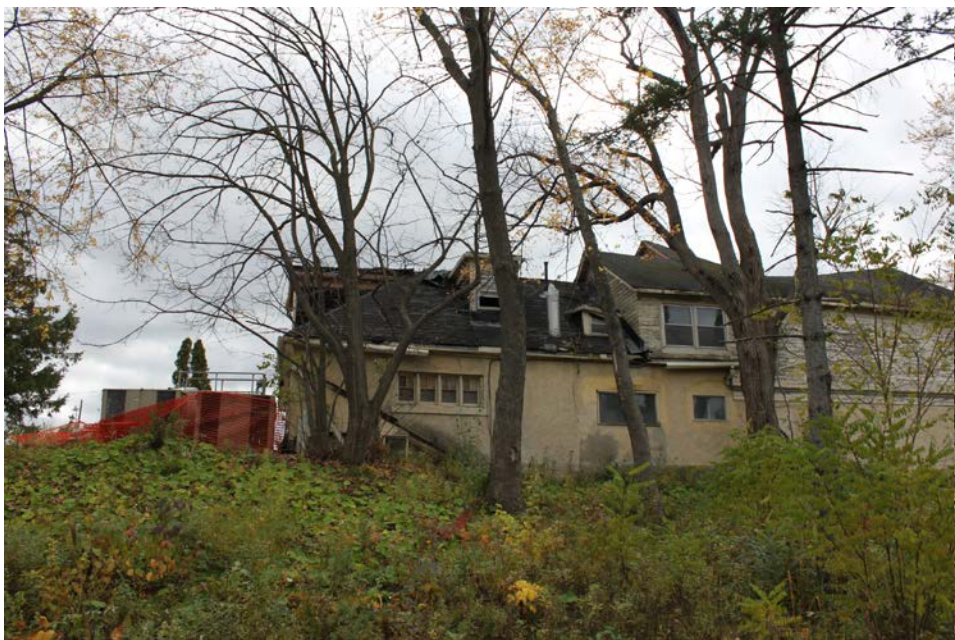
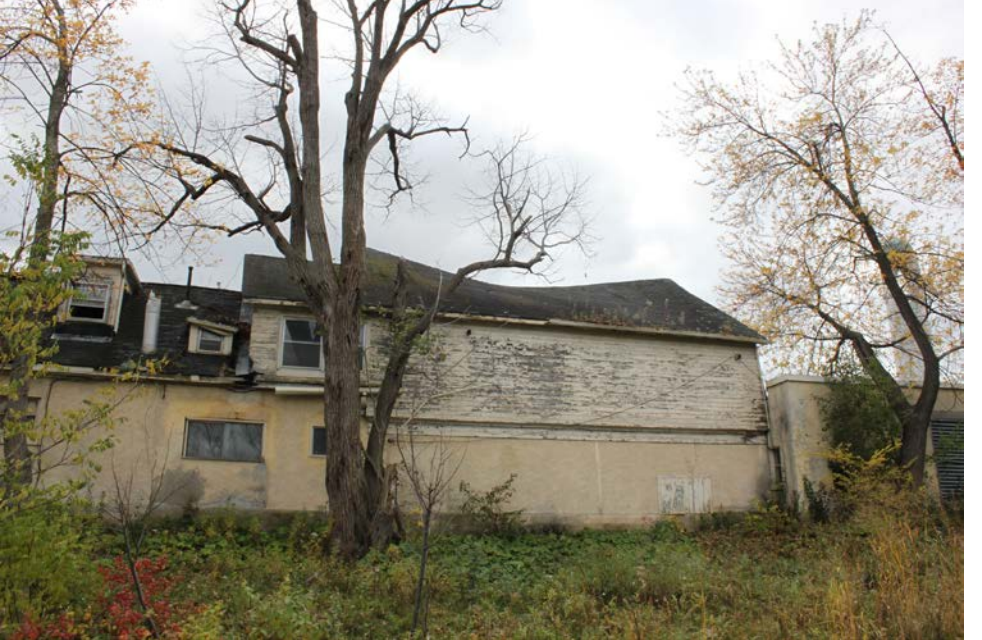
INTERIOR	EVALUATION CRITERIA	GRADING	COMMENTS
Integrity of interior arrangement, finish, craftsmanship, and/or detail are particularly attractive or unique and/or still exist.	E- Excellent interior (80-100%intact).	E – 5	Interior was not accessible due to a collapsed roof and a flooded basement.
	VG- Very good interior (70-79% intact).	VG – 3	
	G- Good interior (50-69% intact).	G- 2	
	F/P- Fair or poor (0-49% intact).	<u>F/P – 0</u>

CONDITION	EVALUATION CRITERIA	GRADING	COMMENTS
Exterior/interior of building is in good structural condition (i.e. evidence of decay in exterior siding, roof, or interior basement, wall surface, flooring, or ceiling, suggesting structure to be unsound.)	G- Good structural condition. (No evidence of decay)	G- 20	
Checklist: Exterior Siding/Gutters (cracks, spalling) Roof/Interior Ceiling/Gutters Flooring, unstable, depressions Interior Wall surface, cracks, etc Basement (leaks mold, dry or wet rot on beams)	S- Somewhat good structural condition. (Minor/little evidence of decay)	S – 15	- Roof caved in - Basement flooded significantly - Entire building unstable
	F- Fair structural condition (Some (i.e. 2 from adjacent list) evidence of decay).	F- 10	- Cracks throughout entire structure
	P- Poor structural condition. (Significant/considerable evidence of decay.)	<u>P- 0</u>

Exterior photos, October 30, 2014

1. That Heritage Vaughan approve the demolition of the outbuilding at 9000 Bathurst Street.

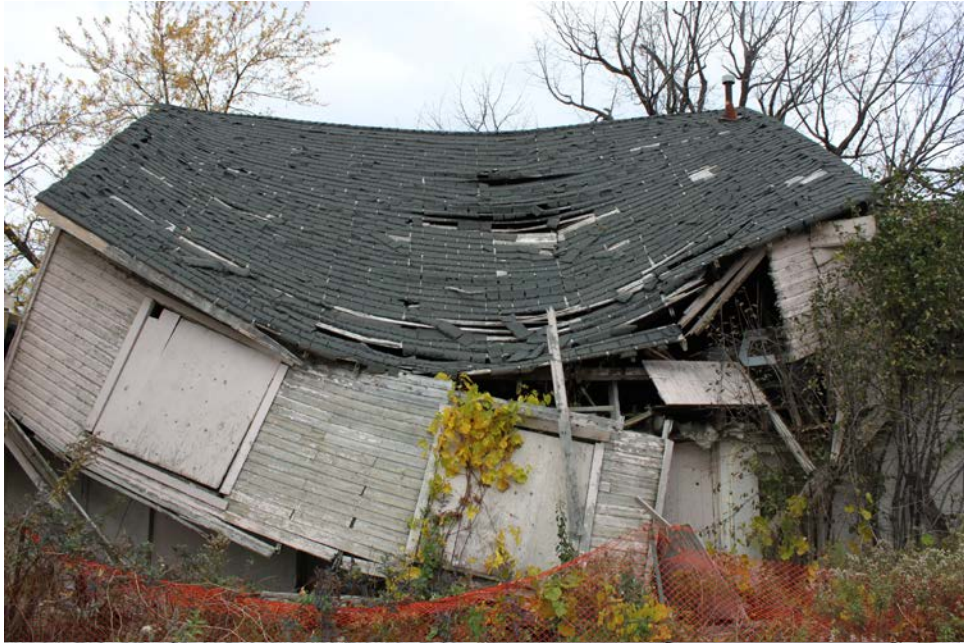
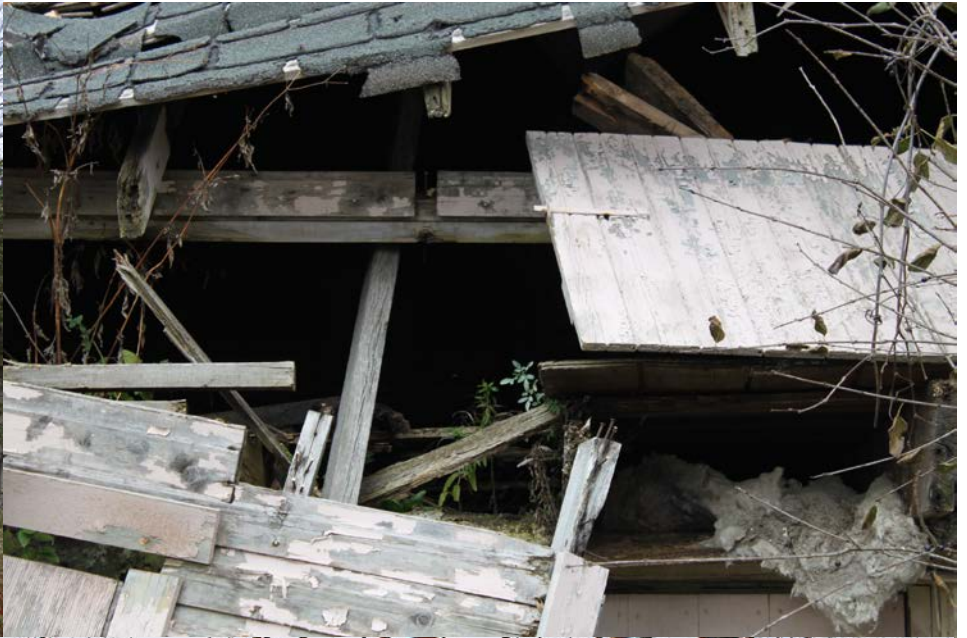
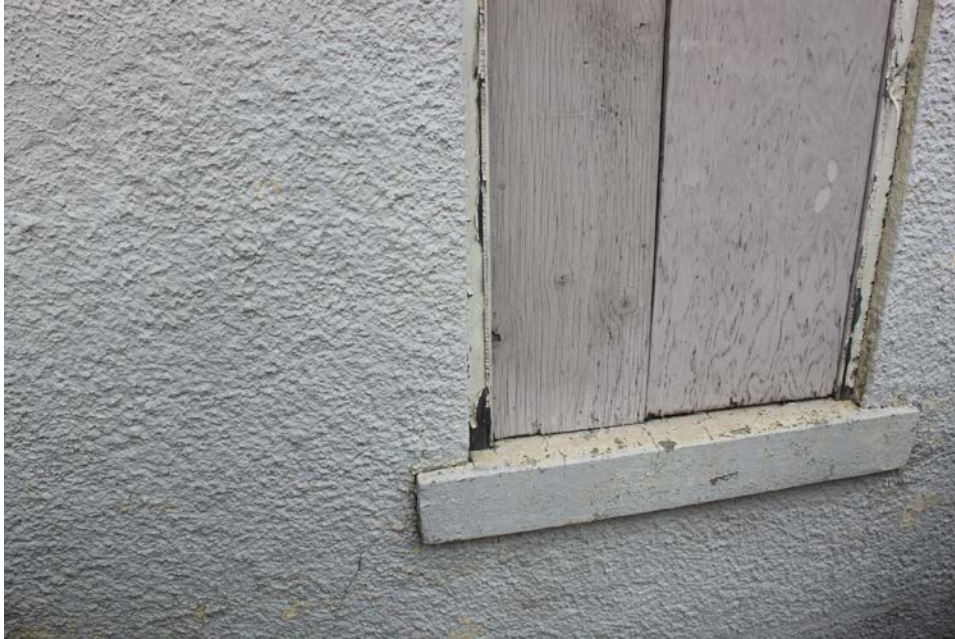
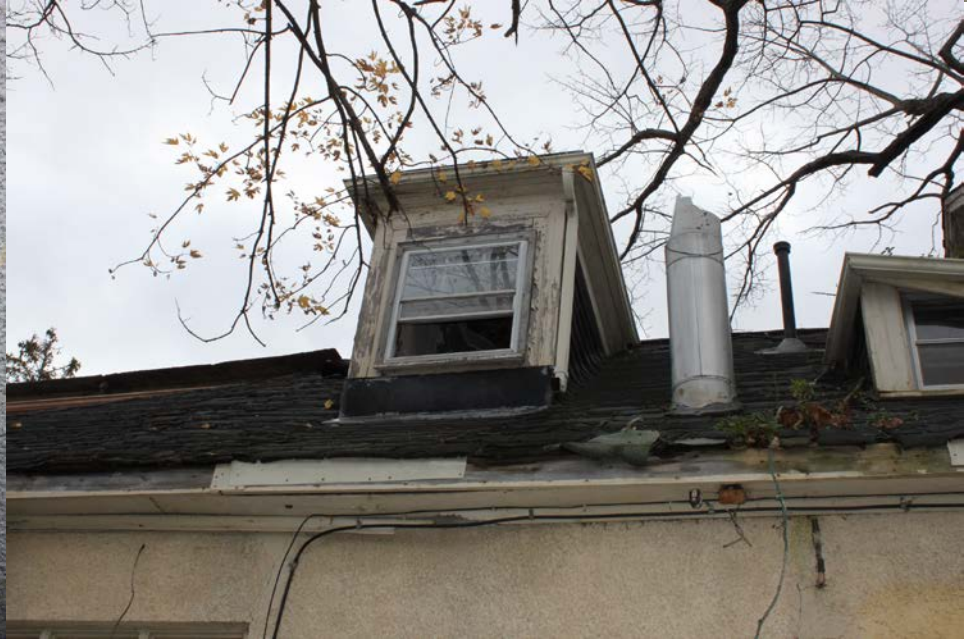
Exterior Details, October 30, 2014
