HERITAGE VAUGHAN REPORT

**TITLE: NEW CONSTRUCTION – SINGLE DETACHED DWELLING
77 CLARENCE STREET, WOODBRIDGE HERITAGE
CONSERVATION DISTRICT**

CULTURAL HERITAGE IMPACT ASSESSMENT

**77 CLARENCE STREET
CITY OF VAUGHAN, ONTARIO**

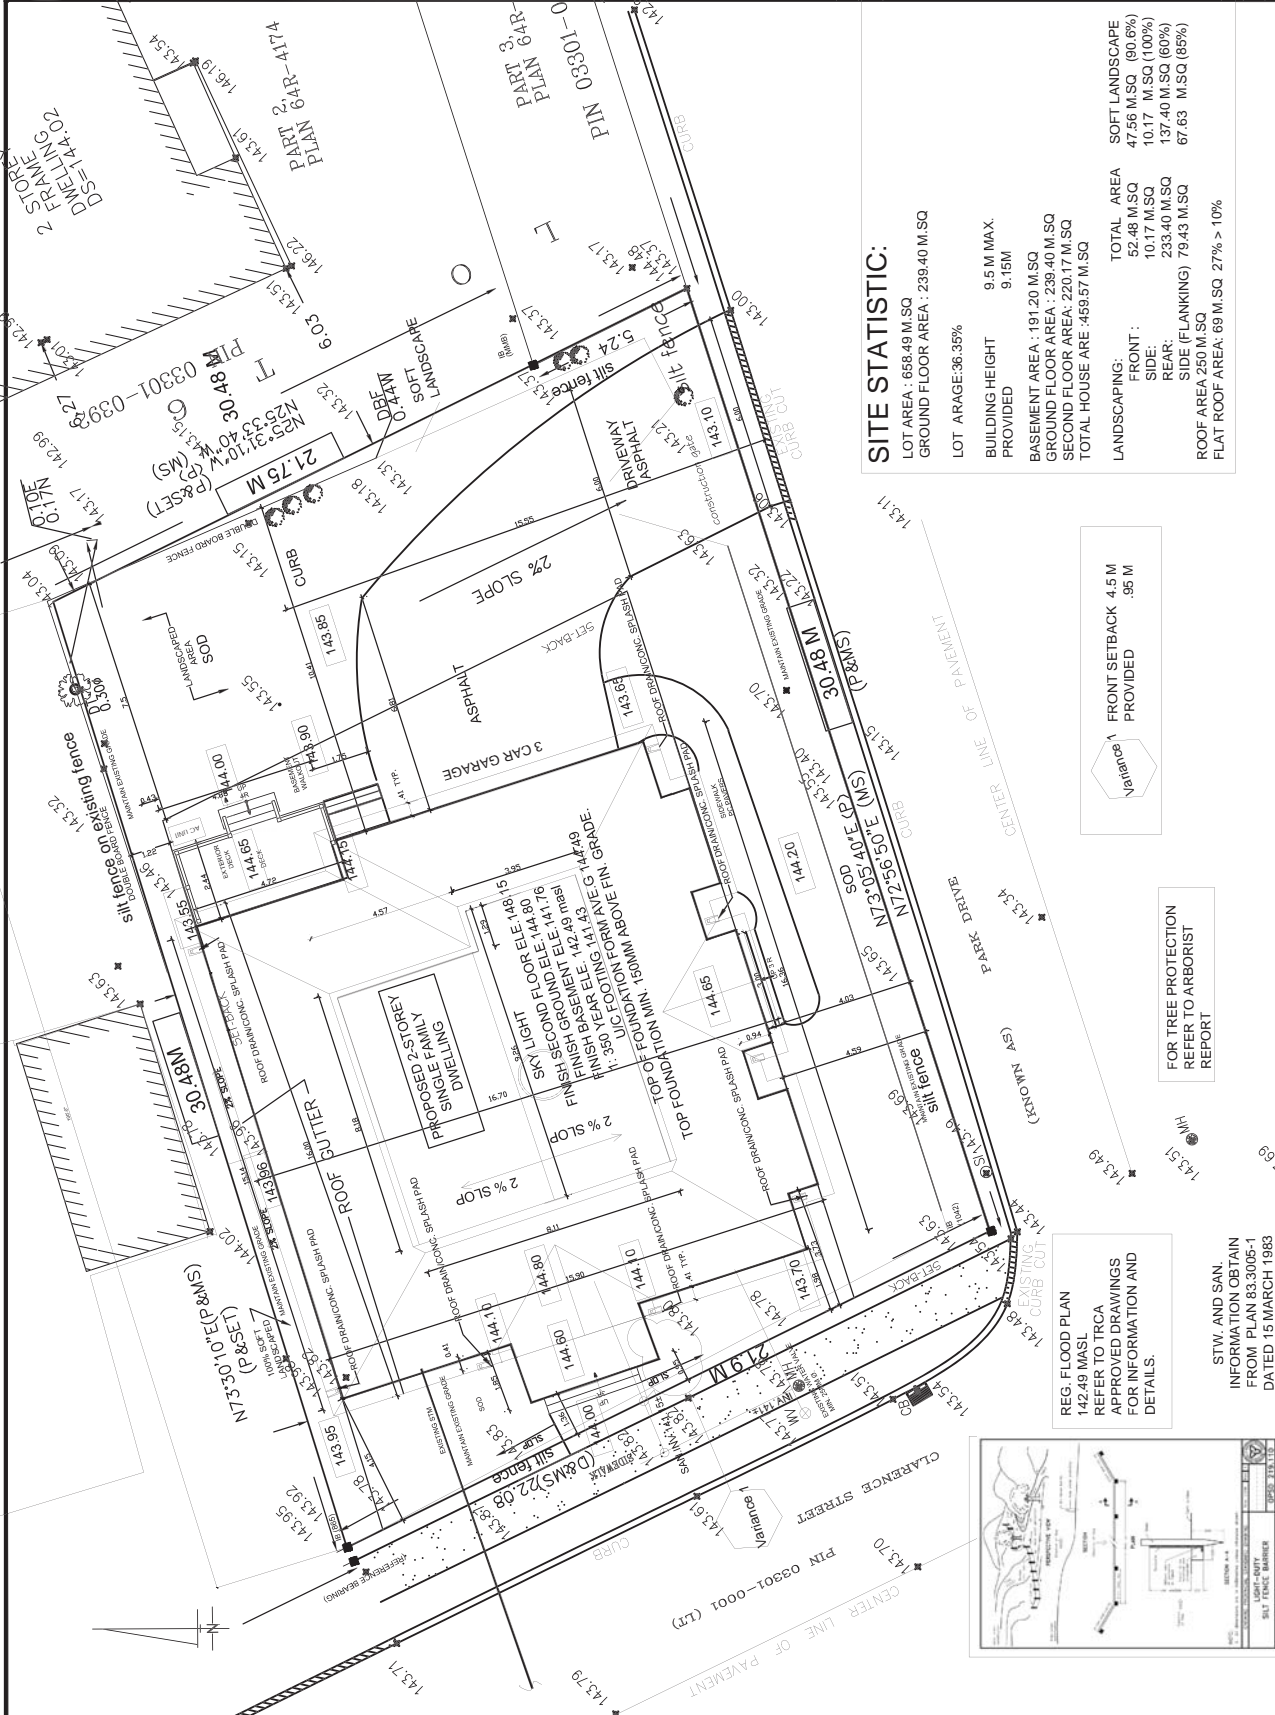
LOT AREA: 658.49 M.SQ
GROUND FLOOR AREA: 239.40 M.SQ
TOTAL HOUSE ARE: 459.57 M.SQ
BUILDING HEIGHT PROVIDED: 9.15M
BASEMENT AREA: 191.20 M.SQ
GROUND FLOOR AREA: 239.40 M.SQ
SECOND FLOOR AREA: 220.17 M.SQ
TOTAL HOUSE ARE: 459.57 M.SQ
LANDSCAPING: TOTAL AREA: 52.48 M.SQ (90.6%)
FRONT: 10.17 M.SQ (100%)
SIDE: 233.40 M.SQ (80%)
REAR: 17.63 M.SQ (85%)
ROOF AREA: 250 M.SQ
FLAT ROOF AREA: 69 M.SQ 27% > 10%

STW. AND SAN.
INFORMATION OBTAIN
FROM PLAN 833005-1
DATED 15 MARCH 1983

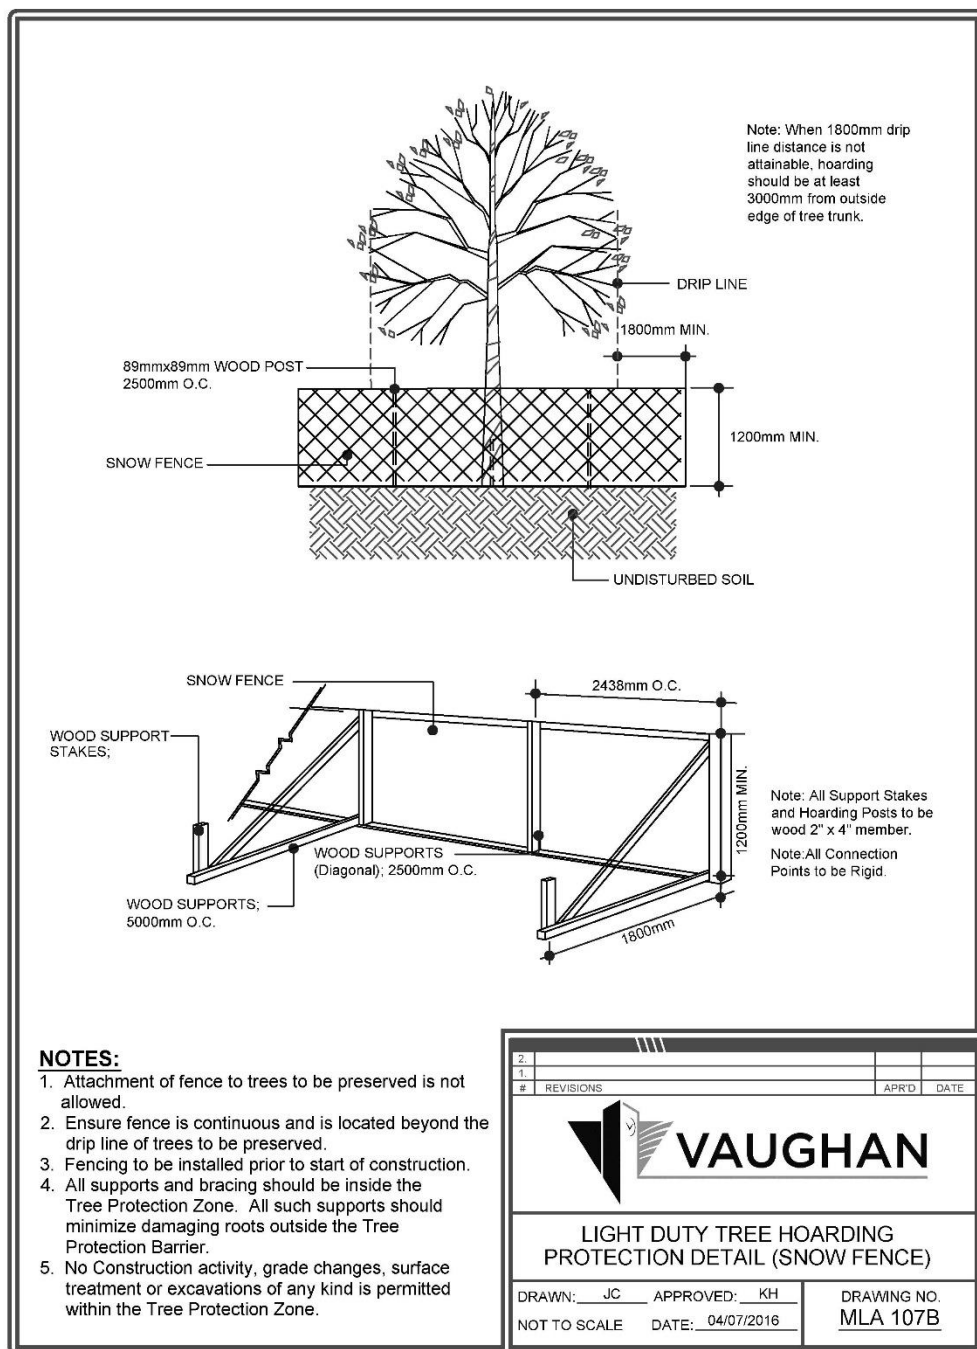
Tree protection plan details: Light Duty

Establishing a TPZ is necessary to prevent physical harm to the stem and branches of the tree which may otherwise be incurred due to proximity of construction or demolition activities. The TPZ will encompass the tree's critical root area, protecting the roots from being damaged during excavation and from soil compaction which may occur due to the presence of heavy machinery.

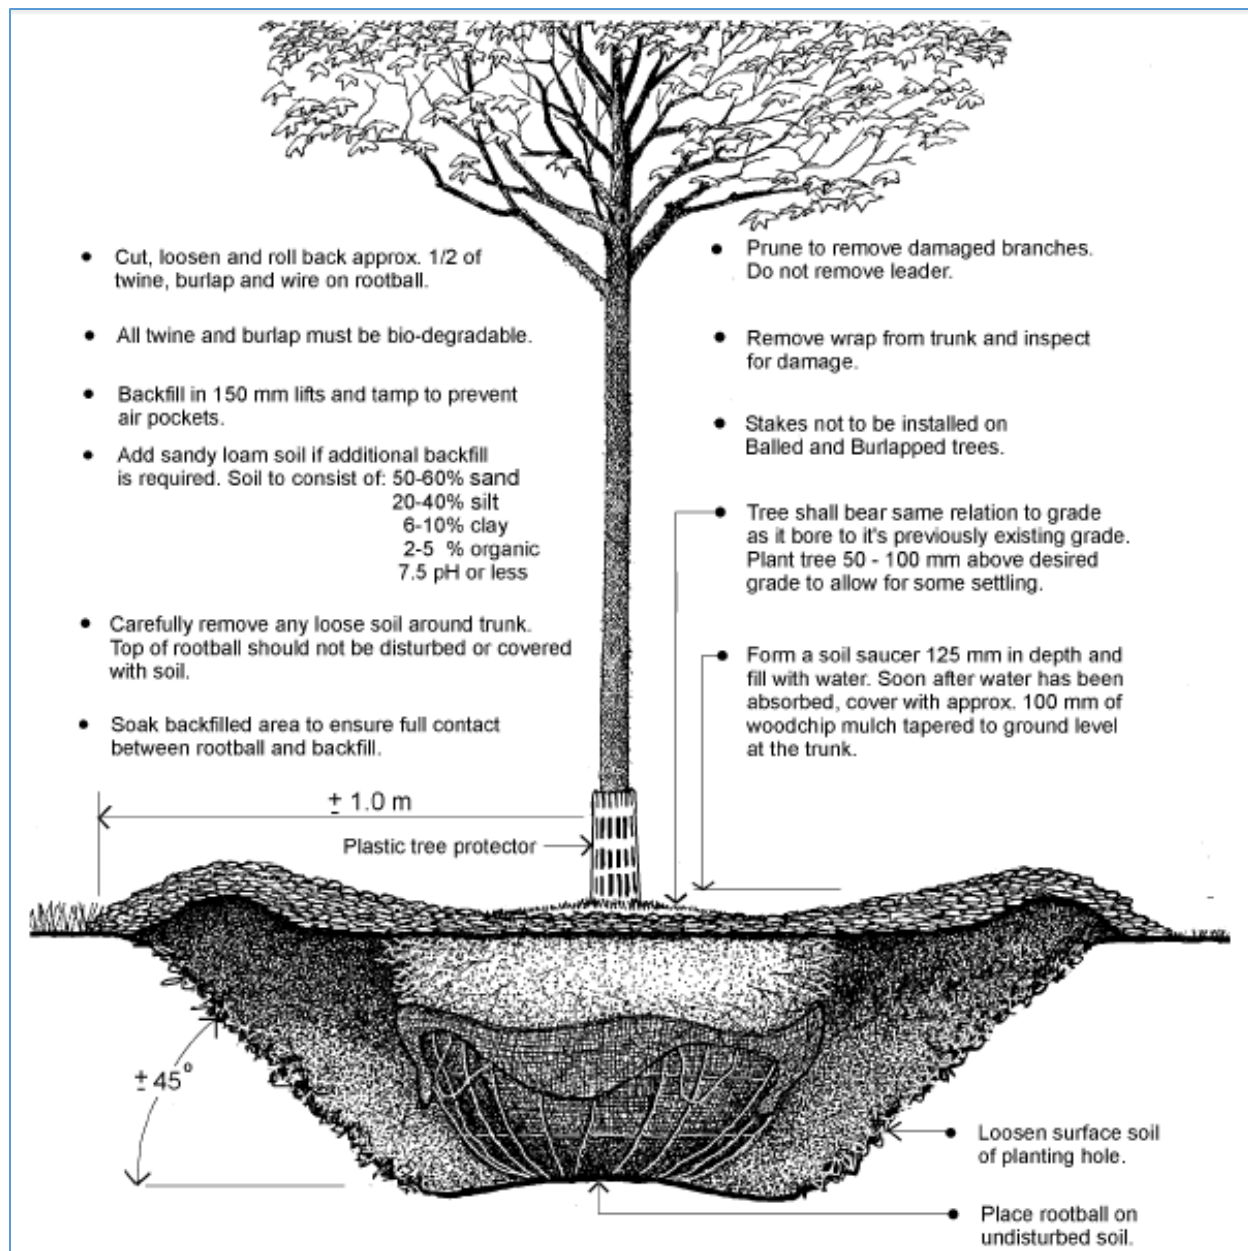
Figure 1. Tree planting methodology

Replacement trees must be: For evergreen (coniferous) trees, at least 200 cm (6.5 ft) tall. For leafy (deciduous) trees, have a caliper of at least 50 mm (2 in). If fruit trees or small statured trees are desired, you must plant two trees for each regular replacement. Replacements are to be planted within one year of the issuance of the tree removal permit. Replacements cannot be a shrub, trees for the purpose of hedging, or of a low growing variety. Replacements cannot be an invasive species. Replacement trees shall meet the highest horticultural standards of the Canadian Nursery Trades Association with respect to grading and quality and shall be in strict accordance with the approved Plant List and Specifications and shall be installed as per City approved details and standards.

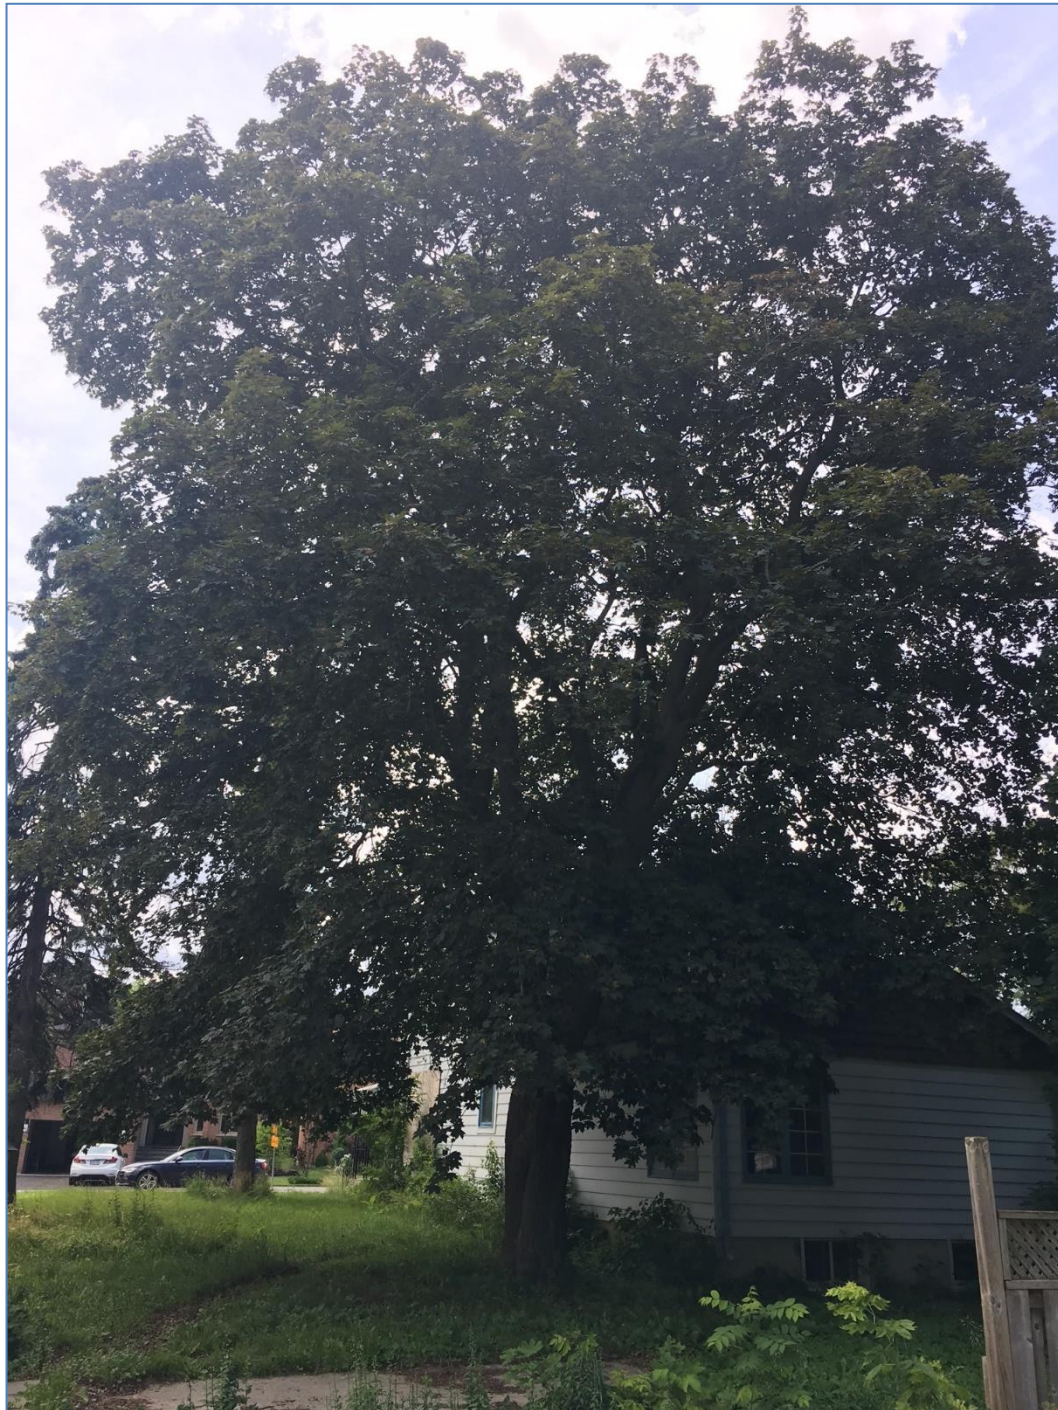
Tree 1: Norway Maple (Acer platanoides)

Tree 1: 2.5-meter include bark seam on backside of tree

Tree 1 is an 87-cm. mature Norway Maple located on private property, within the footprint of the proposed development at 77 Clarence Street. This tree cannot be preserved and therefore, we are requesting a permit for removal. For a tree removal of this size (50 cm. + base diameter), the City of Vaughan requires 4 replacement trees as compensation. Please see the section titled, “Replanting Plan” for more details.

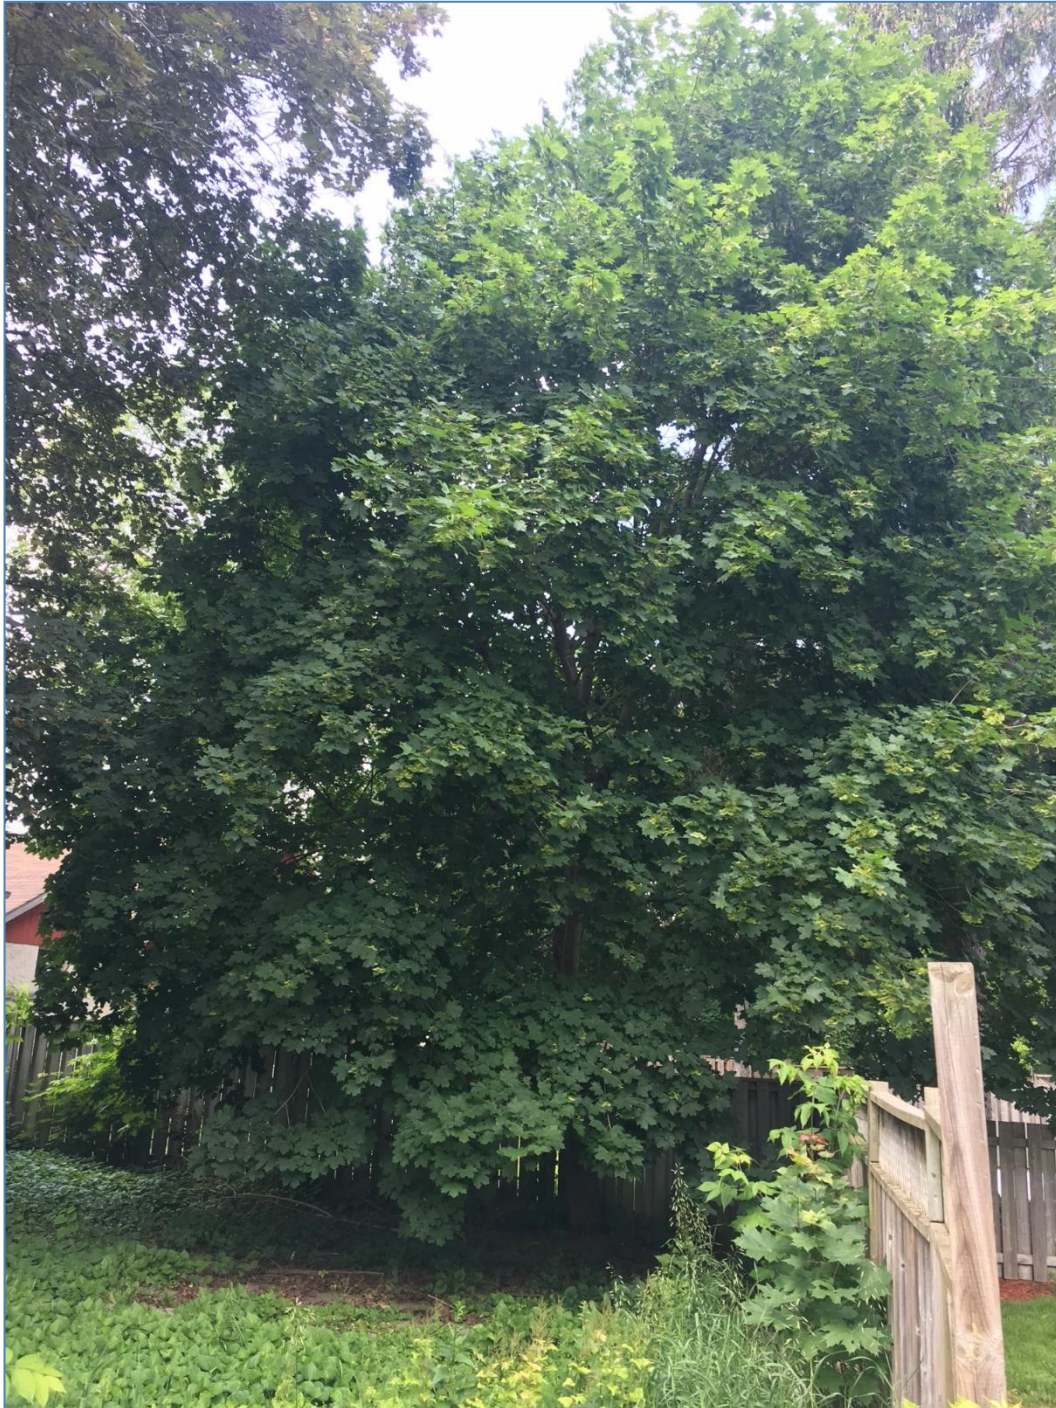
Tree 2: Norway Maple (Acer platanoides)

Tree 2: Visible lean, minor fence damage, source of basal girdling

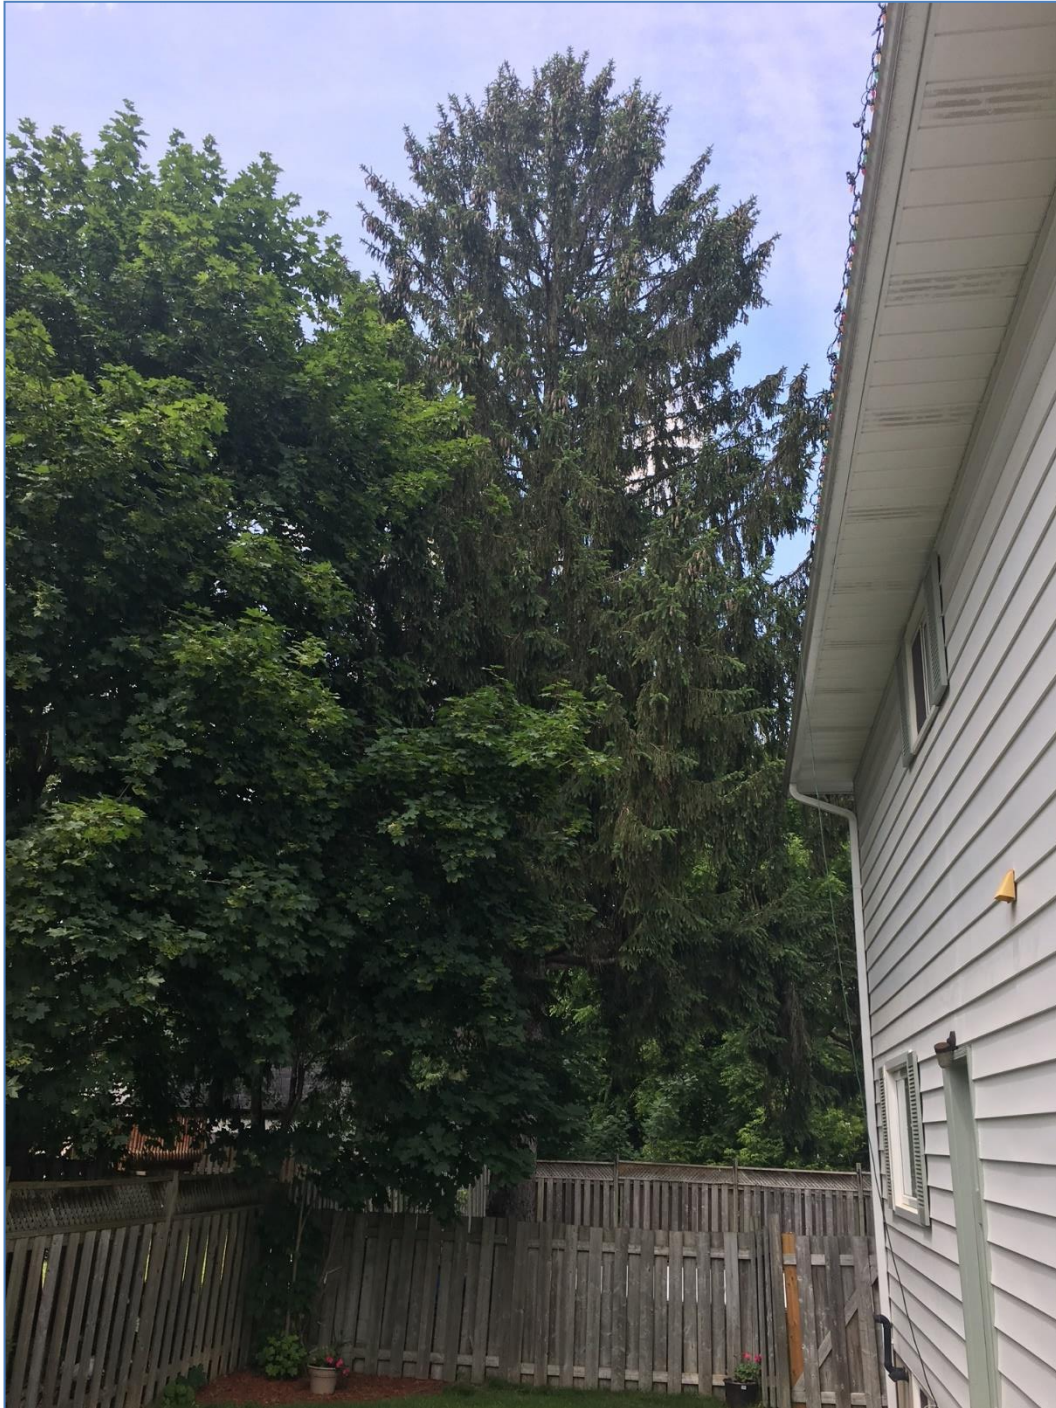
Tree 3: Norway Spruce (*Picea abies*)

Tree 3: Well-established root flare with pronounced surface rooting

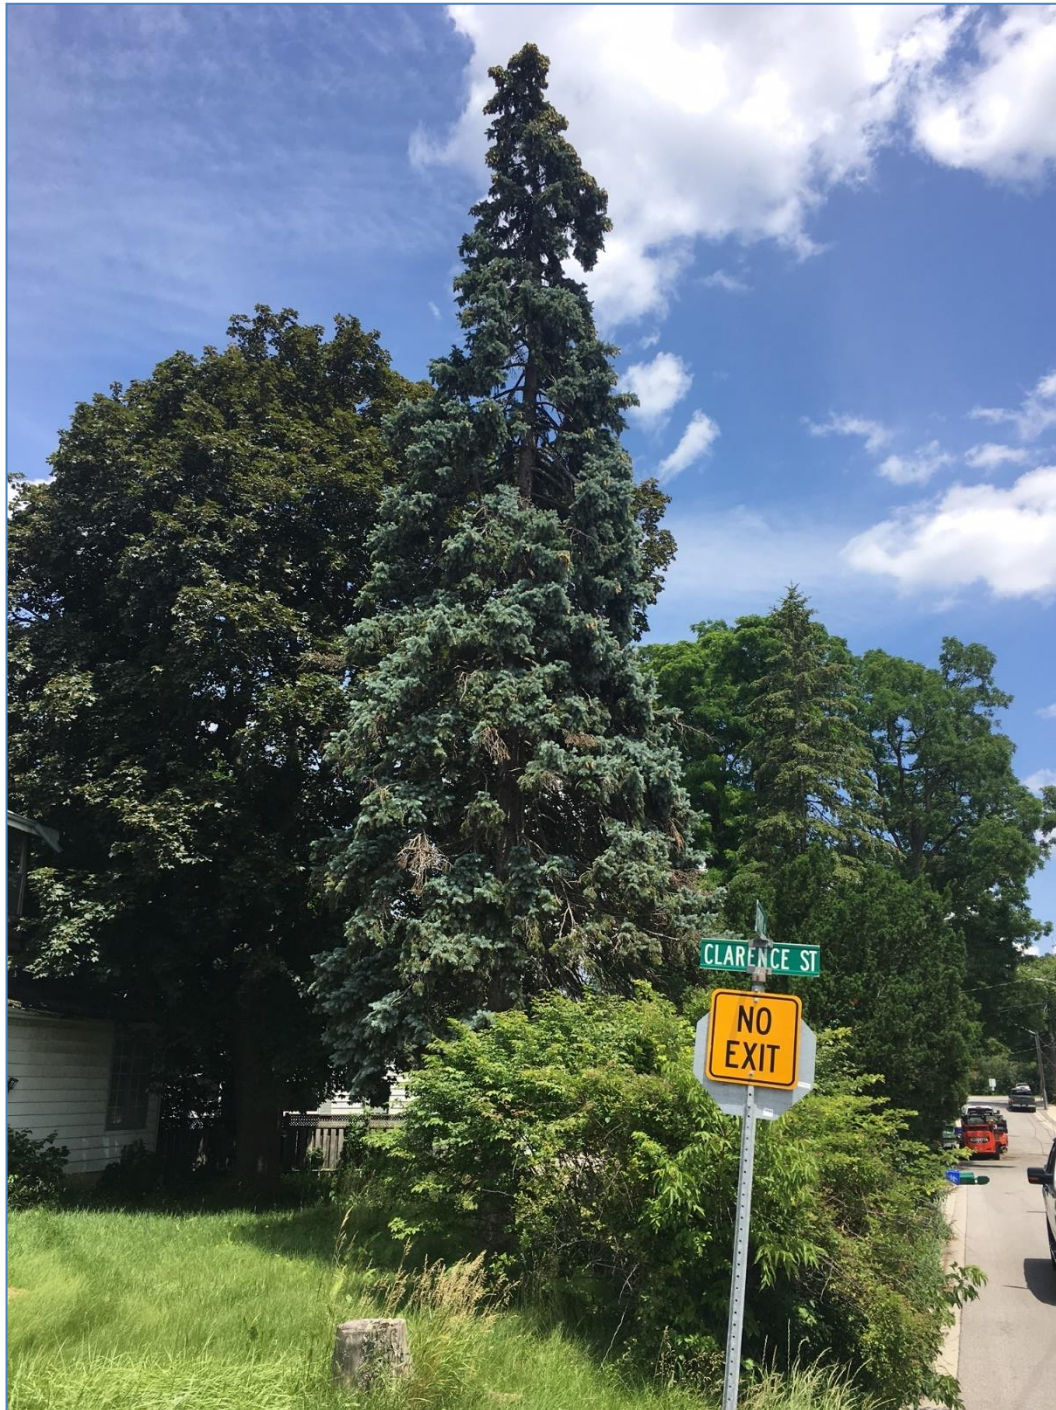
Tree 5: Colorado Spruce (*Picea pungens*)

Tree 5: Gummosis on main stem

Tree 5 is a 41-cm. Colorado Spruce in poor condition located within just within the limit of excavation required for the proposed development at 77 Clarence Street. The tree cannot be retained in safe and healthy condition and therefore, we are requesting a permit for removal. For a tree removal of this size (41-50 cm. base diameter), the City of Vaughan requires 3 replacement trees as compensation. Please see the section titled, “Replanting Plan” for more details.

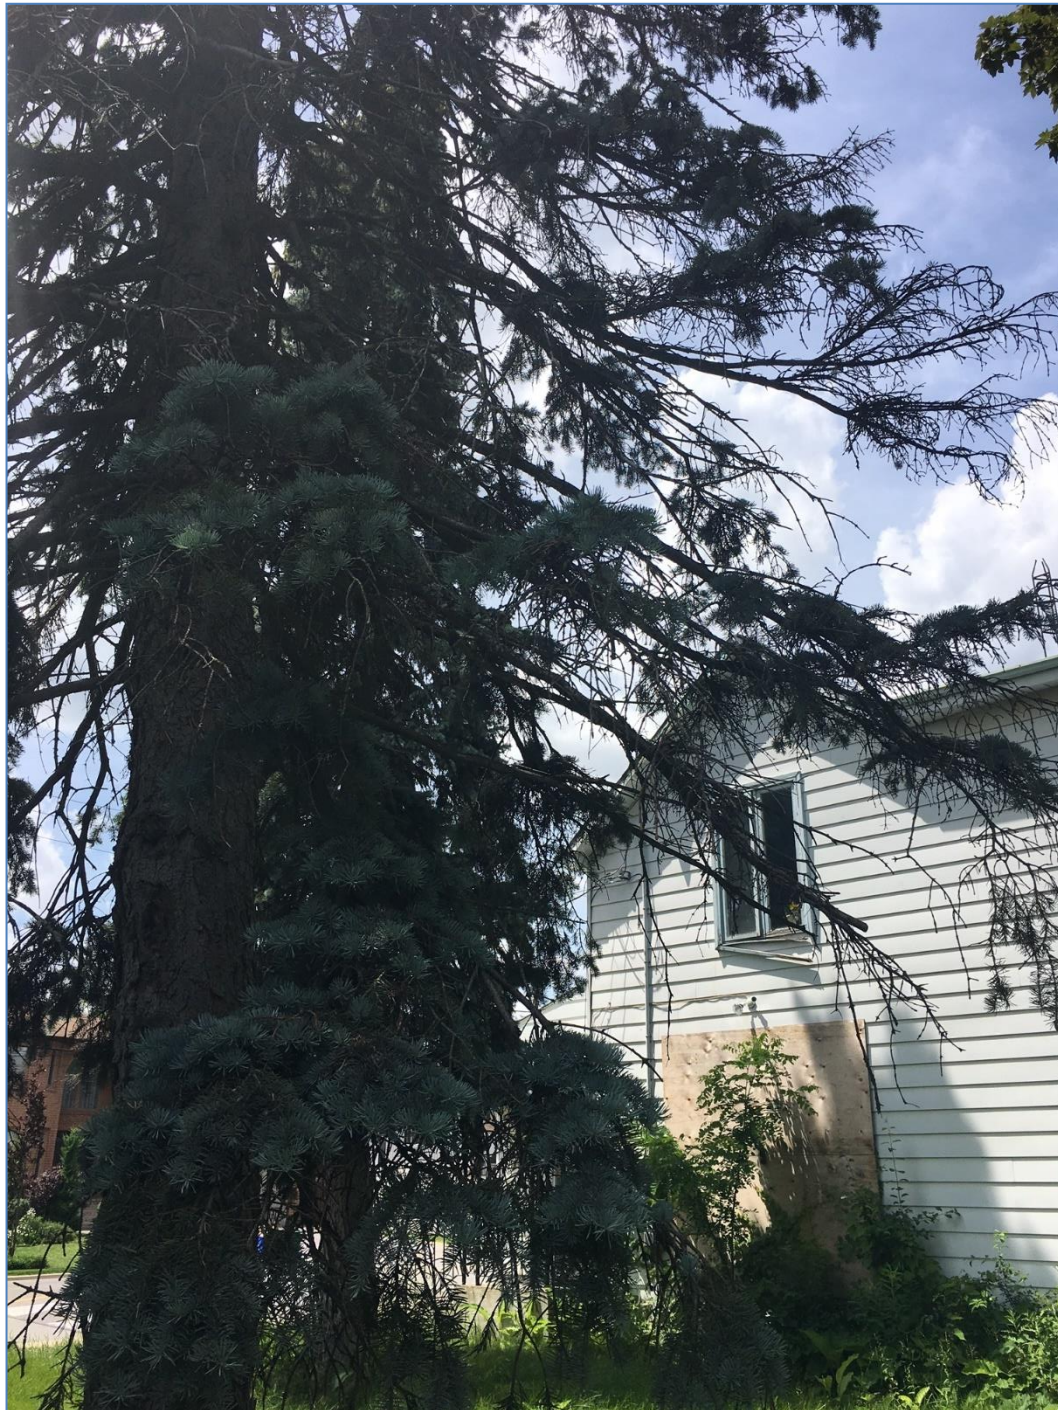
Tree 5: Significant dieback through lower crown

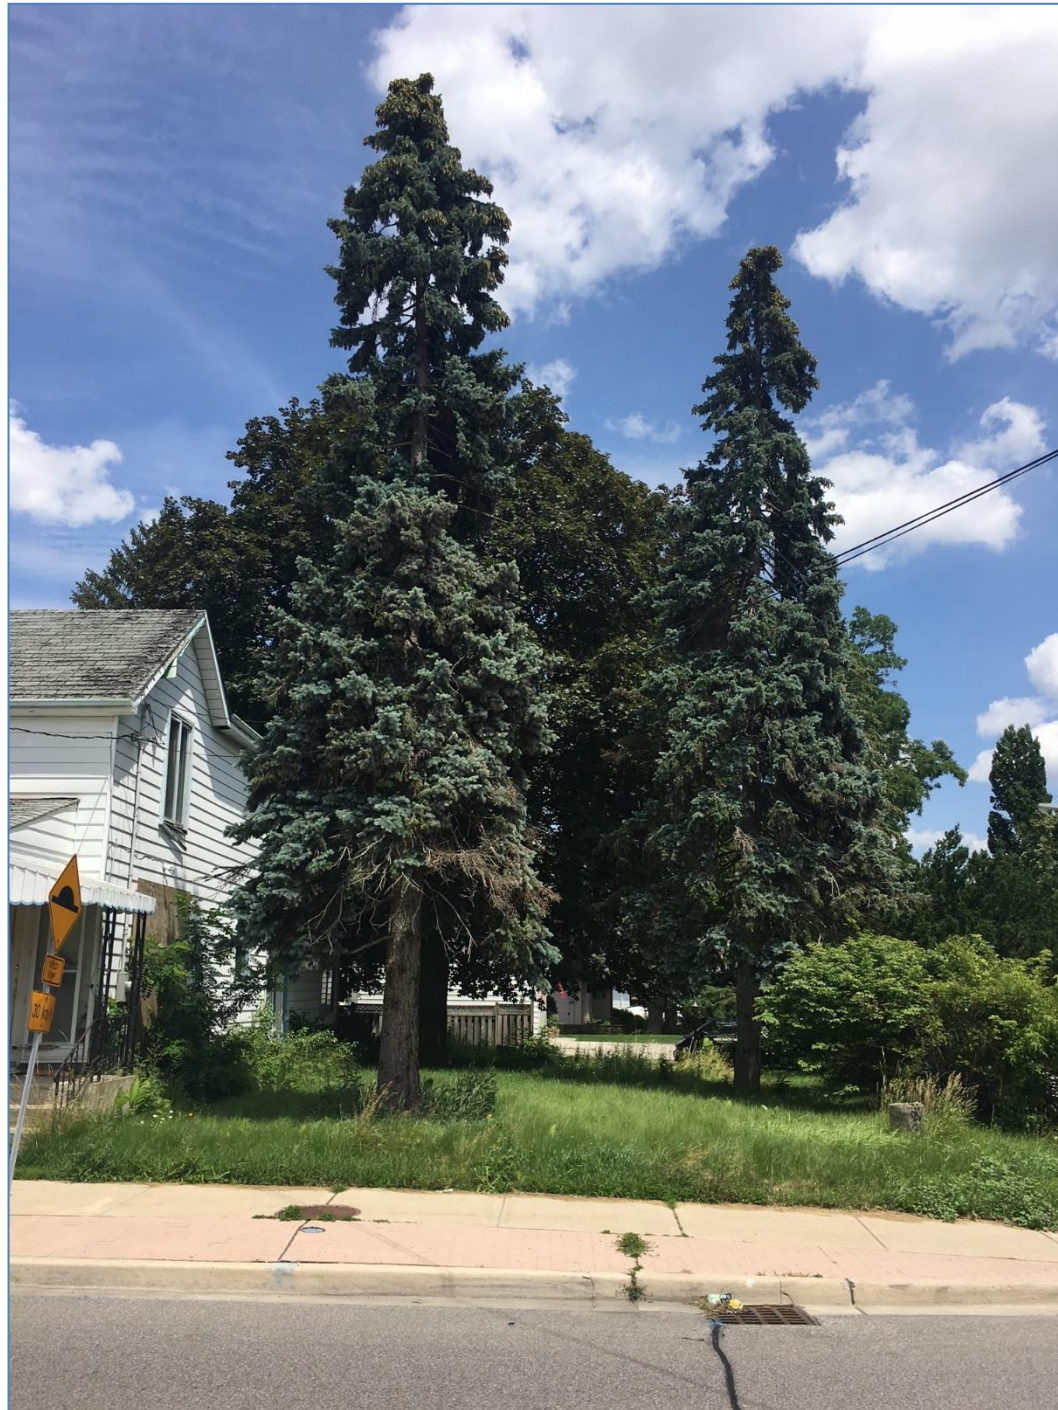
Trees 5 & 6: Colorado Spruce (*Picea pungens*), 5 at right, 6 at left

Tree 6: Gummosis on main stem

Tree 6 is a 46-cm. Colorado Spruce in fair-poor condition located within just within the limit of excavation required for the proposed development at 77 Clarence Street. The tree cannot be retained in safe and healthy condition and therefore, we are requesting a permit for removal. For a tree removal of this size (41-50 cm. base diameter), the City of Vaughan requires 3 replacement trees as compensation. Please see the section titled, “Replanting Plan” for more details.

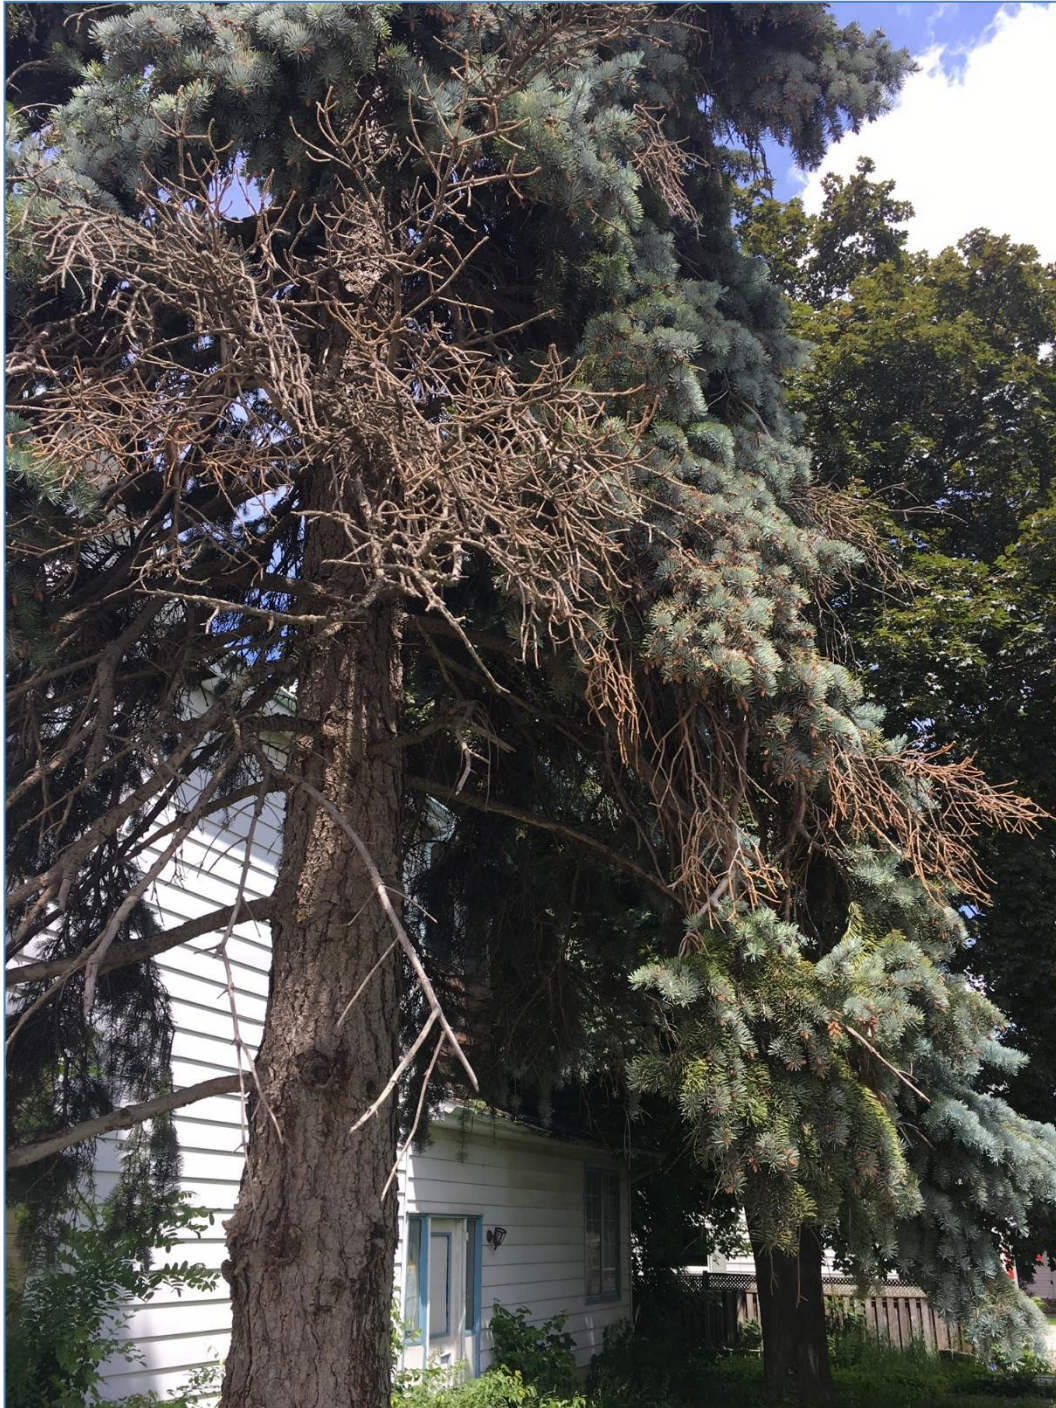
Tree 6: Significant dieback through lower crown

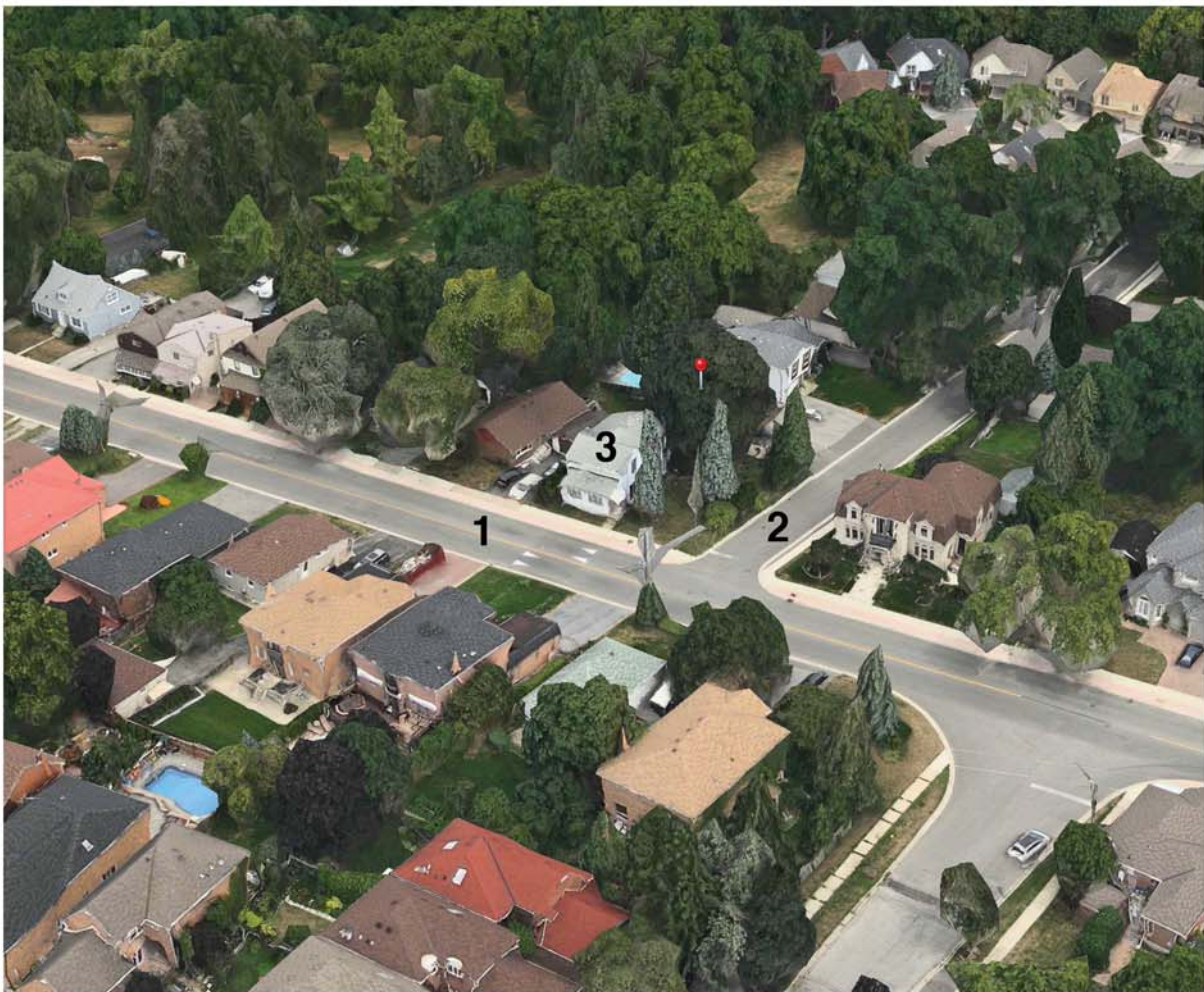
Aerial View Showing Features of the Property

1 - Clarence Street, 2 - Park Drive 3 - 77 Clarence Street, (Tree Closest To Corner Died & Removed)

There are three mature trees on the site, one coniferous at the south - west corner of the house, and two deciduous trees, one at the south - east corner of the addition, and one at the east end of the north property line. There is a mature bush at the north - west corner of the house. The remainder of the lot is grass.

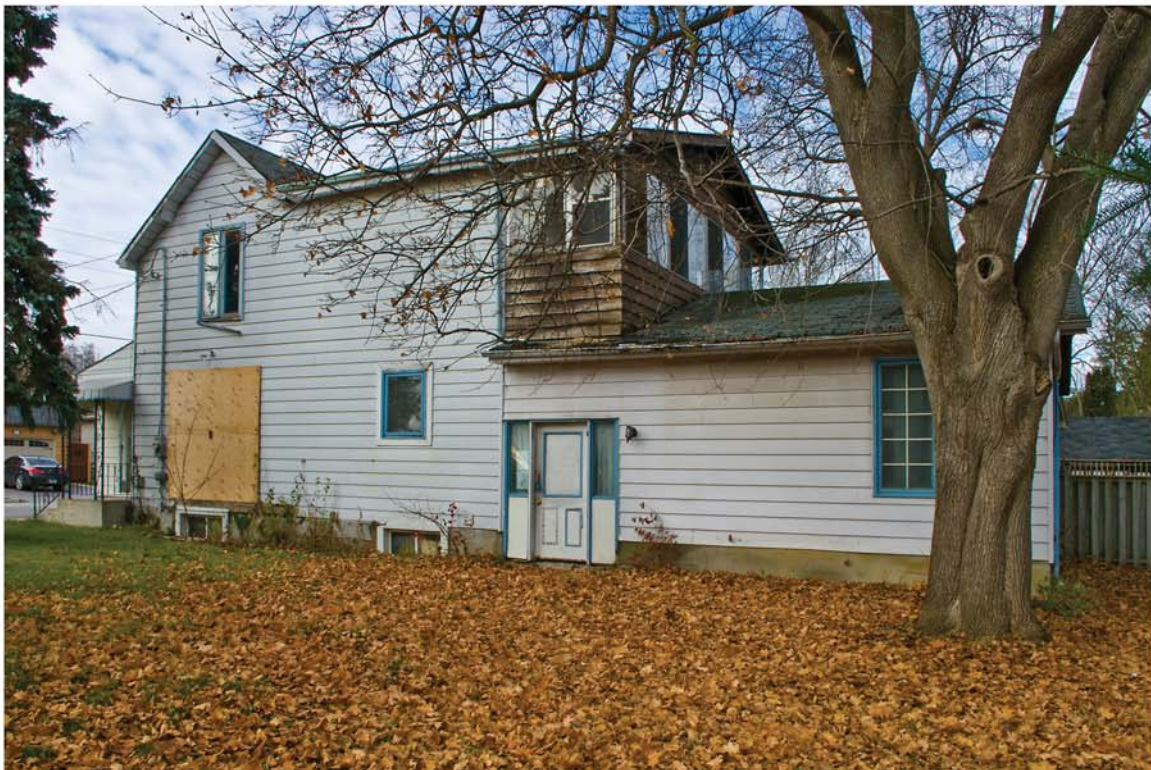
The house has a basement. The ceiling height in the front section is lower than the ceiling height under the kitchen and the addition which is 8' - 0". The building is very lightly constructed, as noted in various sections of the house, particularly in the basement where the first floor joists can be seen to be spaced much wider than 20" apart.

Original Two - Storey House Left, Kitchen Section Middle, And Newer Addition Right

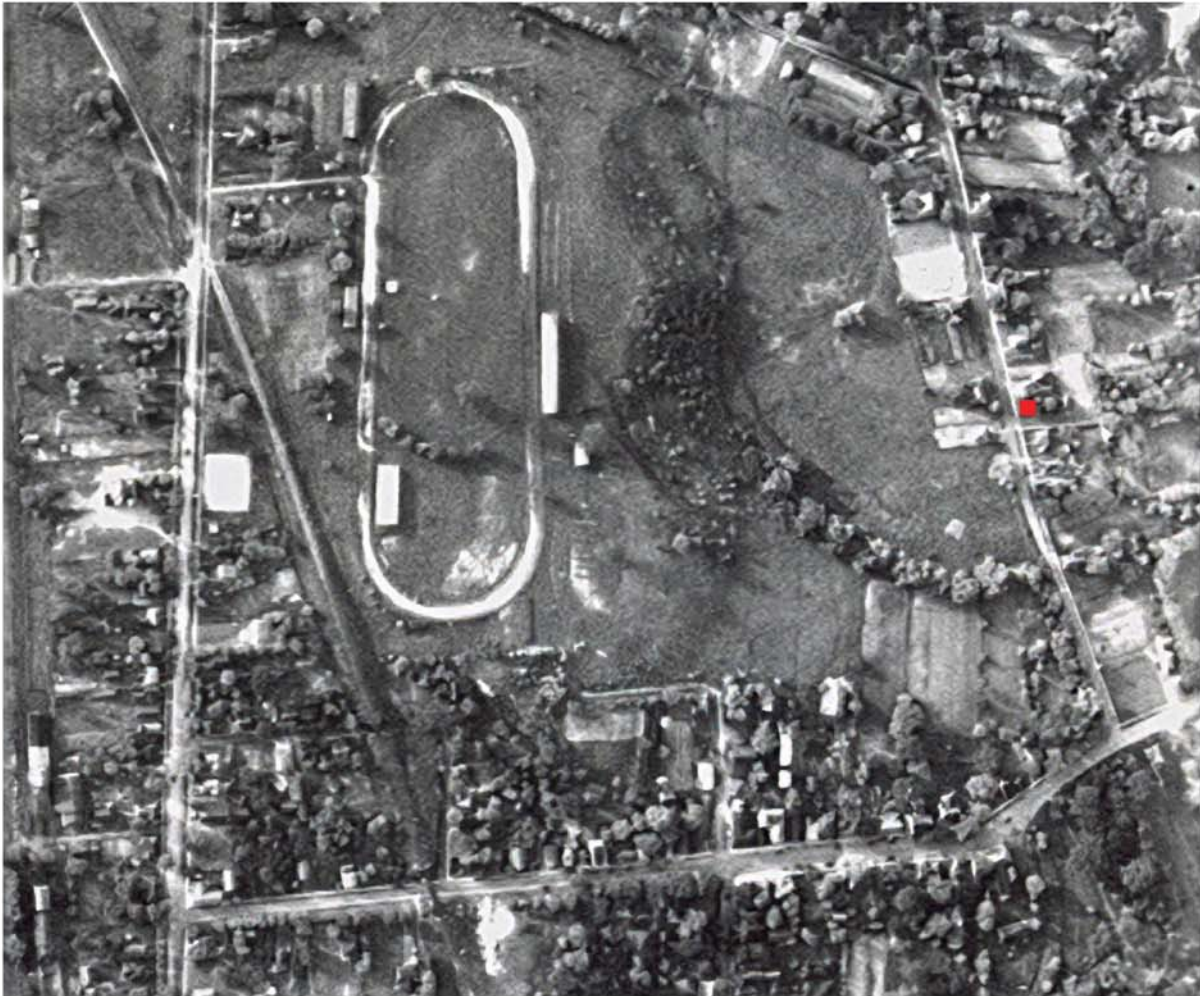
Aerial Image Depicting The Area Of Woodbridge In 1942 - 77 Clarence Street Shows Arthur George Banks House, On The Large Lot Before It Was Subdivided Into Three Lots. The Photograph Also Shows The Distribution And Location Of The Buildings At That Time.
Image From City Of Vaughan Archives And Records Management Services.

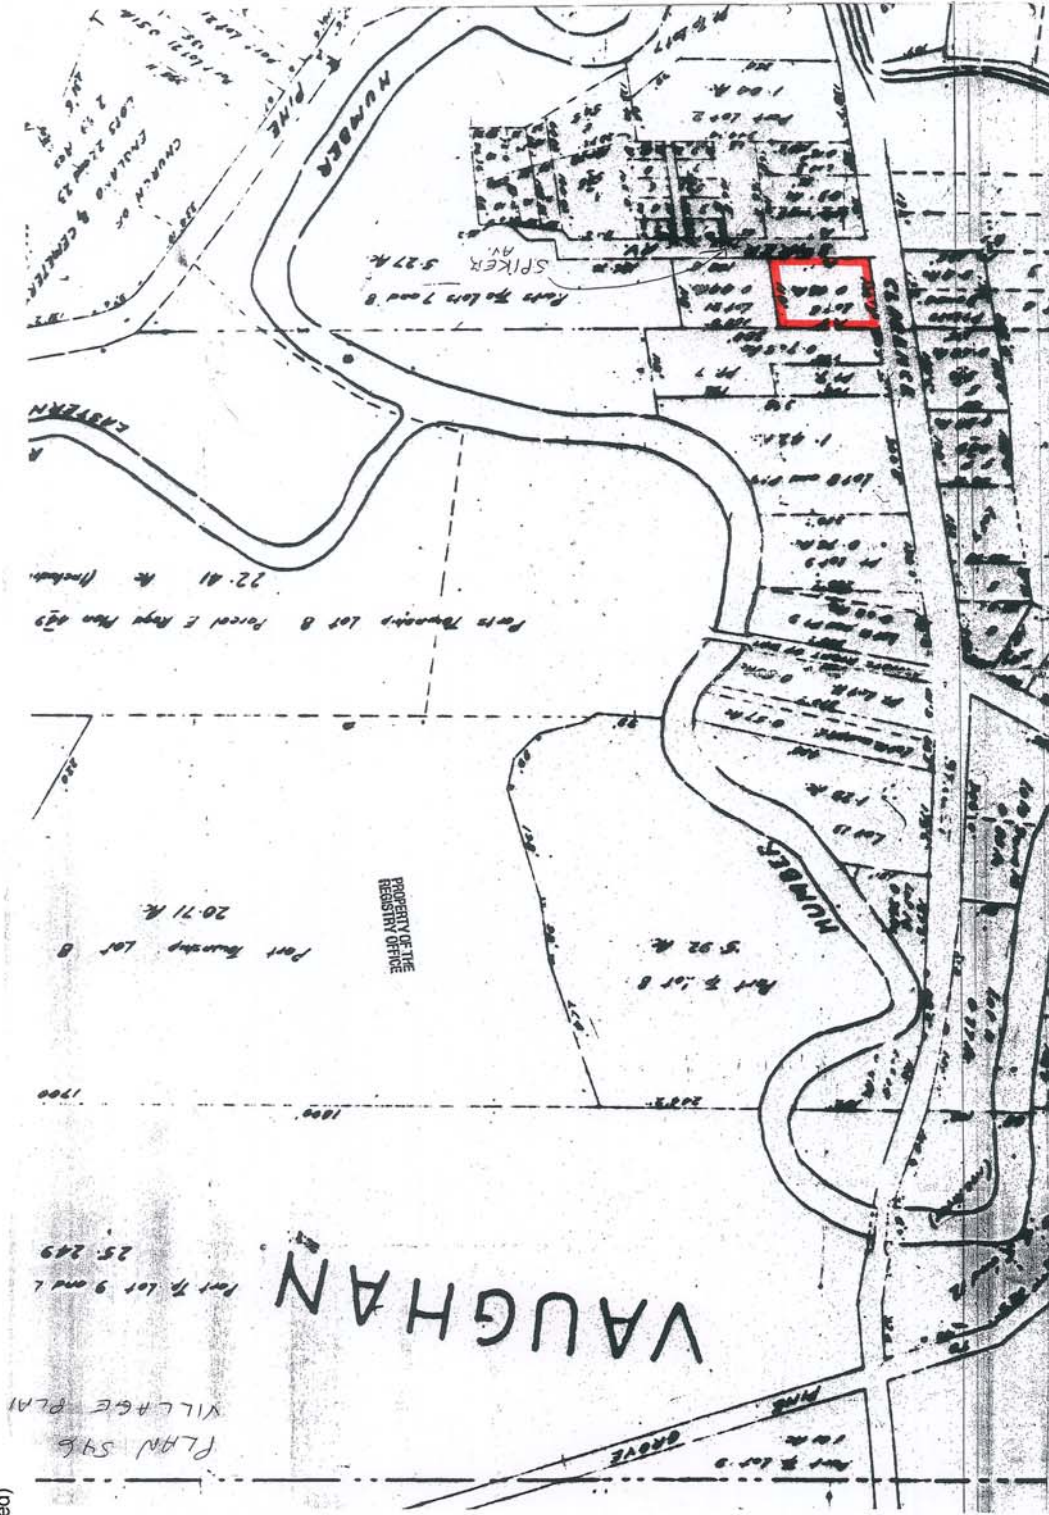
2.2 Plan 546 - Village Plan
Showing Lot 6 which was purchased by Arthur Banks
in 1925, and upon which the house was built.
(Lot 6 outlined in red)

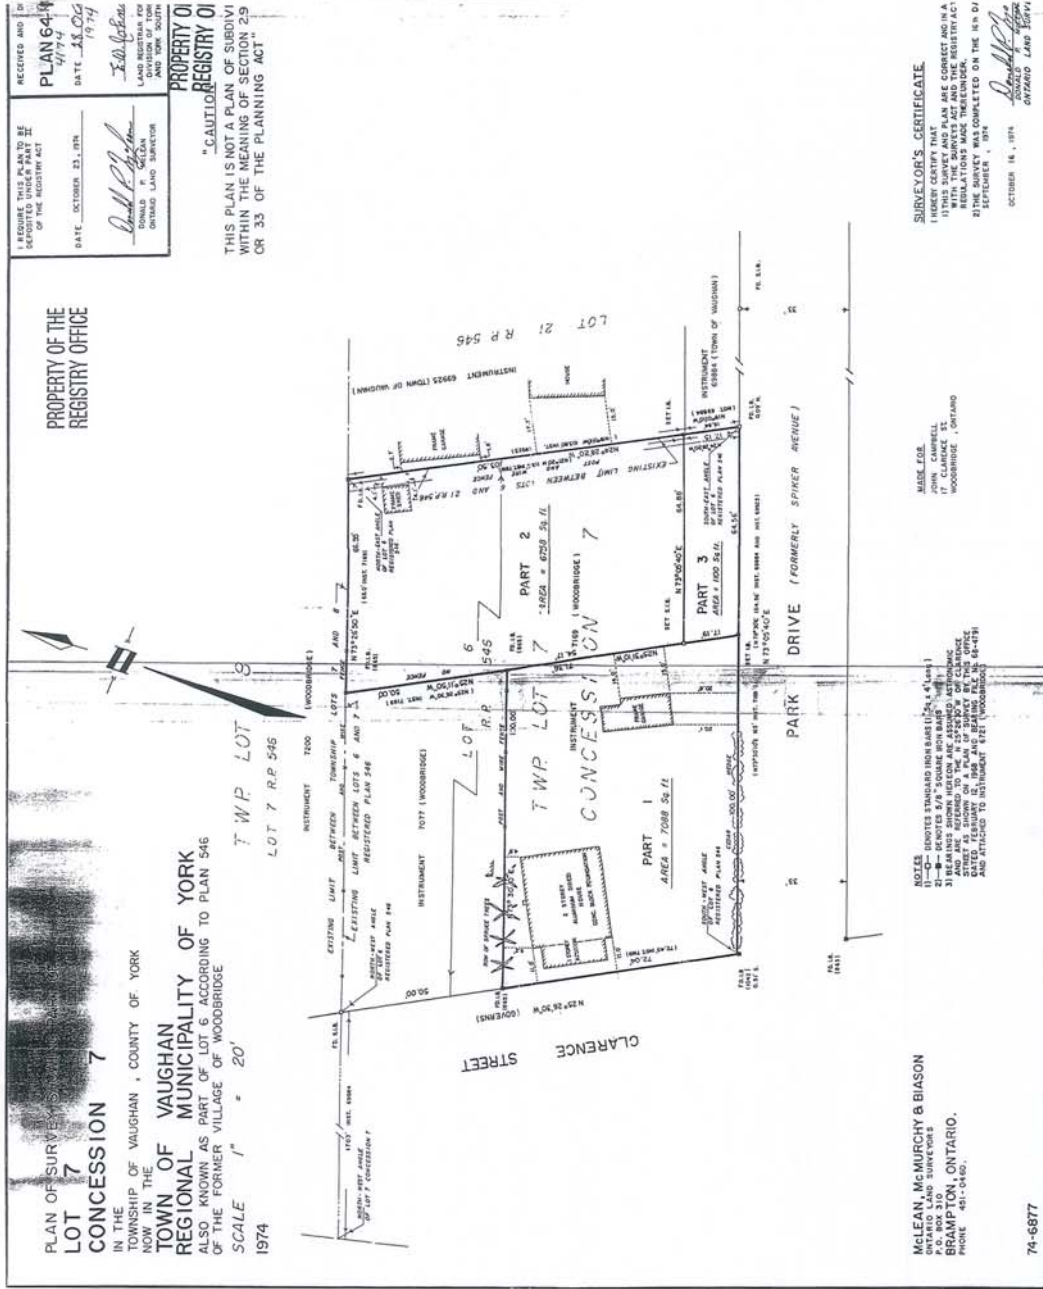
2.3 Plan of Survey Showing Part of Lot 7 Concession 7
IN THE TOWNSHIP OF VAUGHAN, COUNTY OF YORK,
NOW IN THE TOWN OF VAUGHAN, REGIONAL MUNICIPALITY
OF YORK, IN PLAN 64R - 4174

This 1974 Survey shows the present lot noted as PART 1
