HERITAGE VAUGHAN REPORT

**TITLE: NEW CONSTRUCTION – SINGLE DETACHED DWELLING
77 CLARENCE STREET, WOODBRIDGE HERITAGE
CONSERVATION DISTRICT**

CULTURAL HERITAGE IMPACT ASSESSMENT

**77 CLARENCE STREET
CITY OF VAUGHAN, ONTARIO**

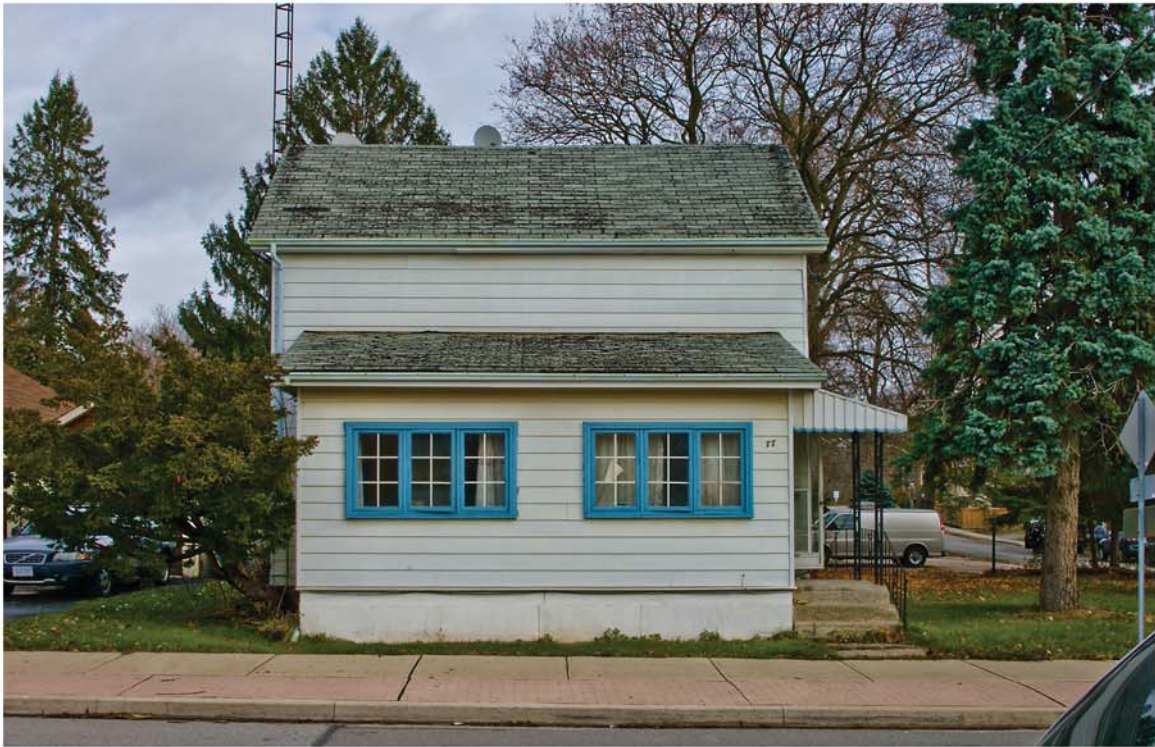
West Elevation

- 1. Original House
- 2. Altered Porch
- 3. Later Addition

The original porch was approximately 17' - 0" N/S by 7' - 0" E/W, and the house including the kitchen / dining is 24' - 3" N/S by 28' - 3" E/W. The later rear addition is 24' - 3" E/W by 24' - 3" N/S. The building is on a concrete block foundation.

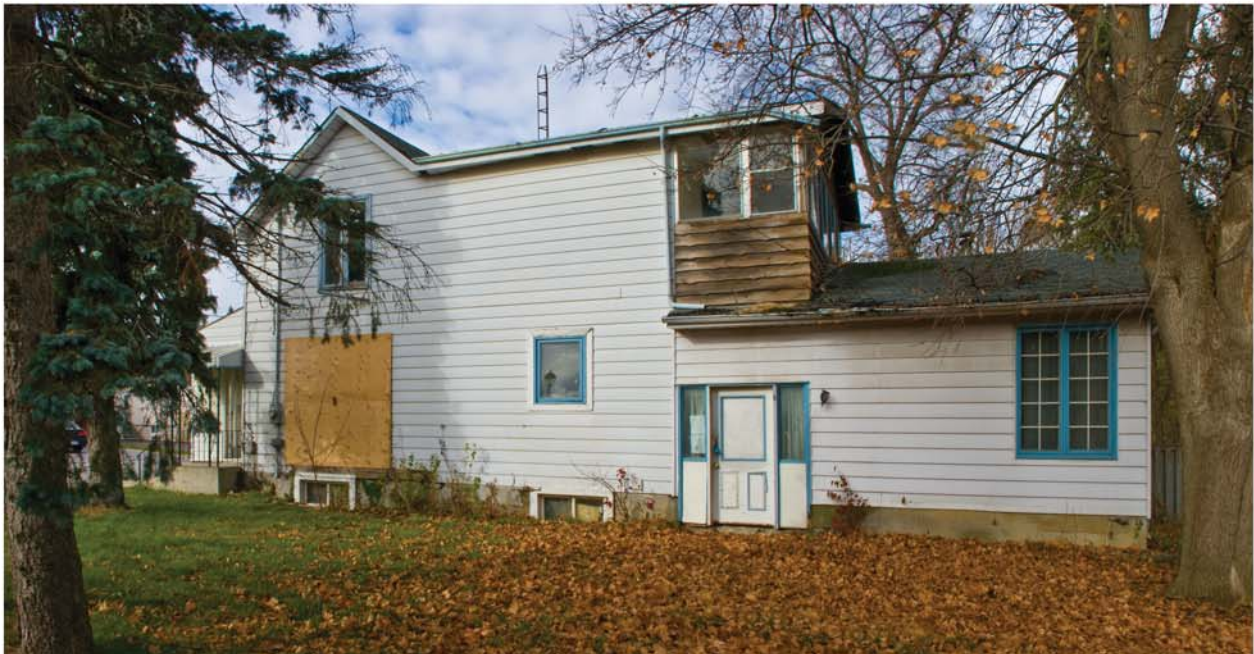
Porch	Front Part Of House	Kitchen / Dining Section	One - Storey Addition With Enclosed Deck
-------	------------------------	-----------------------------	---

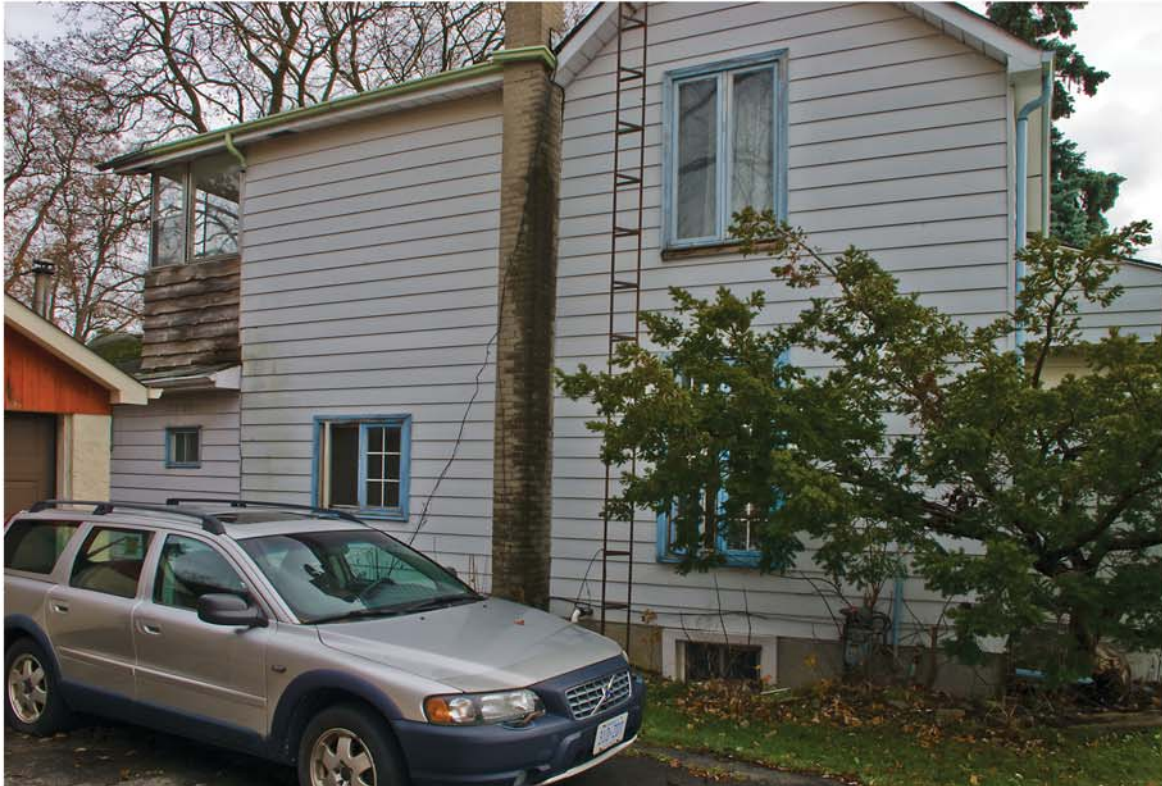
All the original windows have been replaced with casement windows, some with simulated divided lights and some with none. In 1925, the original windows could have been either casement windows with divided lights or double hung windows with or without divided lights. No evidence of the original windows was found, nor was any photographic evidence or reference material located. Some of the windows in some of the rooms are out of scale (too large) with the size of the room. The window openings may have been enlarged when the windows were replaced.

North Elevation Showing Metal Siding, Soffits & Fascia, Enlarged Window On The Second Floor, & Brick Chimney

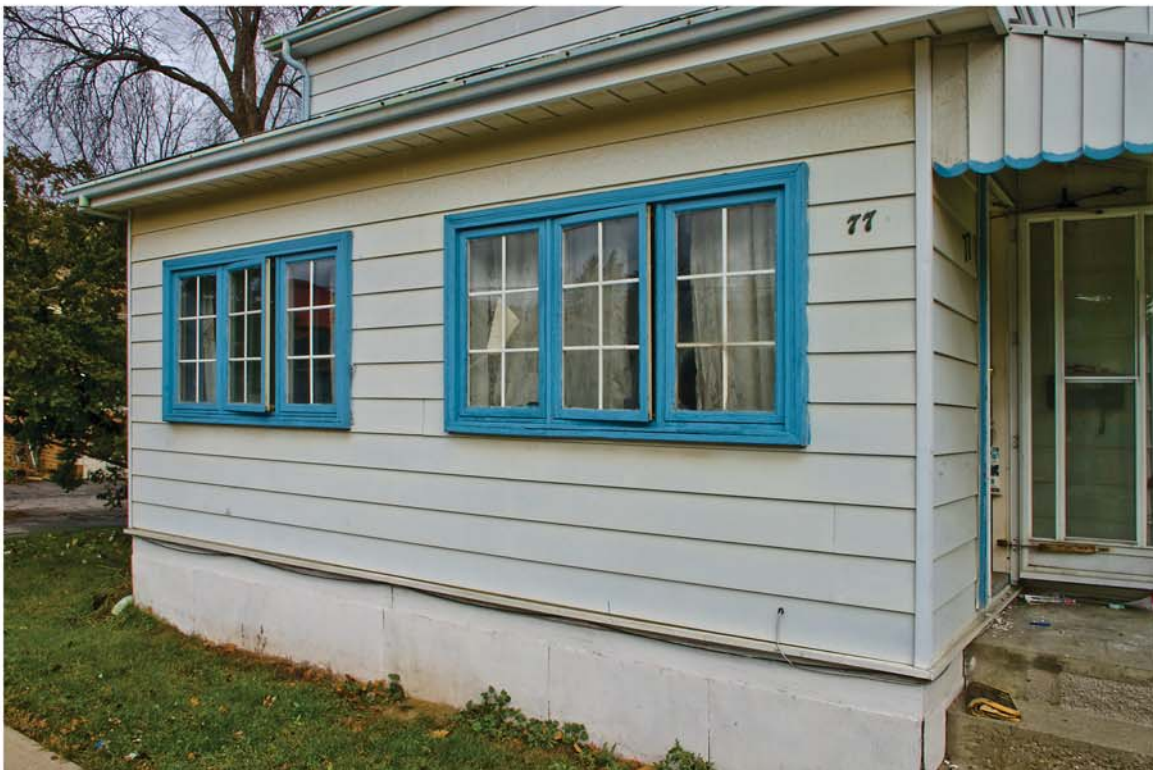
The porch was built on posts, and has no foundation. Traditionally, the space under the porch would have been open and vented by a wood trellis enclosure from the platform to the ground. As this space is now under the living room, flimsy panels have been installed to close off this space from the weather, which gives a temporary appearance.

West Elevation Of The Enclosed Front Porch, And A Portion Of The New Front Entry

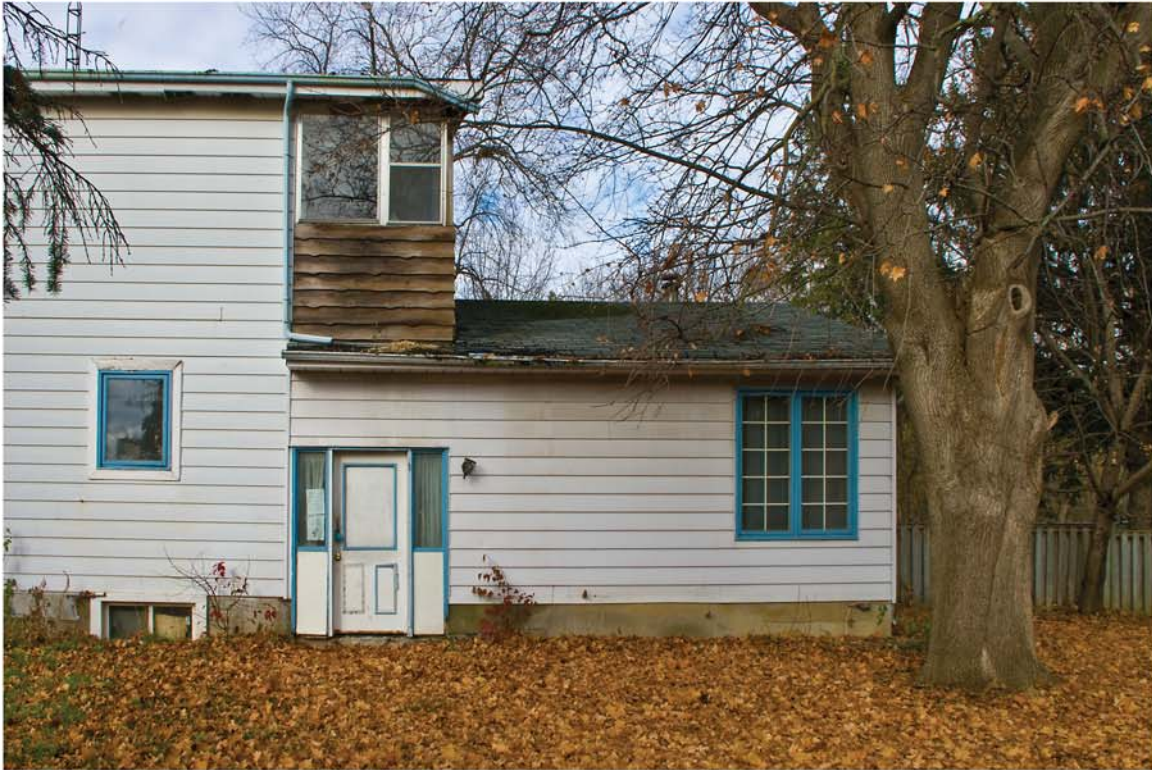
The recent side entry on the south elevation is located at the west end of the one - story addition, and is a poorly constructed door with sidelights. Directly above this is the deck off the master bedroom on the roof of the one - storey addition. It appears to have been built at the same time that the one - storey addition was added, and then enclosed with aluminum windows in a make shift manner at a later date. Its design is a very uncomfortable fit with the house.

South Elevation Of The Kitchen Section Of The Two - Floor House, And The Rear Addition: Showing The Side Entry Door With Side Lights, And The Enclosed Deck Off The Second Floor Master Bedroom

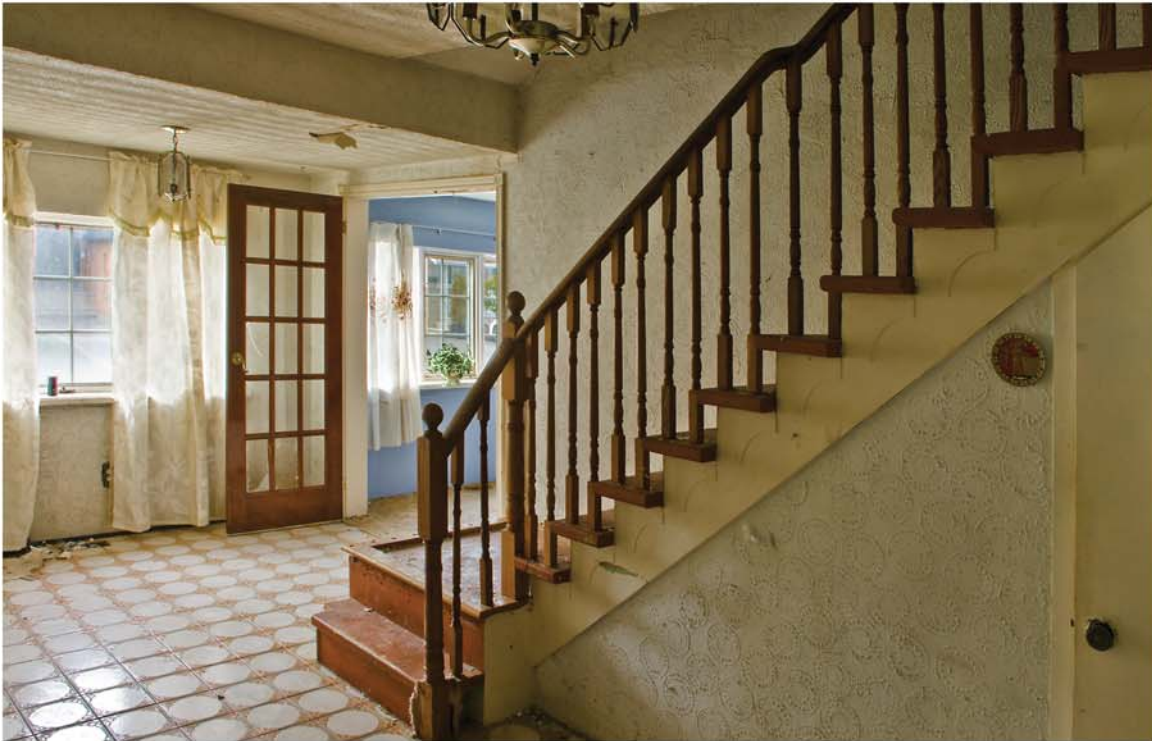
Entry Hall Looking North - West: Showing The Incorporated Enclosed Front Porch Indicated By The Drop In The Ceiling, The Newer Stairs In The Original Location, And No Original Trim

The original first floor plan has been altered by the incorporation of the front porch into the living room and front entry. There are two bedrooms over the original section of the house. The two storey kitchen/dining section with master bedroom above was likely an early addition before the 1974 one storey family room addition to the rear was added. There is no original trim, doors, or baseboard remaining. All of the interior is in very poor condition.

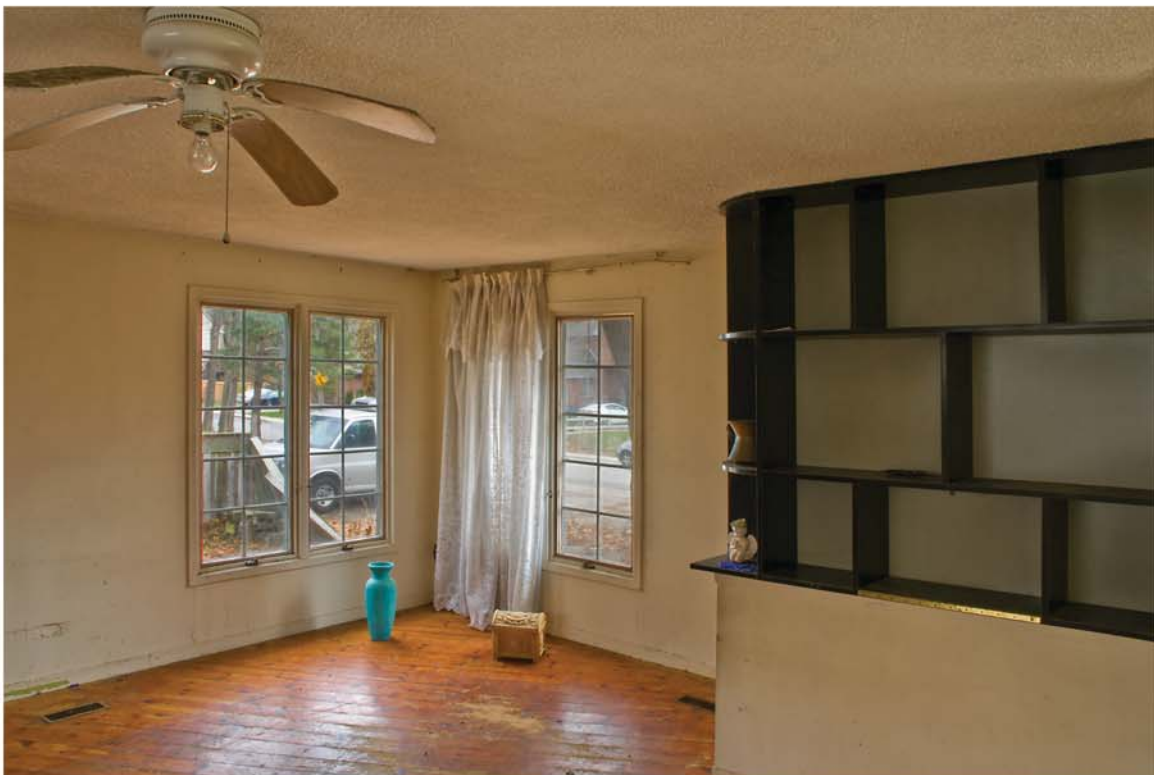
Living Room Looking North - East: Showing Replaced Window, Original Stained Wood T & G Ceiling with Drywall Over, Step Down Entry Doorway To Dining Area, And No Original Trim

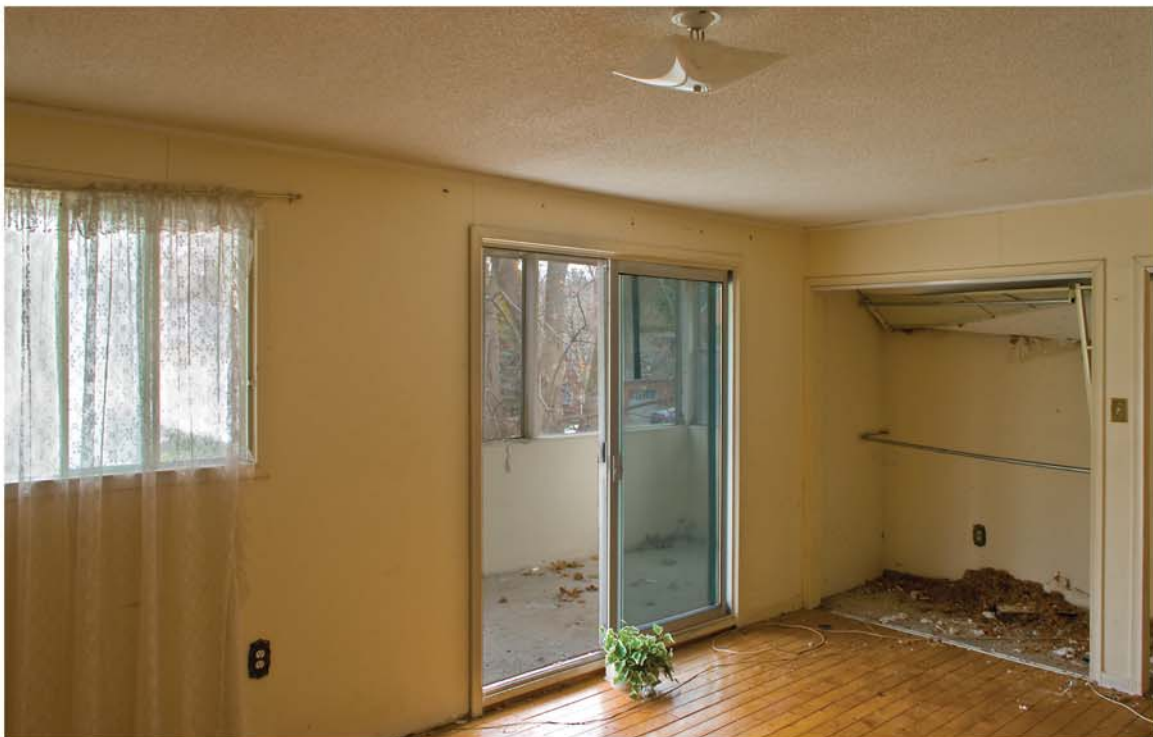
South West Bedroom, Looking South West, Showing New Enlarged Window On The South Elevation, No Window Trim Or Baseboard

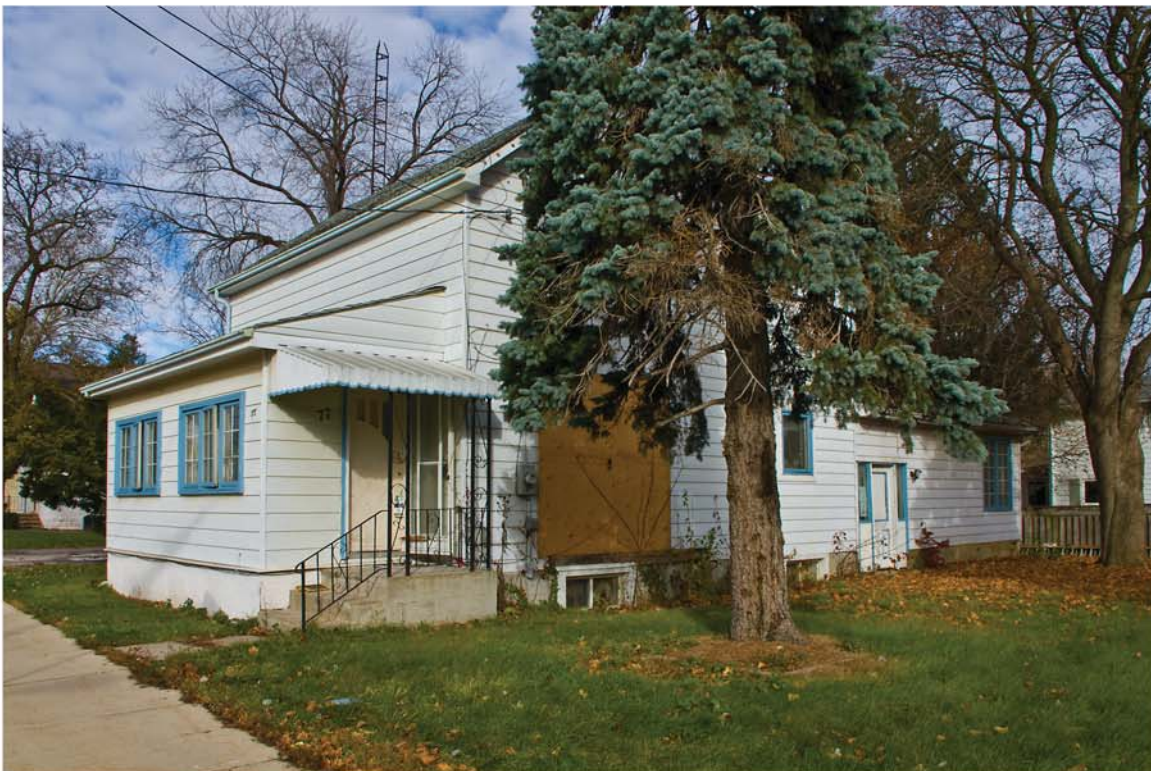
1. Residential building with no particular style
2. Not relevant to 77 Clarence Street's contribution
3. See No. 6
4. Front yard is too short to provide meaningful green space, or tree canopy
5. Although there are two floors the house is a storey and a half
6. North side yard is too narrow to provide a view, the south side yard has a view to part of the house behind, and the houses at the end of Park Drive where the street ends in a T.

South West View of 77 Clarence Street Illustrates Some Of The Above Points

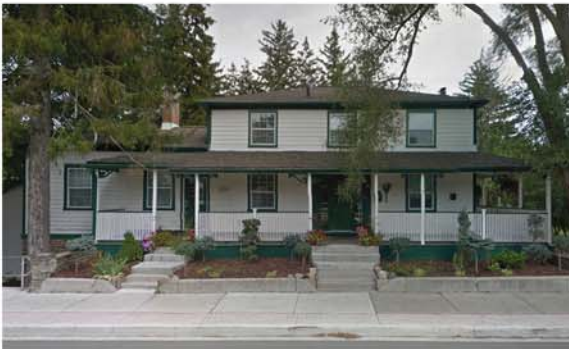
1859 John Abell House - 117 Clarence Street
Early Architecturally Significant House
Georgian Style, Classical Details (Designated)

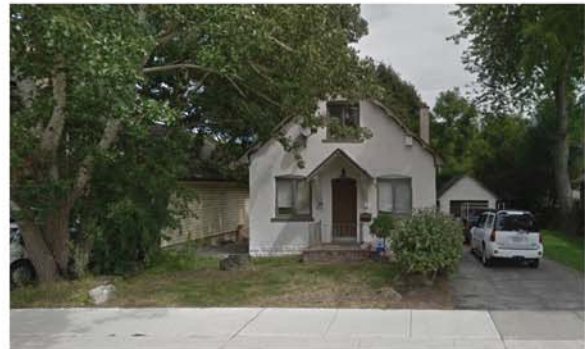
1920 -1925 Vernacular Cottage Style
89 Clarence Street
Typical Workman's Cottage (Listed)

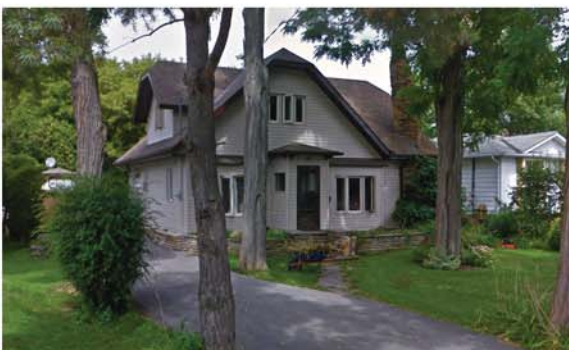
1920 Arts and Crafts Cottage - 20 Park Drive
A More Elaborate Cottage Of The Same Period
As The Vernacular Cottage Style (above right)

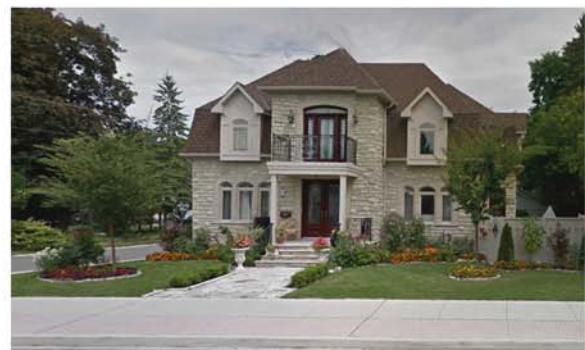
New Residence Built After April 2009
69 Clarence Street - Replaced A Large
Ontario Cottage 1925 - 1950 (demolished)

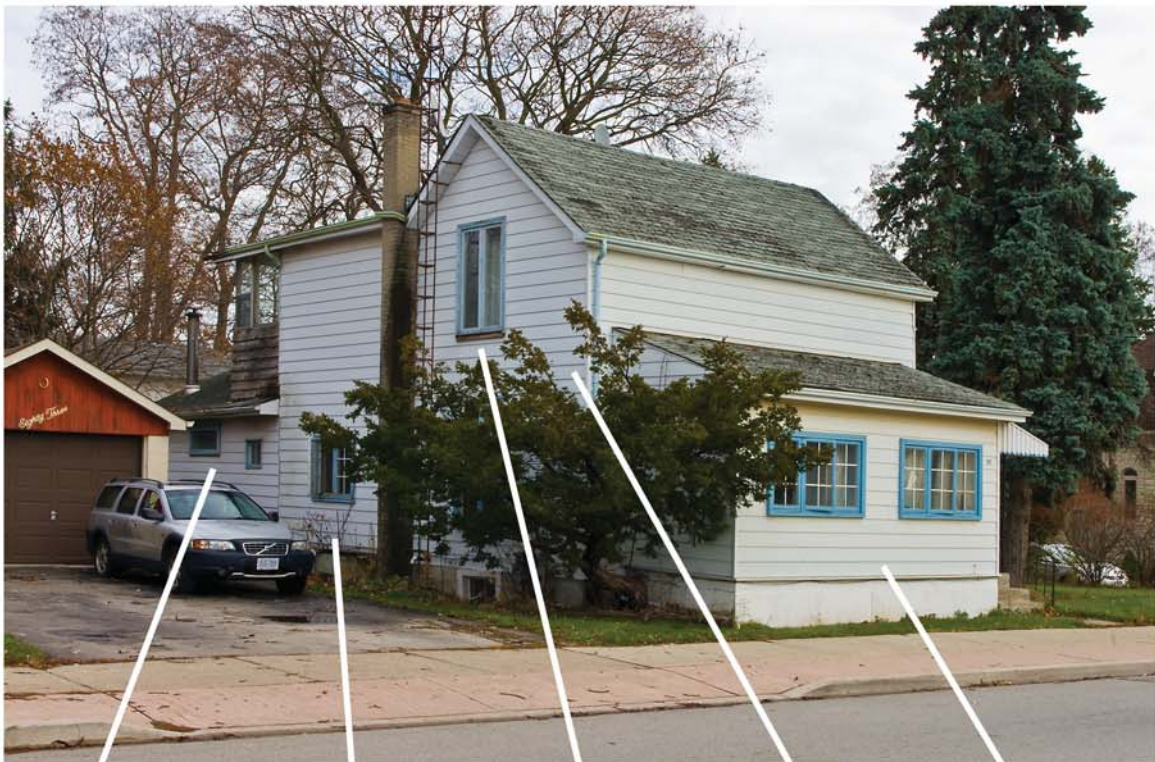
Some of the additions and alterations can be seen in the photograph below. Taking this heavily modified building back to its original form would not leave enough building left to restore.

**One Storey Addition
Built After 1974**

**1 1/2 Storey Addition
Likely Replaced An
Original Kitchen Tail**

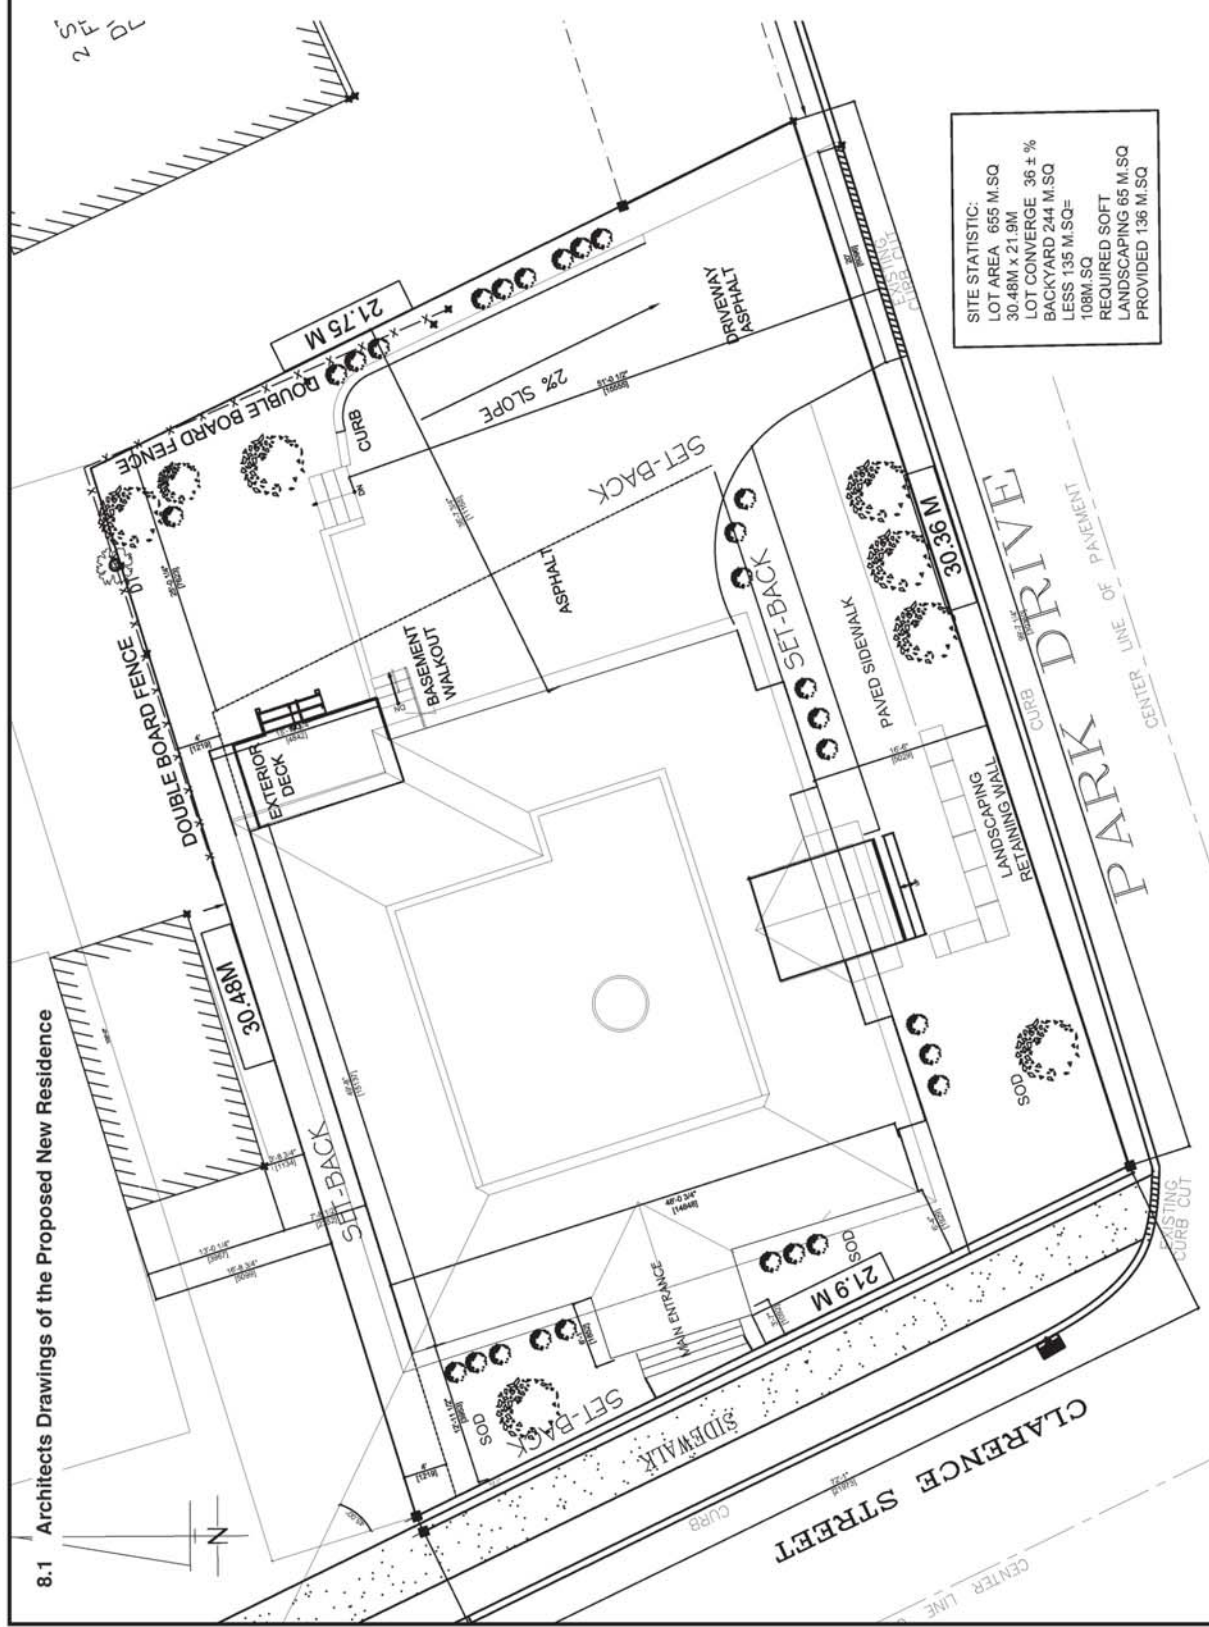
A00

SITE STATISTIC:
LOT AREA 655 M.SQ
30.48M x 21.9M
LOT CONVERGE 36 ± %
BACKYARD 244 M.SQ
LESS 135 M.SQ=
108M. SQ
REQUIRED SOFT
LANDSCAPING 65 M.SQ
PROVIDED 136 M.SQ

The landscape plan (A00) indicates that the front yard on Clarence Street has 1 tree at the north west corner of the lot, and small bushes at the building foundation with the remainder in grass. On Park Drive there are 4 trees, and the continuation of the small bushes at the foundation, the rest is in grass. At the property line there is a small retaining wall and at the east end of the lot is the driveway to the garages. (4)

The house on Clarence Street has a setback of 1.929 m., which is in accordance with the required setback. This will provide landscaping in the front yard as noted above. (3)
