4. Phase 2 – Identification and Evaluation of Alternative Solutions to the Problem

Humber Bridge Trail Bowstring Arch Bridge Class Environmental Assessment

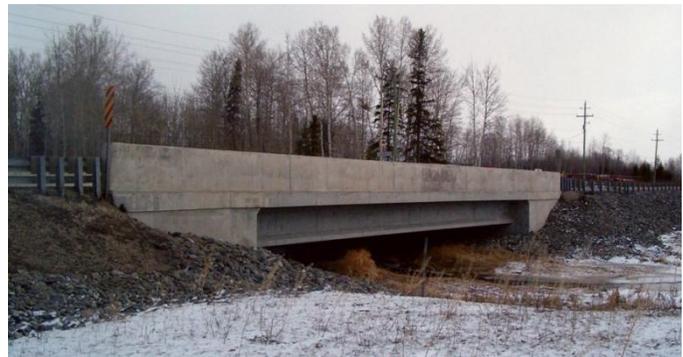
Figure 6. Example of a Concrete Box Girder Bridge

The deteriorating structural integrity, as well as the issue of maintaining access to the residence on the eastern bank of the Main Humber River along Humber Bridge Trail, would be addressed through this alternative by removing the existing structure and erecting a new precast concrete girder bridge in the vicinity of the current bridge. The span of the new bridge would be increased from that of the existing bridge in order to permit construction of the abutments away from the watercourse.

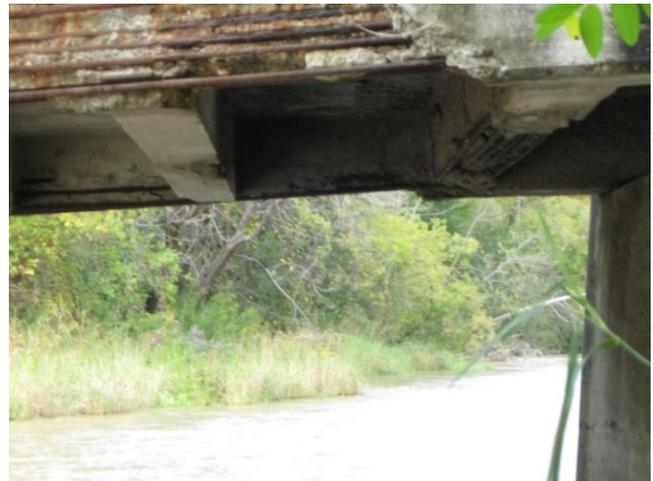
Figure 7. Cross Beams Showing Spalling

The deck top is in fair to poor condition, with roughly half of the deck area exhibiting large cracks and potholes (**Figure 3**). Deck curbs are in fair to good condition, with some scaling (flaking or peeling), especially in the areas where the curb meets the deck, while the deck crossbeams are in significantly worse shape, experiencing scaling to the side faces and most also showing delamination (separation of the concrete above and below reinforcing bars) to the bottom face, with corrosion of the bottom reinforcement bars as well. One beam in particular has experienced severe delamination, to the point of exposing the bottom reinforcement bars (**Figure 7**). The arches that make up the top chord of the truss are in fair to poor condition, with some minor scaling to all surfaces, as well as some areas of spalling (where the concrete essentially breaks off from the main structure in small pieces), especially at the point of connection between vertical spandrel members and the arch (**Figure 8**). The bottom chords of the trusses are both in very poor condition, with severe delamination and scaling, and the majority of reinforcement bars are exposed and heavily corroded (**Figure 4**). The vertical and horizontal spandrel members are in poor condition, each exhibiting varying degrees of delamination, many with their reinforcement bars exposed and heavily corroded (**Figures 9 and 10**). Handrails at either end of the bridge are in poor condition, suffering from delamination and spalling (**Figure 11**). Both abutments appear to be in good to fair condition, with some scaling but without serious cracks or delamination; however inspectors were unable to confirm erosion in front of the abutments, due to high water levels. The wingwalls are in good to fair condition, experiencing some scaling but no delamination, and there is no evidence of erosion to the concrete itself, although high water levels prevented confirmation of this. Serious erosion to the soil was observed behind the northwest wingwall.

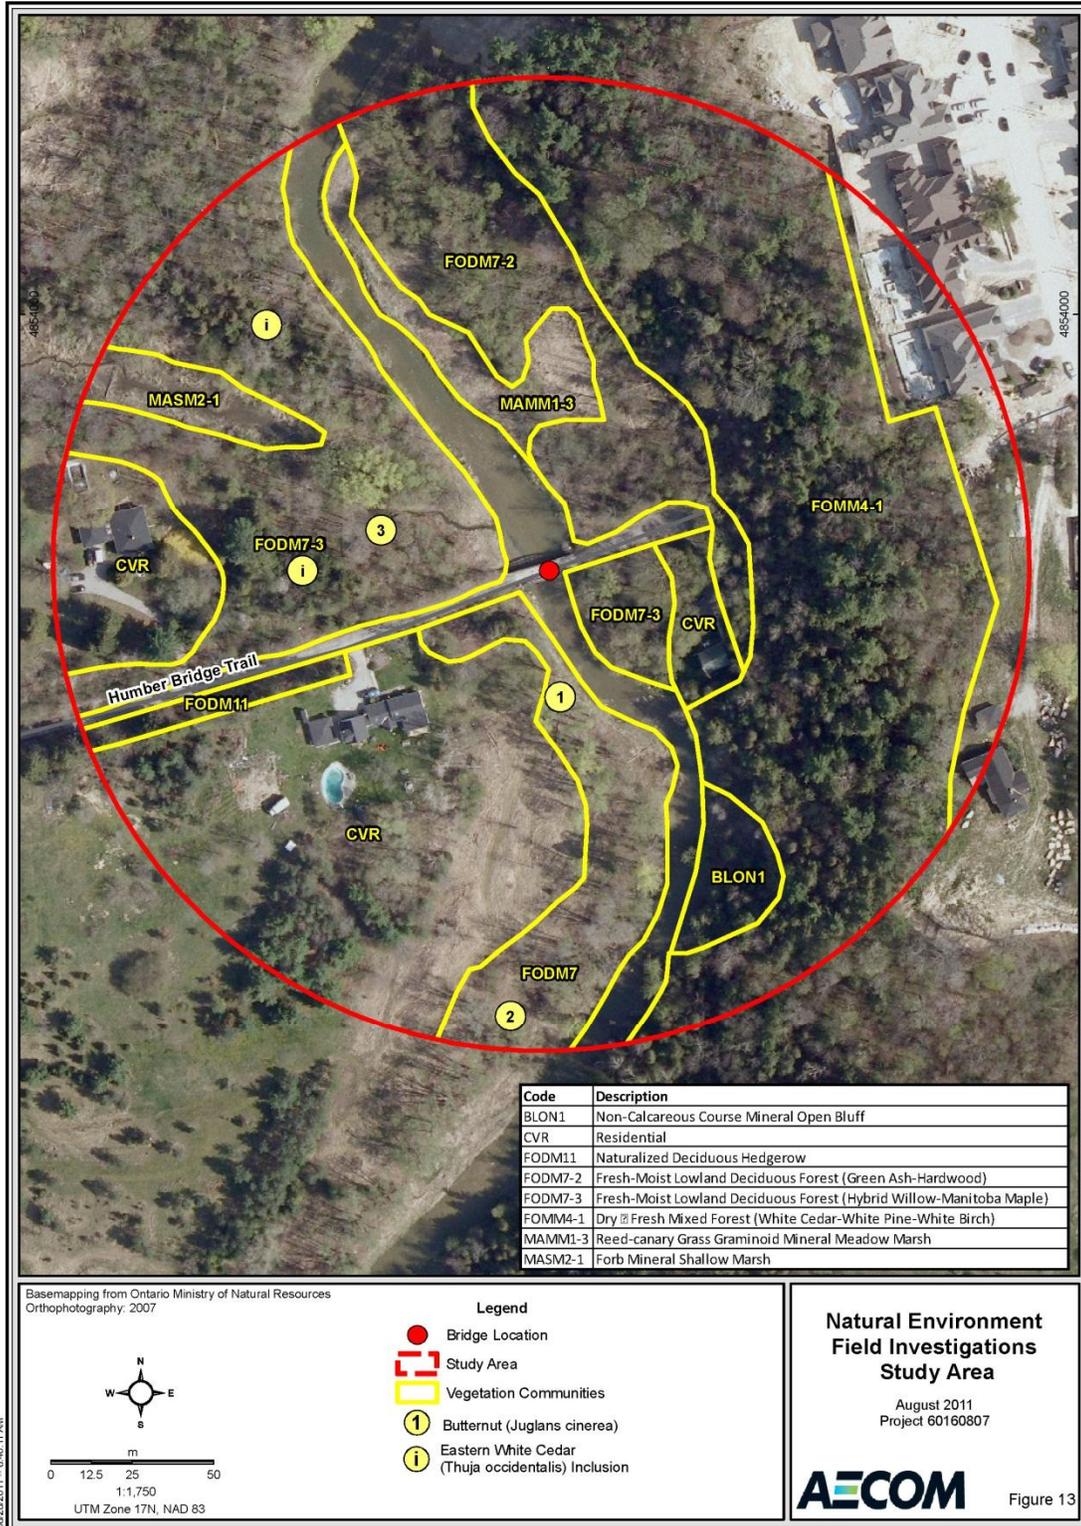
Figure 13. Natural Environment Field Investigations Study Area

Field investigations confirmed the presence of three Butternut specimens within 150 metres of the bridge (**Figure 13**). As this species receives protection under the *Endangered Species Act* (2007), a permit may therefore be required should the proposed undertaking pose a threat to this species. A general description of each Butternut specimen is provided in **Table 4.3** below. All three specimens exhibited signs of Butternut canker disease.

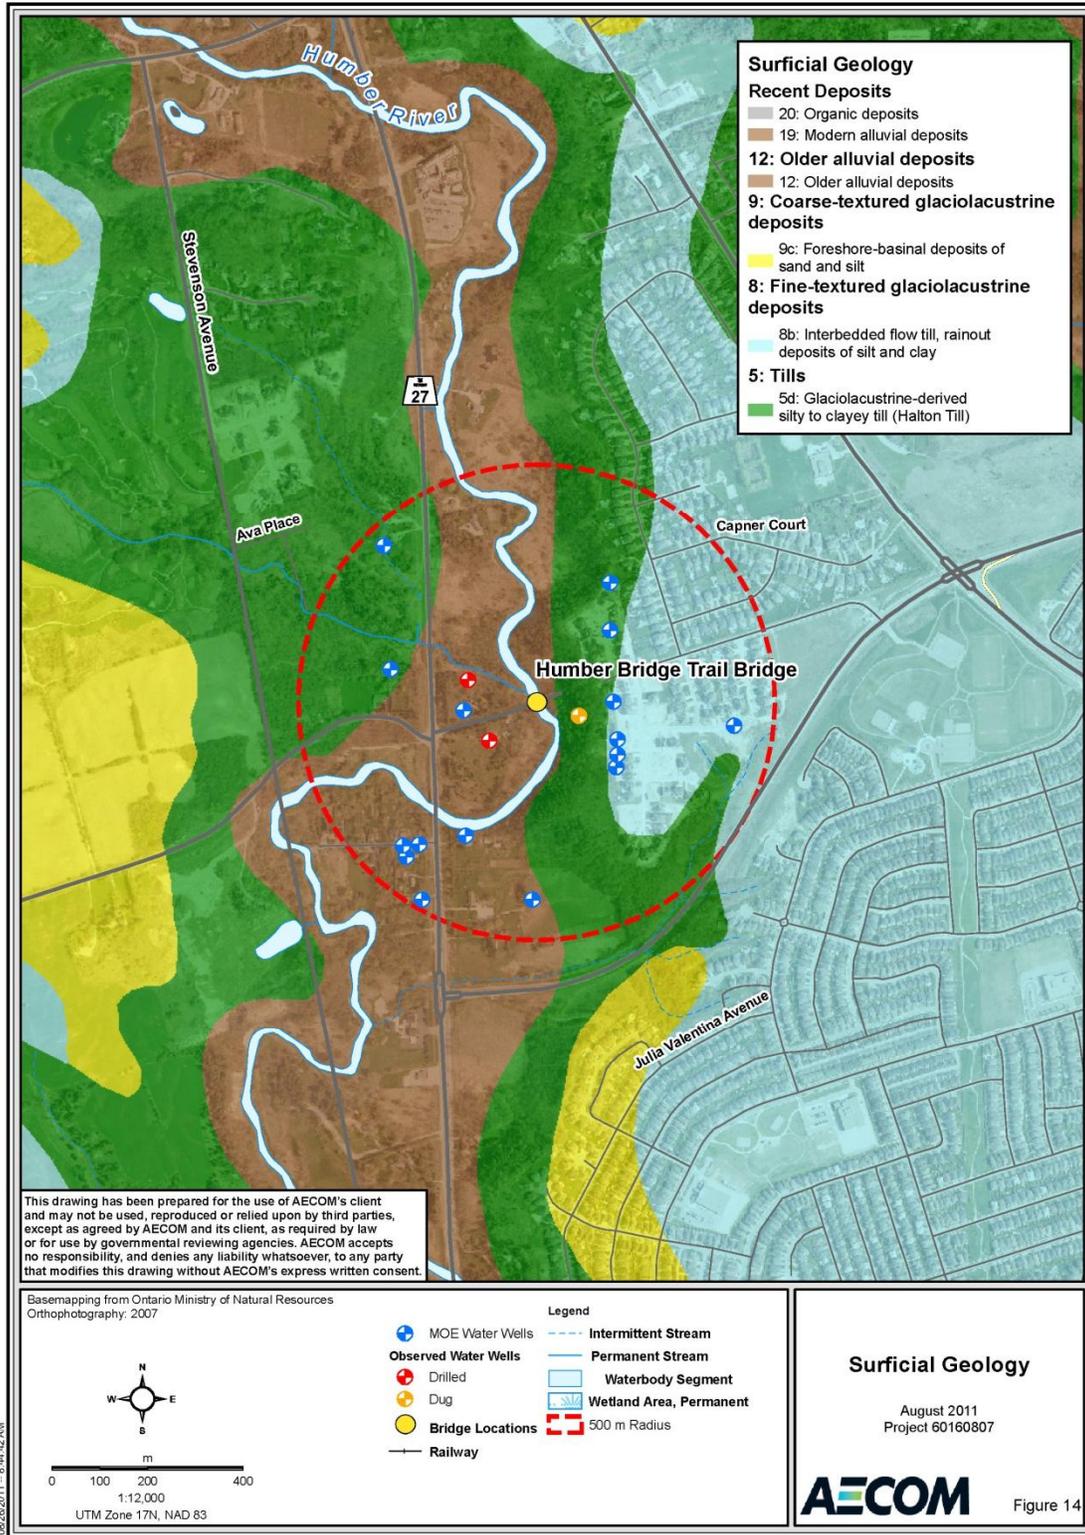
Figure 14. Surficial Geology

As Shown in **Figure 14** the shallow subsurface stratigraphy within the study area is generally made of up of (in descending order):

- Approximately 1 to 2 metres of modern alluvial deposits of silt, sand and gravel; and
- Approximately 10 to 20 metres of clayey silt till from the Halton Till Formation.

Sixteen water wells are recorded to be within 500 metres of the Humber Bridge Trail Bridge. Seven of these wells, located on the eastern side of the Main Humber River, are anticipated to be no longer in use, due to municipal water servicing the subdivision in this area. A road-side well survey was conducted along Humber Bridge Trail and identified three active water wells (referred to as “observed wells” in **Figure 14**):

- #5789 Humber Bridge Trail – a 0.61 metre diameter dug well, likely less than 10 metres deep;
- #5840 Humber Bridge Trail – a 0.15 metre diameter drilled well; and
- #5821 Humber Bridge Trail – a 0.15 metre diameter drilled well.

This section provides an overview of the existing geologic and hydrogeologic conditions associated with the area extending 500 metres from the Humber Bridge Trail Bridge in all directions (**Figure 14**).
