**RESTORATION AND ALTERATIONS TO KLEINBURG UNITED CHURCH
DESIGNATED UNDER PART V, ONTARIO HERITAGE ACT
10418 ISLINGTON AVENUE, KLEINBURG-NASHVILLE HERITAGE CONSERVATION
DISTRICT
WARD 1 - VICINITY OF ISLINGTON AVENUE AND STEGMAN'S MILL ROAD**

Building Condition Assessment
Kleinburg United Church | KLEINBURG

Prepared by:
Lynch + Comisso: Architecture + Light
23 January 2017
1628

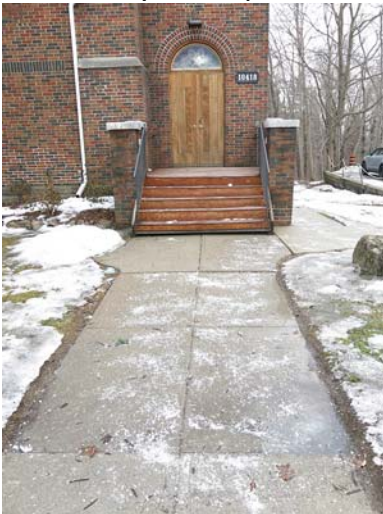
East Entrance from street

Presently, there are many transitions and steps with some uplifted sections of concrete sidewalk. This area will require some work to make the area accessible. A ramp will be required to access the Ground Floor of the facility or a separate structure is needed at the North Side Yard for this purpose.

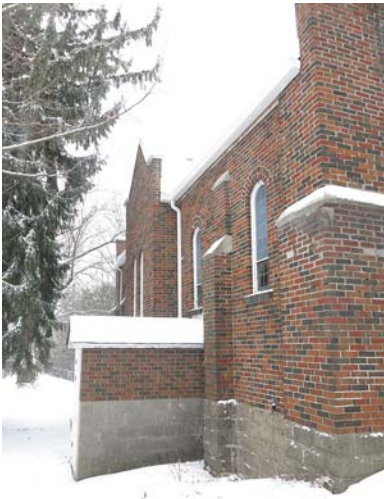
Covered Basement walk-out (South Side Yard)

The covered walk-out concrete exit stair from the Basement needs to be re-built to have a level landing at the top of the stairs. If this encroaches on the property line then a minor variance will be needed or the stair needs to be reconfigured to exit towards the front or rear lot lines. Some re-grading is necessary to ensure that water flows away from the building.

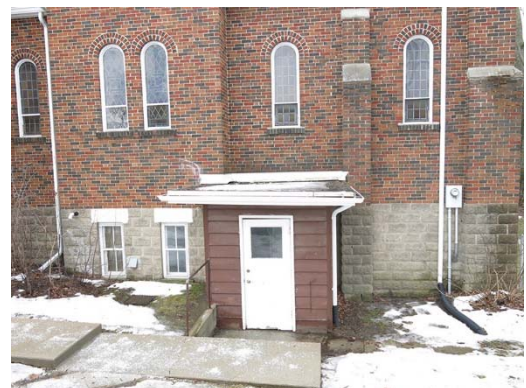
North side of Church

This yard includes access to the Basement and a number of stepped concrete ramps and stairs to access it. In addition there is a catch basin. This area appears to be a source of some water infiltration to the building. It is recommended to remove the existing exit enclosure, remove the exit which does not meet code, and re-grade as necessary to ensure that water flows away from the building.

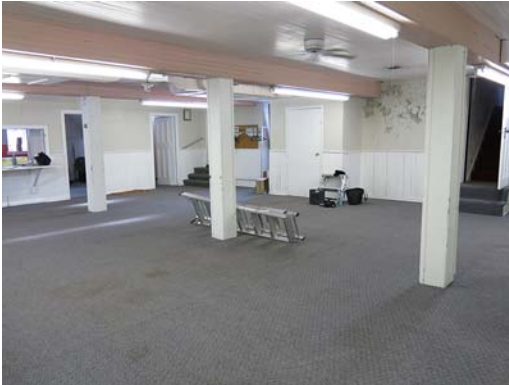
Basement – columns and beams

- Basement columns – do not meet current codes
- Bell Tower intermediate floor and roof structure – intermediate floor is missing boards and access to high level roof was not possible at time of review

Ground Floor consists of existing 2 1/2"x10" full size joists at +/-24" o/c spanning east-west supported on solid timber beams spanning north-south. Timber beams are supported on two exterior north and south walls and one row of columns at the center of the Basement space. Because of notches in these beams, we assume they were salvaged from a timber post and beam structure. Existing Ground Floor joists and beams were measured where possible to confirm the existing sizes provided. Columns are 8x8 solid timber. The Basement was generally finished so structural members and walls are not visible in most locations.

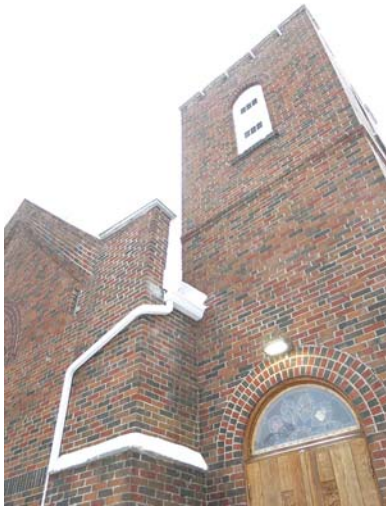
Single downspout on East Elevation

The flashing was installed on all parapets but done in an ad-hoc way; face fastened and relying on caulking vs reglets to prevent water ingress. While the gutters are sized correctly the downspouts appear to be undersized and insufficient in number. The south side only contains 2 downspouts serving the entire elevation and ice formation is visible on the southwest corner. The East elevation has one downspout at the entrance which is undersized and ice formation is visible on the face of brick. Refer to the additional photos of the ice formation included in the masonry section above.

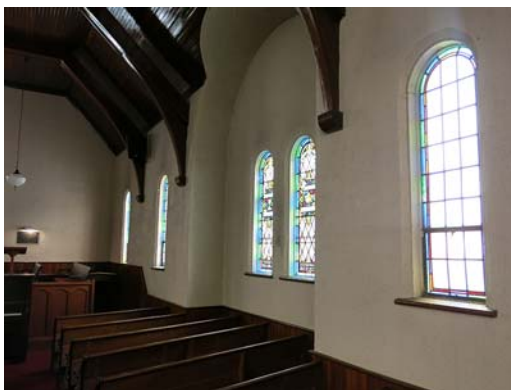
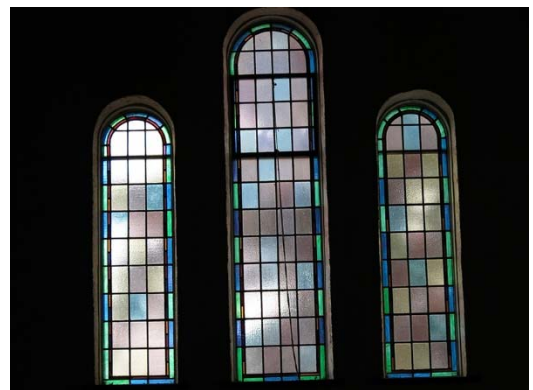
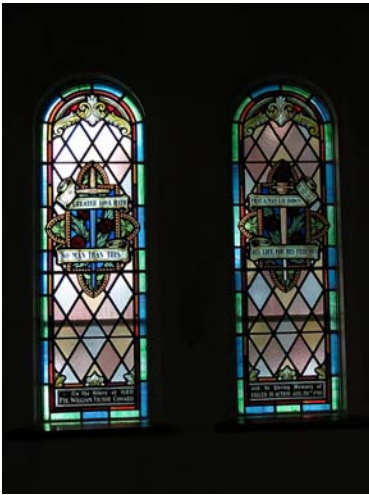
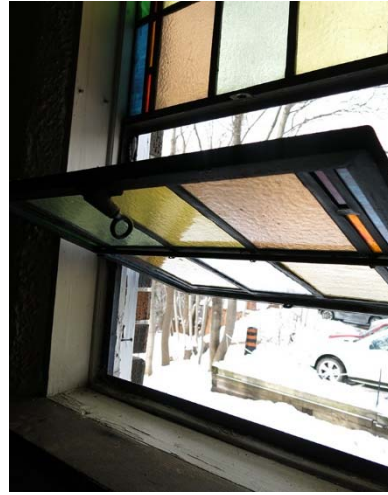
It is assumed that the windows are approximately 90 years old. Generally the stain glass windows are well made, with quality leading and in good maintainable condition. Some units had been repaired in the past but were mostly untouched except for the addition of caulking. The units do not appear to be suffering additional loading from the structure except in a couple of areas. The panes are secured with wood stops. Where operable sashes are present, the bottom of the fixed pane is supported on the steel sash frame. There are over three dozen glass breaks throughout the collection and one or two panes that have been replaced previously with coloured glass that does not match the original.

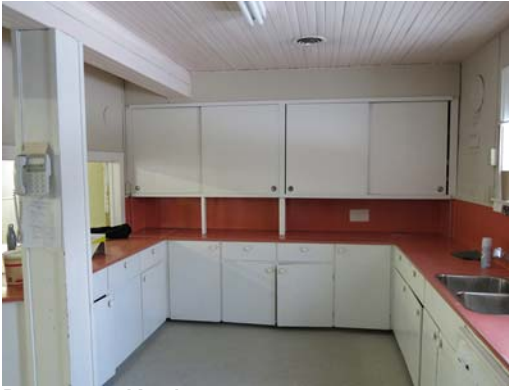
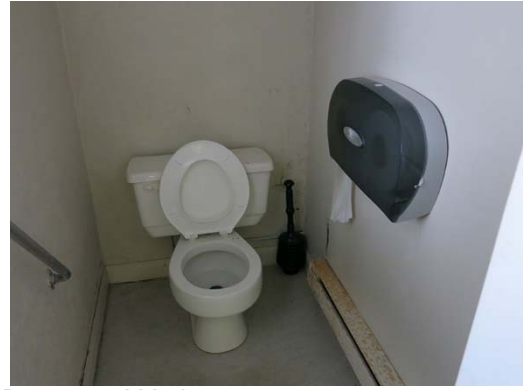
There is Vinyl Asbestos Tile (VAT) under vinyl sheet flooring in the kitchen and bathroom areas (assumed). Please consult DSS for more information.

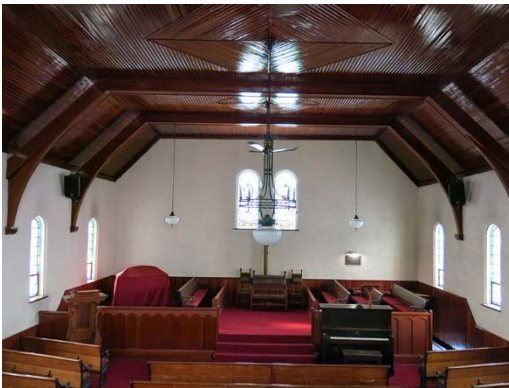
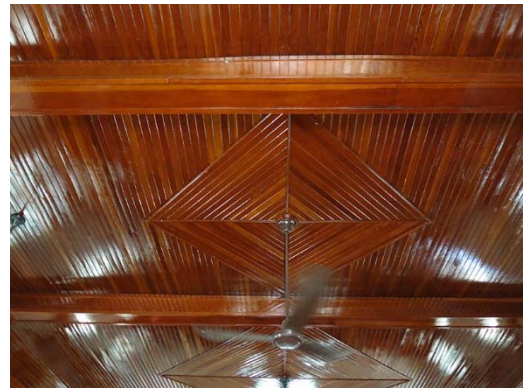
The Ground Floor has a decorative wood ceiling with a glossy stained finish. The ceiling is in good condition.

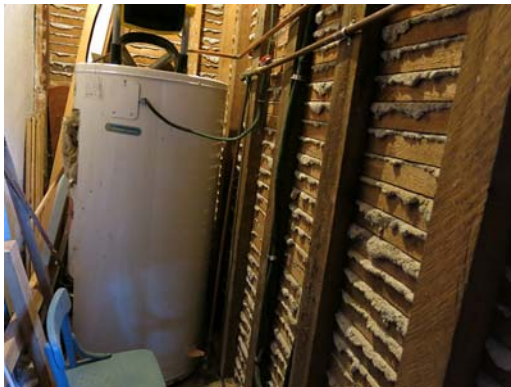
The domestic hot and cold water piping distribution system appears to be of copper piping and fittings and in good condition. A ½" (12.7mm) copper water line complete with water meter enters the Basement in the south-west corner for domestic cold water which is undersized. The utilities plan for the street indicates there is a ¾" (19mm) line to this site. An existing 40 gallon (150L) electric hot water tank is located via the Basement, below the stair in the north-west corner of the Basement. There are two washrooms and a kitchen located at the west end of the Basement which domestic hot and cold water are serving. Plumbing is routed through the ceiling space of the Basement from the water meter to serve this area. The plumbing fixtures in the existing men's and women's washrooms are in poor condition. The existing domestic water main is not equipped with a back flow prevention assembly.

Electric hot water tank below stair
in north-west corner Basement

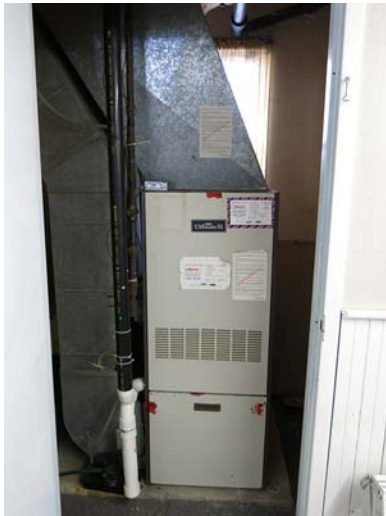
The existing building is served by two forced air gas-fired furnaces located in the Basement. Each furnace is located in a closet and serves the south and north sides, respectively, of the building providing heating via round diffusers for the Basement and rectangular registers for the main floor. The existing gas meter is located on the south side of the building and gas piping is routed into the building and through the Basement to serve each furnace.

Existing forced air gas fired furnace

The Church is equipped with two natural gas forced air furnaces that are not adequate for the space. The system should be replaced with one new gas fired furnace to service both the Ground Floor and Basement floor area. Consideration should be given to the installation of larger ceiling fans in the Sanctuary with high volume/low speed capability. These fans would provide a comfortable cooling breeze and would also help circulate warm air in the winter months. New air-conditioning is proposed as well as the installation of an energy recovery ventilator to increase the air circulation and amount of fresh air. We recommend a new exhaust system complete with duct work, exterior wall louvers and controls be installed in the men's and women's washrooms.

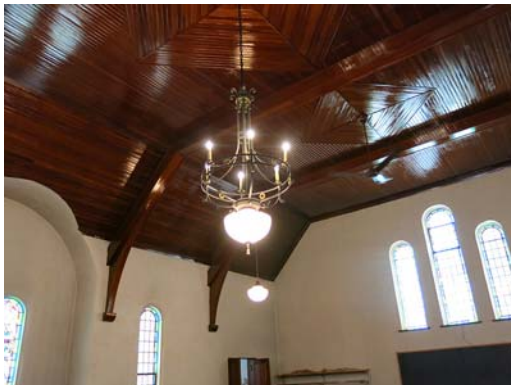
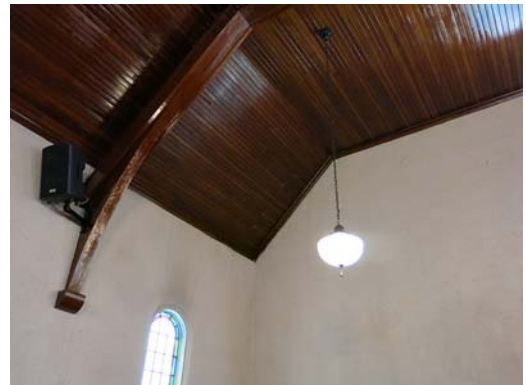
General lighting in the Nave is aesthetically appropriate for the use as a church, though the light level is low. Single and cluster pendant fluorescent lighting fixtures are installed throughout the main floor level and controlled by wall mounted remote switches. Surface ceiling mounted strip fluorescent lighting fixtures (8' c/w 2-T12 lamps) are installed on Basement level and controlled by remote and pull chained switches. Indoor stairs are equipped with wall mounted fluorescent lighting fixtures. Vestibule areas are equipped of wall mounted LED lighting fixtures c/w photo sensor switch. Outdoor wall mounted lighting luminaires are installed at front & north sides of the building.

General lighting on the Ground Floor is inadequate and although aesthetically appropriate it does not provide the required light levels for the new proposed use. There is minimal lighting at the exterior of building at night and all internal lighting is off making for a completely dark building. This is unsafe as well as being neglectful of this beautiful building. The Church would benefit from a lighting overhaul which would create an immediate and lasting impression within the church. The existing light fixtures in the Sanctuary should be retrofitted to accommodate LED lamps to improve light quality and energy efficiency. Additional supplementary lighting should be designed to provide additional ambient light as well as exhibit/ task lighting. Additional exterior lighting along the north and east elevation, by all doors and stairs should be provided for security and safety.
