**2. PROPOSED RENOVATIONS AND ADDITION OF 8006 KIPLING AVENUE IN WOODBRIDGE
HERITAGE CONSERVATION DISTRICT
WARD 2 - VICINITY OF WOODBRIDGE AVENUE AND KIPLING AVENUE**

Heritage Impact Statement
8006 Kipling Avenue, Woodbridge, ON
In the City of Vaughan
17 March 2015

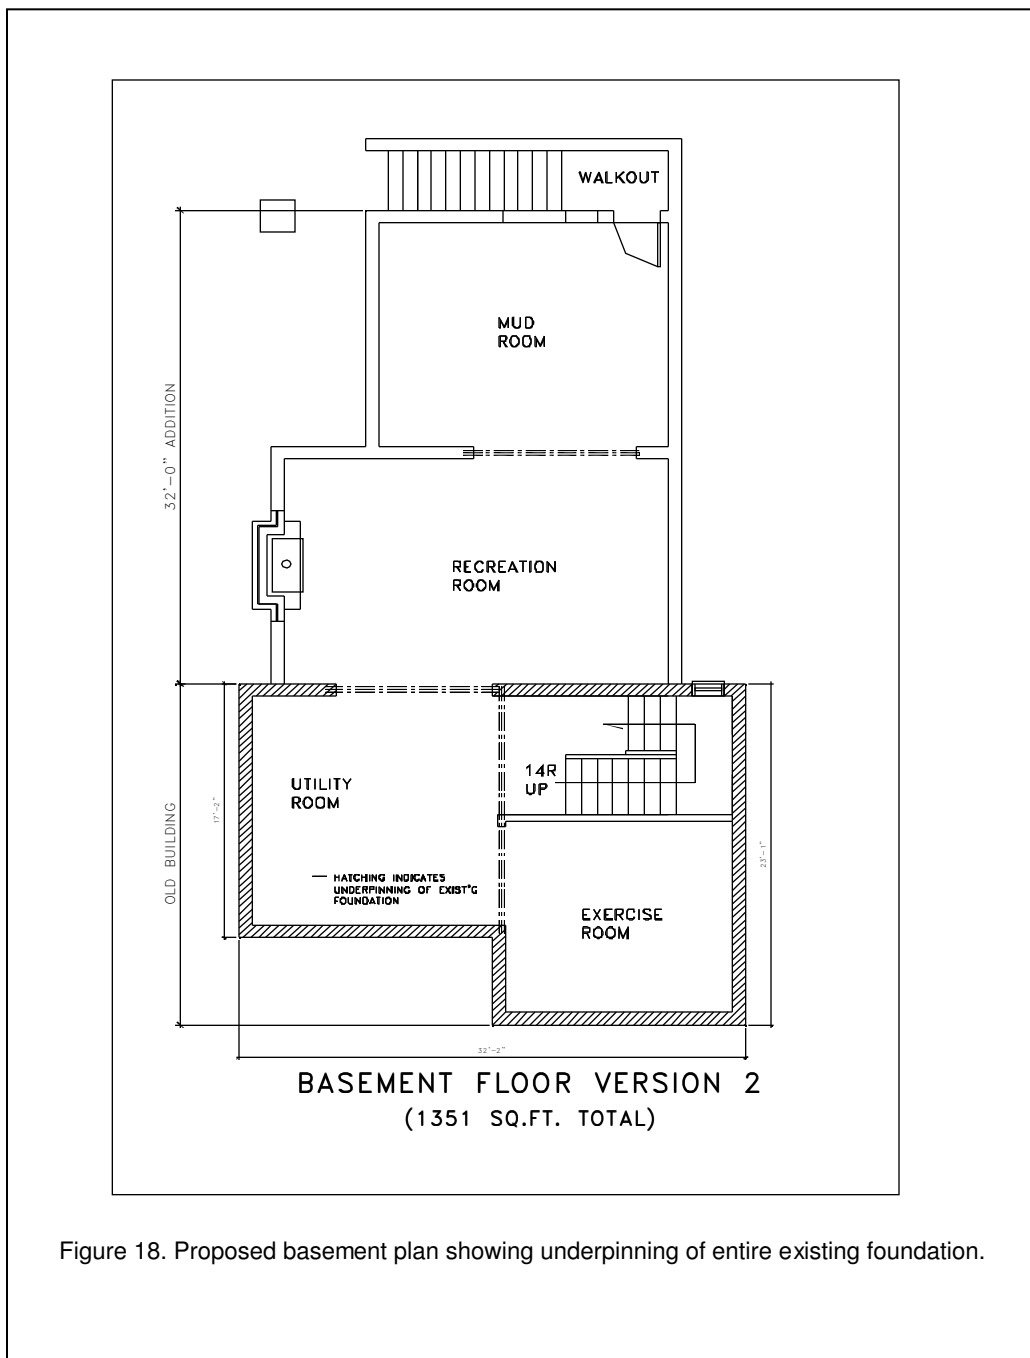
Structural Remedies

The first order of business is to stabilize the structure by underpinning the existing deficient foundation to a depth of 4 feet in order to get the bearing level below the frost line. The basement portion of the house, which has a ceiling height of only 5 feet will also be underpinned, to provide a useable height basement. These steps will provide a solid foundation under the heritage resource, to forestall future movement. At the same time, existing deficiencies in the ground floor framing will be corrected. The basement of the rear addition will be full-height.

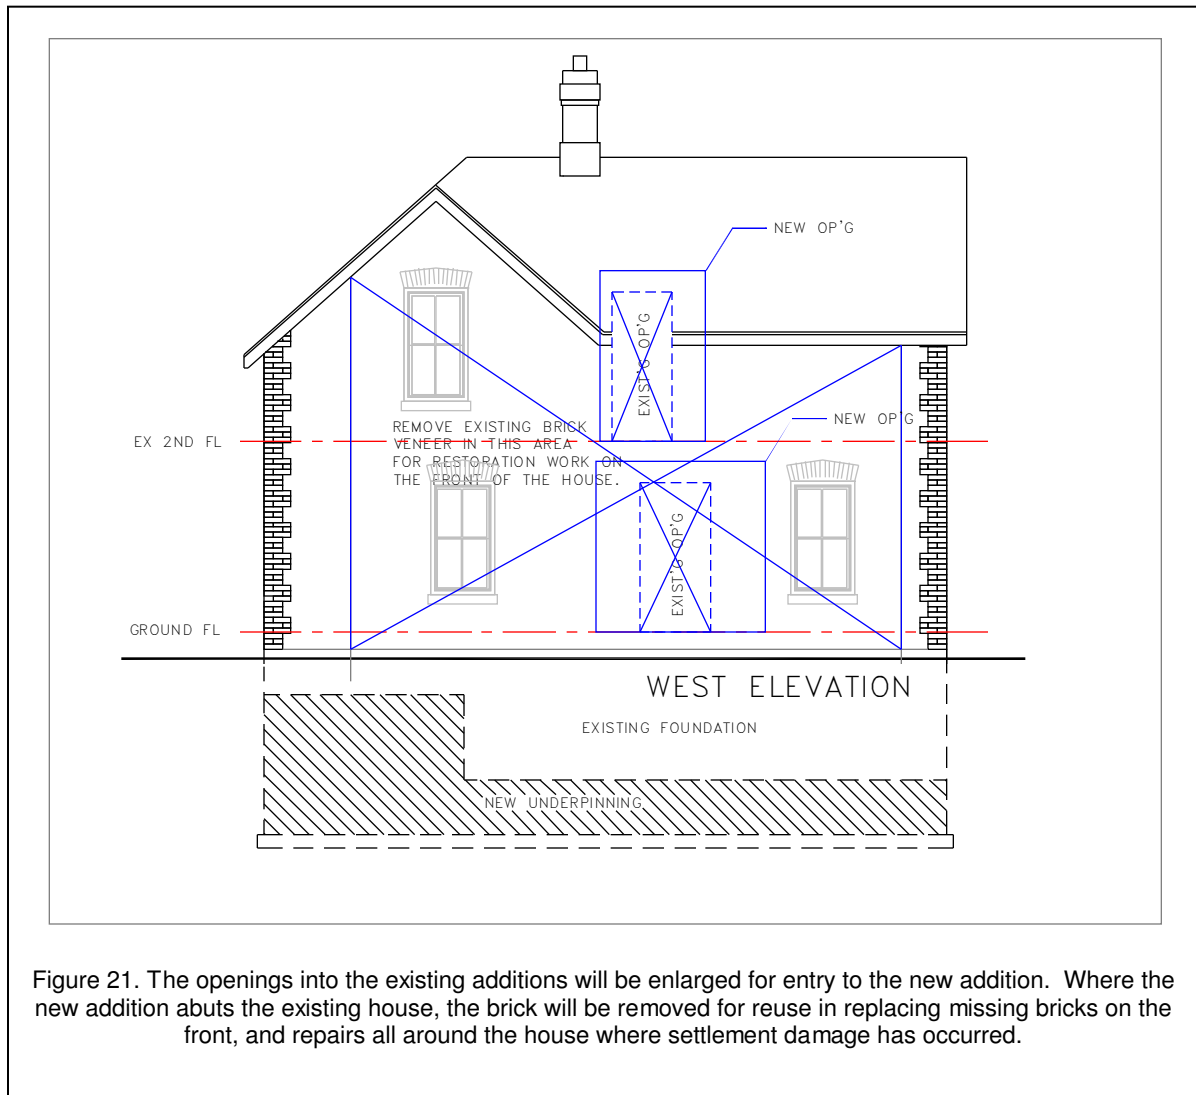
Removal of Existing Additions and Alterations to Existing Building, continued.

The rear of the existing building will be altered as shown in Figure 21.

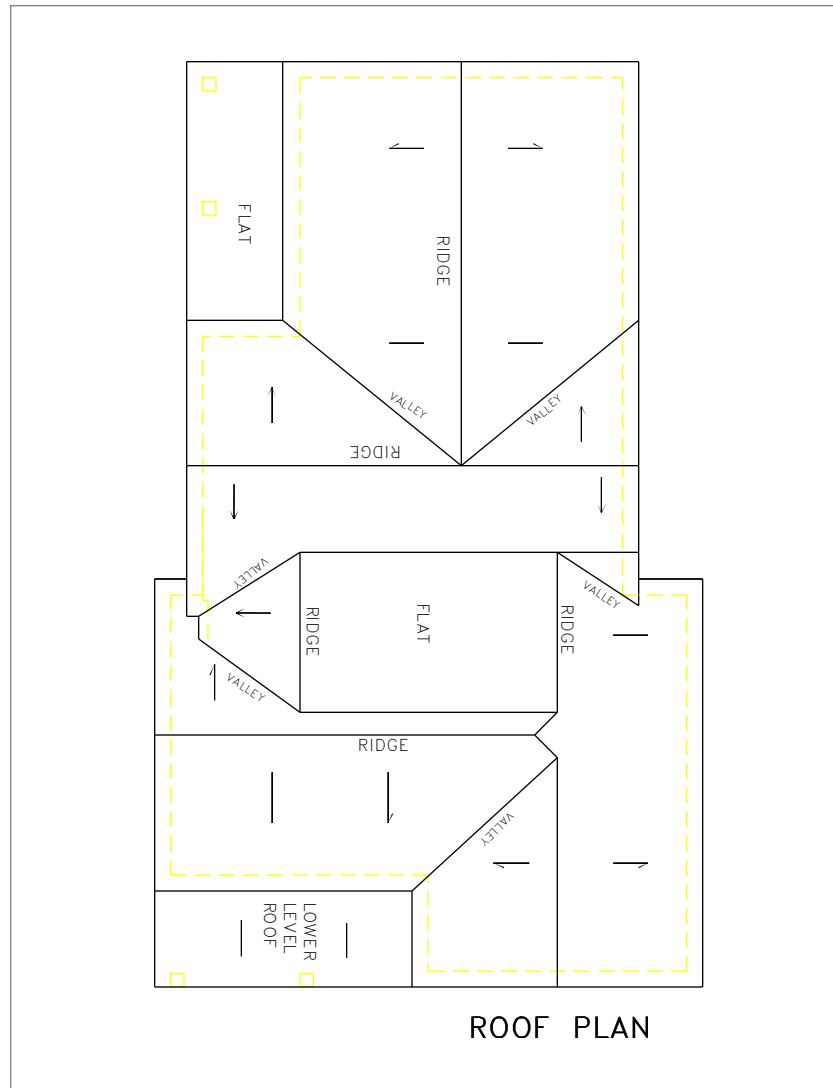
Figure 24. Proposed roof plan.

The design of the addition required careful consideration of a roof plan to ensure minimal visibility from the street. To a great extent, the roof determined the design of the building below.

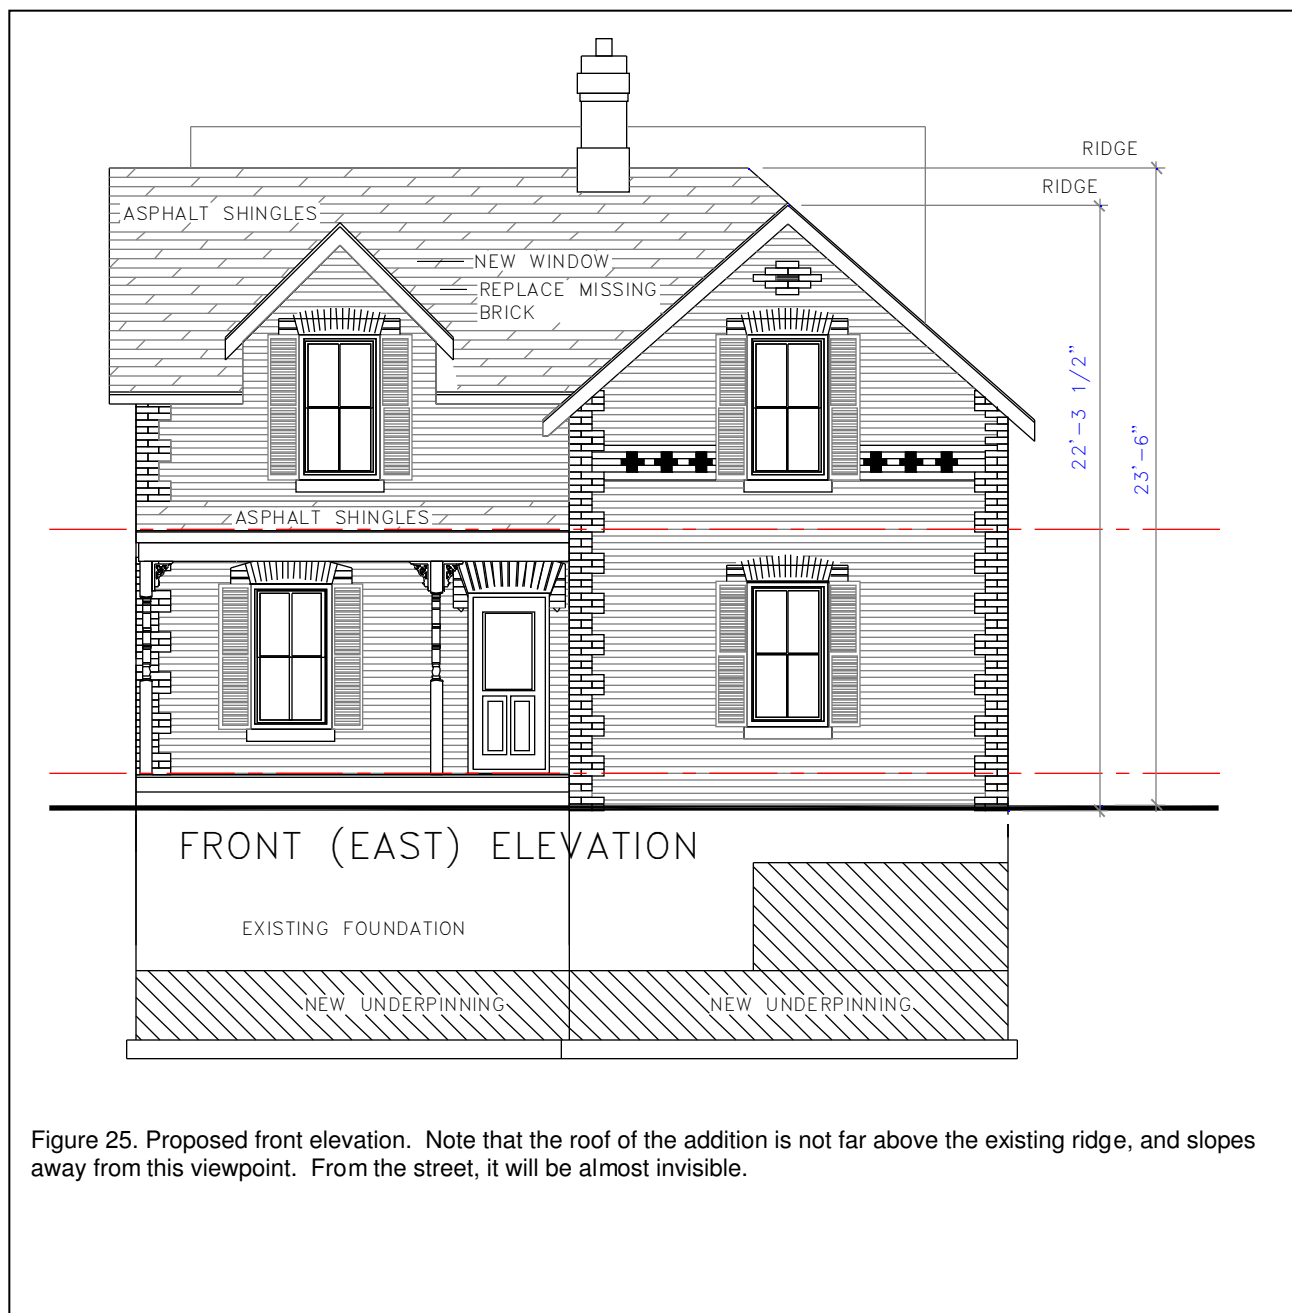
Figure 25. Proposed front elevation. Note that the roof of the addition is not far above the existing ridge, and slopes away from this viewpoint. From the street, it will be almost invisible.

The exterior masonry of the existing house will require extensive repair. (See Figures 10-13, and Supplemental Photograph in the Addenda.) In addition, the later and unsympathetic sunroom addition will be removed. All of the brick behind was removed when it was constructed. This brickwork will have to be replaced (about 1000 bricks), and a front wall dormer will be constructed. We propose to use brick removed from the existing rear wall where the addition abuts it to provide the material for repair and replacement of missing wall. The elevations of the proposed project are shown in Figures 25 through 28.

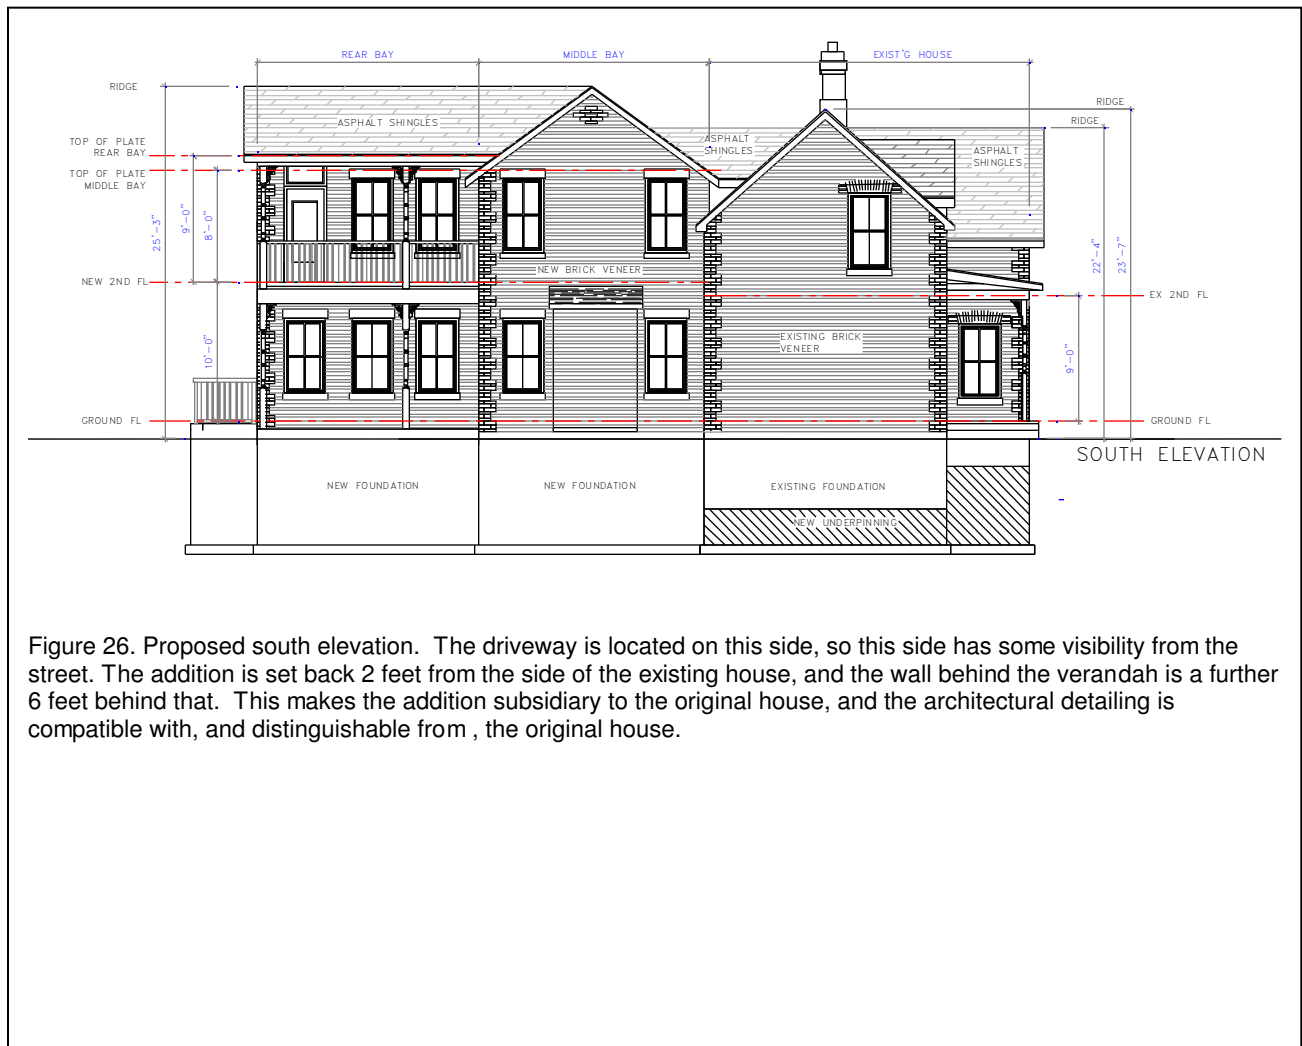
Figure 26. Proposed south elevation. The driveway is located on this side, so this side has some visibility from the street. The addition is set back 2 feet from the side of the existing house, and the wall behind the verandah is a further 6 feet behind that. This makes the addition subsidiary to the original house, and the architectural detailing is compatible with, and distinguishable from, the original house.

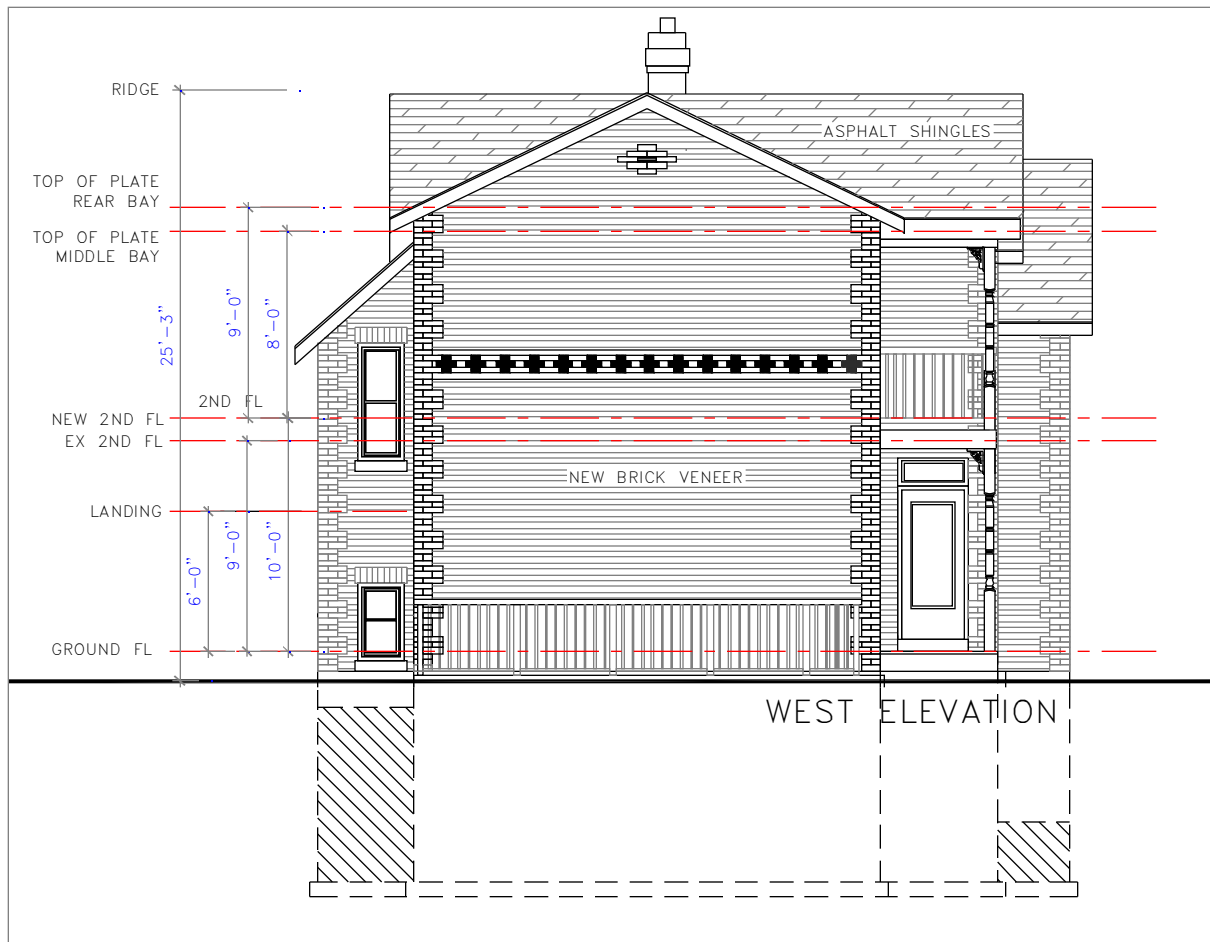
Figure 27. Proposed west (rear) elevation. This elevation is not visible from the street.

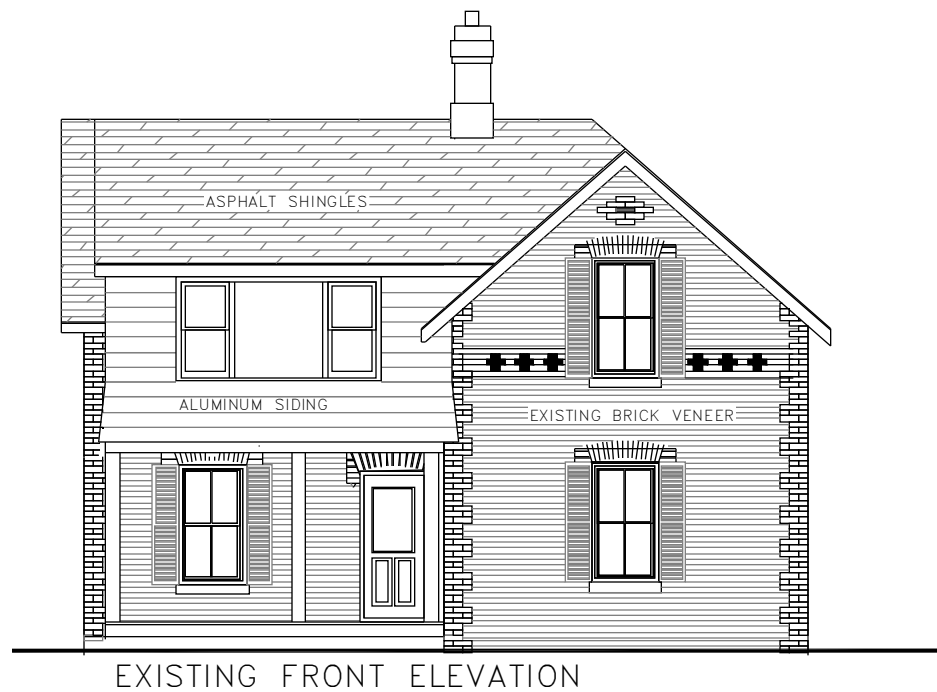
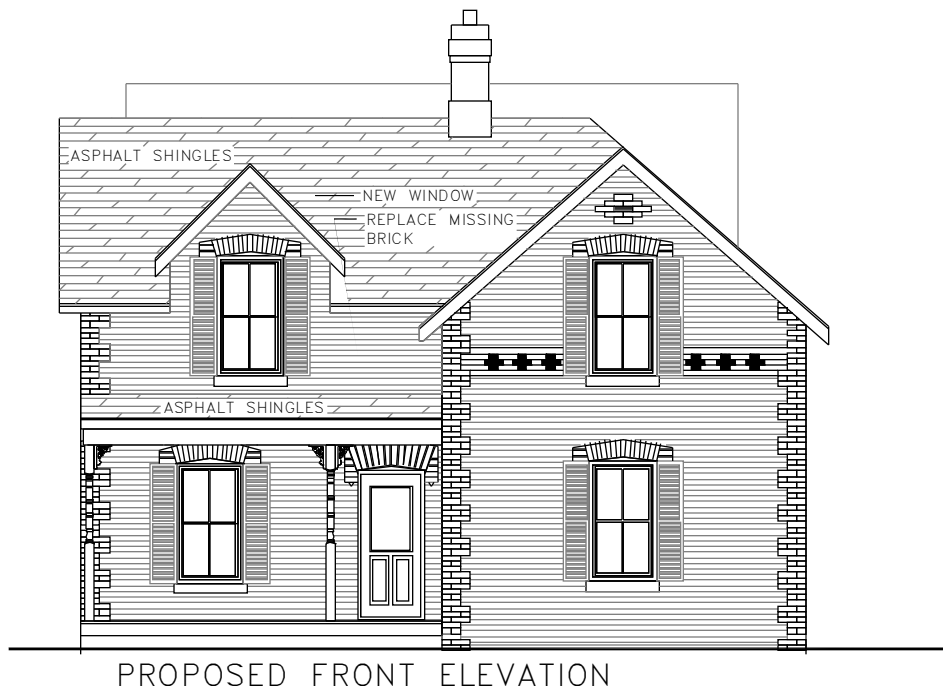
Figure 29. Before and after comparison of the street view of the house. The proposal represents a great improvement in the heritage character of the Kipling Avenue streetscape.

The proposal will stabilize the structure, will remove the unsympathetic sunporch, and replace it with a porch which replicates the probable style of the original front verandah. The missing brick behind the sunporch will be replaced with existing brick from the rear of the house in order to have well-matched masonry, and a small window installed above the existing ground floor window. New windows, with simulated divided lights with spacer bars, will be provided in the original 2 over 2 design, and the modern replacement front door will be replaced with a new door of a design compatible with the original architecture. The settlement-damaged masonry will be replaced with existing brick and all walls repointed as required. All of this work will result in the visual aspect of the house being to its original form. This is evident in the comparative front elevations shown in Figure 25 on the next page.
