HERITAGE VAUGHAN COMMITTEE AUGUST 16, 2017

**RESTORATION OF A DETACHED RESIDENTIAL BUILDING AND NEW DEVELOPMENT
9869 KEELE STREET AND 9891 KEELE STREET (WILLIAM BAILEY HOUSE) - MAPLE
HERITAGE CONSERVATION DISTRICT
DESIGNATED UNDER PART V, ONTARIO HERITAGE ACT
WARD 1 - EAST SIDE OF KEELE STREET AND SOUTH OF MAJOR MACKENZIE DRIVE**

(GBCA Project No: 17021)

Date of issue: May 15, 2017

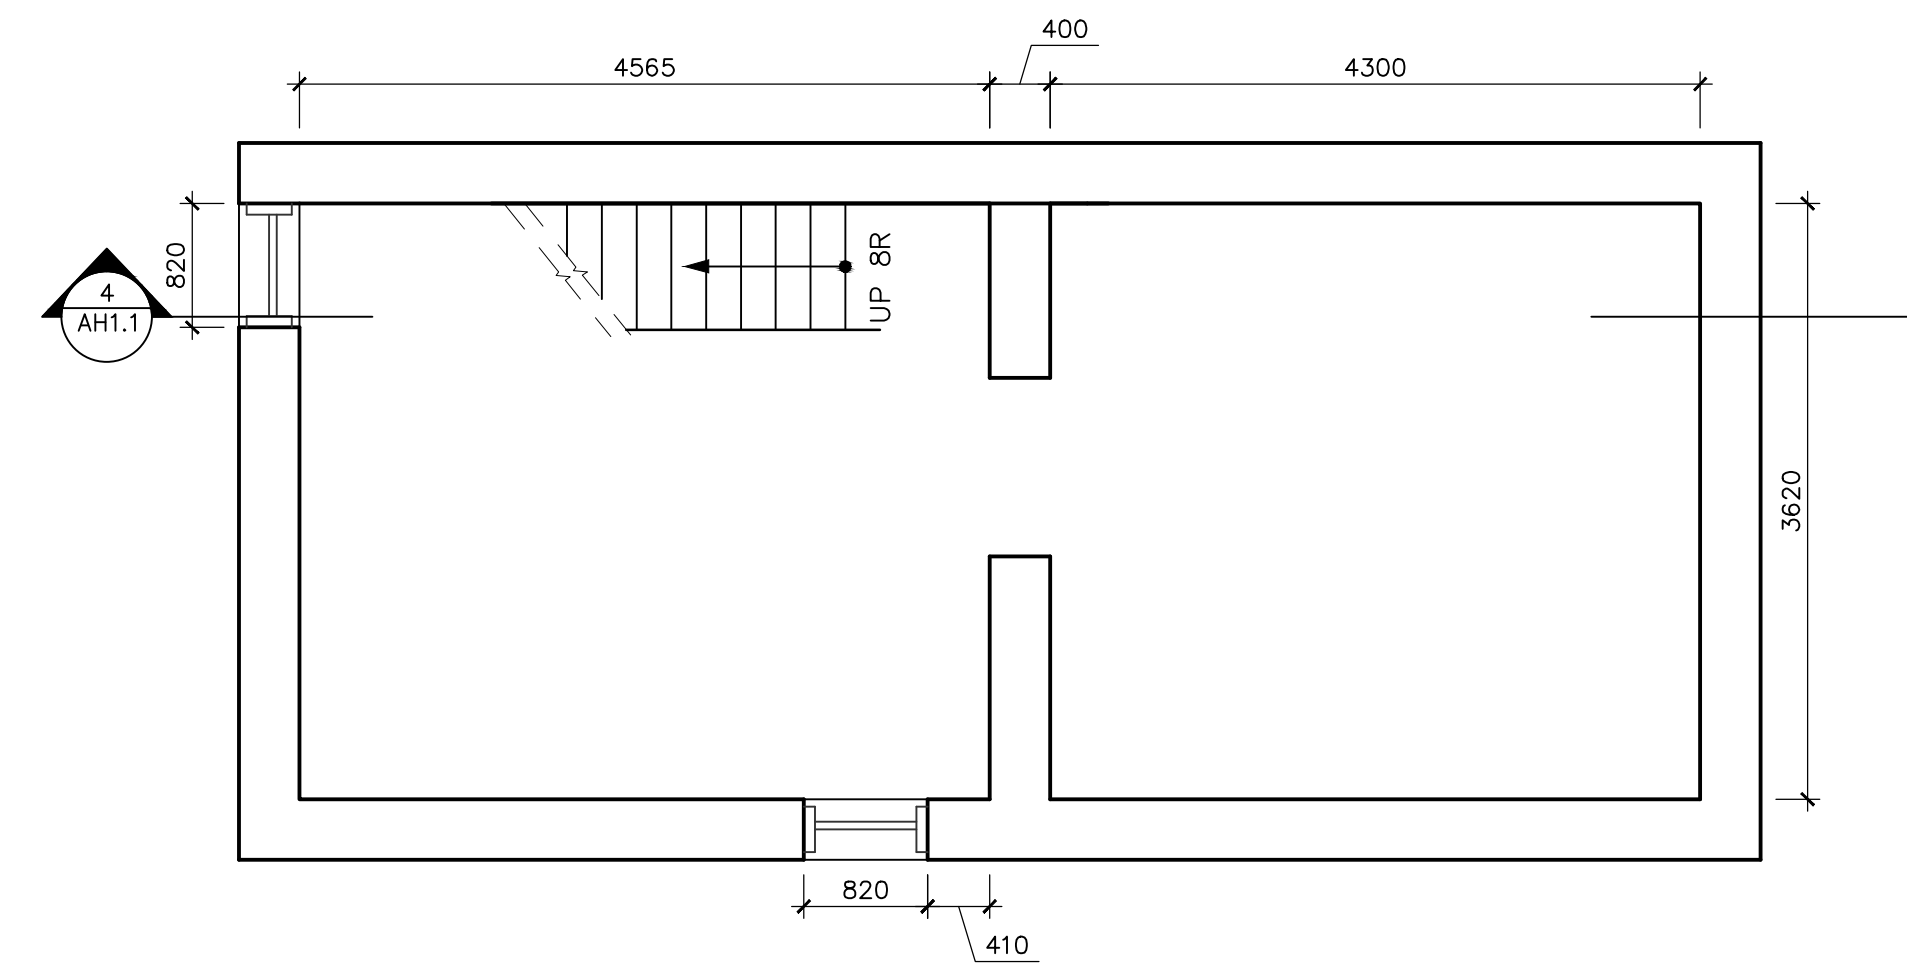
1 Basement Floor Plan
AH1.1 SCALE 1:50

The rubble stone foundation appears to have been recently painted. Underneath this is a poured concrete floor which has encountered some deterioration, especially at the foot of the staircase, and is also evident on the floor and sill plate. This is likely due to standing water at a recent point in time. The presence of moisture retention in the concrete is evident from dampness to the touch, and from visible wicking on cinderblocks that support the furnace.

Above: Location of significant deterioration/buckling of the concrete floor before entry to boiler room, to the left. At the right, concrete foundation deterioration at foot of stair.

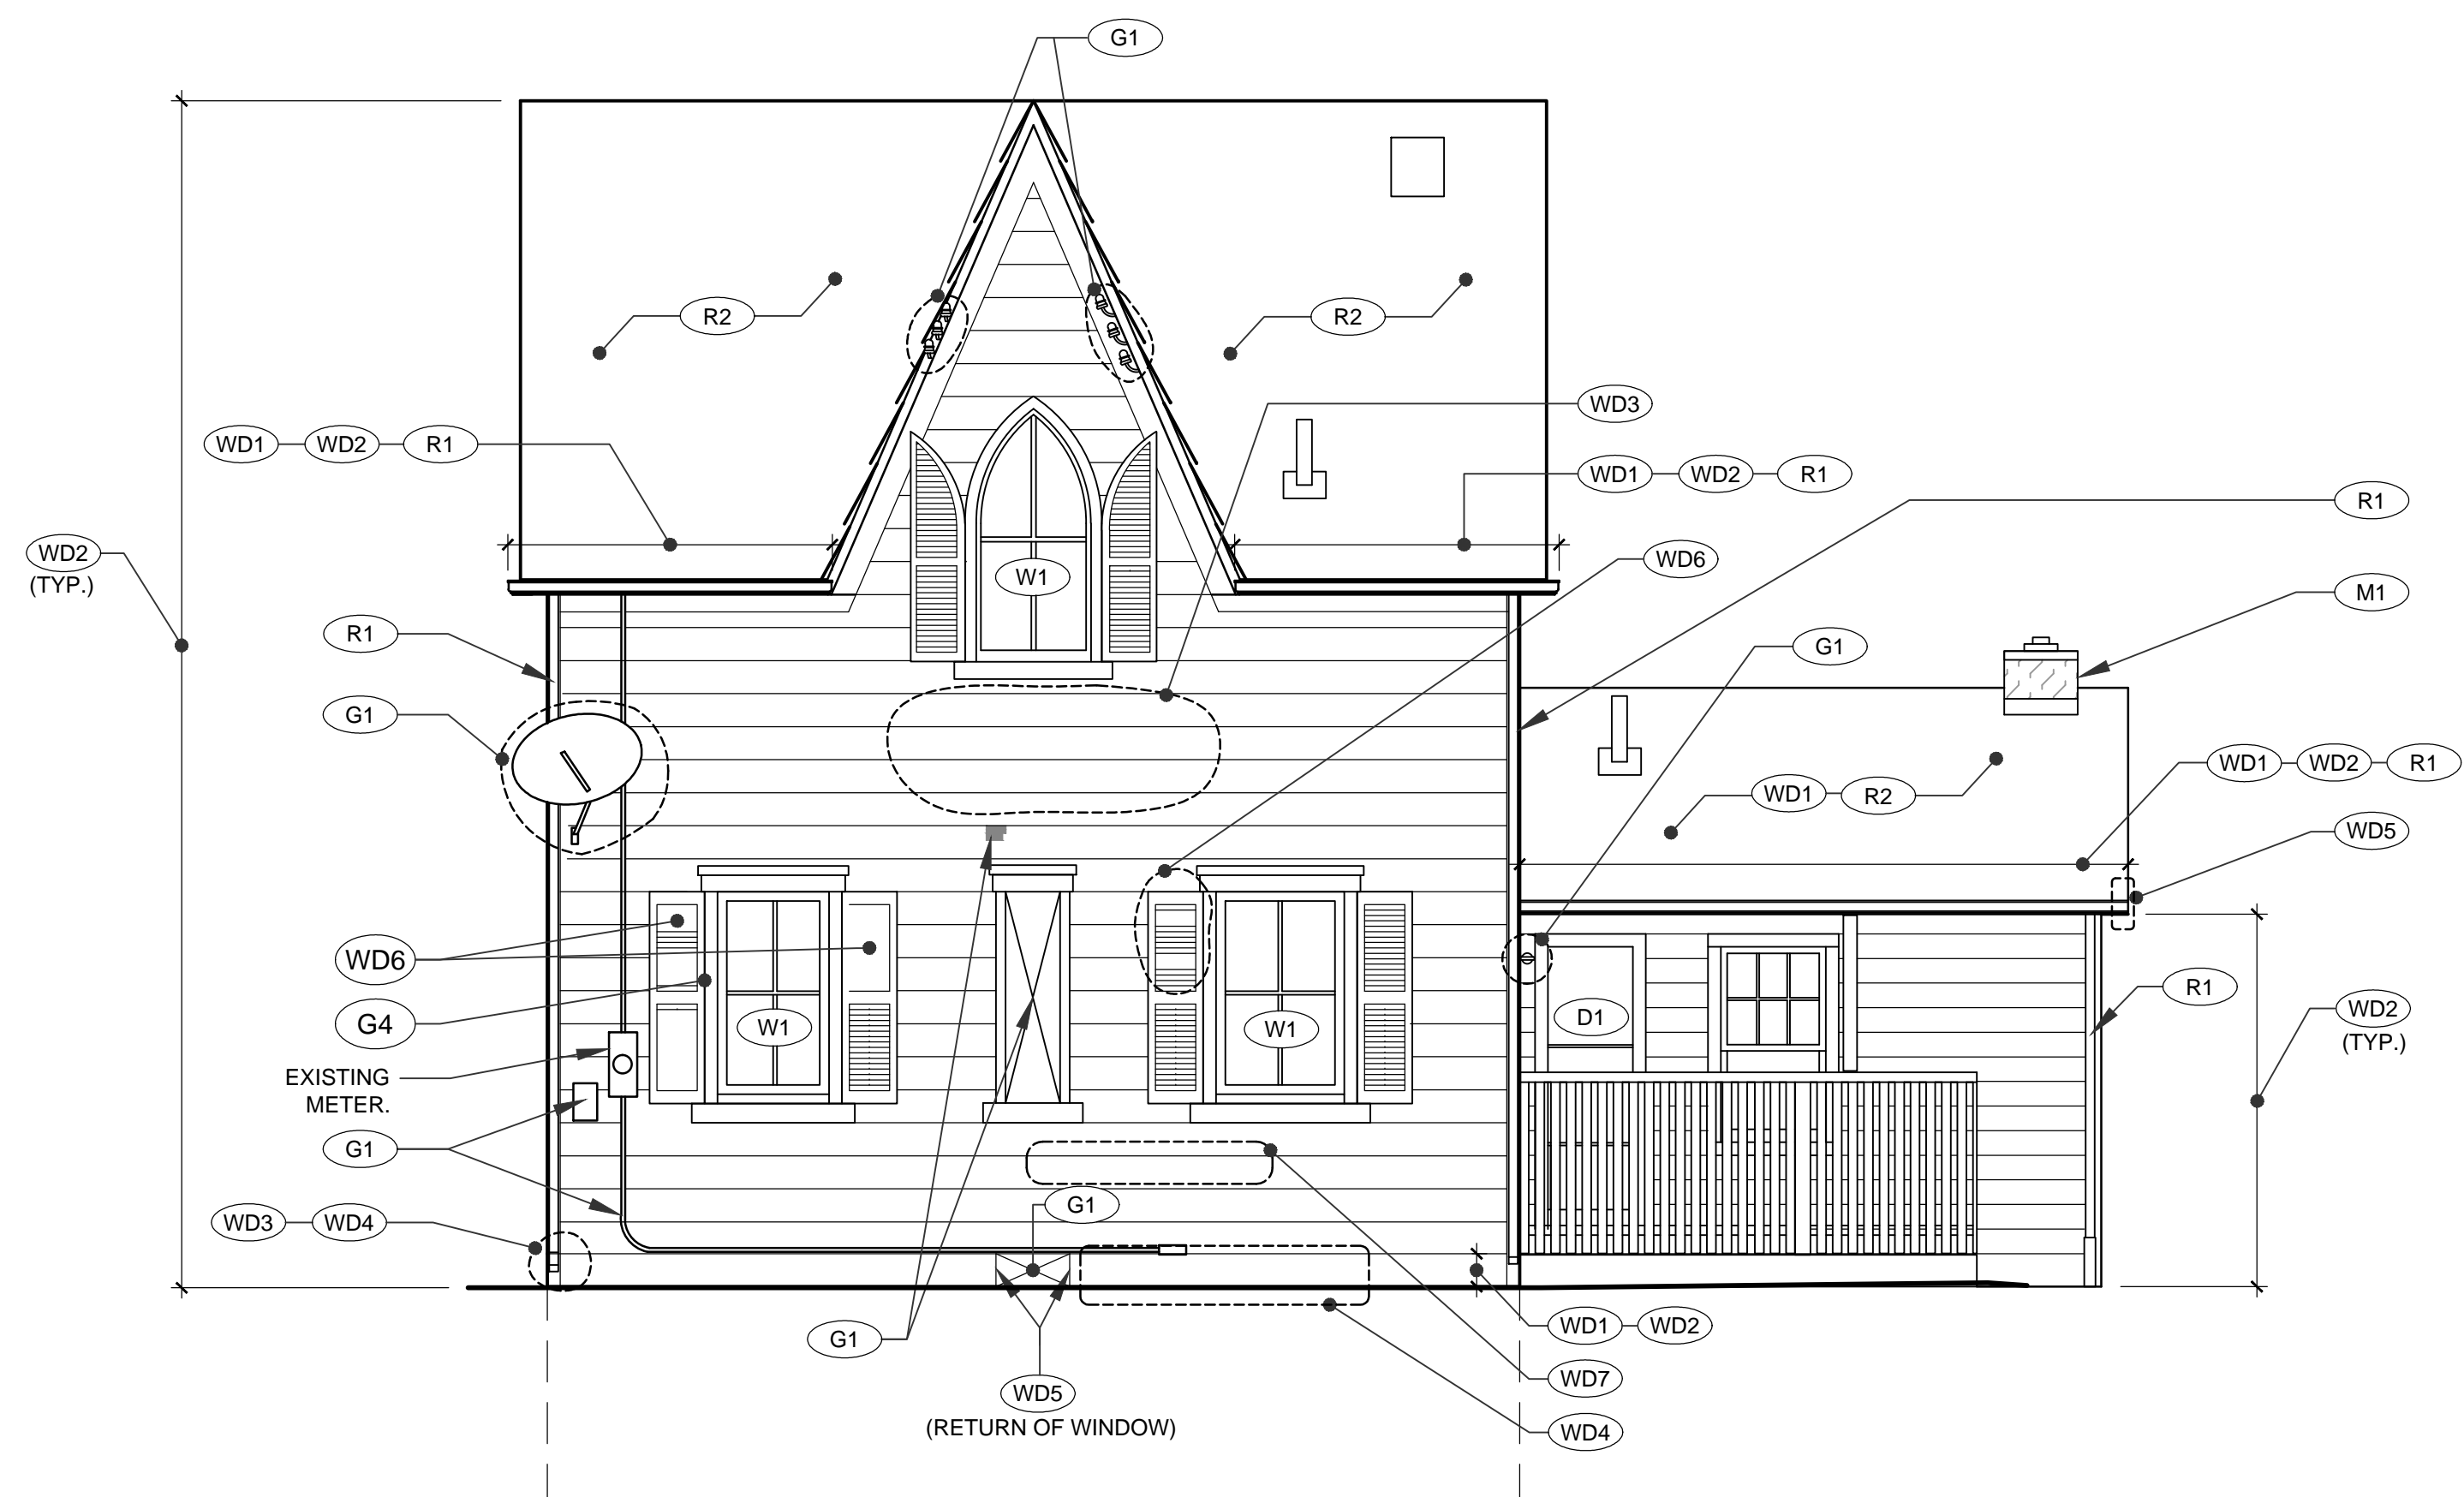
2 South Elevation
AH1.2 SCALE 1:50

Above and Below: South and east facade exhibits wood cladding condition with areas of deterioration and openings. It is evident that different degrees of deterioration have occurred in wood elements of the building.

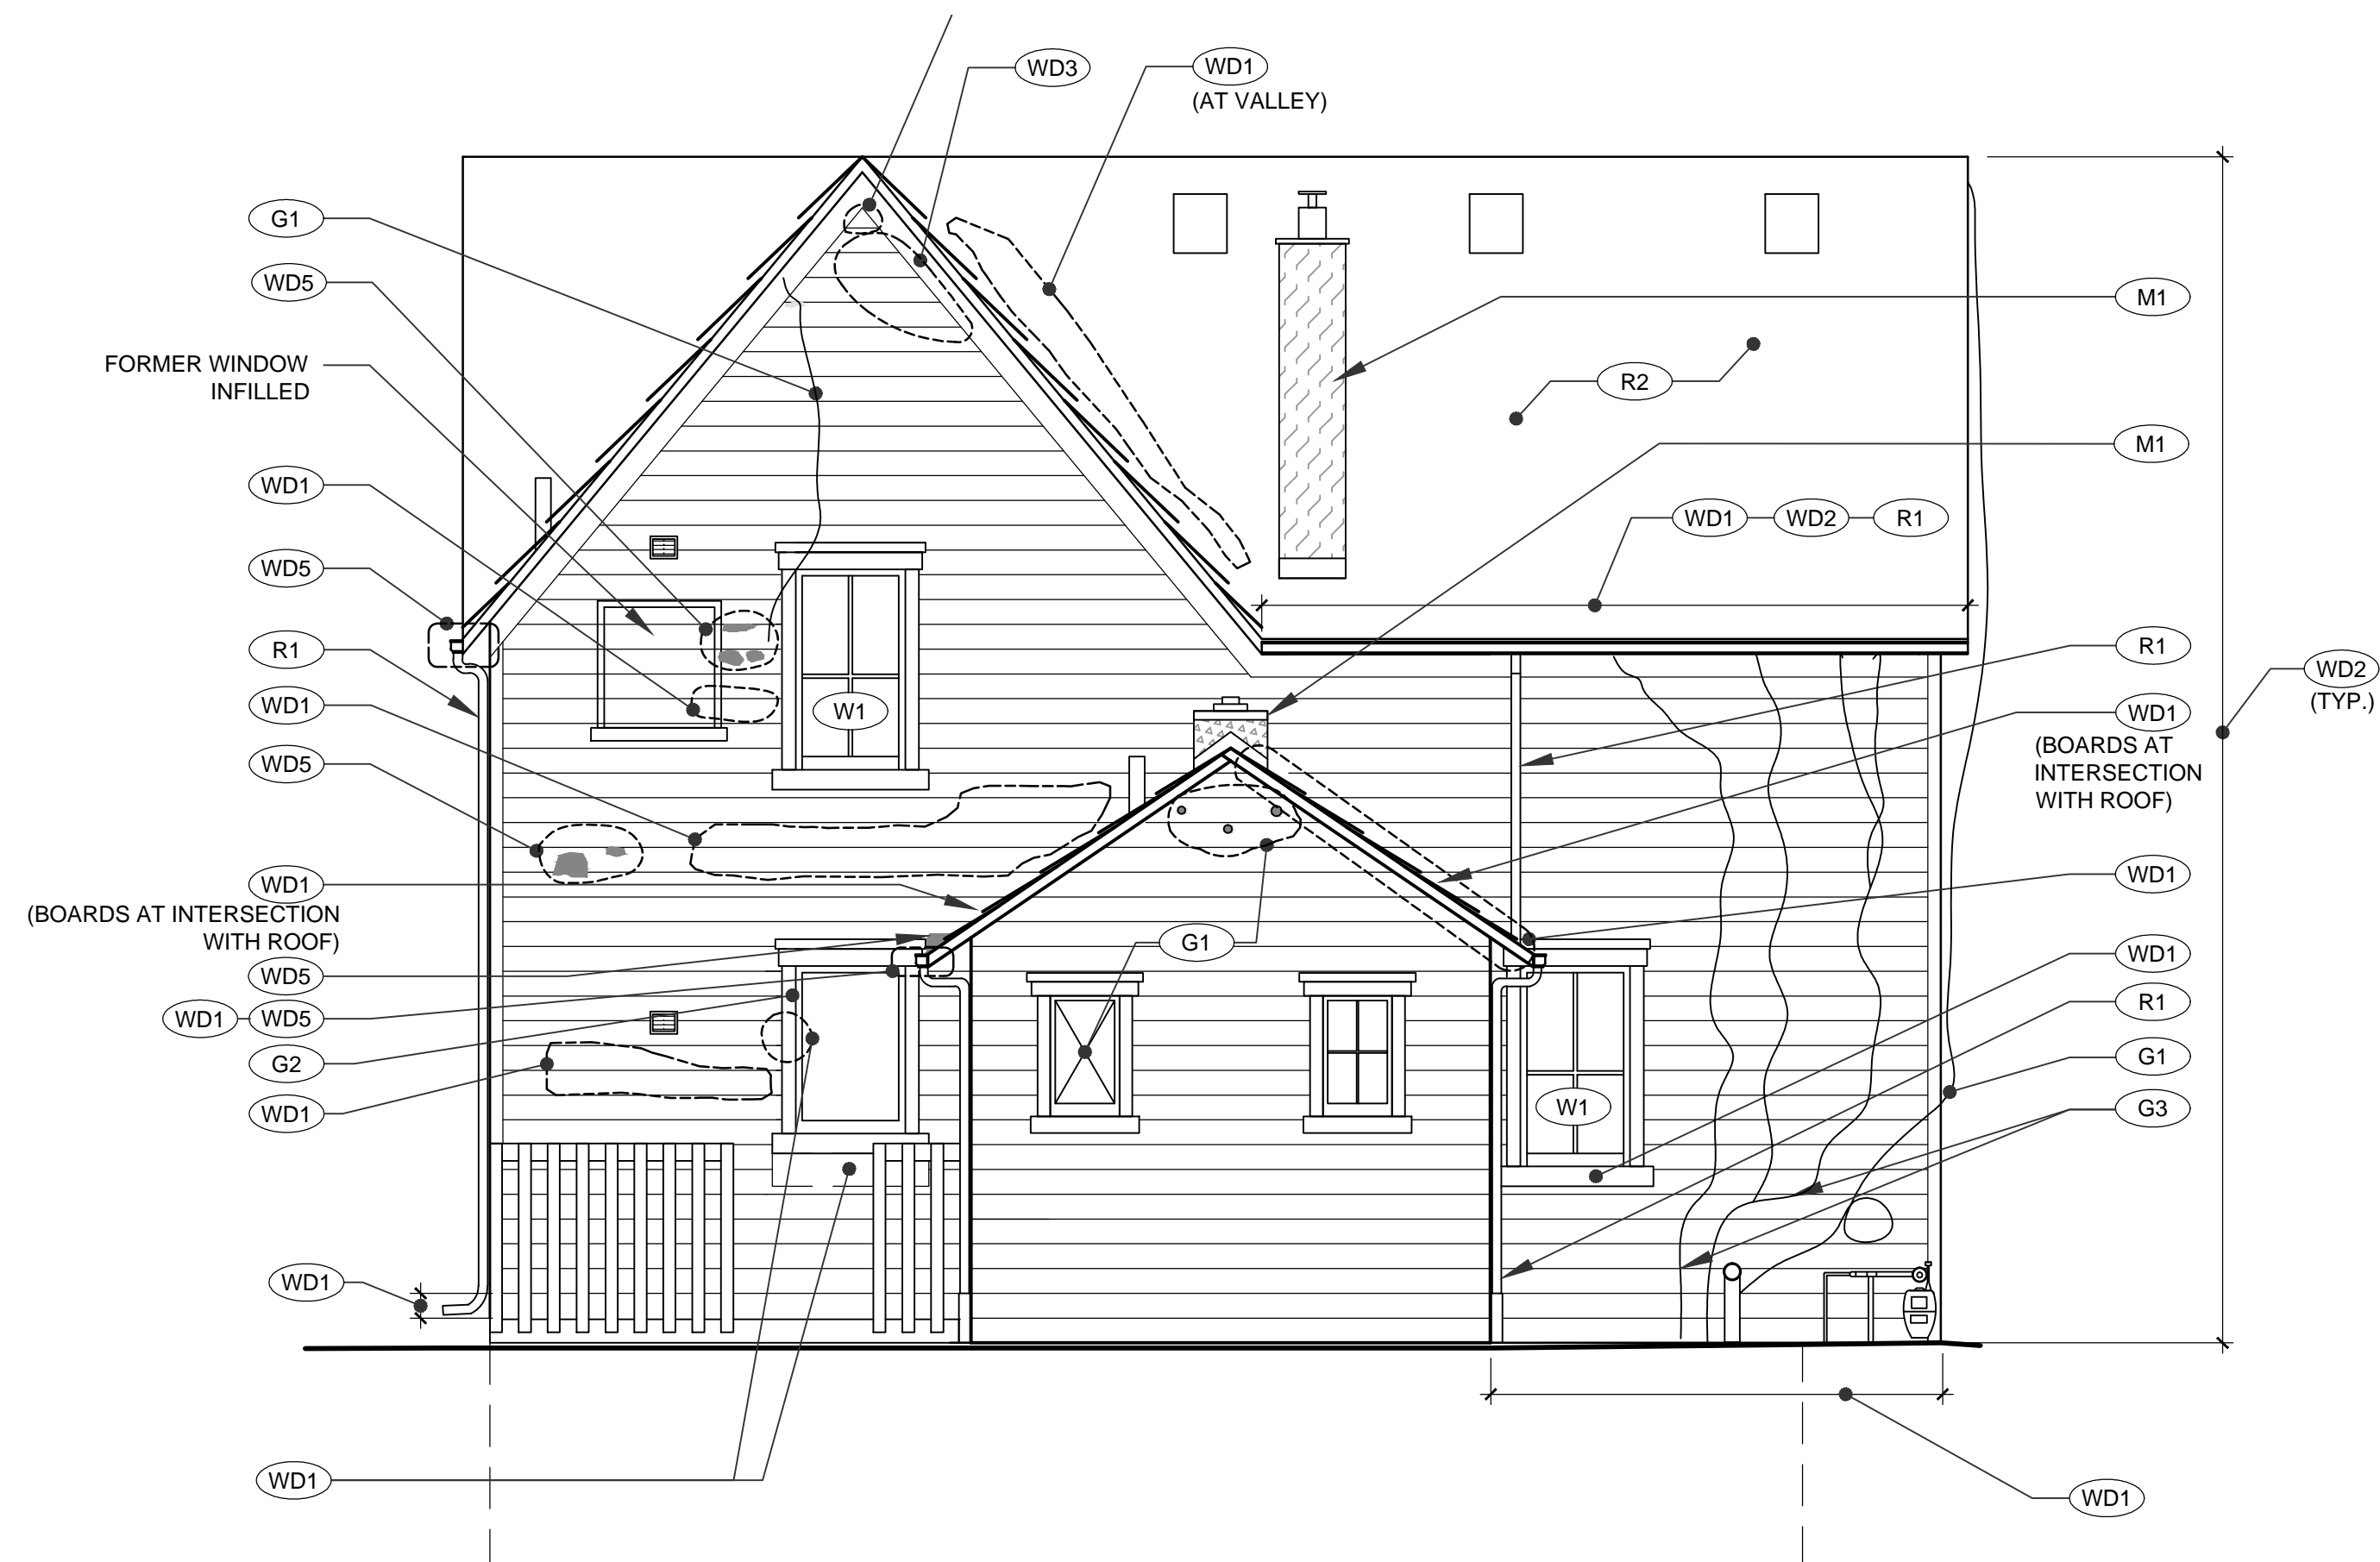
3 East Elevation
AH1.2 SCALE 1:50

The wood siding on the east elevation is different than that on the west, north, and south elevations. While the structure does not appear to have settled, it is probable that the siding was replaced due to deterioration.

Above: Detail of wood cladding deterioration, peeling paint, and sill rot noted on the east elevation.

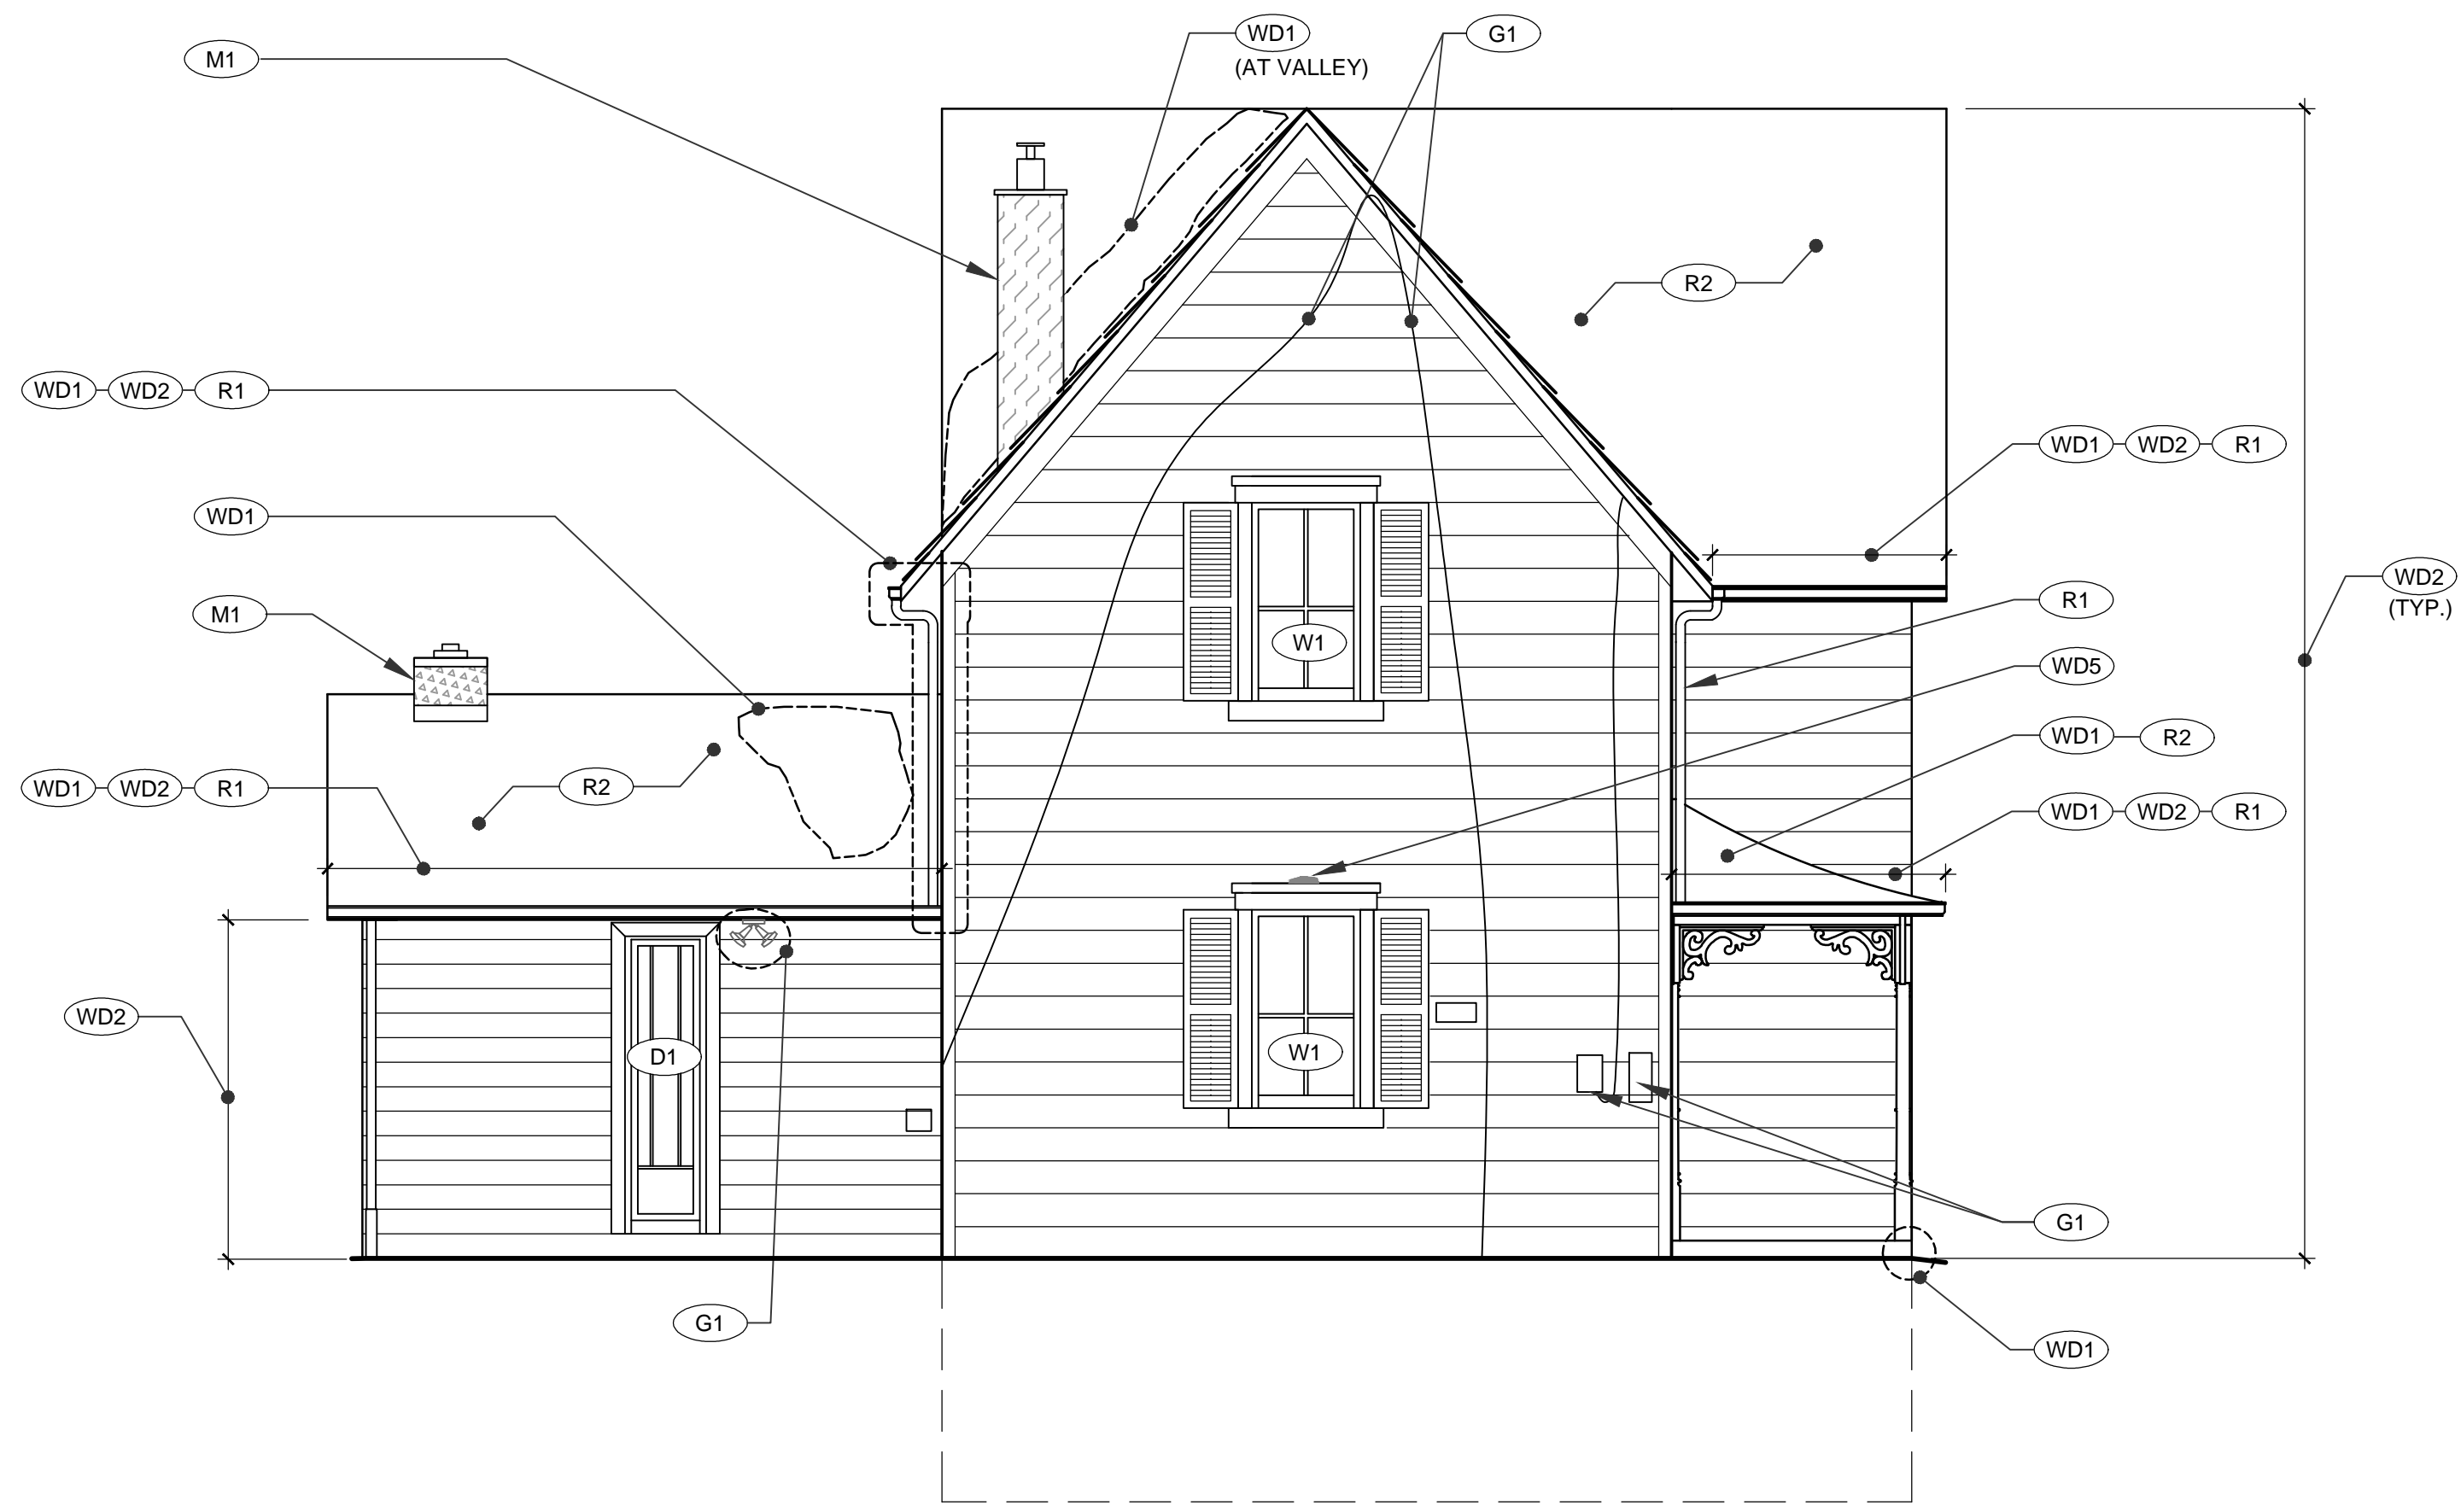
4 North Elevation
AH1.2 SCALE 1:50

Below: Significant deterioration of mortar joints of rubble foundation on the north facade.
