**Tree Inventory and
Assessment:
EA for Portage Parkway
Widening and Extension,
Applewood Crescent to
Creditstone Road**

February 2016

Cima+ project #B000541

Tree Inventory and Assessment Drawing TI-1 to TI-6

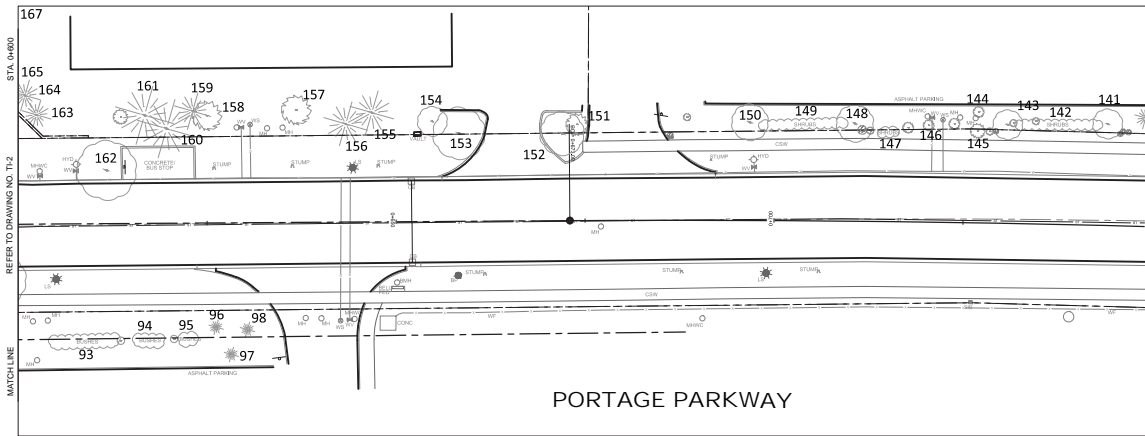
DATE: DECEMBER 2015 PAGE NO: 3 of 6

140 139 EXISTING TREES WITH TREE INVENTORY NUMBERS (SEE TREE REPORT)

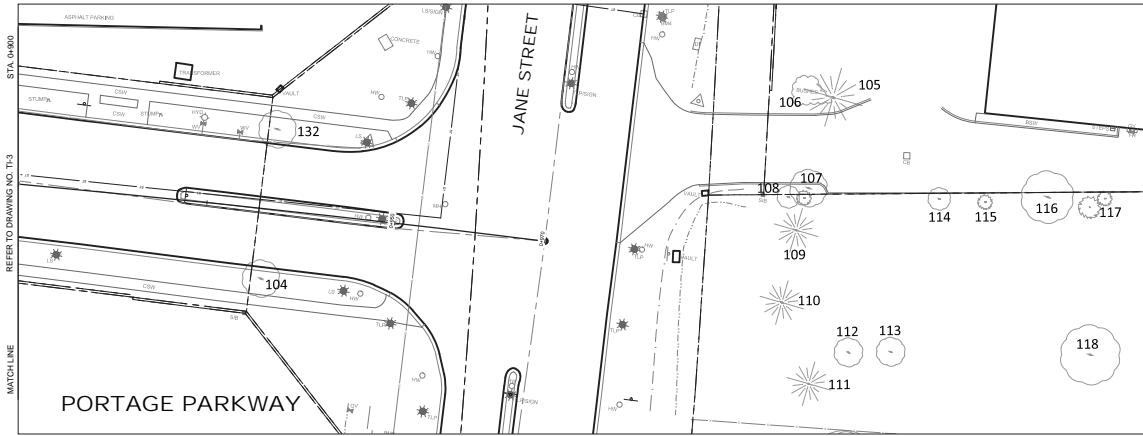
DESIGNED BY	DATE	SCALE	PROJECT NO.
MMF	04/23/2015	1:500	T1-4

EXISTING TREES WITH TREE INVENTORY NUMBERS (SEE TREE REPORT)

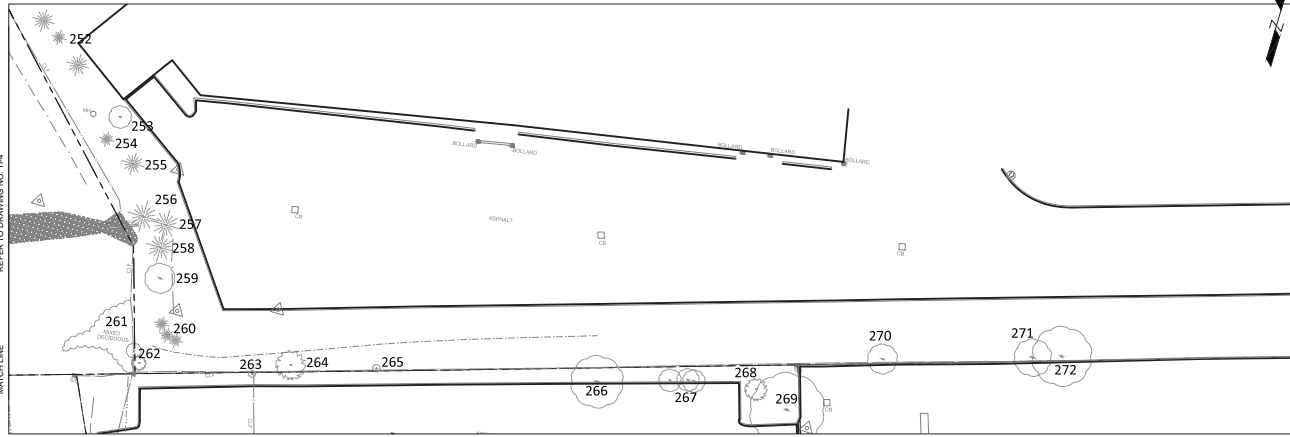
PROJECT:	EA FOR PORTAGE PARKWAY WIDENING AND EXTENSION, APPLEWOOD CRES TO CREDITSTONE RD.
CLIENT:	
DATE:	2015.12.04
SCALE:	1:500
DRAWN BY:	TI-5
CHECKED BY:	TI-5
DATE:	2015.12.04
PAGE:	5 of 6

140 139
 EXISTING TREES WITH
 TREE INVENTORY NUMBERS
 (SEE TREE REPORT)
