## **CITY OF VAUGHAN**

#### **11            ALTERATION TO AN EXISTING BUILDING AND THE DEMOLITION OF OUTBUILDINGS 872 NASHVILLE ROAD, KLEINBURG-NASHVILLE HERITAGE CONSERVATION DISTRICT DESIGNATED UNDER PART V, ONTARIO HERITAGE ACT WARD 1 – VICINITY OF HUNTINGTON ROAD AND NASHVILLE ROAD**

**Heritage Impact Statement**  
**872 Nashville Road**  
**In the Kleinburg-Nashville Heritage Conservation District**  
**City of Vaughan**

**Phillip H. Carter Architect and Planner**  
**& Paul Oberst Architect**  
**June 2017**

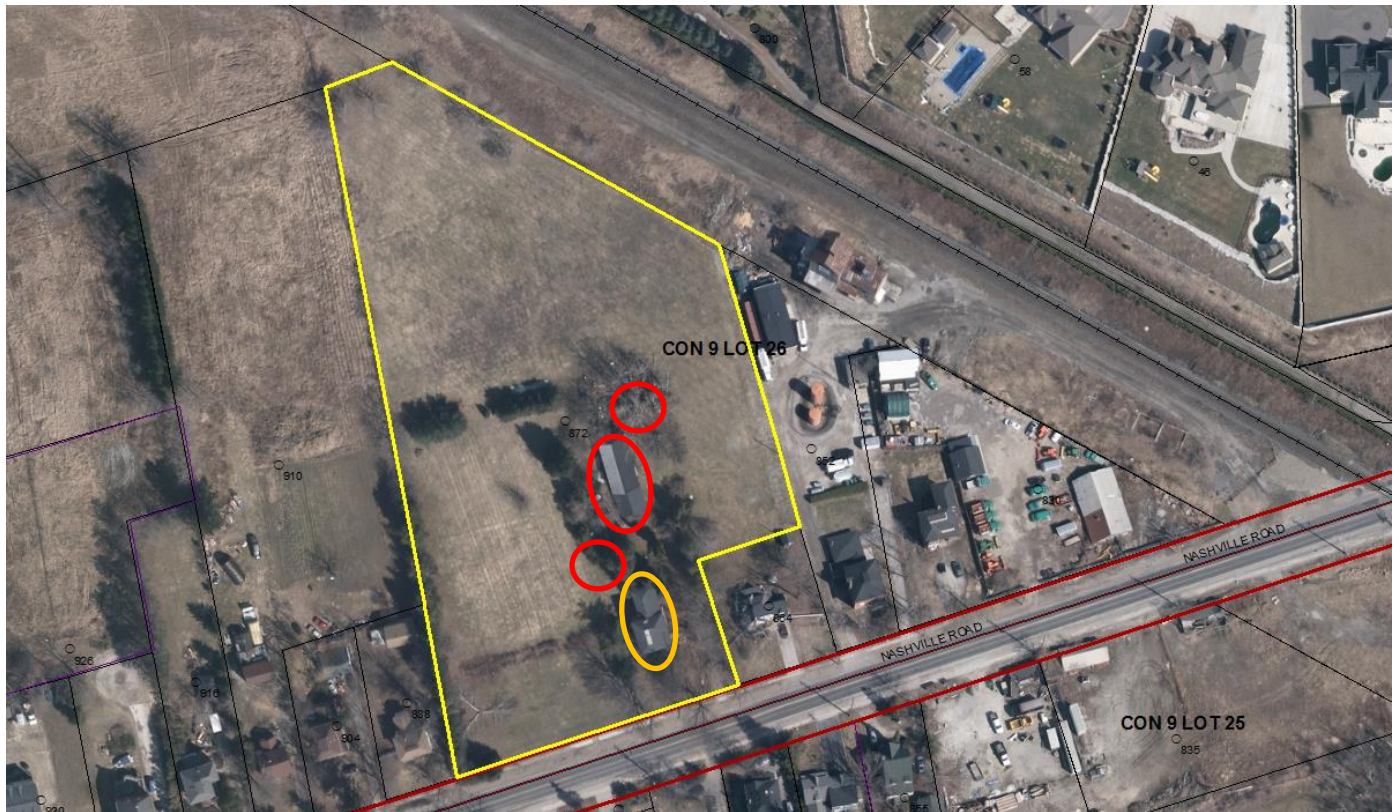
**Site Map**

**Victorian Brick House to be restored  
(outlined in orange)**

**Outbuildings to be demolished  
(outlined in red)**

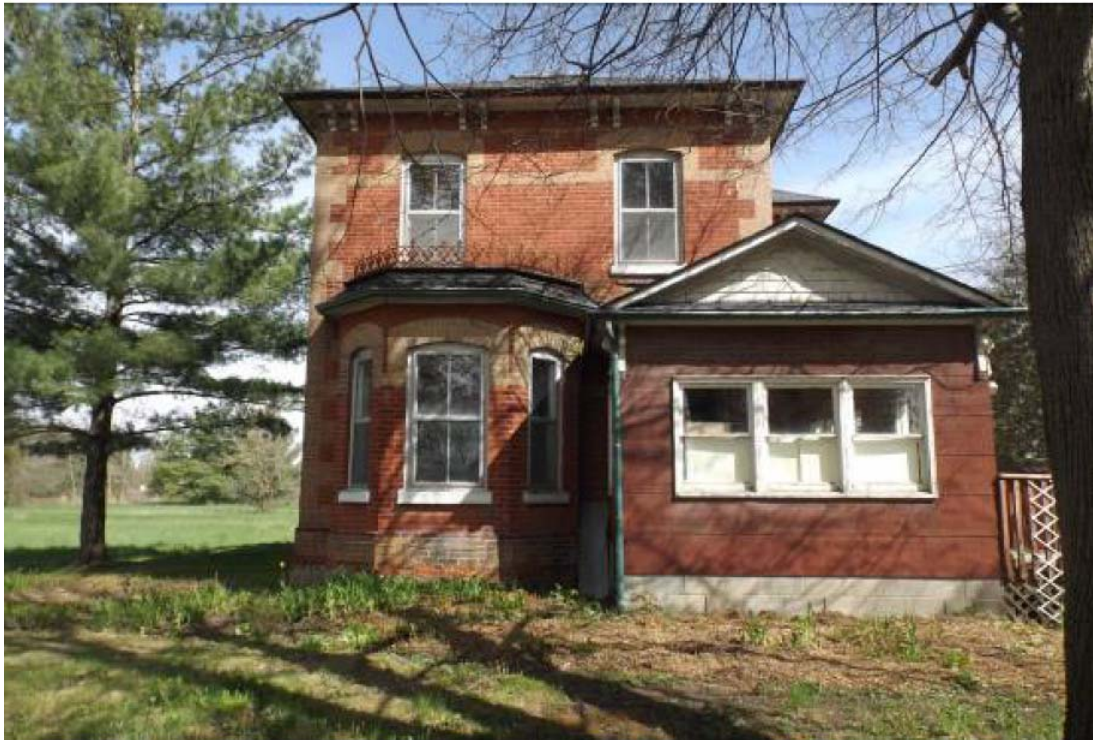
The Victorian house (front elevation) (from HIA)

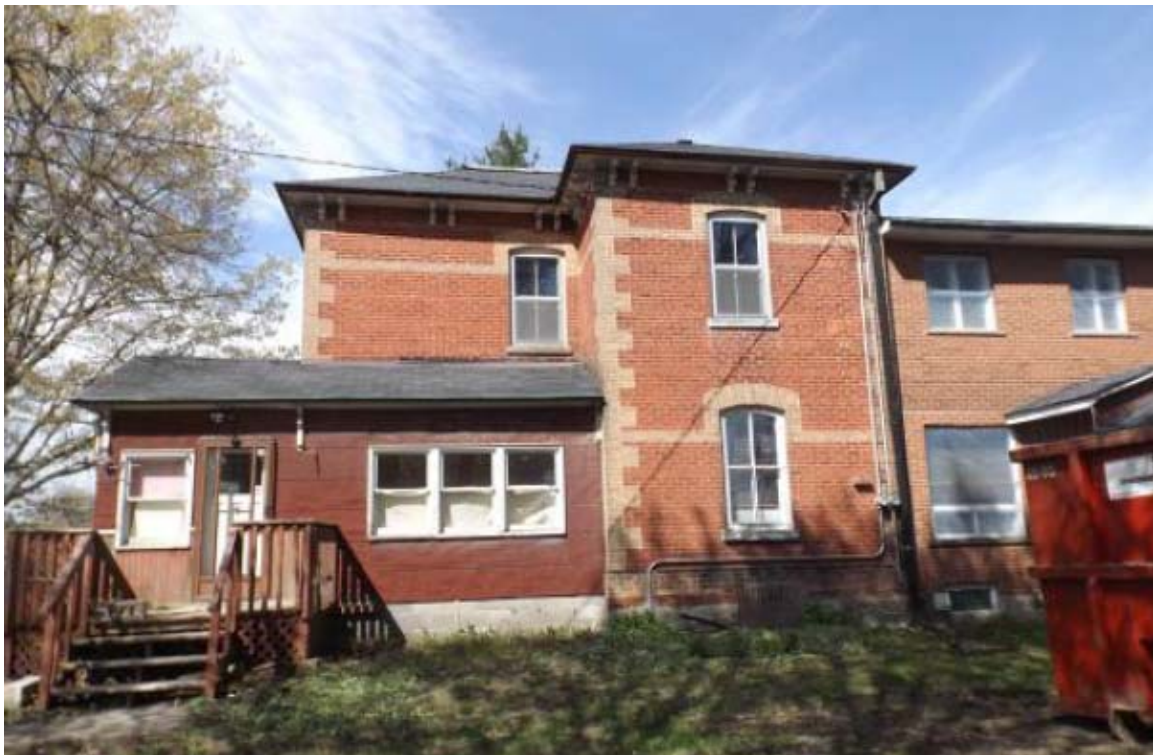
The Victorian house (side-east elevation) (from HIA)

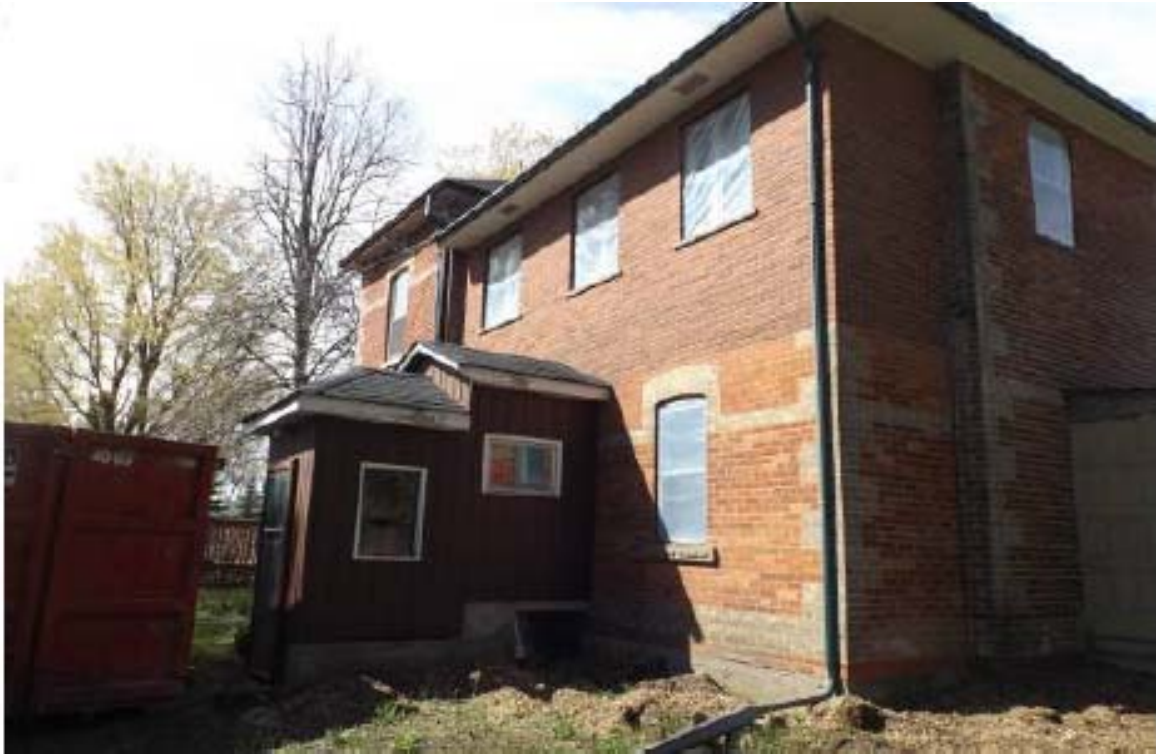
The Victorian house (side-north-east elevation) (from HIA)

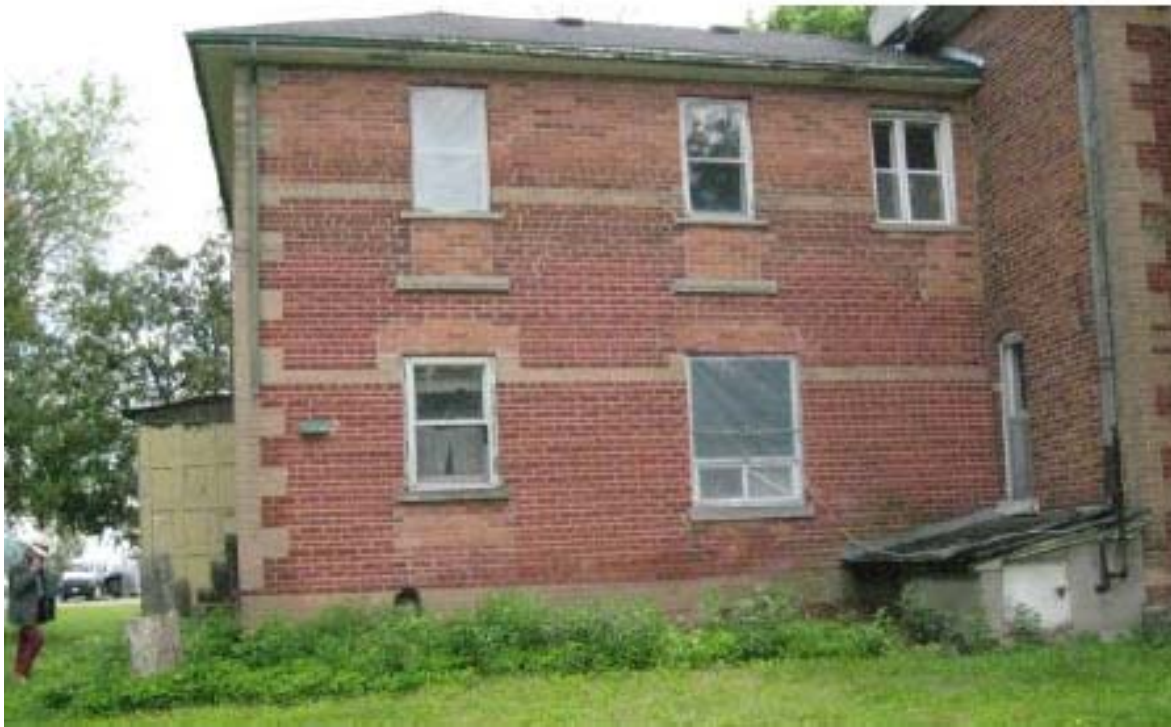
The Victorian house (side-west elevation) (from HIA)

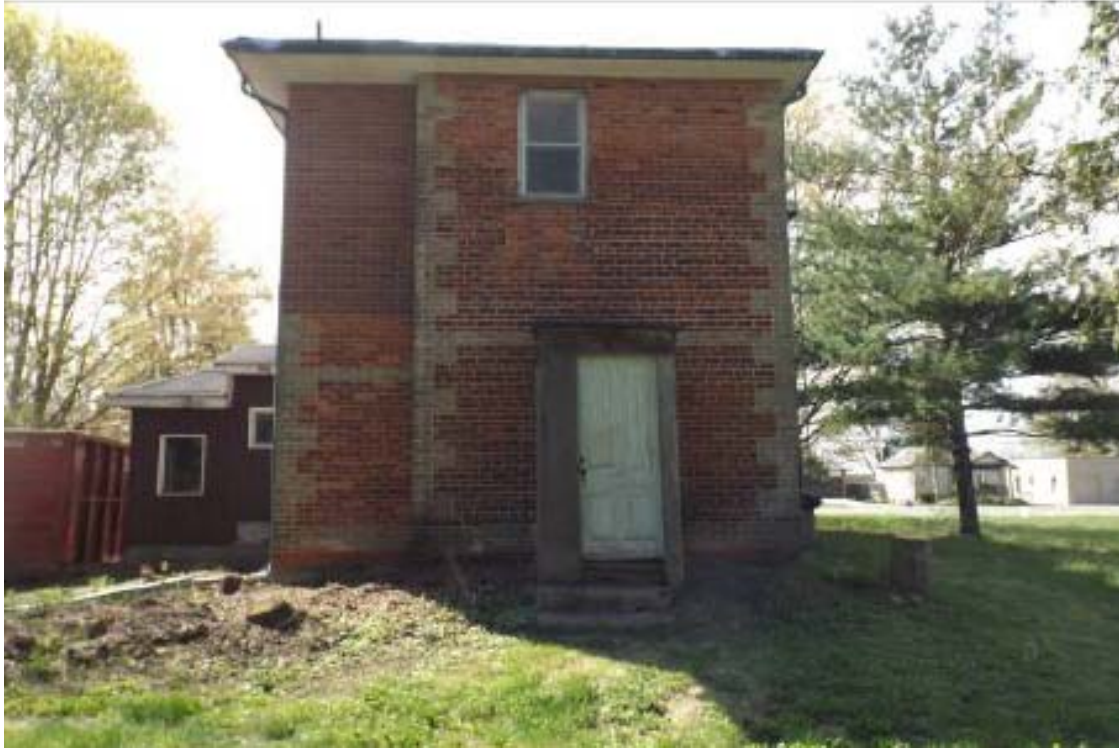
The Victorian house (side-north elevation) (from HIA)

- The later unsympathetic, heavily-altered kitchen tail will be removed and the north elevation masonry will be restored. It is noted that the plan for this work cannot be provided until such time the kitchen tail is removed.

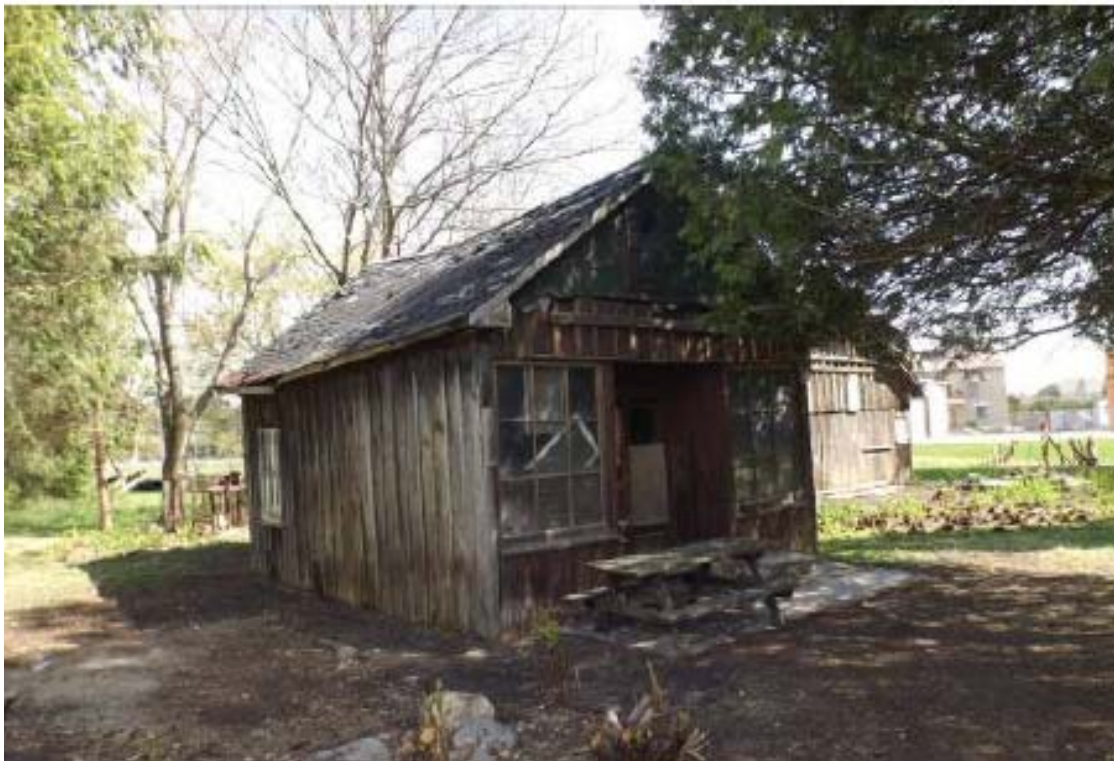
Small Outbuilding (from HIA)

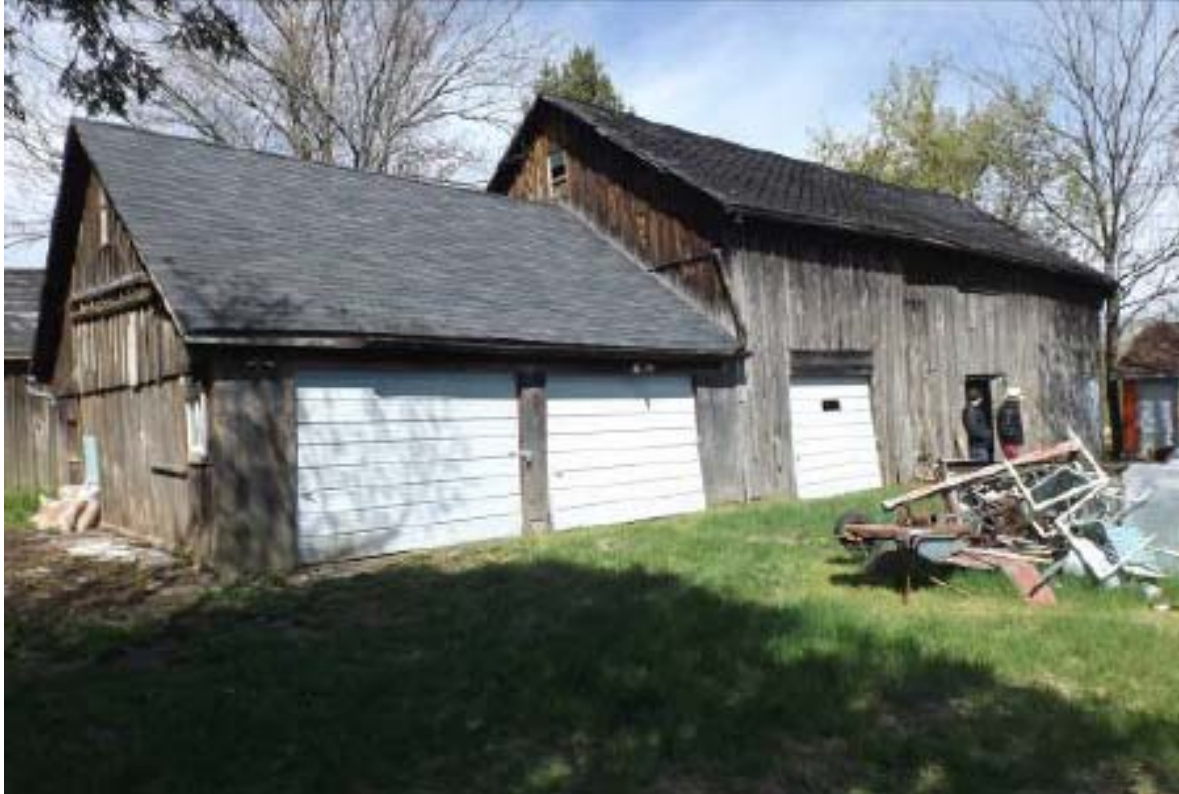
The Barn (from HIA)

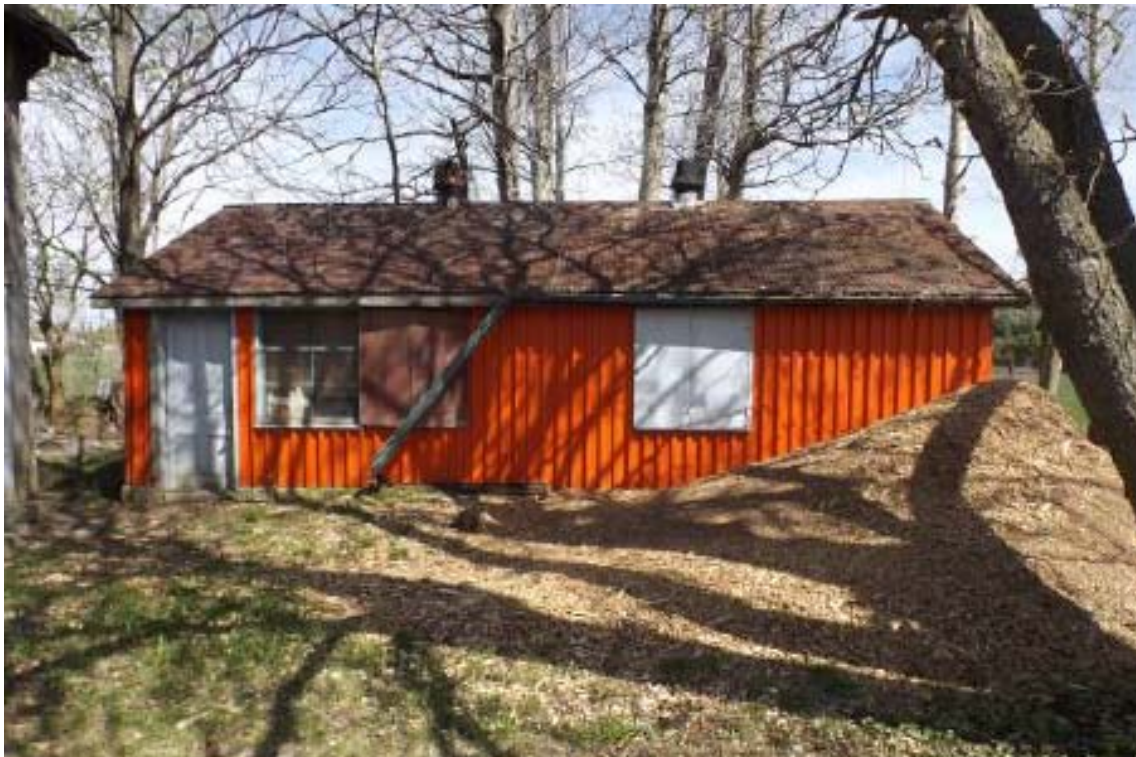
The Steel Shed (from HIA)

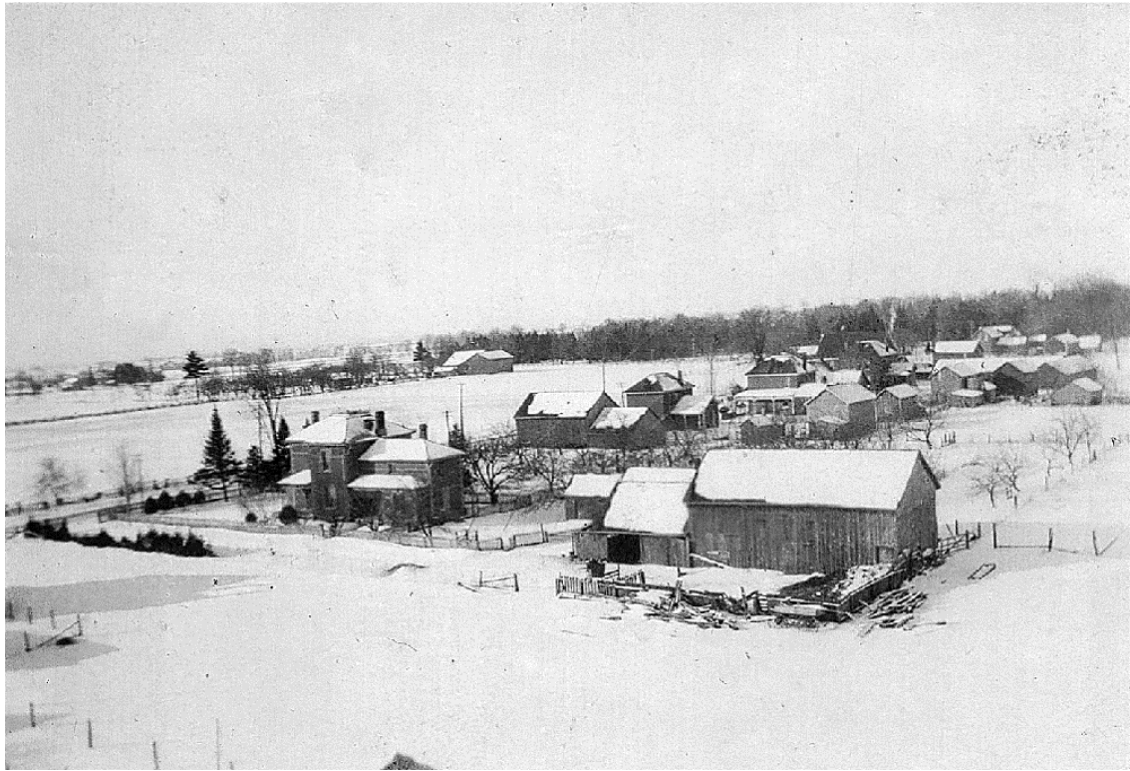
Undated Aerial Photograph of the property from the City of Vaughan. House to the left, with outbuildings to the right. The house shows a smaller, open, front verandah, and the original tail with a one-storey pantry (?) at the northeast corner and a rear kitchen verandah under an extension of the pantry roof. Note that there is no building to the northeast of the barn, where the current steel shed sits. Compare with the 1942 aerial photo in figure 5, which suggest that this image predates that aerial photo.

- Based on the research undertaken in the HIA, it has been found through historic aerial photography and the visible post brackets on the exterior of the closed in verandah that the closed-in verandah was once open and that the original kitchen tail has since been altered significantly. The verandah will be restored to an open design. The tail addition will be removed and the north wall of the dwelling restored.

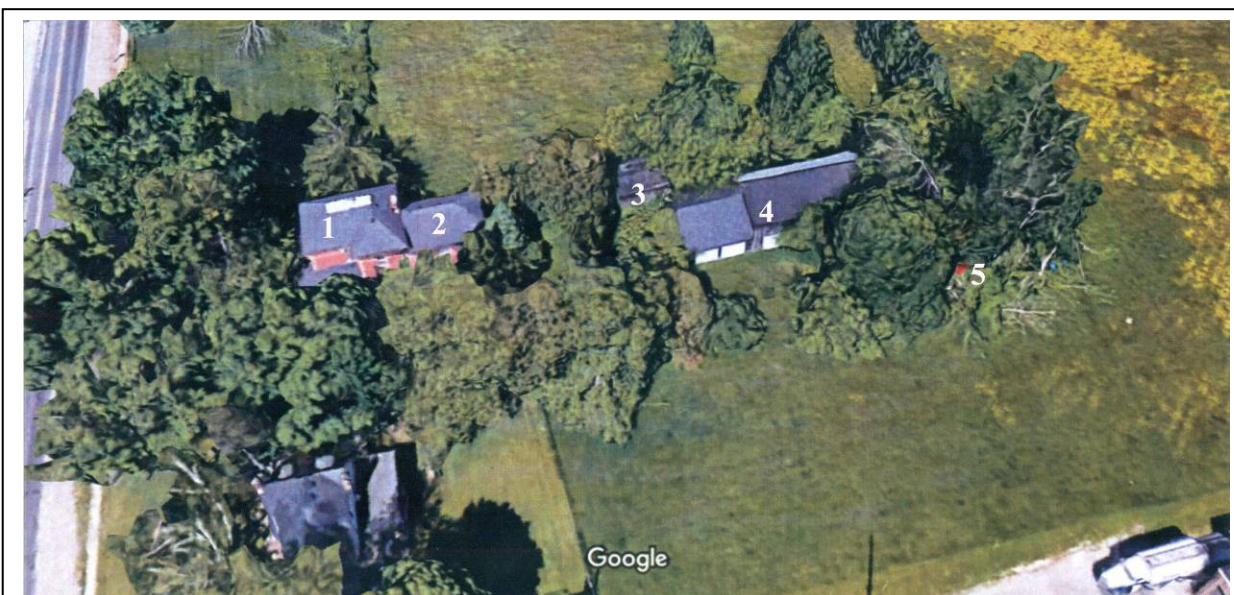
Figure 4. Aerial view showing the existing buildings on the property.

There are 5 structures on the property, shown in the Google satellite view above.

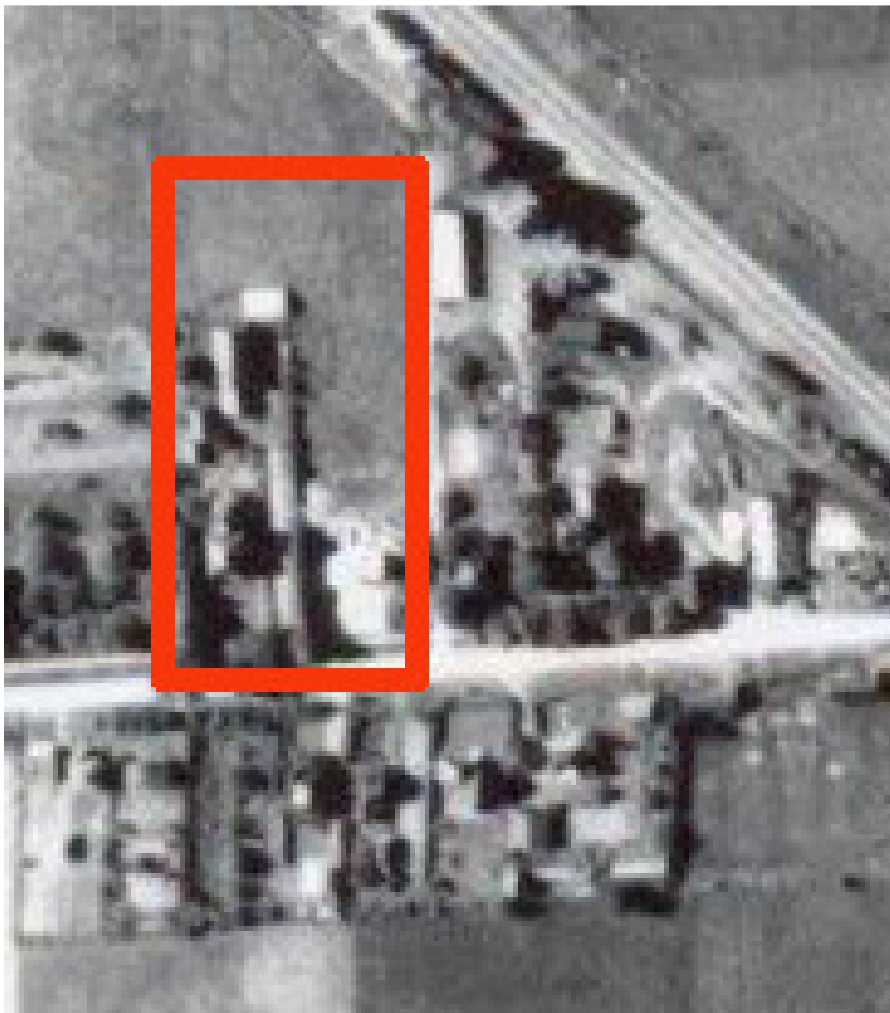
Figure 5. Detail from aerial photo, April 1942, from the Vaughan Archives. The house and outbuildings are visible. There appears to be a smaller building to the left front of the small outbuilding. We believe that the rear-most building is an older building, not quite of the same size and location as the current red steel shed. See drawing in Figure 24. See also survey in Figure 4 in Su Murdoch's Ownership Chronology, Appendix A.

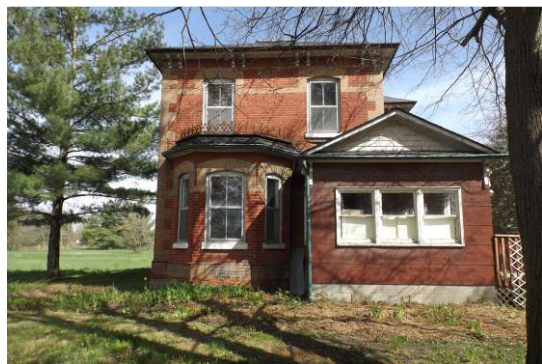
The farmhouse is a two-storey polychrome brick vernacular Victorian house with both Gothic and Italianate aspects. The walls are of red brick, with quoins and hooded segmental window arches in contrasting buff brick. There are two-course buff bands on both storeys at the level of the bottom of the window hoods. There is a 4-course band of buff brick at the level of the ground floor, topped by a dark projecting water-table course. The foundation is shaped field stone.

The main roof of the house is a shallow hip with strongly projecting eaves supported by paired brackets. It has a small flat section at the top. The verandah roof has a shallow front-facing gable. There is a one-storey octagonal bay-window on the right. The bay has a flat roof with a steep-slope shingled skirt, topped with iron cresting. All roofing material is asphalt shingle.

The overall condition of the masonry is good, with some spalling and mortar erosion.

Figure 6. Front (south) elevation.

- Renew all roofing, including main house, verandah, and bay window, and including flat roof portions,
- Remove enclosure of the verandah, restoring original appearance. It appears that all but one of the original columns are in place, and the replacement column is to replicate the originals.
- Renew or repair all flashings and rainware,
- Remove paint from masonry within existing enclosed verandah using non-abrasive methods. Work to be performed by qualified restoration contractor.
- Clean all masonry using gentlest methods—detergent and water with hand brushing,
- Replace damaged masonry units using salvaged material from the tail,
- Repoint masonry where joints are eroded, using historic lime mortar to match original,
- Insulate the roof, and provide ventilation as required.

- Replace existing windows with modern units matching original design.
- Restore the masonry on the north elevation, where the tail is to be removed. Until the removal, it's not possible to specify the work. We will provide a plan for this work once it is visible. Historic masonry units from the tail should be kept on site for re-use in this work.

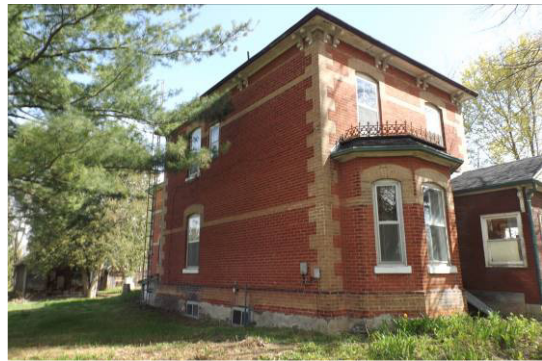
Figure 7. View from the northwest.

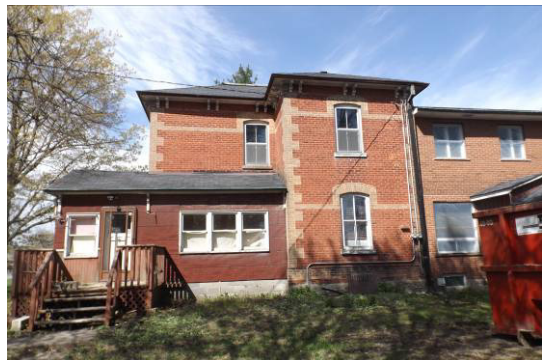
Figure 8. View from the east.

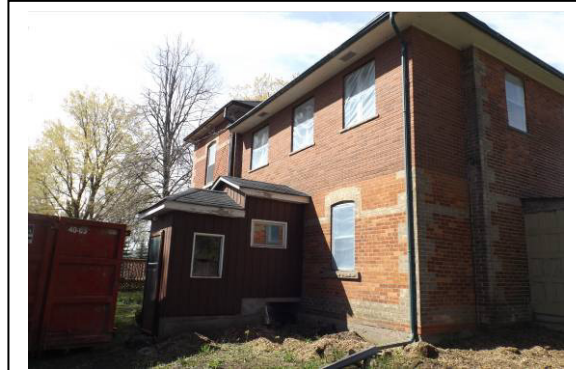
The masonry is in good condition, but greatly defaced by alterations to the window openings.

Figure 9. View from northeast. Window at lower right is the only original opening in the tail. The frame entry porch is recent.

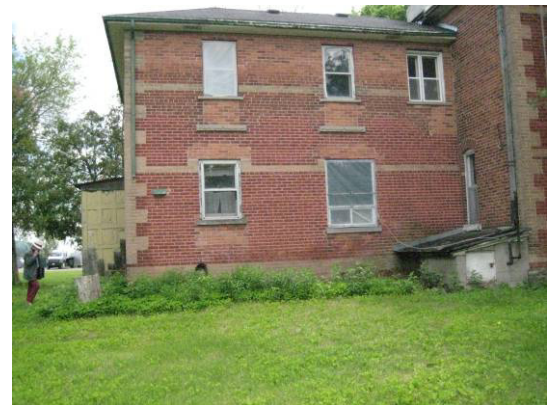
Figure 10. View from west. Original brick, but no original window openings.

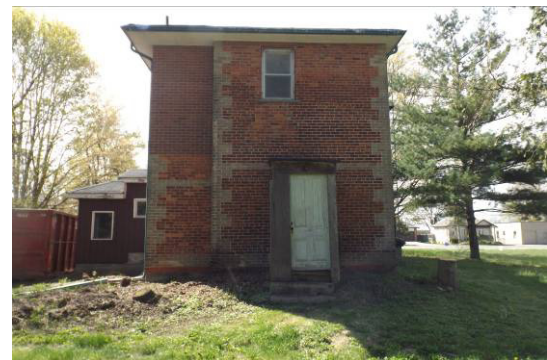
Figure 11. View from the north. Ad-hoc frame rear vestibule. Original brick on the right, and at ground floor on the left. Window opening not original.

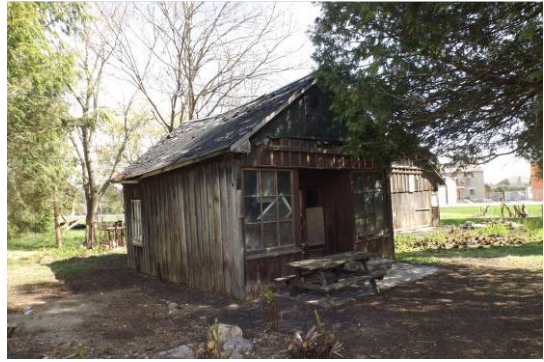
Figure 12. Front (south) side of the small outbuilding. Large 6-pane windows flank a recessed glazed entry door. Sagging wall and roof are evident.

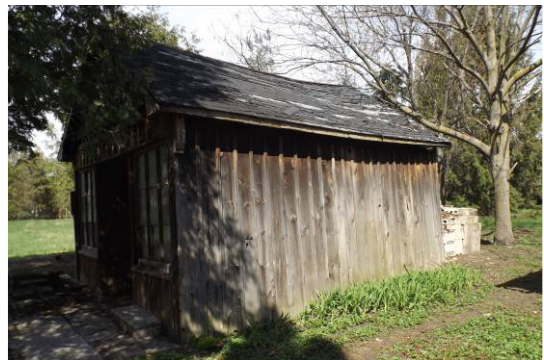
The small outbuilding is located about 15m behind the west side of the farmhouse. It is about 16 ft wide x 20 ft deep, with a steep front-facing gable roof in asphalt shingles. It has been fitted out with a shopfront facing the farmhouse. It is in poor condition, with a great deal of structural sagging in the west wall and the roof. This building appears in historic aerial photos dating from 1942 to the late 60s, and had an additional small building to the left front.

Figure 13. East side of small outbuilding.

In our professional opinion, the outbuildings—due to their structural deficits and poor condition should not be considered worthy of retention for heritage reasons. They are hazardous as they stand, and do not have a viable future use. We find no heritage reasons to prevent their removal.

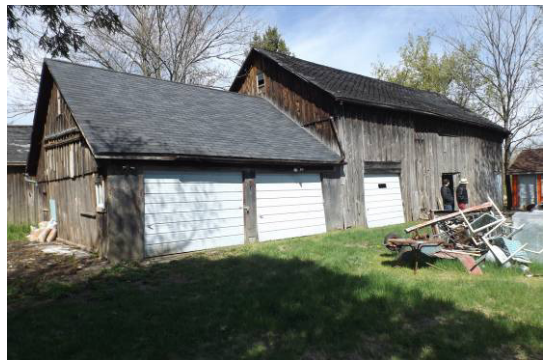
Figure 14. The barn from the southeast. The large openings have been fitted with metal overhead garage doors. Pictures of the barn continue on the next page.

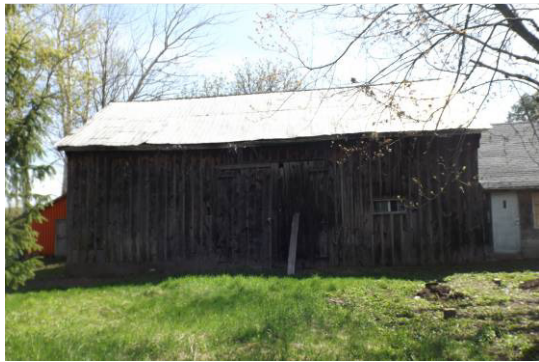
The barn is in poor condition, sagging to one side, with sagging 2<sup>nd</sup> floor joists, and signs of rot. It is framed in studs, not barn framing.

Figure 15. West side of the barn. This roof slope is in metal.

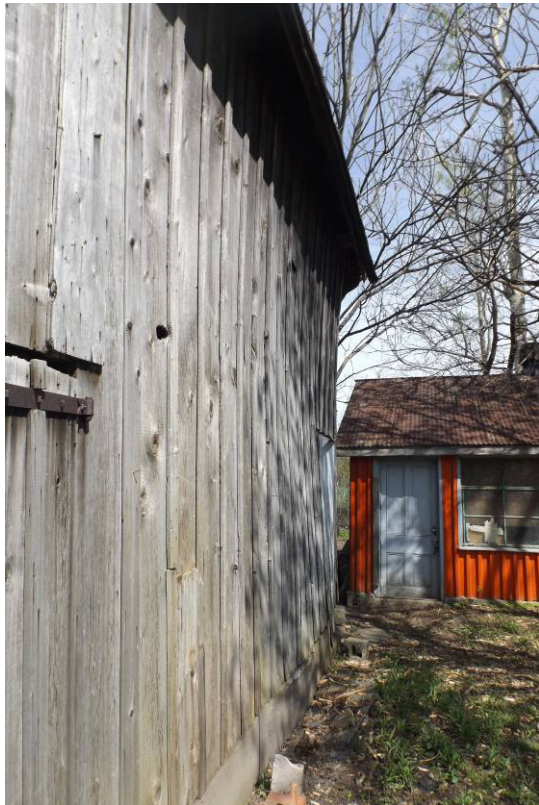
Figure 16. East side of barn showing bowed wall. Steel shed to the rear.

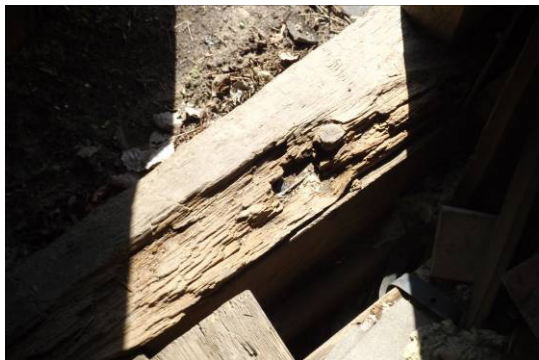
Figure 17. Rot in the timber sill of the barn.

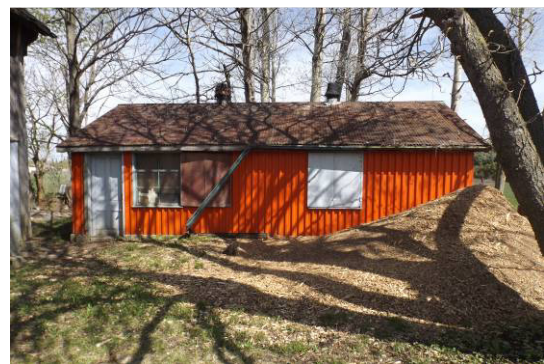
The steel shed is located to the immediate right rear of the barn. The medium sloped roof is of galvanized steel, heavily rusted. A tree has fallen against the middle of the north side. There is a building in this location in the historic aerial photos, but this building is certainly more recent than 1942.

Figure 18. South side of steel shed..

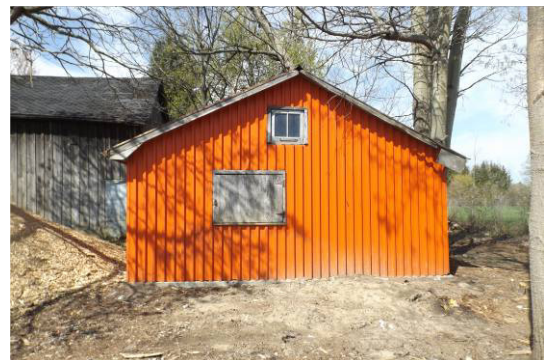
Figure 19. East side of steel shed. Barn is to the rear..

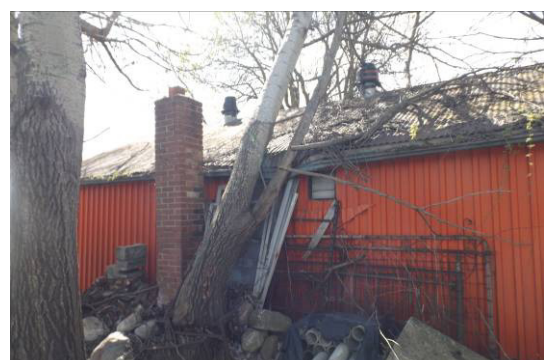
Figure 20. Tree fallen against north wall and roof of the steel shed.

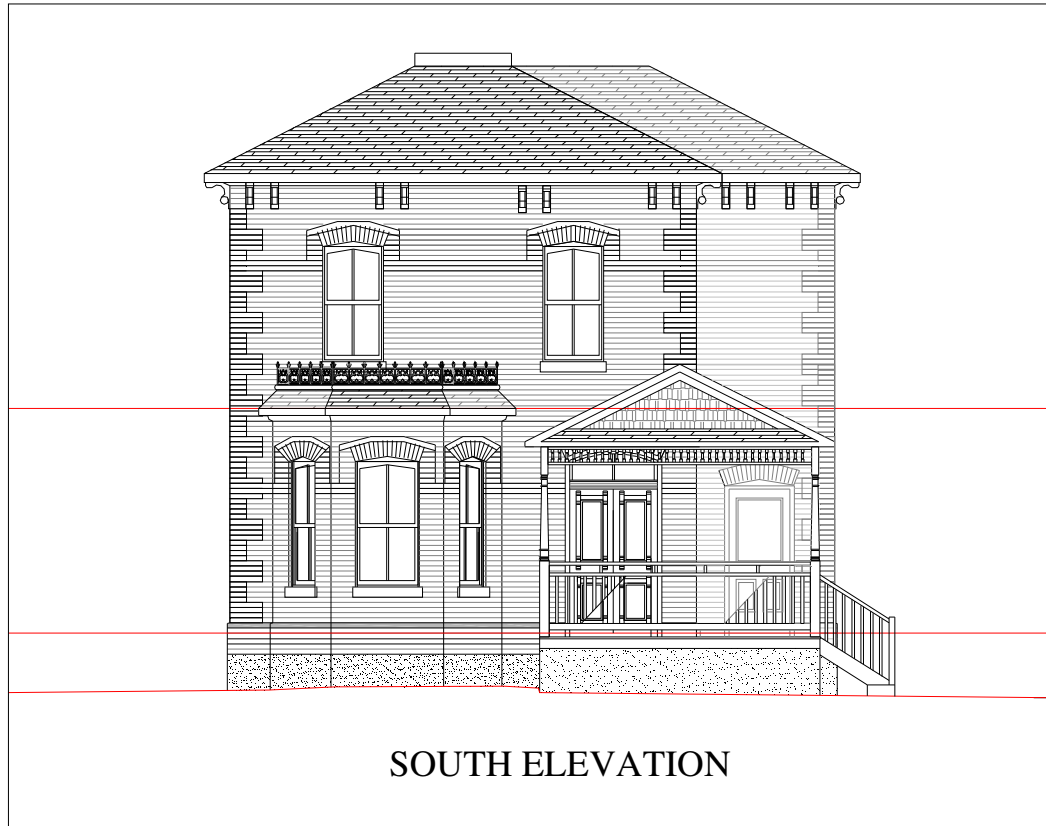
Figure 28.

Victorian columns and gingerbread spindles are conjectural at this point, based on some neighbouring examples. When verandah enclosure is removed, surviving material will form the basis of reconstruction details.

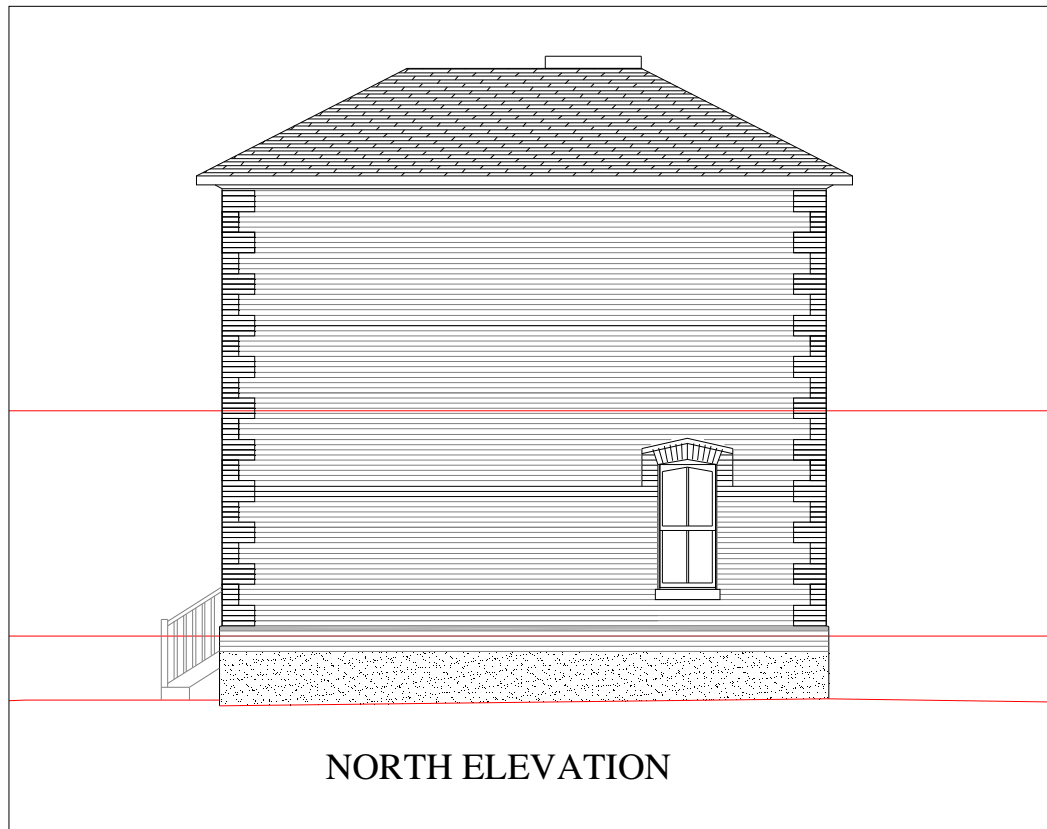
Figure 30.

This elevation is mostly concealed currently. There may have been a doorway on the ground floor. Detail plan for this elevation must await the removal of the tail, so we can determine best conservation measures.
