CITY OF VAUGHAN

EXTRACT FROM COUNCIL MEETING MINUTES OF SEPTEMBER 26, 2017

**RESTORATION OF A DETACHED
RESIDENTIAL BUILDING AND NEW DEVELOPMENT
9869 KEELE STREET AND 9891 KEELE STREET
(WILLIAM BAILEY HOUSE) - MAPLE HERITAGE CONSERVATION DISTRICT
DESIGNATED UNDER PART V, ONTARIO HERITAGE ACT
WARD 1 - EAST SIDE OF KEELE STREET AND SOUTH OF MAJOR MACKENZIE DRIVE**

(GBCA Project No: 17021)

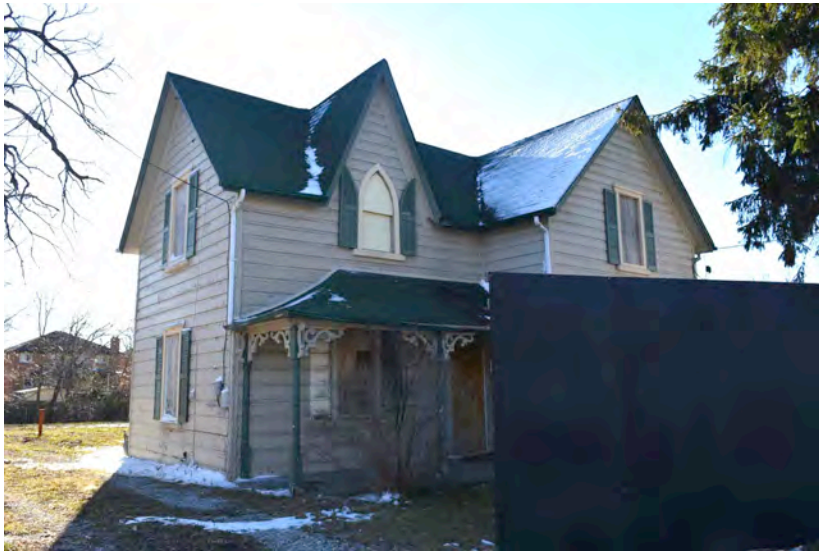
Above: North-West elevation of the building. April 2017.

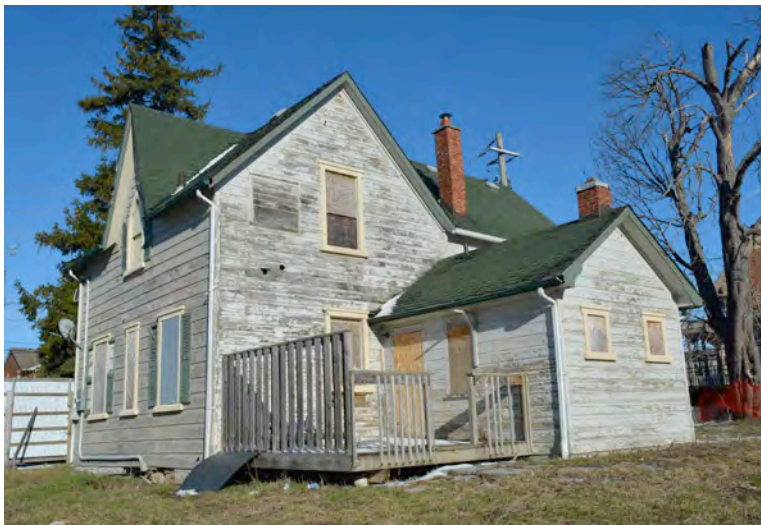
Above: South-East elevation of the building. April 2017.
